**Phase I - Environmental Site Assessment**

Half Moon Bay South (Phase 5)  
Greenbank Road  
Ottawa, Ontario

Mattamy Homes

Report: PE4536-1

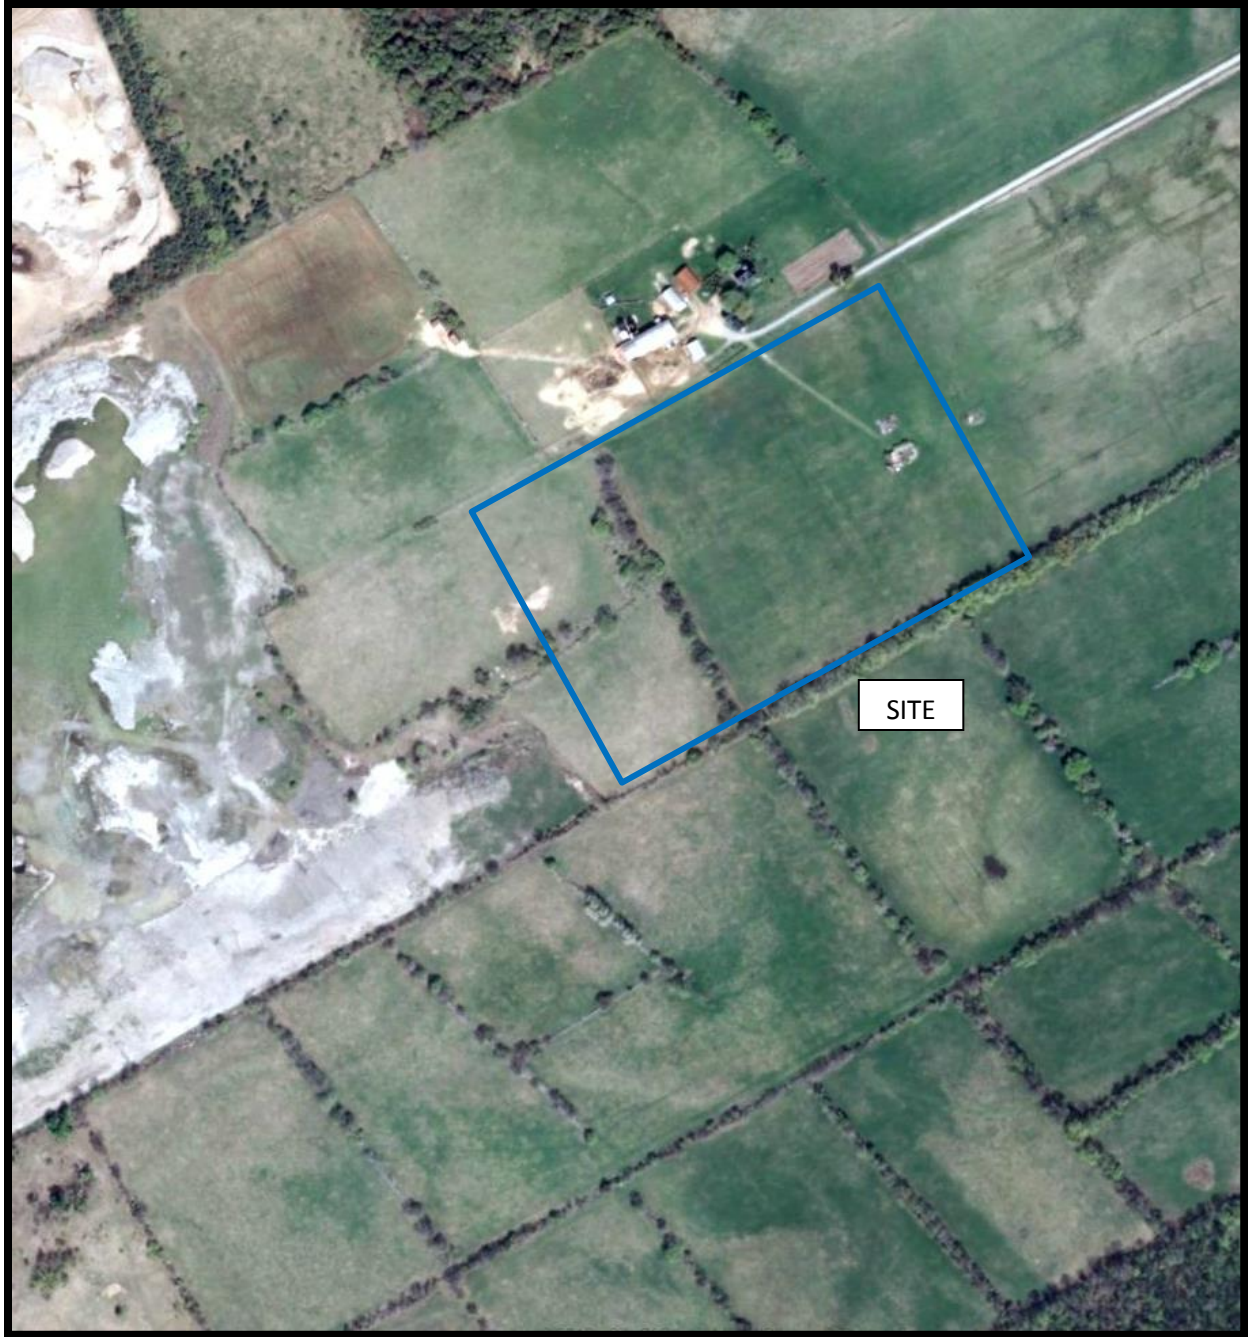
AERIAL PHOTOGRAPH  
2008

| 2008 | (City of Ottawa Website) The two (2) farm buildings on the eastern portion of the property appear to have been demolished. Debris from the buildings appears to remain on-site. No apparent changes have been made to the surrounding properties. |

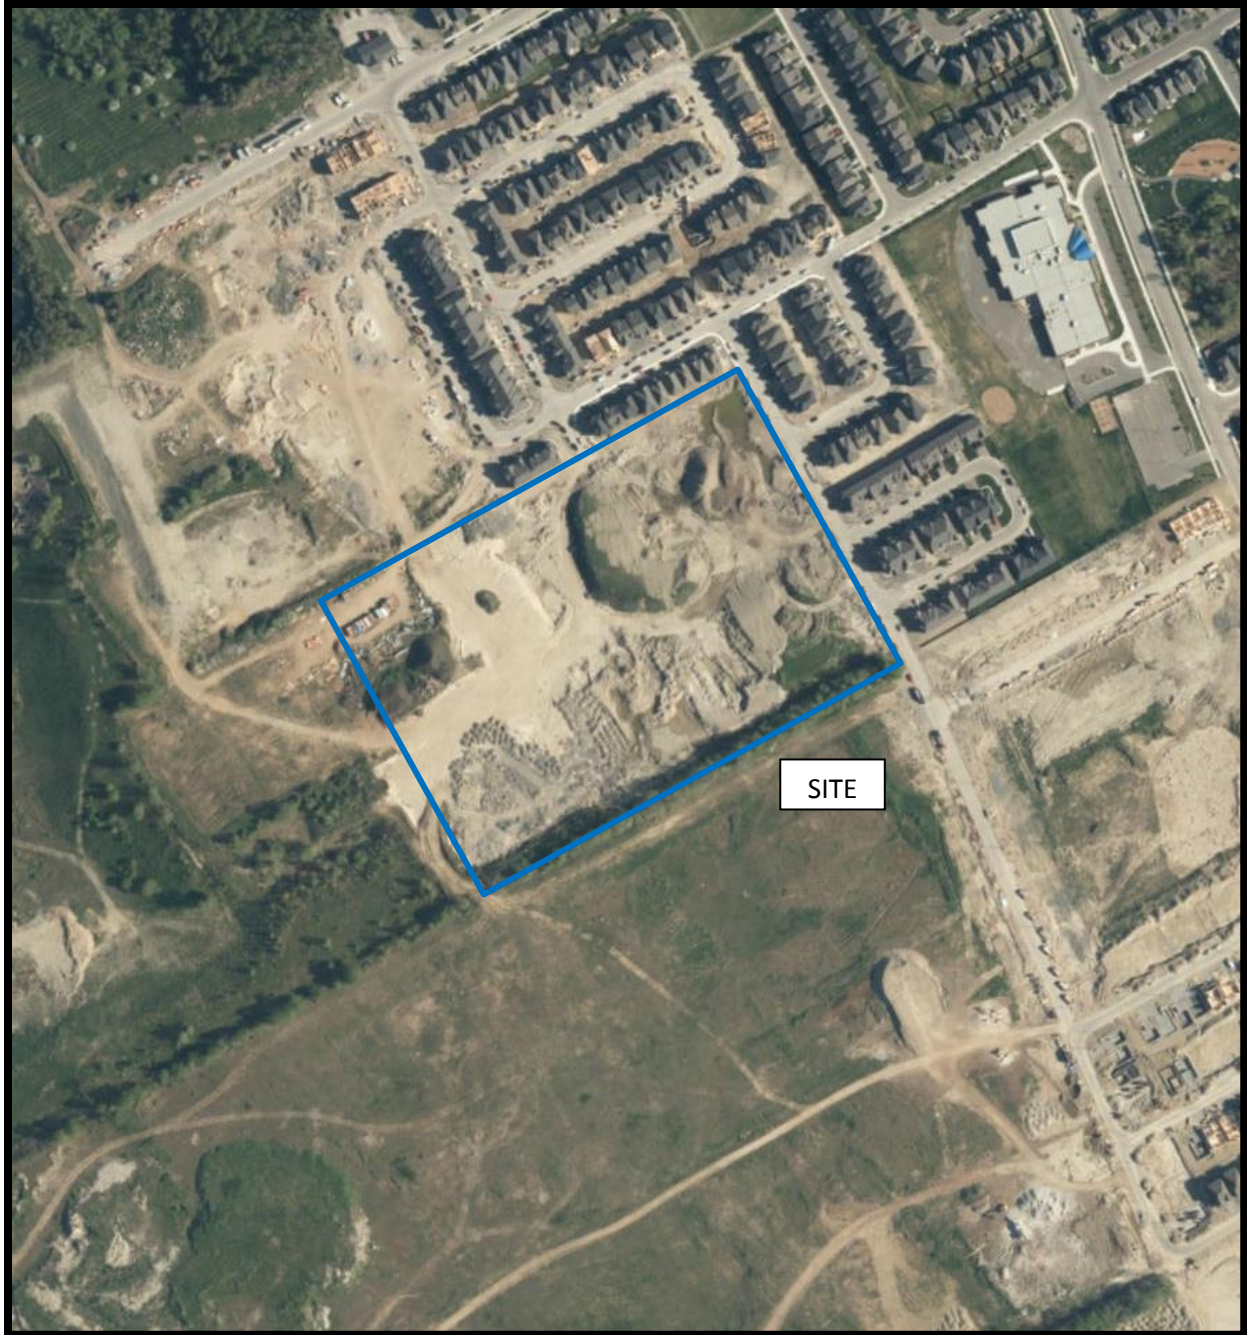
AERIAL PHOTOGRAPH  
2017

| 2017 | (City of Ottawa Website) The subject site appears in its current configuration. A neighbourhood consisting of residential dwellings has been constructed on the surrounding lands to the north and east. A school can also be seen east of the subject site. Large quantities of soil material, organized into piles of varying size, can be seen scattered throughout the subject property. Some metal shipping containers and construction materials can also be seen on the western portion of the subject property. |

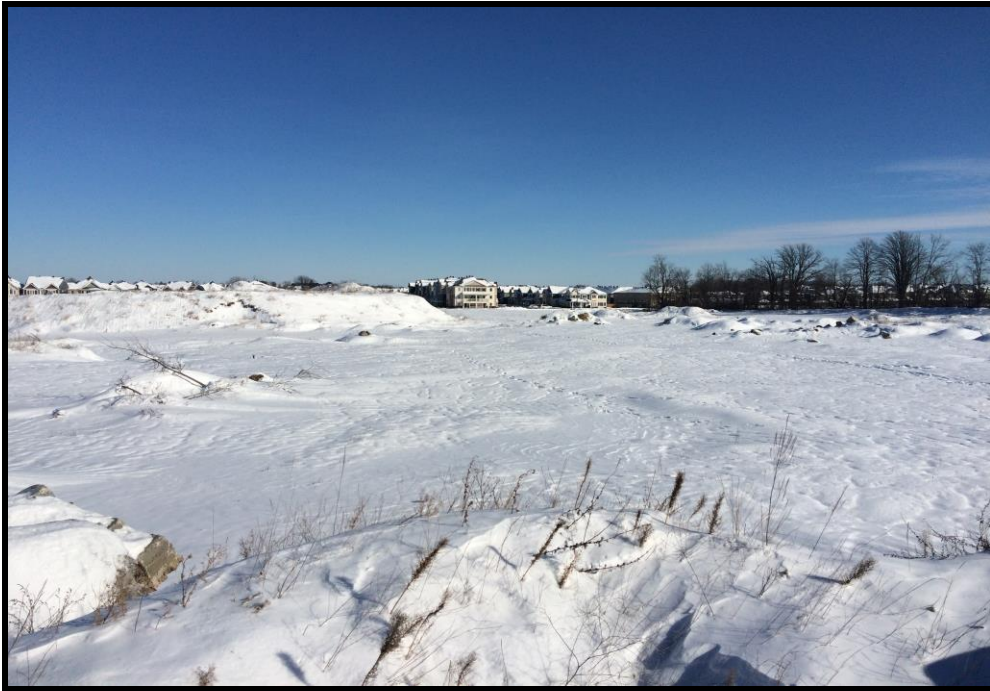
Photograph 3: View of the western portion of the property, facing east.

The subject site is not developed with any buildings and currently exists as vacant land. The subject site contains numerous stockpiles of soil of varying sizes, scattered throughout the property. It is our understanding that this material is excess native soil, which was placed on site during the development of the surrounding residential neighbourhood. Some construction materials, as well as a small metal shipping container, were present on the western portion of the property. The interior of the metal shipping container could not be accessed at the time of the site inspection.

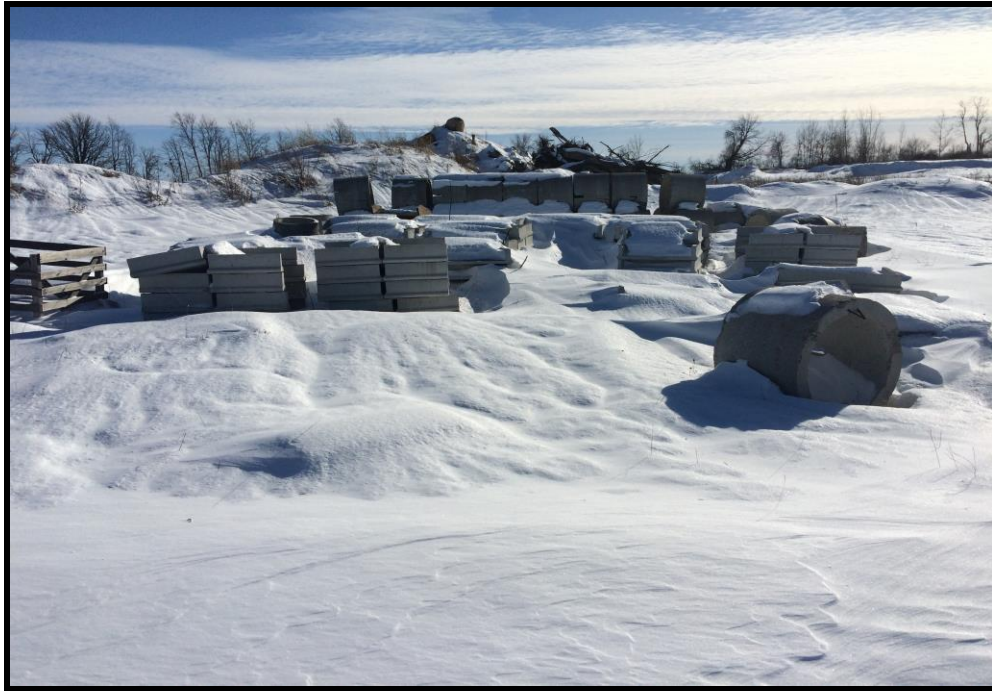
Some construction material was observed, on the western portion of the property, in a small metal bin as well as several piles on the ground. The waste material observed was noted to be mainly wood, concrete and metal and does not pose a concern to the subject property.

Photograph 5: View of construction materials located on the western portion of the property.

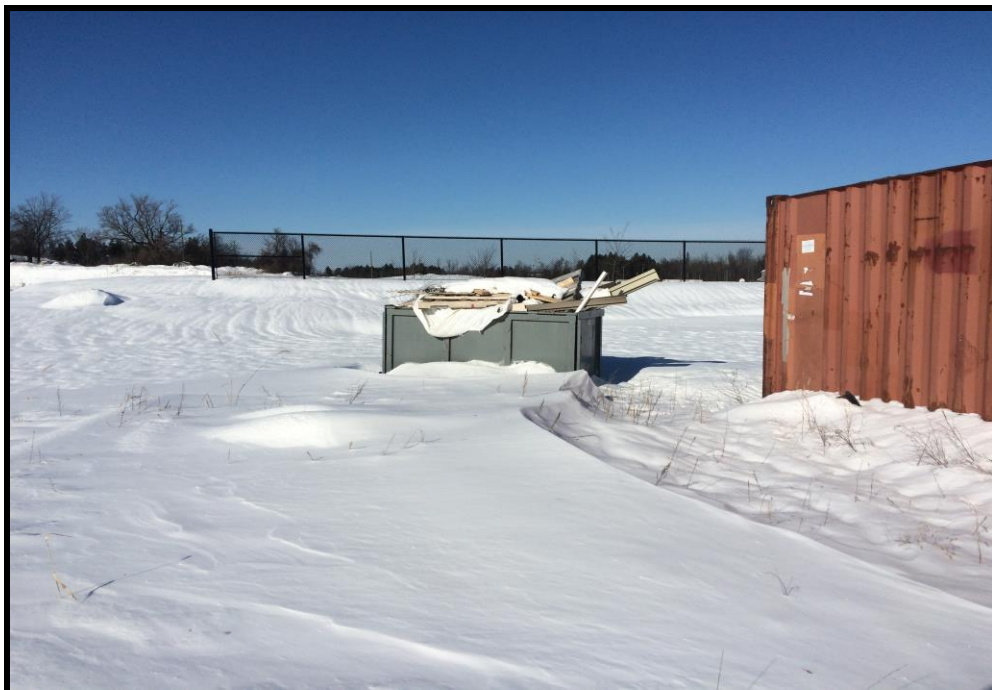
The subject site is currently vacant and grassed, with the exception of one (1) small metal shipping container located on the western portion of the subject property. A depiction of the subject site is presented on Drawing PE4536-1 – Site Plan, in the Figures section of this report.

Photograph 6: View of a small metal shipping container and a small metal bin containing construction materials located on the western portion of the property.
