McKINLEY
ENVIRONMENTAL
SOLUTIONS

Combined Environmental Impact Statement &
Tree Conservation Report (Revised)
1053/1075/1145 March Road

November 2019
Prepared for CU Developments Inc.

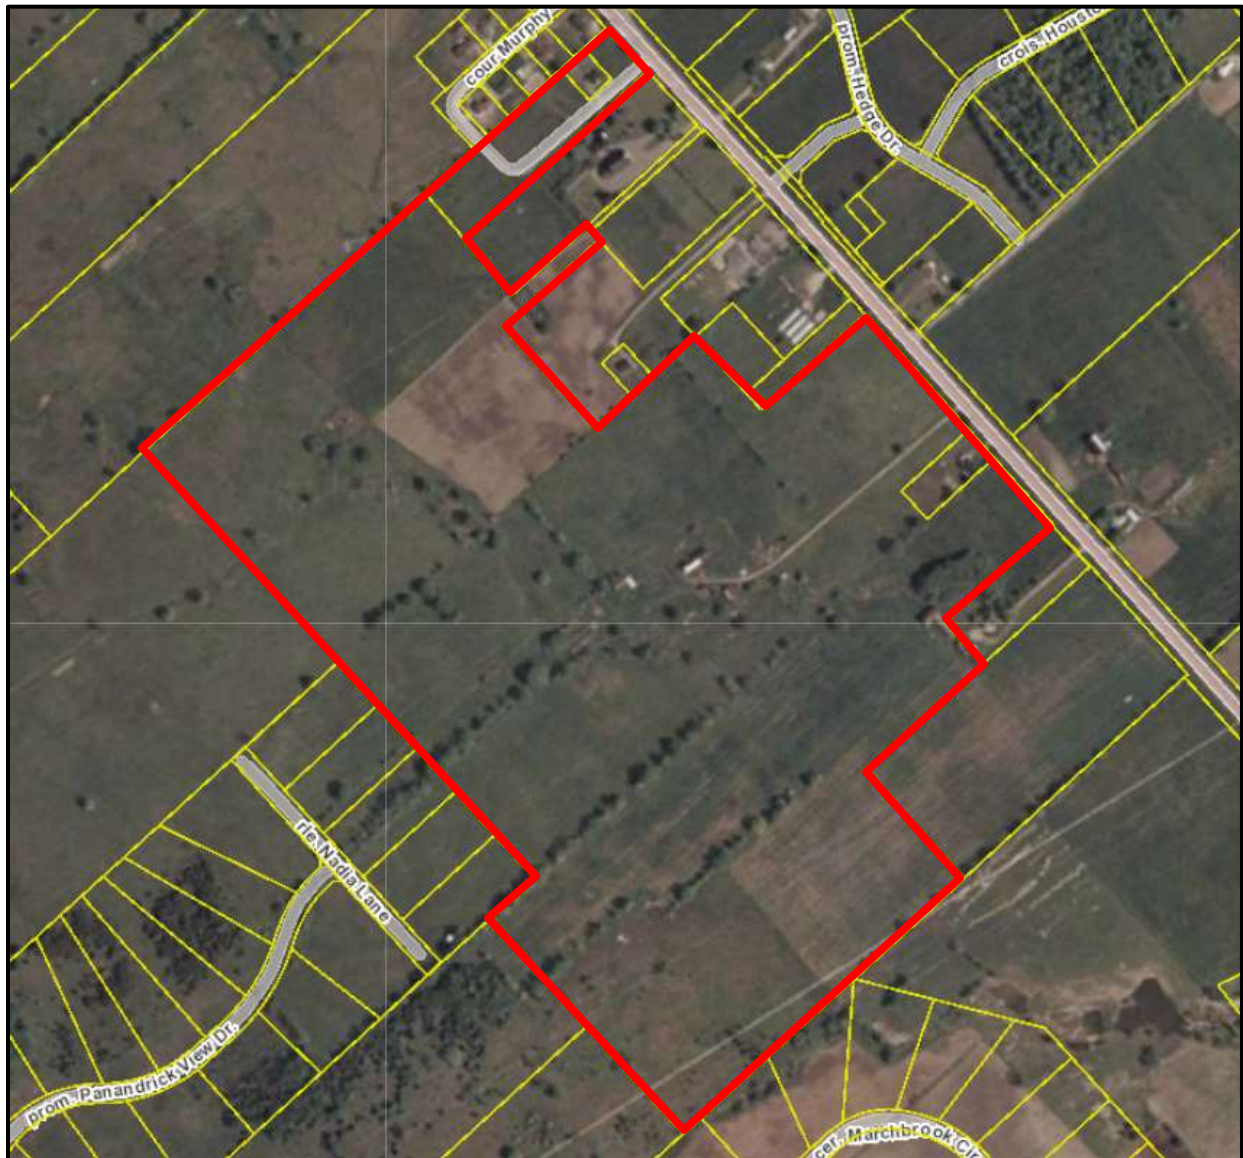
Historic Air Photograph 1: Historic Air Photo from 1976 (Site development limits shown in red). Note that the Study Area was intensively farmed and tree cover was limited to the hedgerows in 1976. Regeneration of trees and shrubs in the southwestern part of the Study Area was not yet underway in 1976 (Photos from City of Ottawa 2018).

Air photos from 1976, 1991 and 2005 are included below (Photos from City of Ottawa 2018). Recent air photos are included in the report figures. The oldest available historic air photo (from 1976), shows that the Study Area was intensively farmed and tree cover was limited to the hedgerows in 1976. Regeneration of trees and shrubs in the southwestern part of the Study Area was not yet underway by 1976. The majority of the Study Area continued to be farmed in 1991, and mature tree cover continued to predominantly be confined to the hedgerows. However, regeneration of trees and shrubs in the southwestern corner of the Study Area and surrounding areas was underway by 1991. Based on their size in the 1991 air photo, it is likely that the largest trees in the southwest corner of the Study Area were approximately 10 years old at that time, which suggests that some stems may be up to approximately 40 years old in 2019. In 2005, the majority of the Study Area continued to be farmed, with mature tree cover limited to the hedgerows and Cultural Woodlots F and G. However, regeneration of trees and shrubs in the southwestern corner of the Study Area and surrounding areas had advanced significantly by 2005.

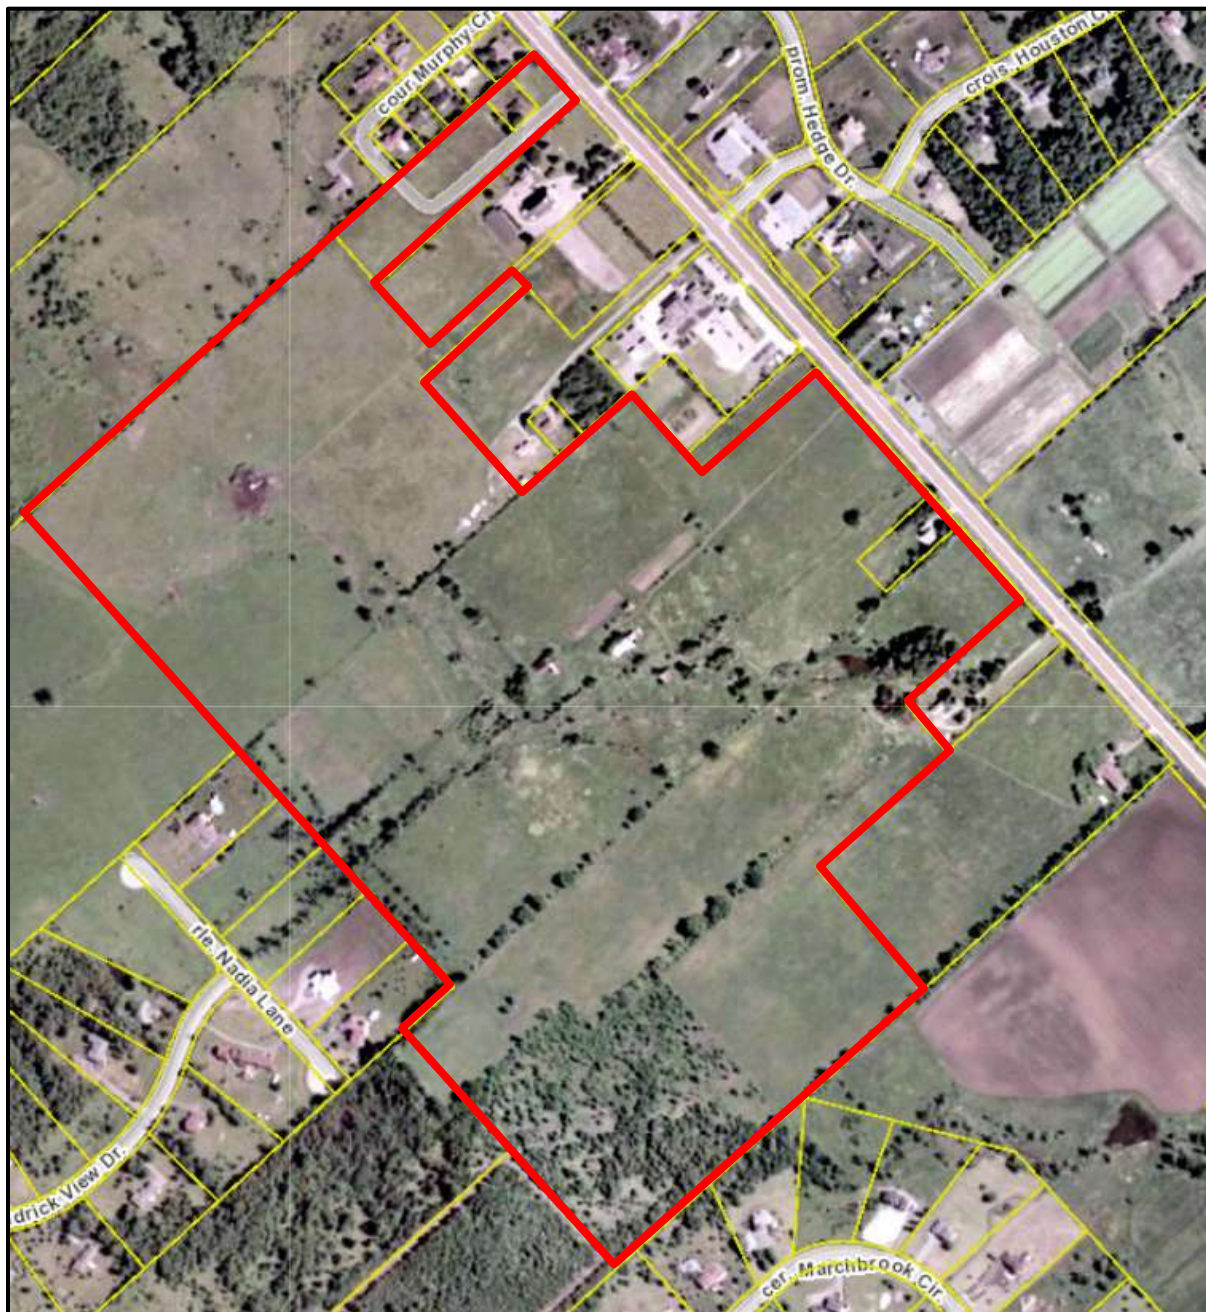
Historic Air Photograph 3: Historic Air Photo from 2005 (Site development limits shown in red). Note that the majority of the Study Area continued to be intensively farmed. Tree cover was limited to the hedgerows and Cultural Woodlots F and G in 2005. However, regeneration of trees and shrubs in the southwestern corner of the Study Area and surrounding areas had advanced significantly by 2005 (Photos from City of Ottawa 2018).

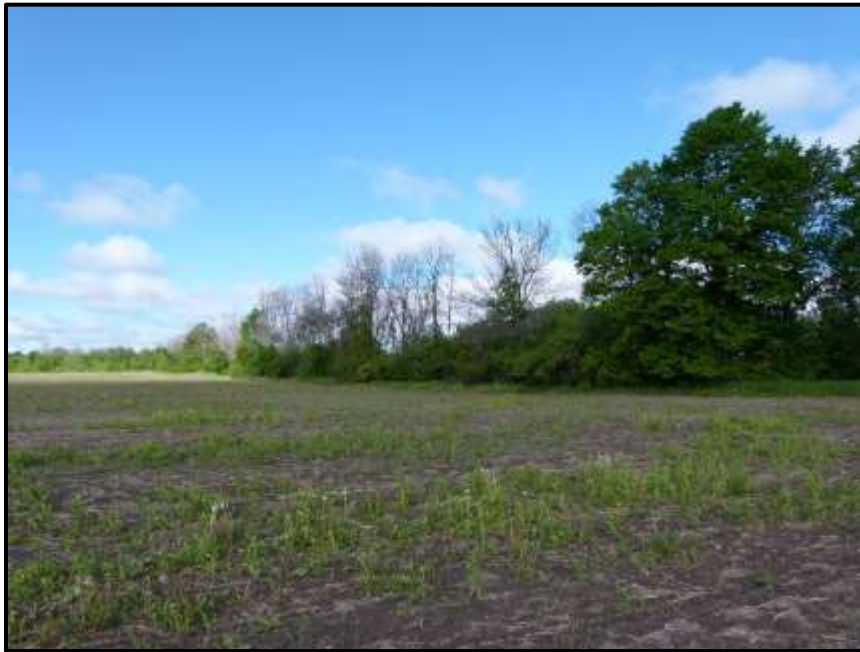
Photograph 9: Looking northwest at Deciduous Hedgerow H with a large Bur Oak (63 cm dbh) shown on the right. Dead/stressed Ash stems are visible in the center of the photo (June 3rd, 2017).

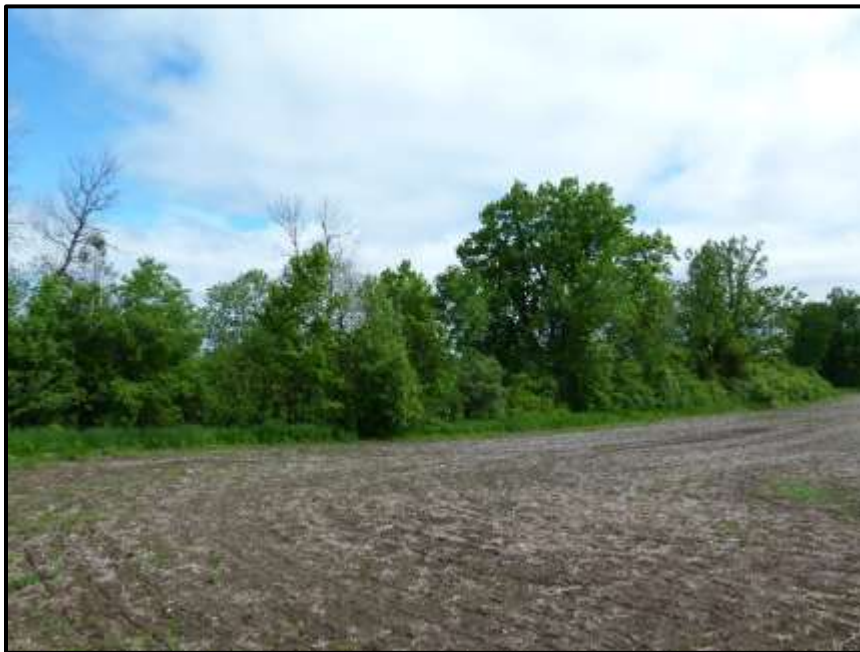
Photograph 10: Looking north at Deciduous Hedgerow I with a large Bur Oak (70 cm dbh) shown on the right (June 3rd, 2017).

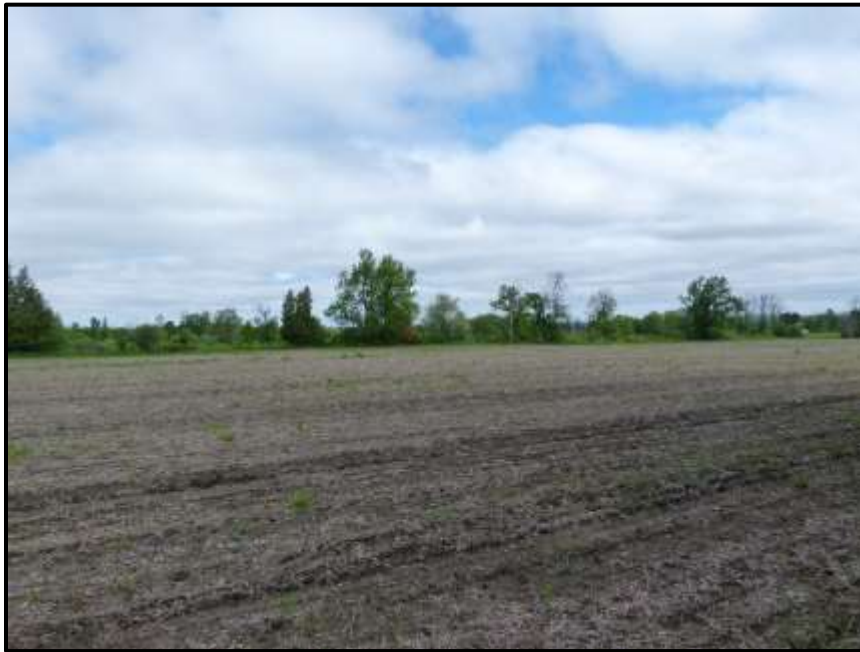
Photograph 11: Looking north at Deciduous Hedgerow J with a large approximately 66 cm dbh Bur Oak shown in the center of the photo (June 3rd, 2017).

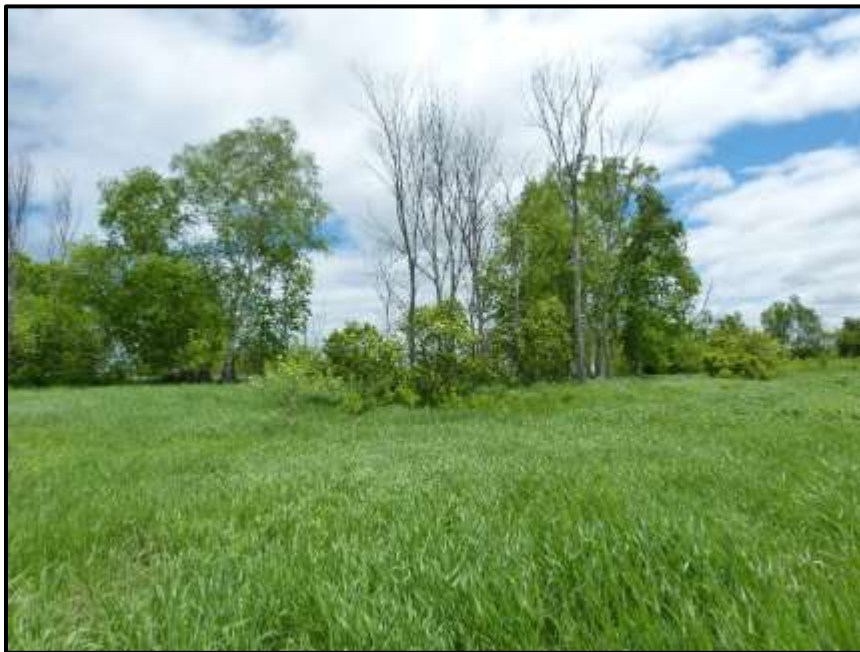
Photograph 12: Looking southwest at Deciduous Hedgerow K with a dead American Elm shown in the foreground (June 3rd, 2017).

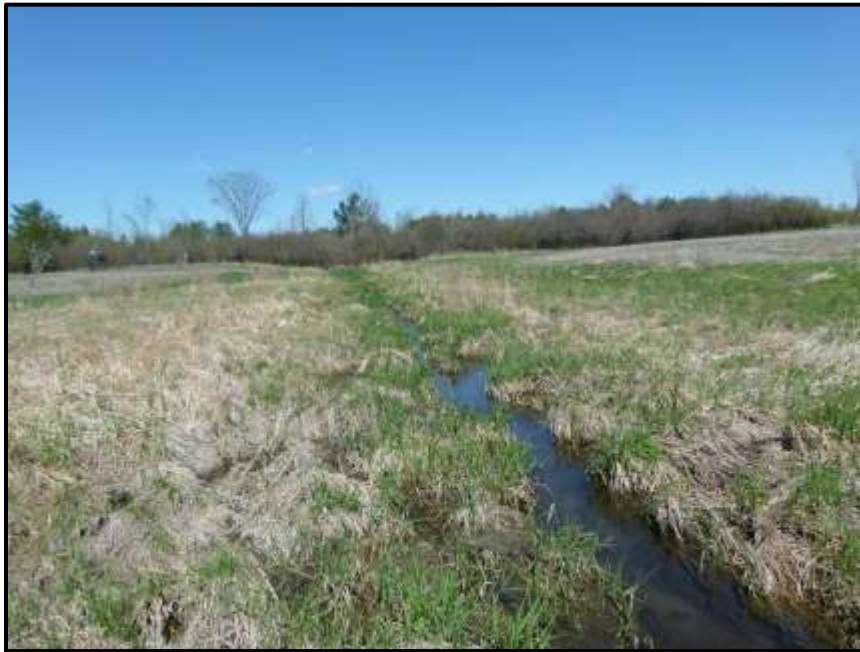
Photograph 24: HDA Survey Site #4 upstream – north fork, facing upstream. Note that the channel is narrow and relatively shallow, even in the spring. The area shown is typical of the North Tributary throughout the Study Area (May 12th, 2018).

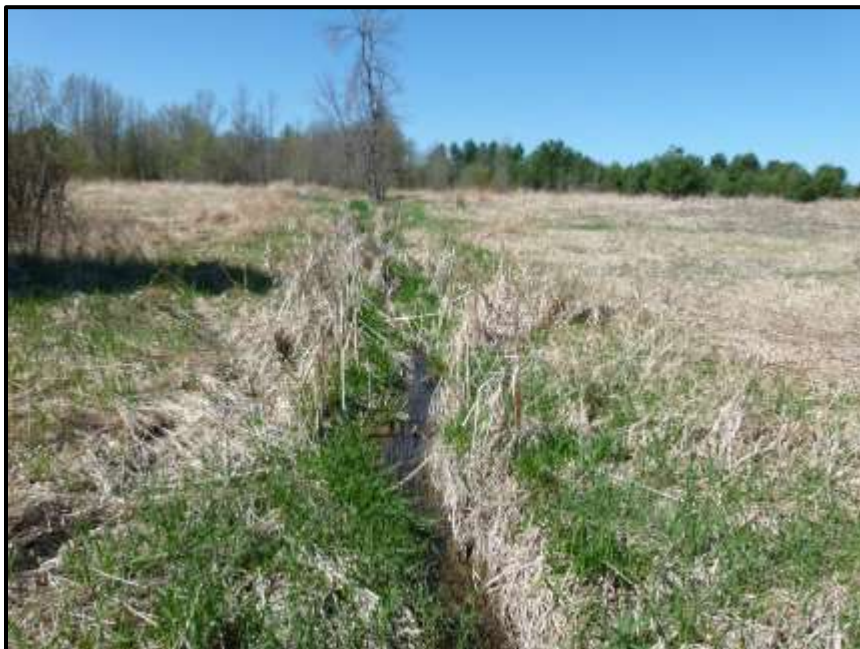
Photograph 25: HDA Survey Site #3 (Channel F), facing upstream. Note that Channel F does not convey substantial water flow, even in the spring (May 12th, 2018).

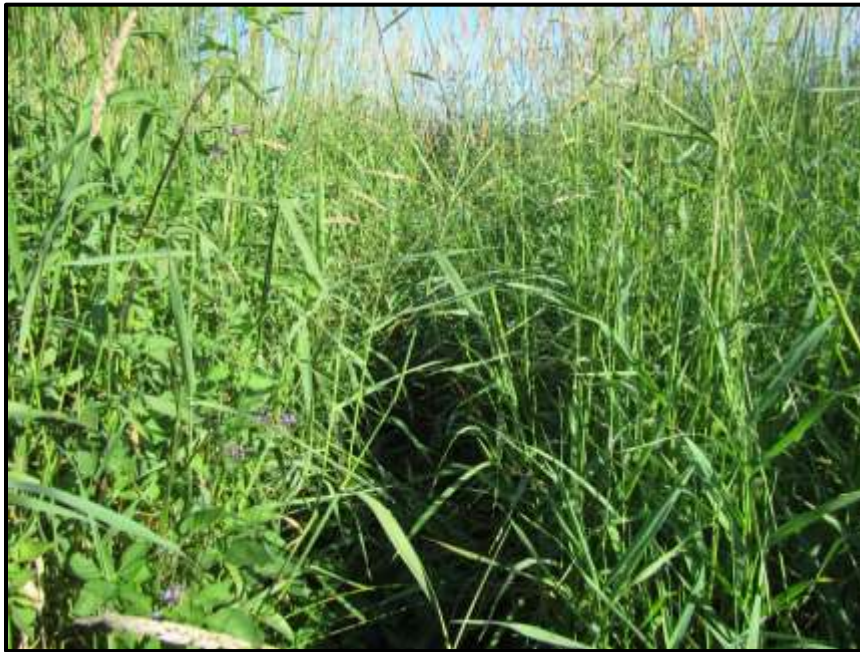
Photograph 26: HDA Survey Site #3 (Channel F) downstream, facing upstream. Note that Channel F is completely overgrown and dry in the summer (July 4th, 2018).

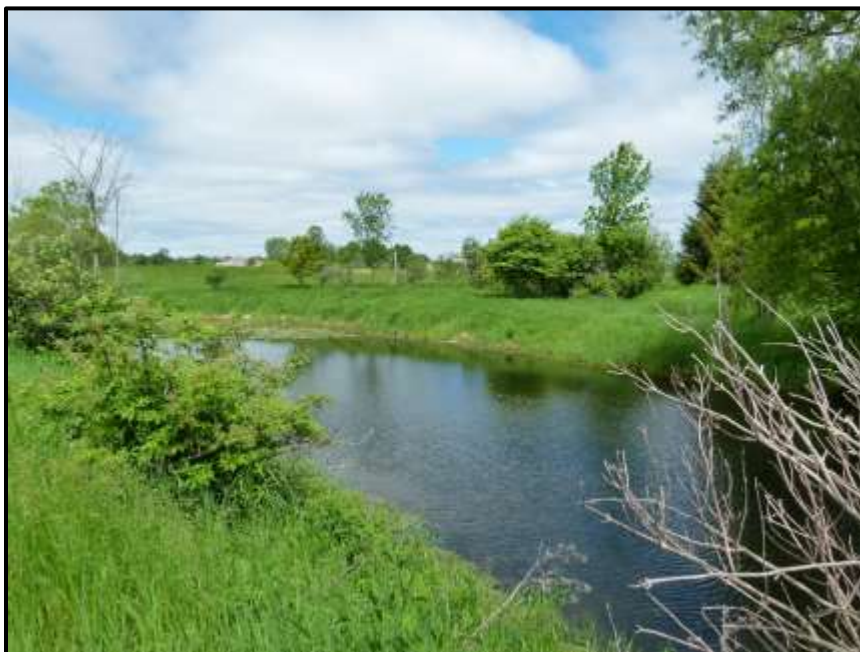
Photograph 27: Looking west at the pond. Note that the majority of the pond's surface area remains as open water, even in mid-summer (June 3rd, 2017).

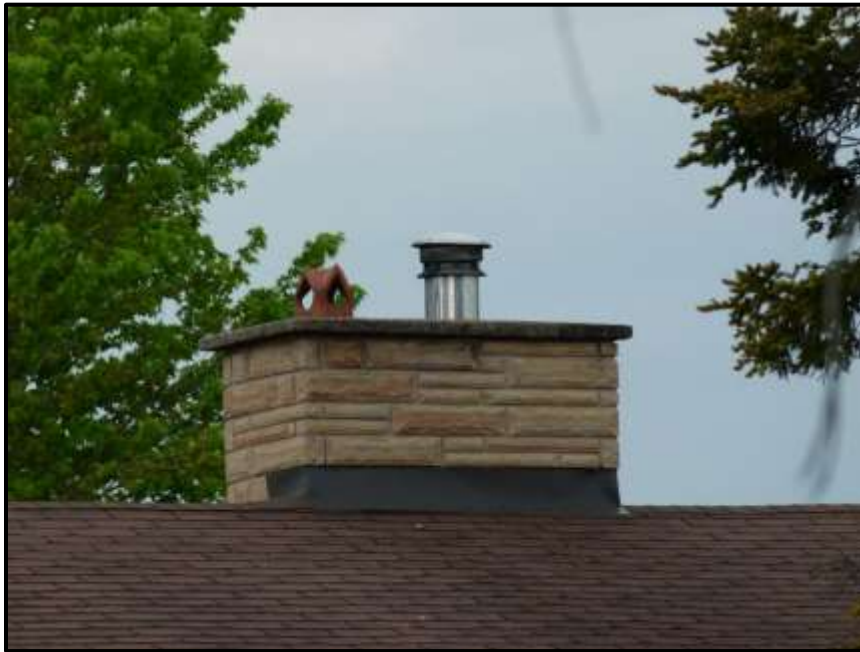
Photograph 31: Chimney at 1015 March Road. Note the metal cap and ceramic liner (May 24th, 2017).

Photographs of the chimneys are included below. Chimney Swift typically will not nest in chimneys with ceramic liners, as they are unable to affix their nests to the smooth interior surface. Chimney Swift are unable to enter chimneys with wire mesh or metal caps. There are therefore no chimneys within the Study Area which may be suitable for Chimney Swift nesting. Due to the absence of potentially suitable chimneys within the Study Area, a survey for Chimney Swifts was not required.

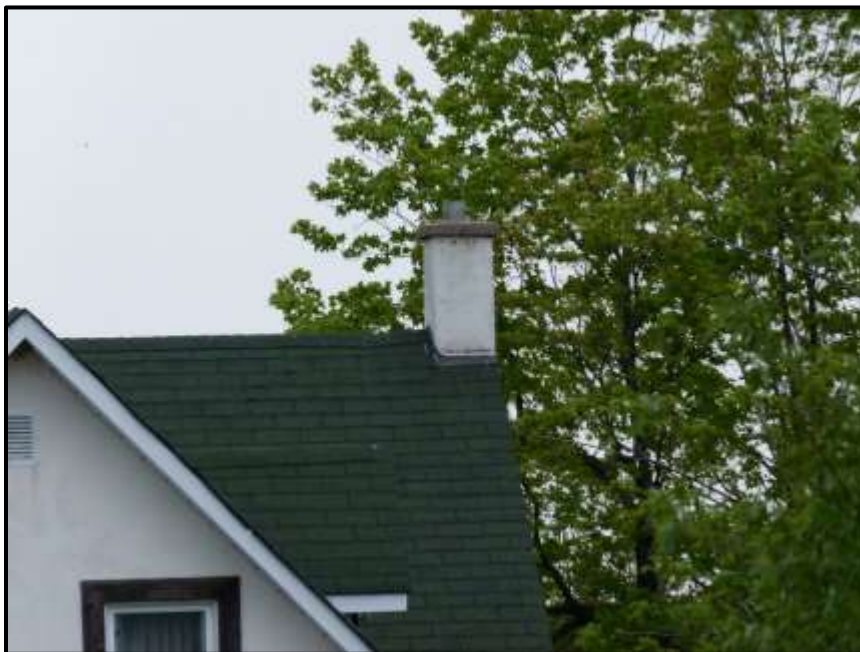
Photograph 32: Chimney at 1035 March Road. Note the metal liner (May 24th, 2017).

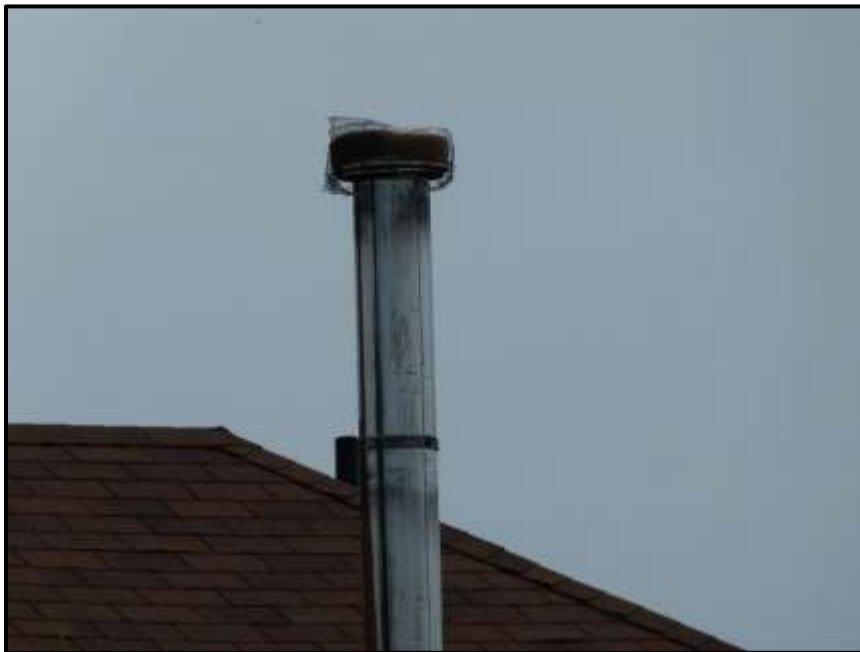
Photograph 34: Chimney at 1113 March Road. Note the metal liner and wire mesh cap (May 24th, 2017).

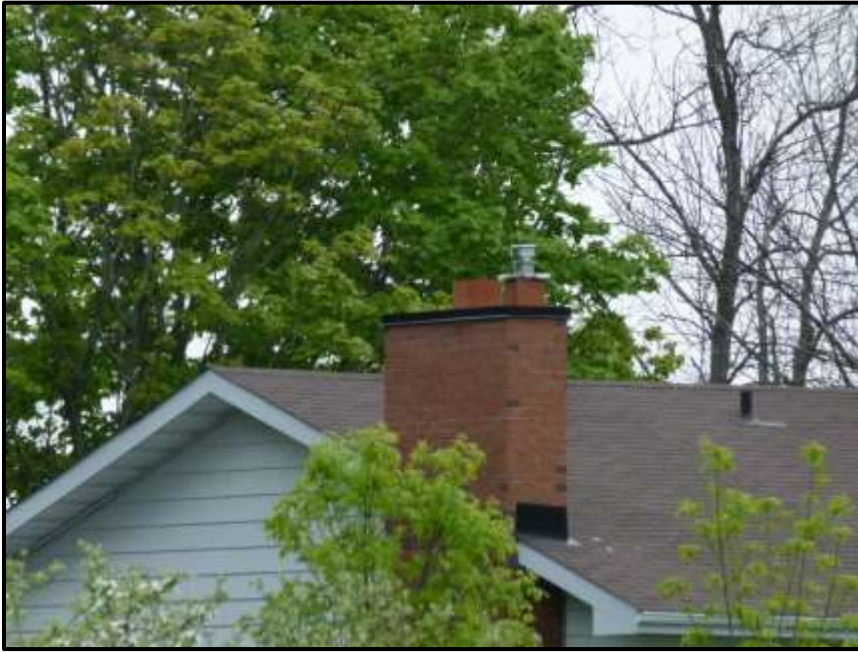
Photograph 35: Chimney at 1145 March Road. Note the ceramic liner and metal cap (May 24th, 2017).
