Phase I Environmental Site Assessment

Vacant Land
Trim Road and Portobello Boulevard
Ottawa, Ontario

January 20, 2018

Report: PE4111-1

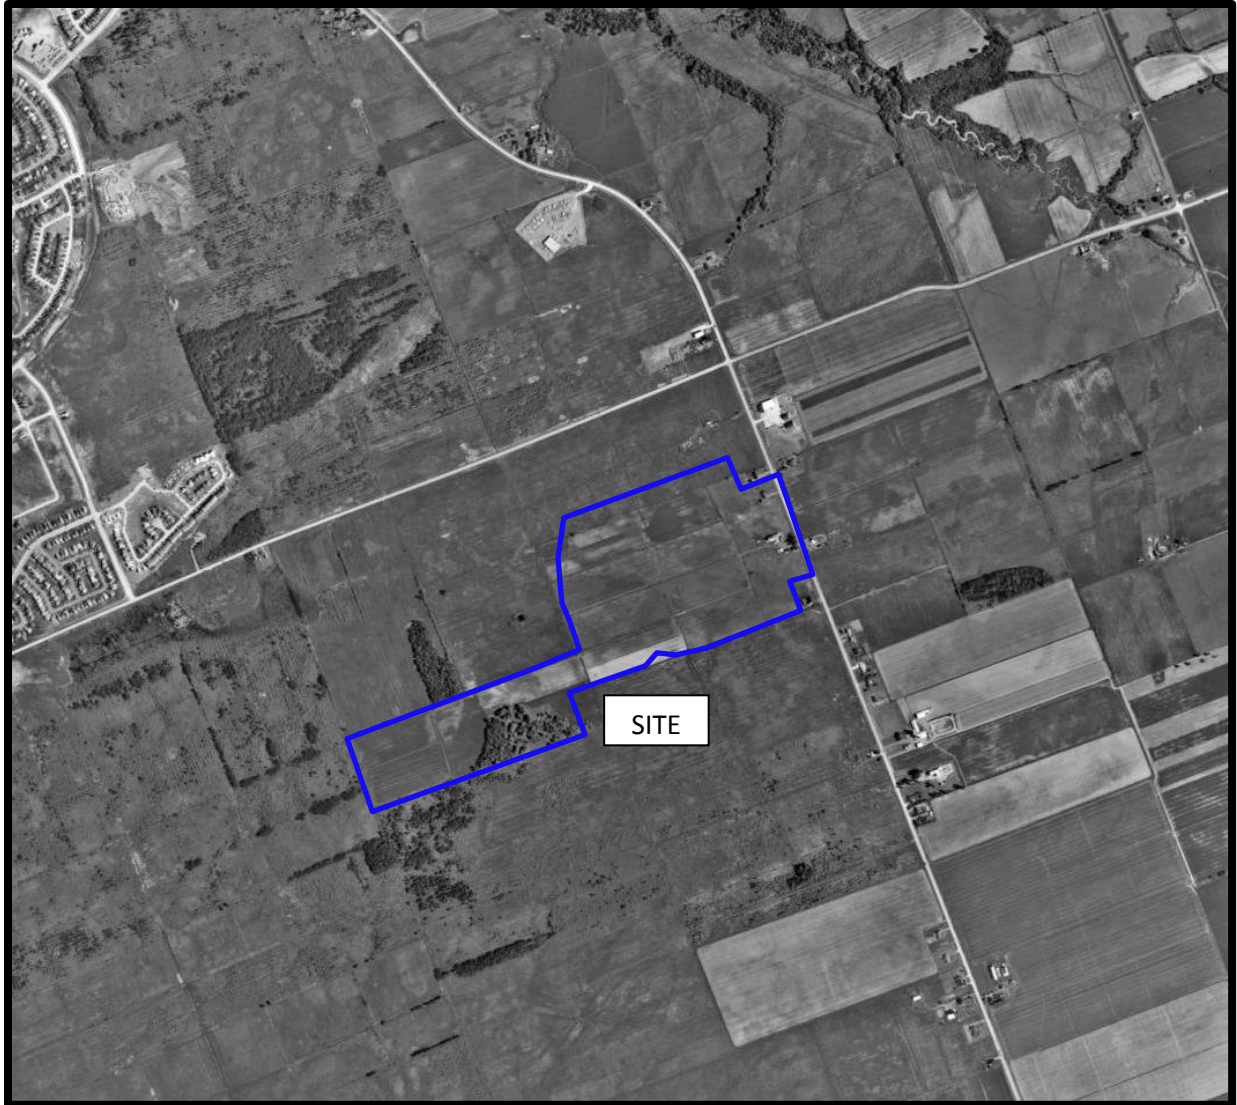
AERIAL PHOTOGRAPH
1991

| 1991 | (City of Ottawa website) No significant changes have been made to the subject site. Residential dwellings have been developed adjacent to the subject site along Trim Road. |

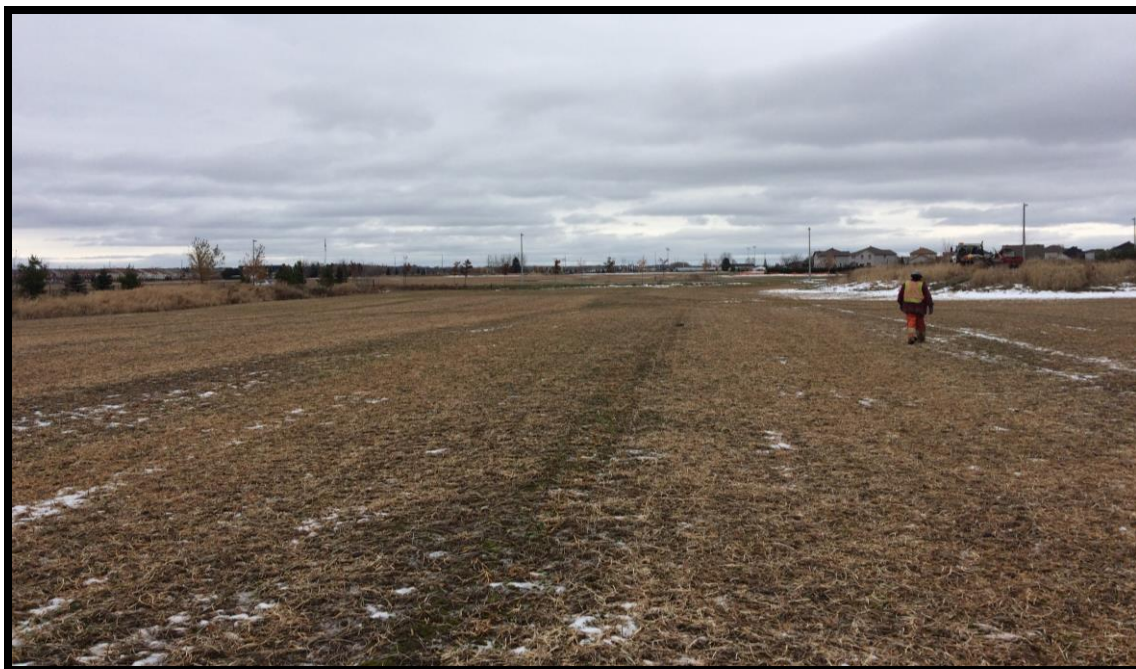
Photograph 1: View of the southwestern portion of the site, facing east. Photograph depicts an agricultural field, the main land cover on the site.

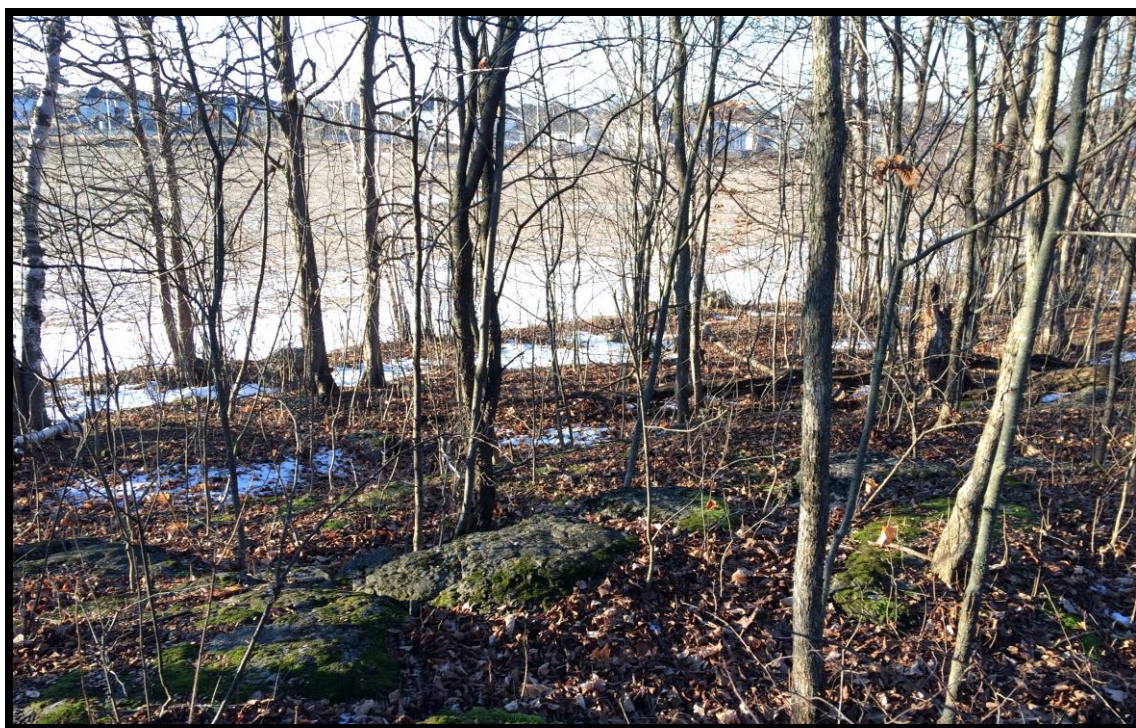
The subject site is generally flat and undeveloped agriculture land. A small forested ridge with outcropping bedrock is located on the southern portion of the site, north of the Lalande Conservation Park and east of Portobello Boulevard. Drainage consists primarily of infiltration with some sheet flow to catch-basins along adjacent roads. The adjacent properties are generally at grade with the subject site. The site was snow covered at the time of the site visit, however, site photographs were taken by Paterson personnel from the geotechnical department in November, prior to the arrival of snow.

Photograph 2: View of the forested area with outcropping bedrock on the southwest portion of the subject site, facing north.
