Muncaster  
Environmental  
Planning Inc.

**RE: 5618 Hazeldean Road**  
**Tree Conservation Report and Environmental Impact Statement**

This Tree Conservation Report and Environmental Impact Statement addresses the existing vegetation, potential tree retention, Species at Risk utilization and other natural environment features on an approximate 86 hectare site at 5618 Hazeldean Road, on the south side of Hazeldean Road, east of Iber Road. The site is within Concession 11, Part of Lot 28 in the Goulbourn Geographic Township of the City of Ottawa.

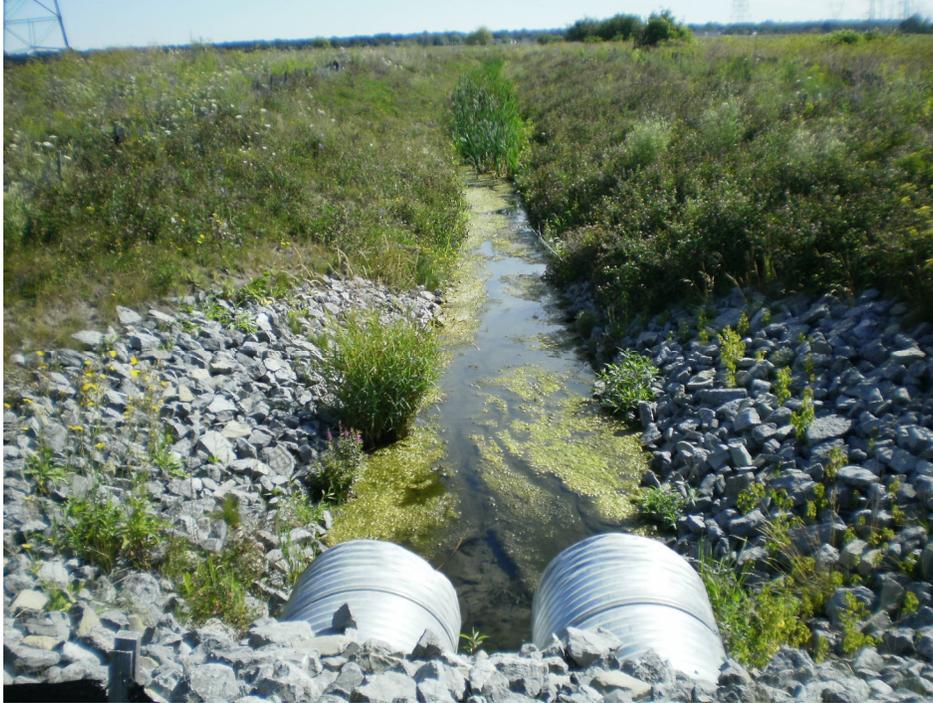
*Photo 1 – Realigned portion of the West Tributary downstream of the new high school.  
View looking east*

As part of the construction of the Paul-Desmarais High School the West Tributary was piped for the first 190 metres from the west site boundary and a temporary channel created along the east edge of the school to collect drainage from the Abbott Street extension and surrounding lands (Photo 1). On May 9<sup>th</sup>, 2007 23 fish, representing three fish species - northern redbelly dace, creek chub and brook stickleback, were netted by Muncaster (2007) along the portion of the West Tributary that is now piped. The fish community included a good representation of young creek chub.

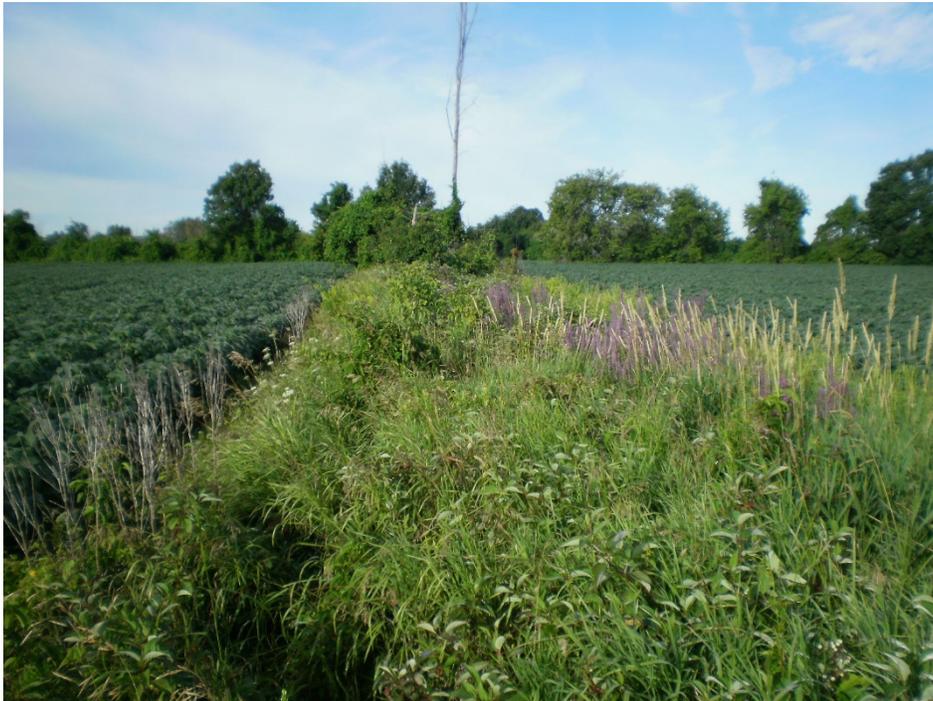
*Photo 2 – Former west to east channel in the central portion of the site*

There are two remaining tributaries to the Carp River on and adjacent to the site. The Hazeldean Tributary crosses Hazeldean Road adjacent to the northwest corner of the site while the West Tributary, as named in the Fernbank Community Design Plan (Muncaster, 2007), flows from the Granite Ridge Stormwater Management facility to the east under Iber Road and enters the site in the vicinity of the new Paul-Desmarais High School (Map 1). A third west to east channel is shown on background mapping in the middle of the site. This channel enters the West Tributary at the east edge of the site, approximately 550 metres south of Hazeldean Road. The confluence with the West Tributary was historically altered by deepening the reach of the West Tributary oriented to the south along the east site boundary. Fish access into the middle channel did not appear possible under typical flows and no fish were captured in this channel by Muncaster (2007). It is likely that the flows in the middle channel were decreased substantially as a result of development along Iber Road and to the west. The channel is now choked with vegetation and has no apparent aquatic characteristics (Photo 2). In 2006 Muncaster (2007) reported maximum water depths less than 10cm and in 2016 there was no evidence of flow in the middle channel.

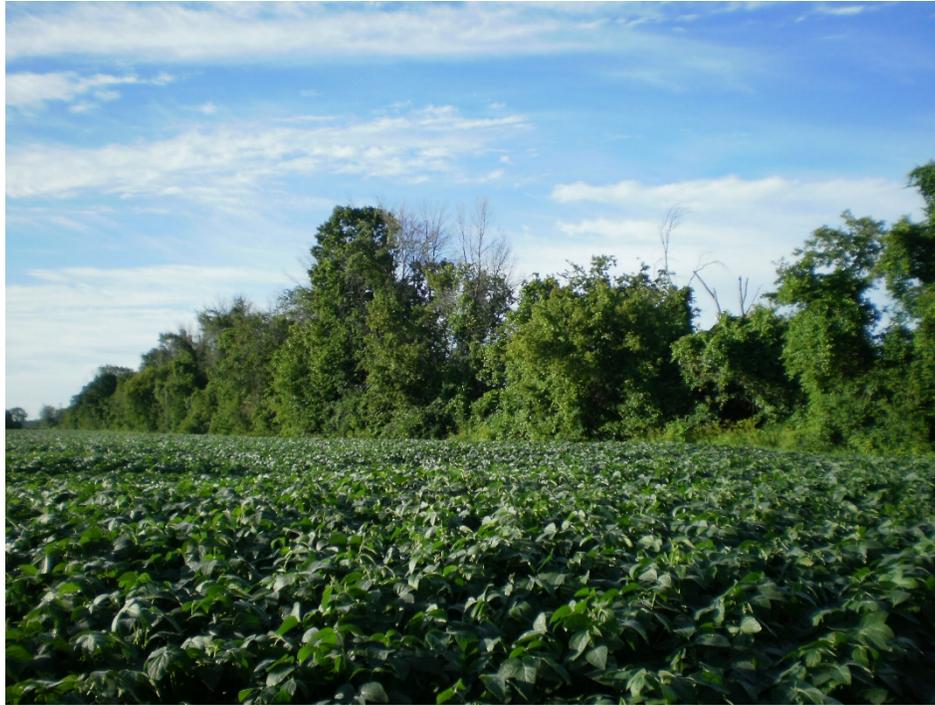
*Photo 3 – Cultivated field of soybeans south of Hazeldean Road, with view looking west to the north portion of the central north-south deciduous hedgerow*

The site is dominated by cultivated fields, planted in soybeans in 2016 and previously planted in corn (Map 1, Photos 3, 4 and 5).

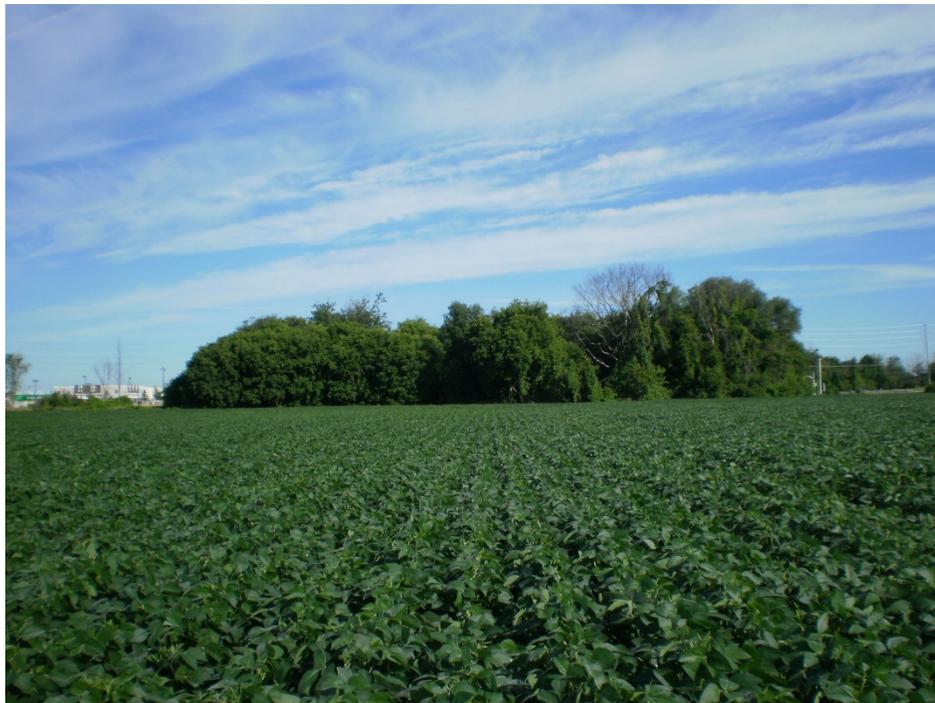
*Photo 4 – Cultivated field of soybeans south of Hazeldean Road, with view looking north to the west cultural woodland representation south of Hazeldean Road*

Areas of cultural woodland are south of Hazeldean Road (Photos 4 and 8) and in the west portion of the site. White elm, Manitoba maple, bur oak and crack willow between 60 and 105cm dbh were the largest trees in the cultural woodlands with smaller green ash, white ash and trembling aspen also present. The larger white elm and Manitoba maple had many broken limbs, with vine growth common and fungus on the larger elm. Trembling aspen was dominant in the west cultural woodland representation, with white elm common. Manitoba maple was dominant in the central-east cultural woodland and the woodland south of Hazeldean Road. Many of the aspen and elm were in poor condition with reduced leaf-out.

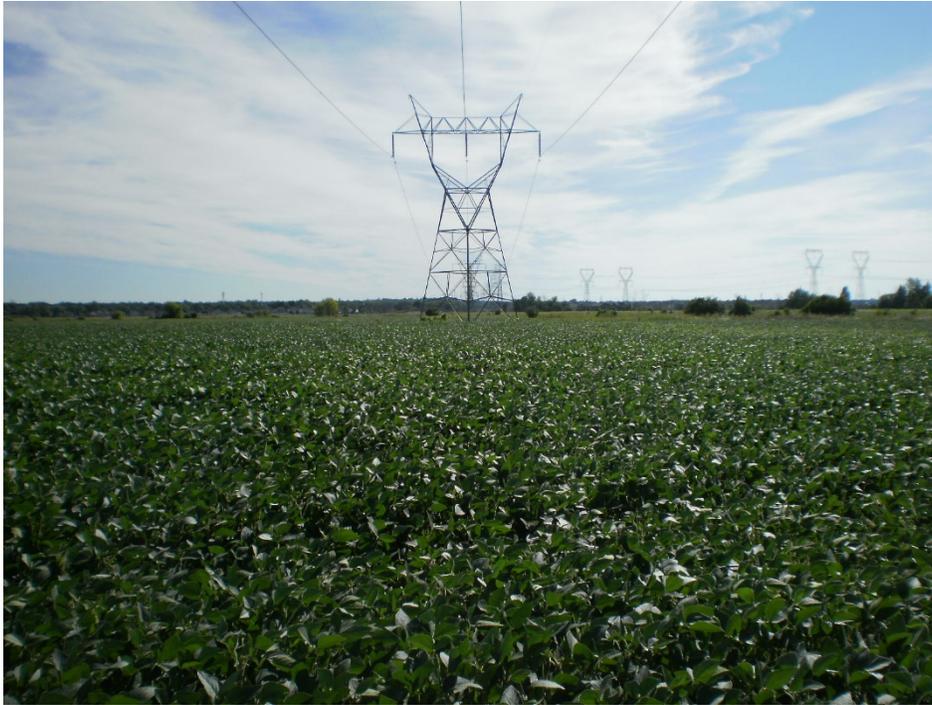
*Photo 5 - Cultivated field of soybeans in the southeast portion of the site.  
View looking southeast along the hydro corridor*

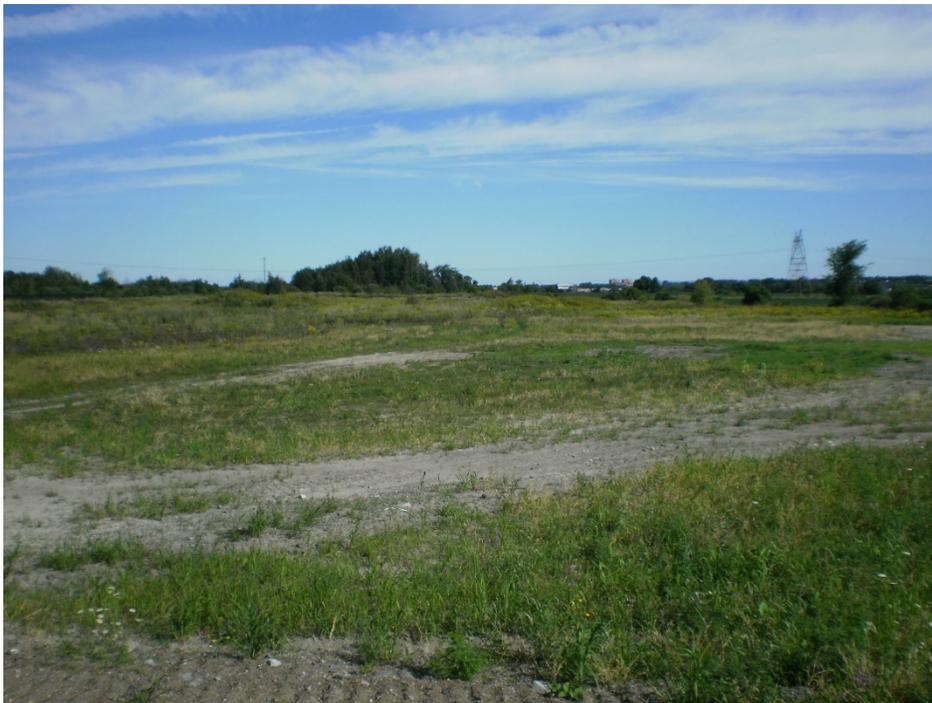
A few areas of cultural meadows are adjacent to the agricultural fields (Photo 6). The vegetation in the cultural meadow habitats were dominated by non-native and/or invasive ground flora such as field sow-thistle, Canada thistle, bull thistle, stinging nettle, curled dock, purple loosestrife, blueweed, bird's-foot trefoil, Canada goldenrod, common mullien, common milkweed, wild parsnip, wild carrot, tall buttercup, red clover, lamb's quarter, black medic, common ragweed, field mustard, hedge bindweed, chicory, common dandelion, crown vetch, white bedstraw, Canada anemone, common burdock, thicket creeper, meadow grass, brome grass, reed canary grass and bluegrass, along with common buckthorn, glossy buckthorn and hawthorn shrubs.

*Photo 6 – Cultural meadow regenerating on areas of stripped topsoil in south portion of the site  
between the high school to the west and cultivated fields to the east. View looking north to area  
of cultural woodland and the hydro corridor*

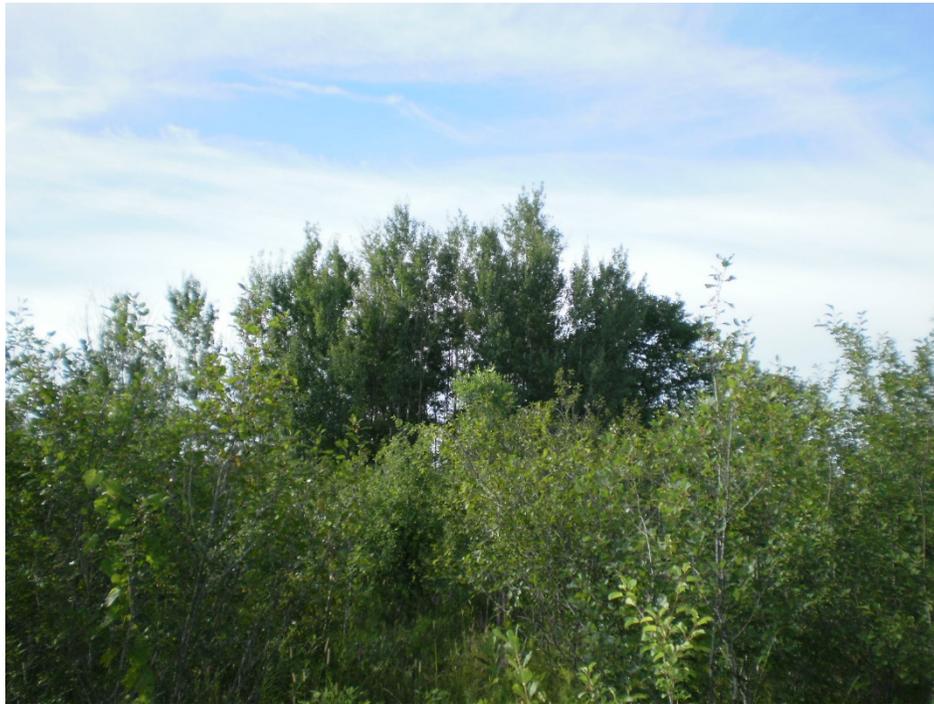
Cultural thickets are the dominant habitat in the southwest portion of the site (Photo 7). Glossy buckthorn is dominant in many areas, with common buckthorn, hawthorn, slender willow, staghorn sumac, red-osier dogwood, highbush cranberry, nannyberry, apple, narrow-leaved meadowsweet and red raspberry other shrubs present. Green ash, trembling aspen, eastern cottonwood, white cedar and white elm stems were up to 20cm dbh. White elms in the southwest cultural thicket had extensive trunk damage and/or no or reduced leaf-out. Some of poplars had fungus and trunk decay.

*Photo 7 – Cultural thicket vegetation in the southwest portion of the site*

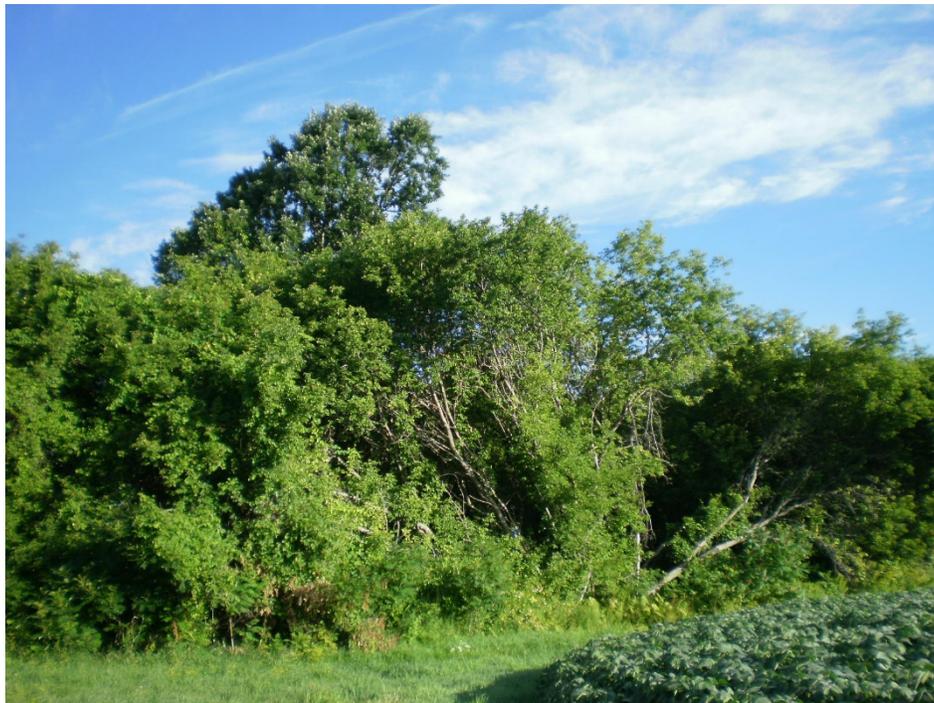
*Photo 8 – Cultural woodland south of Hazeldean Road and the north-central site edge*

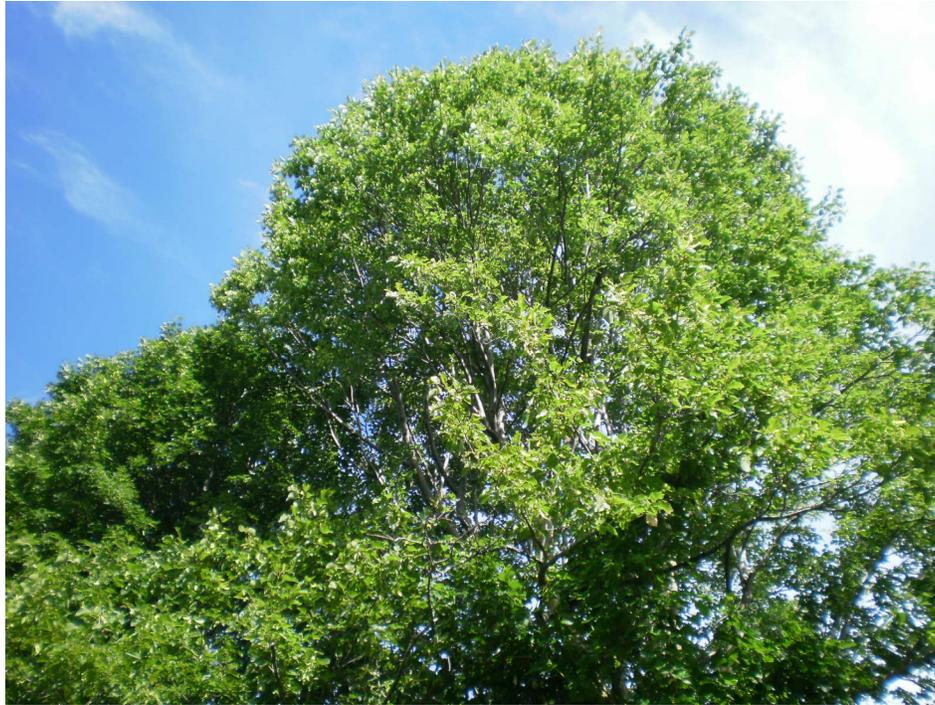
*Photo 9 - Mature basswood in an east-west deciduous hedgerow in the northwest portion of the site with good leaf-out*

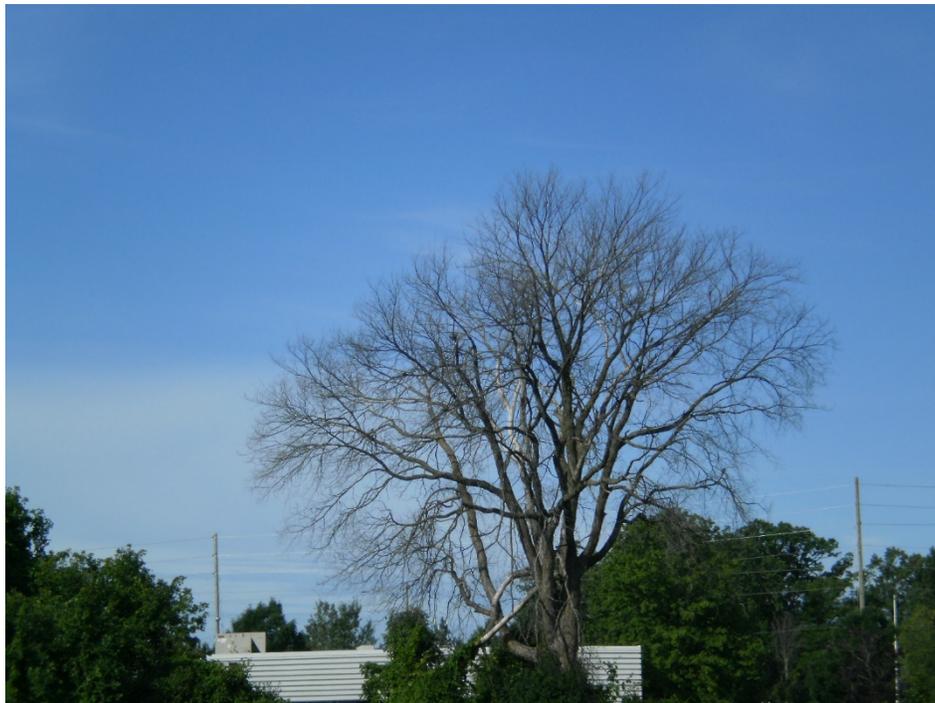
*Photo 10 – White elm with no leaf out on July 30<sup>th</sup>. This tree is along the west edge of the site approximately 100 metres south of Hazeldean Road. View looking west to Iber Road*

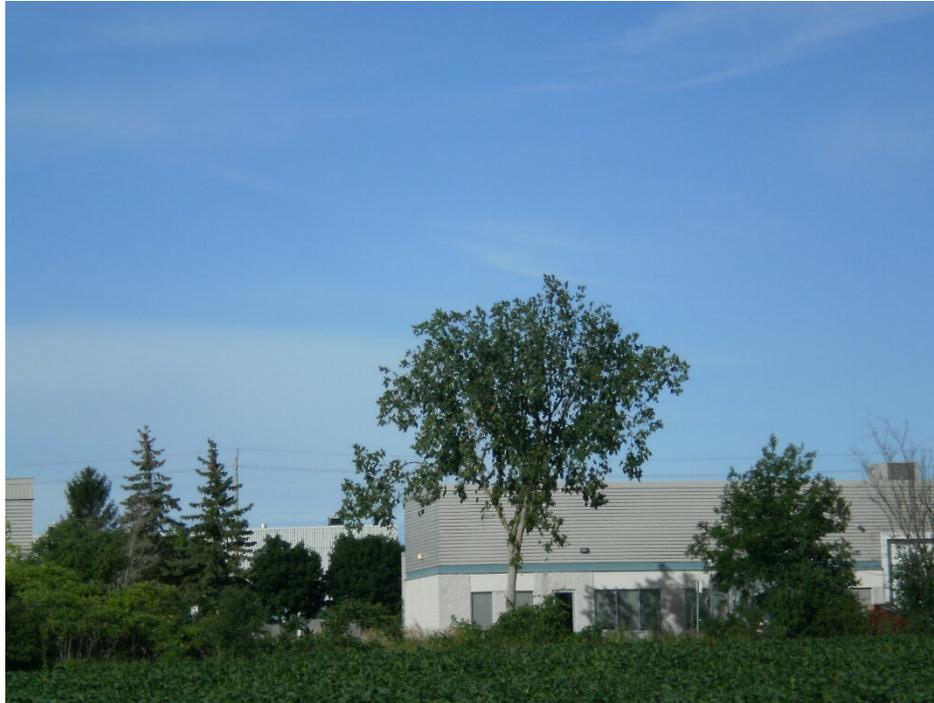
*Photo 11 – White elm with good leaf out in the intermittent deciduous hedgerow along the west edge of the site approximately 450 metres south of Hazeldean Road. View looking west to the rear of the commercial buildings off the east side of Iber Road*

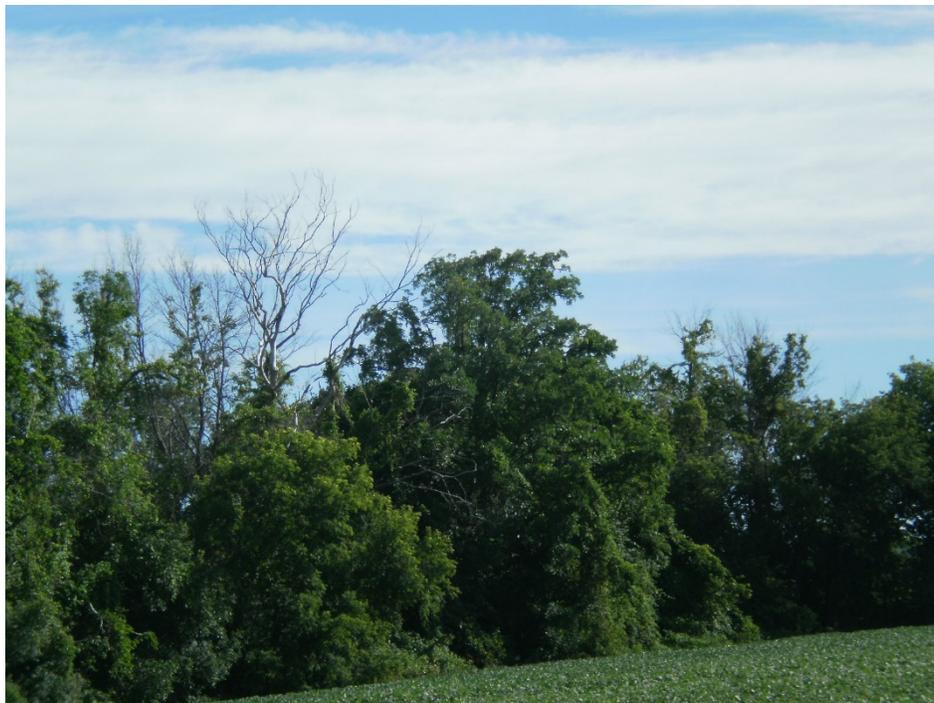
*Photo 12 – Bur oak with good leaf-out among ash and elm trees in poorer condition in the north east-west hedgerow*
