**Phase I-Environmental Site Assessment**

760 River Road  
Ottawa, Ontario

**October 22, 2018**

**Report: PE4467-1**

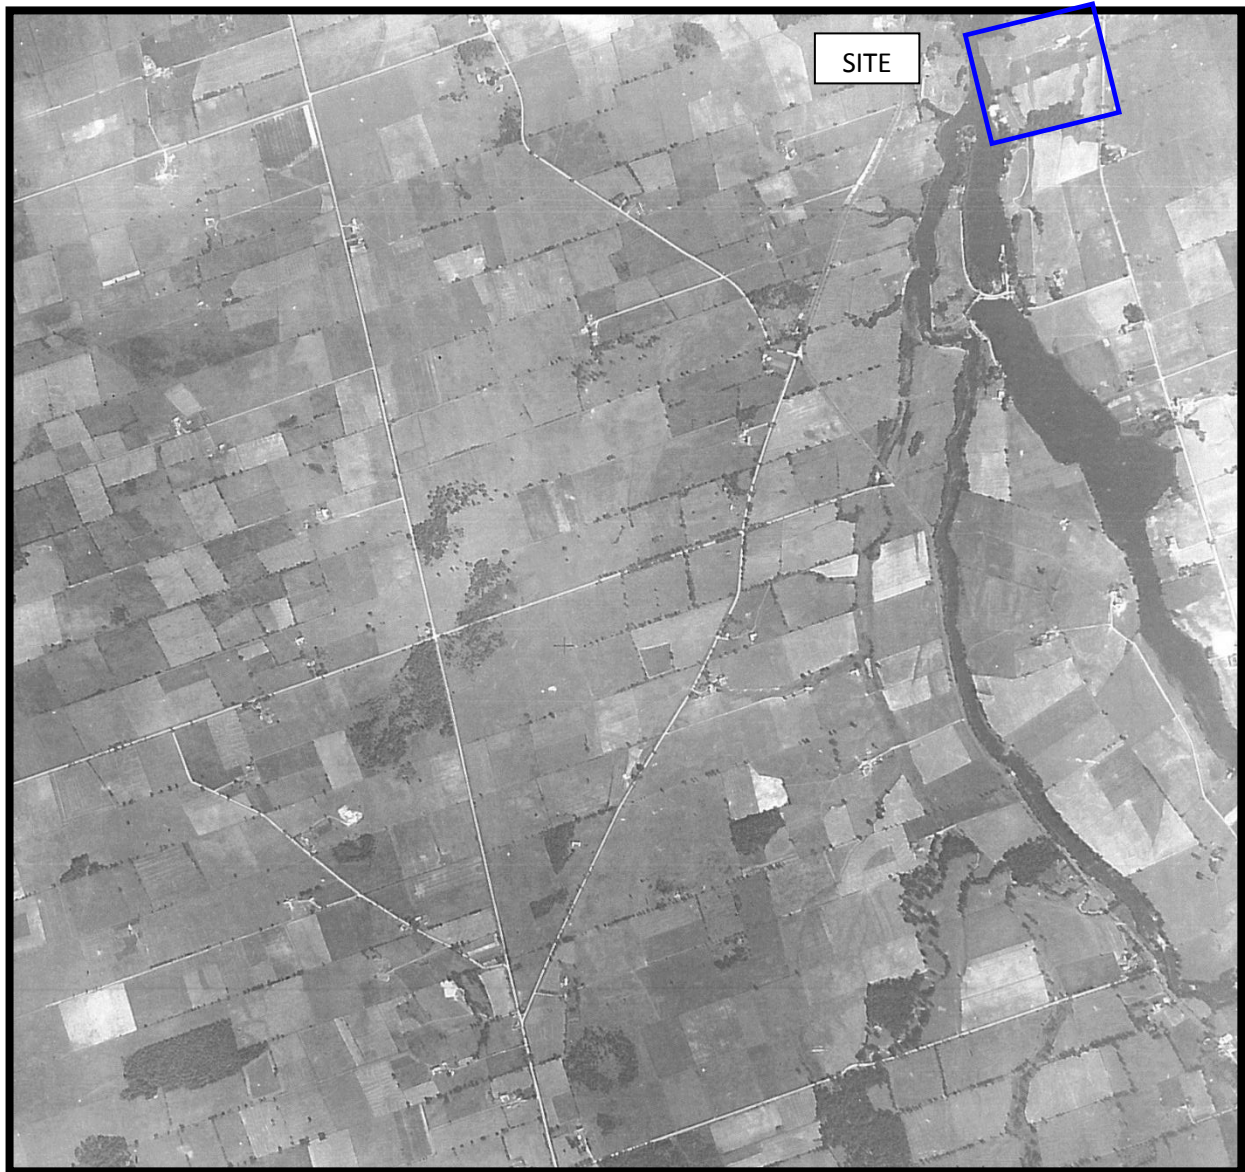
AERIAL PHOTOGRAPH  
1946

| 1946 | The subject site appears to be occupied by a couple of large barn-like structures, a private garage and residential dwelling. The majority of the subject land is agricultural fields. The surrounding lands appear as vacant agricultural land with occasional residential dwellings. The Rideau River is present to the west and River Road is present to the east. |

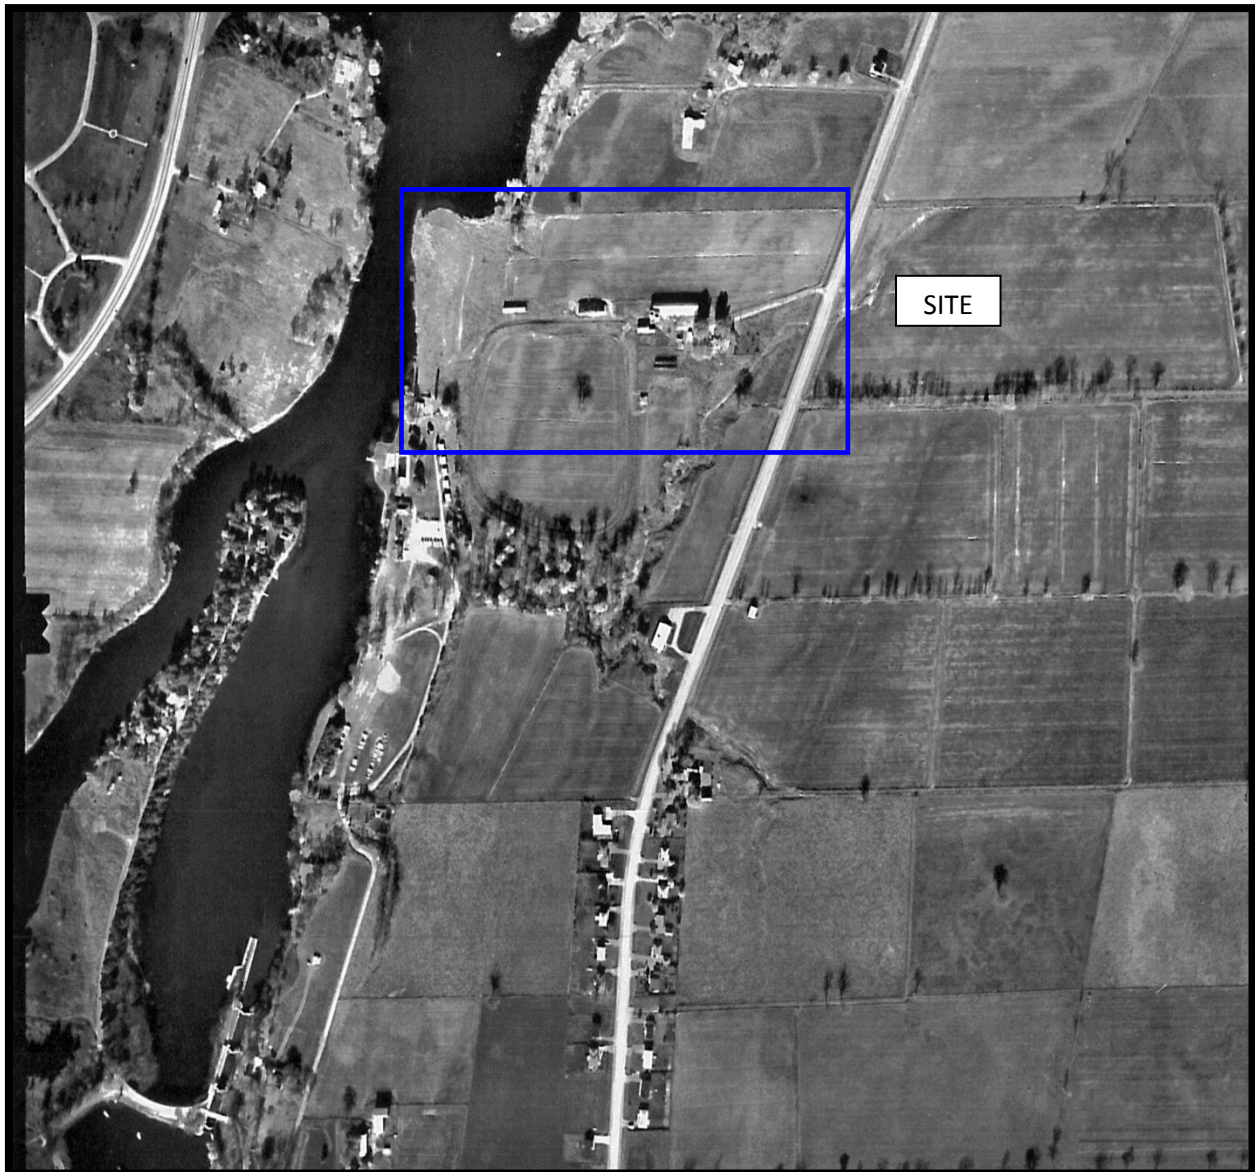
AERIAL PHOTOGRAPH  
1968

| 1968 | No significant changes are apparent to the subject site. The adjacent property to the north appears to be occupied by a farmstead as well. No significant changes have been made to the surrounding lands. |

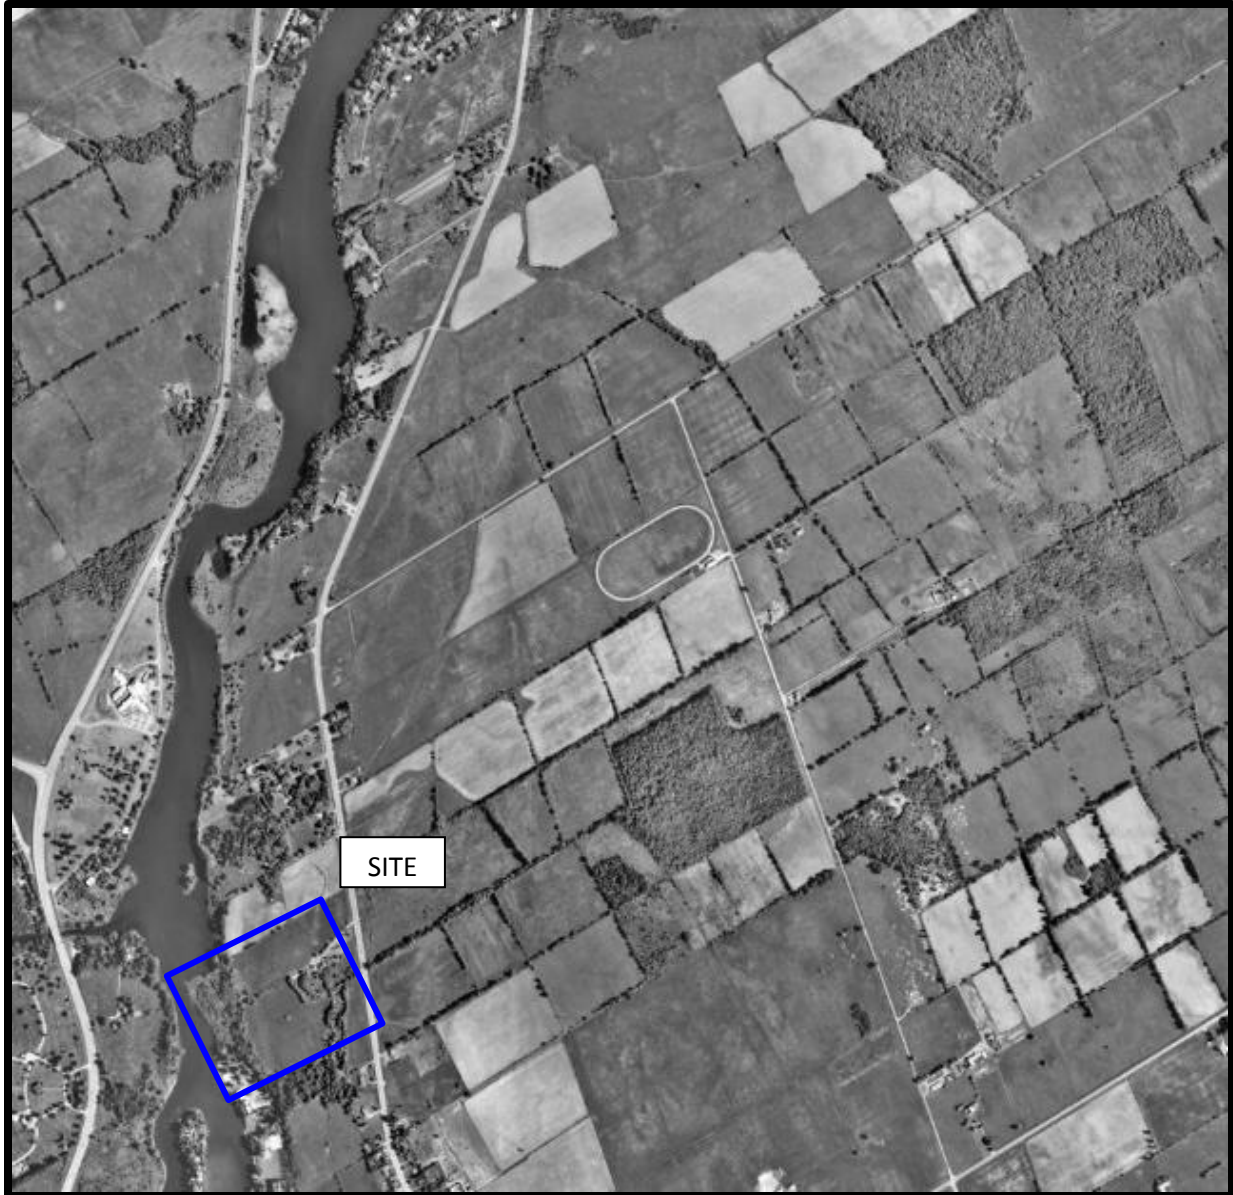
AERIAL PHOTOGRAPH  
1991

| 1991 | No significant changes are apparent to the subject site or surrounding area, with the exception of more tree coverage on the subject property. |

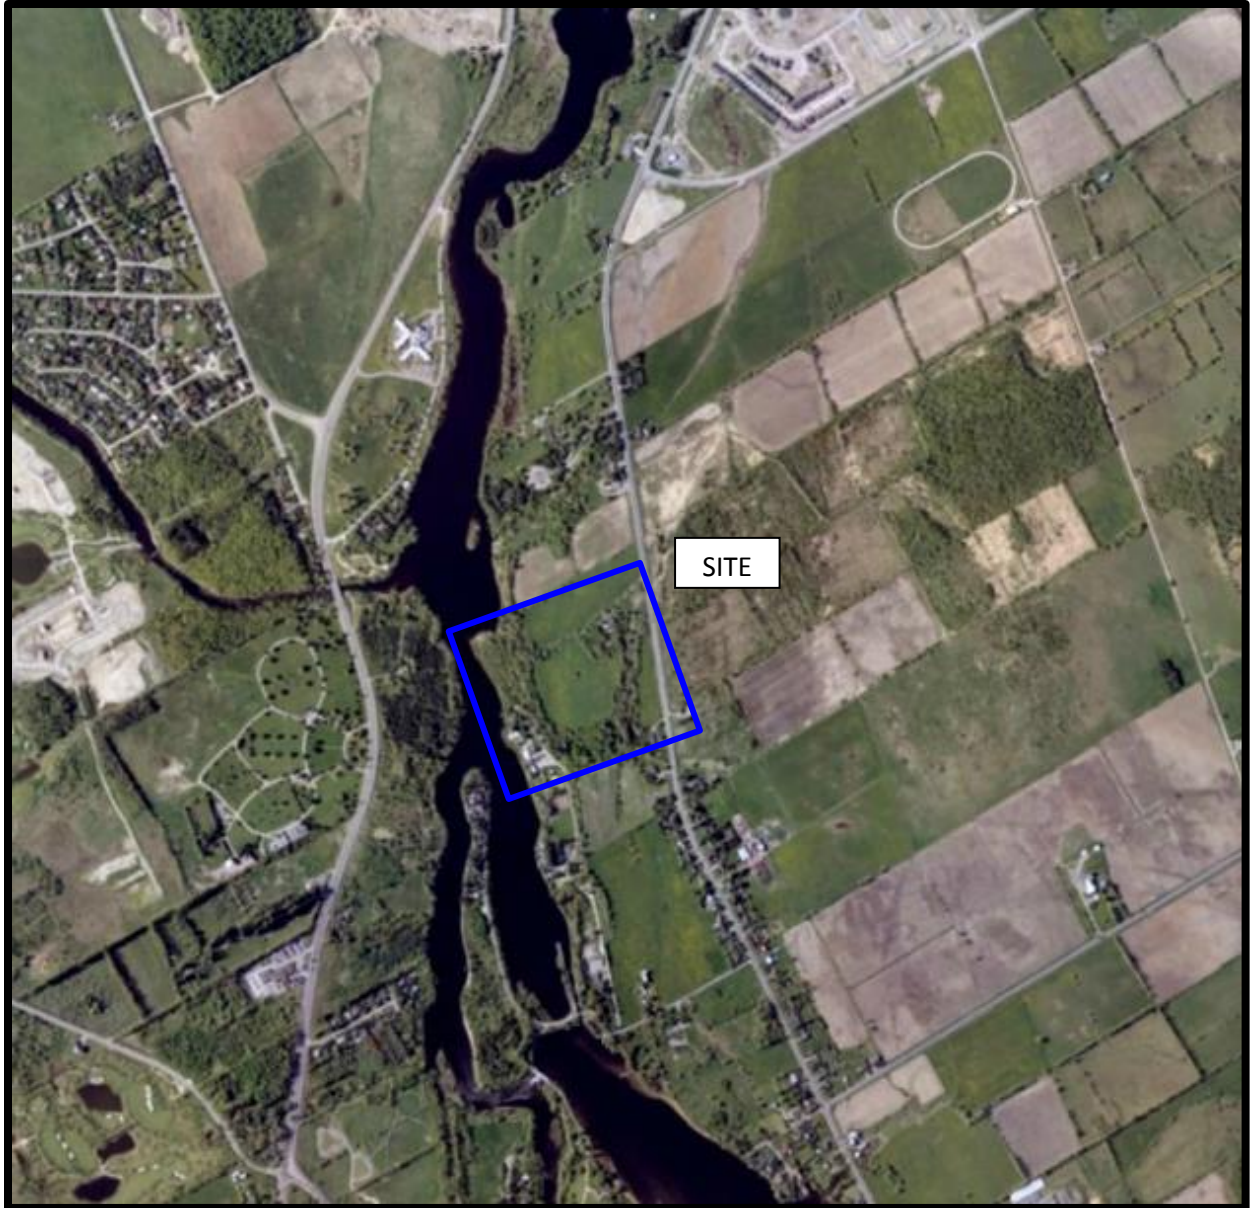
AERIAL PHOTOGRAPH  
2002

| 2002 | No significant changes have been made to the subject site or surrounding properties. Residential development is beginning to occur further to the north. |

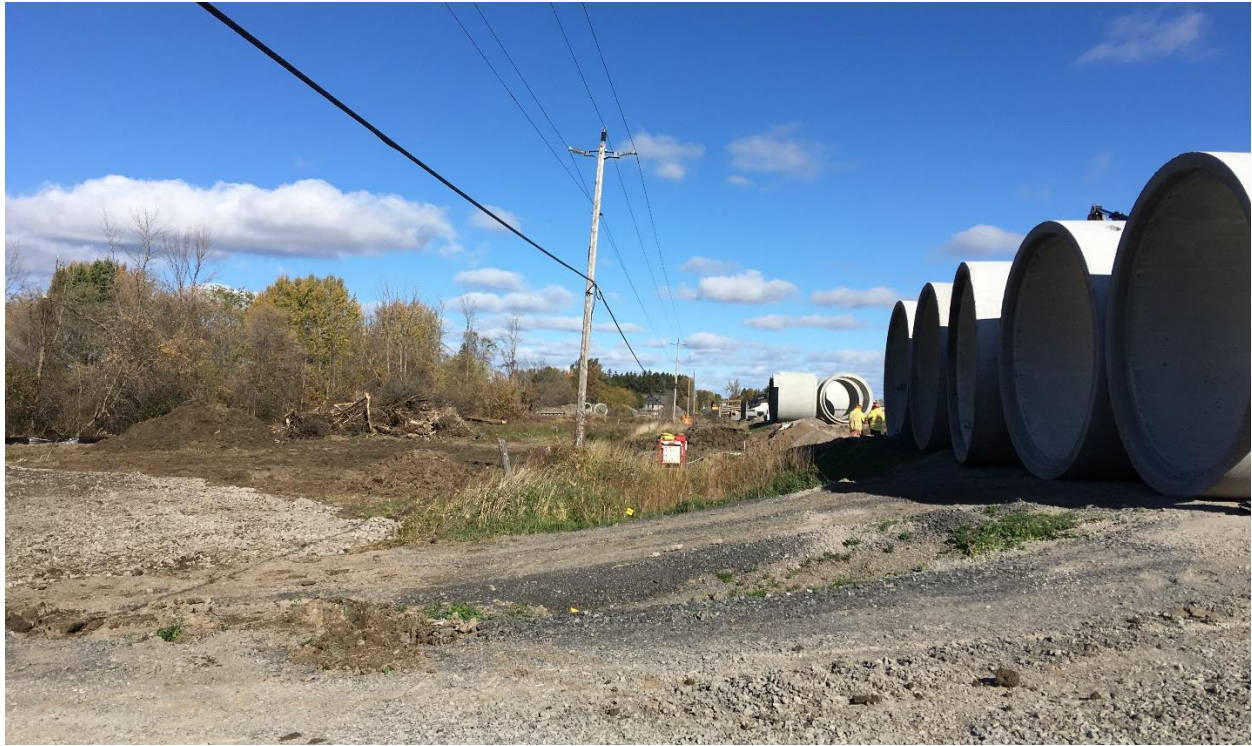
Photograph 3: View of the northeast side of the subject site, along River Road, looking north.

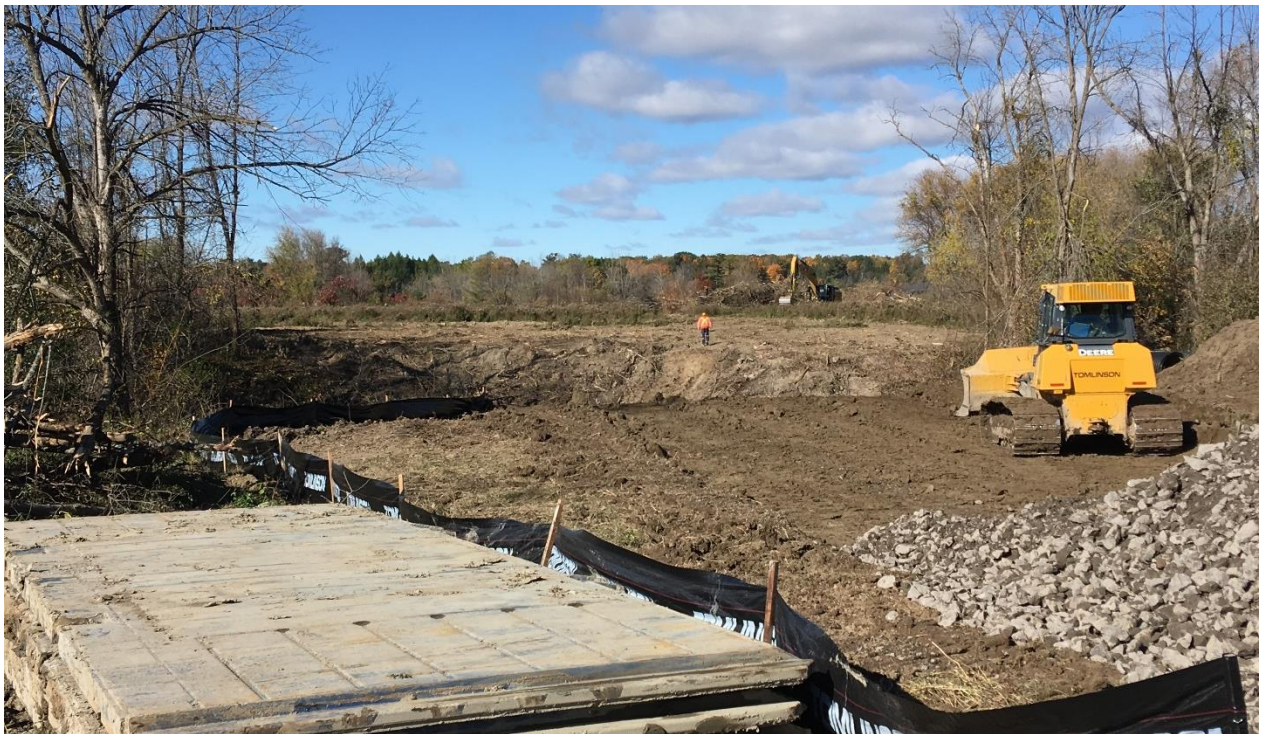
Photograph 4: View of the central portion of the subject site, looking west.
