RE: Findlay Creek Stage 5 Lands
Tree Conservation Report and Environmental Impact Statement

This combined Tree Conservation Report (TCR) and Environmental Impact Statement (EIS) assesses the Findlay Creek Stage 5 lands, which are in the northwest portion of the Findlay Creek area, to the south of Leitrim Road and west of Kelly Farm Drive and portions of the Barrett urban residential development under construction.

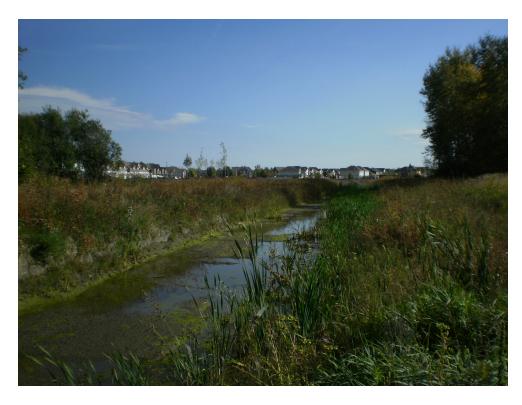
Photo 1 – Recently constructed north-south channel immediately to the east of the site. View looking south.

A north-south channel immediately adjacent to the east edge of the site has been constructed (Photo 1) and will collect the surface runoff from north of the site once swale realignments are completed to the north of Leitrim Road. The north-south channel was enhanced with in-stream structure and plantings of native trees and shrubs along the channel corridor. The on-site channels were part of the Hope Municipal Drain until the Drain was removed from the authority of the *Drainage Act* as part of decommissioning process completed by Stantec Consulting around 2000. A Department of Fisheries and Oceans Authorization issued on October 25th, 2003 (File Number 5250-100) covered the destruction of these channels as tributaries of Findlay Creek as part of the overall Findlay Creek Village development. The geographical scope of the Authorization extended from Leitrim and Albion Roads south to the Rideau Carleton Raceway and east to Bank Street. The culverts required for the subdivision road crossings were installed at the time of the north-south channel construction.

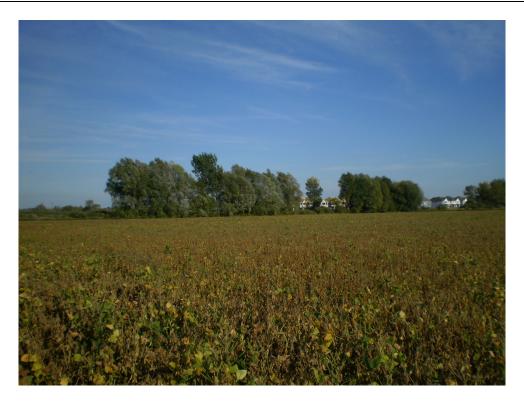
Photo 2 – Cultivated field planted in soybeans in 2019 in the central portion of the site. View looking southeast to an intermittent deciduous hedgerow

Much of the site remains in agricultural use, with the topsoil now stripped from the east field, which is scrapped clear with no ground vegetation of note. In 2019, the remaining agricultural fields in the central and north portions of the site were planted in soybeans (Photo 2). Regenerating upland deciduous treed areas are in the southwest corner of the site, along with cultural habitats, also with regenerating vegetation on former agricultural lands (Map 1).

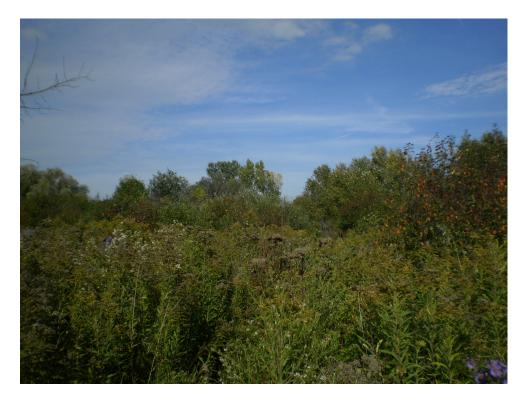
Photo 3 – Typical cultural meadow habitat in the southeast corner of the site. View looking northeast to a deciduous hedgerow

Cultural thickets and meadows are in the south portion of the site, south of the agricultural fields (Photos 3 and 4, Map 1). Glossy buckthorn and common buckthorn are dominant shrubs in the thicket habitats, with red raspberry, blackberry, slender willow, red raspberry and Bebb's willow also present in the cultural meadow and thickets. Regenerating poplar and ash stems are well represented in areas. The largest poplars were eastern cottonwood up to 30cm diameter at breast height (dbh), with balsam poplar, white ash, white birch, and trembling aspen up to 25cm dbh and green ash and Manitoba maple generally less than 20cm dbh.. A couple of crack willows were in the range of 40cm – 50cm dbh. These were likely part of former deciduous hedgerows. Many of the ash trees appeared dead or in very poor condition from the emerald ash borer.

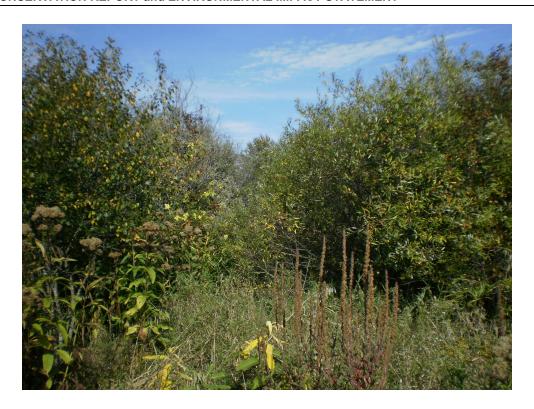
Photo 4 - Cultural thicket habitat in the south-central edge of the site. View looking east

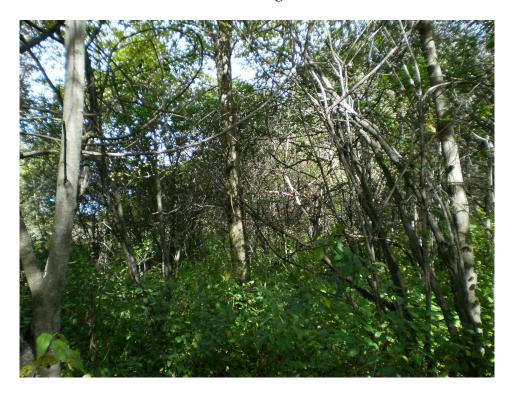
Photo 5 – Upland poplar deciduous forest in the southwest corner of the site. View looking east

Trembling aspen up to 35cm dbh dominate an upland forested area in the southwest portion of the site (Photo 5, Map 1). Smaller balsam poplar, Manitoba maple, green ash, and white ash are also present. As with the balance of the site, this area was an agricultural field in 1976. Fungus was on many of the poplars and the trunks of the ash were often impacted by emerald ash borer. The understory is very thick in most areas with common buckthorn, glossy buckthorn, and regenerating ash stems (Photo 5). Prickly gooseberry, red raspberry, and regenerating Manitoba maple stems were also present. Common ground flora in the upland deciduous forest include June meadow grass, helleborine, wild grape, field horsetail, motherwort, white avens, Canada goldenrod, narrow-leaved goldenrod, joe-pye-weed, New England aster, white bedstraw, sensitive fern, violet, Pennsylvania sedge, and common strawberry.

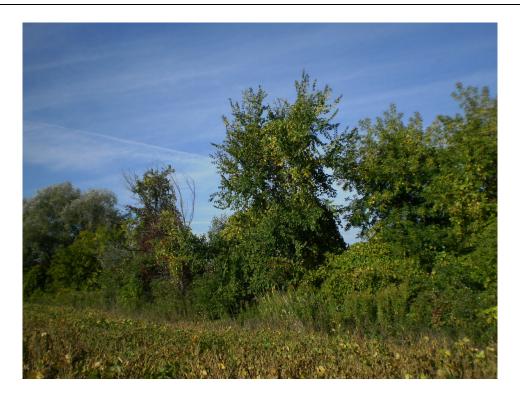
Photo 6 – Typical intermittent north-south deciduous hedgerow. This example is in the south-central portion of the site, with view looking northeast

Intermittent deciduous hedgerows (Photo 6) are common in the central and north portions of the site, between agricultural fields and along the west and south periphery of the fields. Trembling aspen and crack willow are dominant in areas, with white elm, eastern cottonwood, grey birch, white ash, green ash, and Manitoba maple common in areas. Many of the crack willows are coppice (multi-stem), with individual stems up to 50cm dbh. The larger limbs of the crack

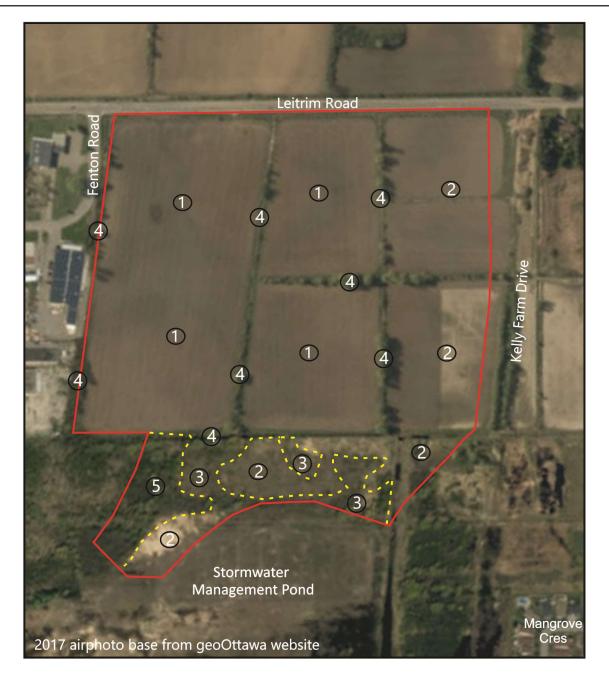
Map 1

- Cultivated field
- Cultural meadow
- Cultural thicket
- Deciduous hedgerow
- Upland poplar deciduous forest

CURRENT VEGETATION

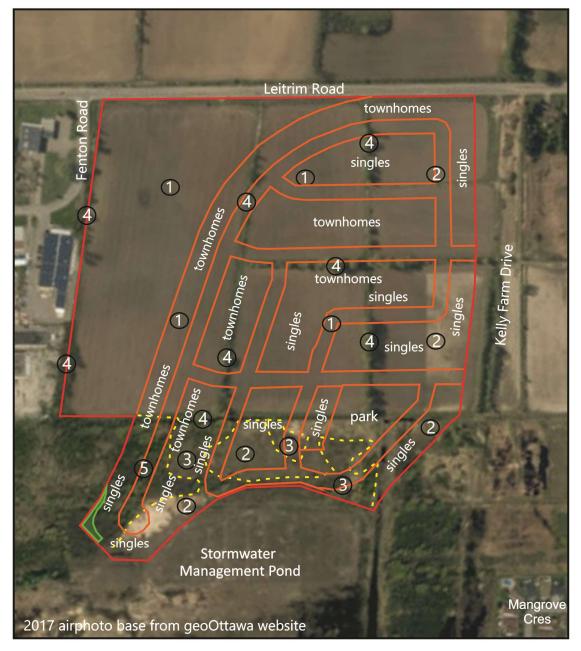
Map 2

Possible Tree Retention

PROPOSED CONSERVED VEGETATION

The proposed development will accommodate approximately 388 units which include 169 single detached family homes (44% of total units) and 219 townhouse units (56% of total units) (Map 2). All units will be on full urban municipal services and the stormwater management pond immediately to the south of the site will be utilized. A 0.9 hectare park block is proposed for the southeast portion of the site. A 25 metre wide open space corridor immediately to the east of the site and west of Kelly Farm Drive includes a channel conveying overland flow originating from north of the site, north of Leitrim Road. Access to the site will be via two streets west off Kelly Farm Drive. Theses streets will connect to internal crescents throughout the site.

Due to the adjacent developments, the southwest corner is the only area where the critical root zones of adjacent trees may extend onto the site. As indicated above and on Map 2, there is the potential for tree retention in this area. This tree retention would also protect the critical root zones of the adjacent trees. If tree retention in this area is not possible, no grade changes should occur within three metres of the site boundary where the critical root zones of adjacent tree may extend onto the site.
