**Scoped Environmental Impact Statement
3713 Borrisokane Rd. – Eastern Parcel**

Final Report

May 22, 2020

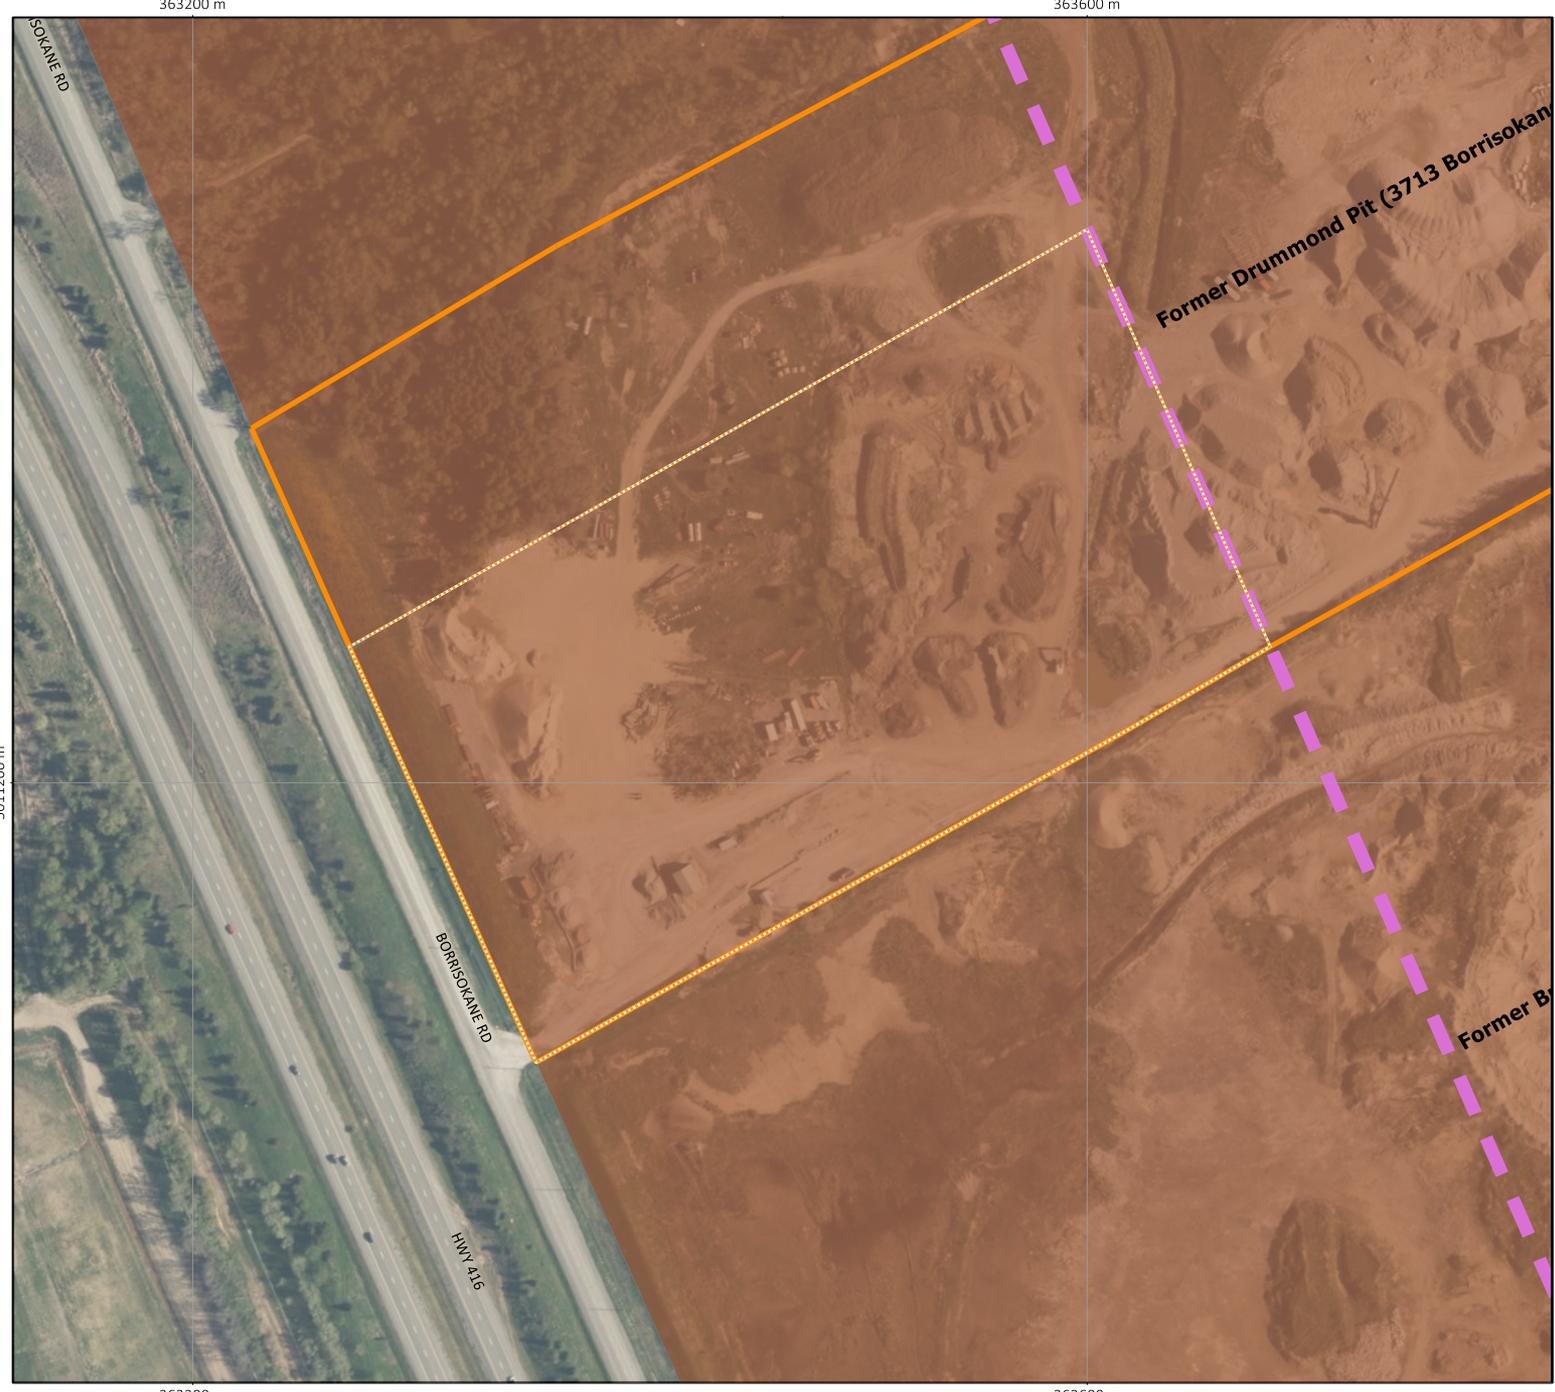
Figure 2 Proposed development

Note: The only trees remaining on site are located within FOD4

“notable” size, species type or character (Mark Richardson, City of Ottawa Planning Forester, personal communication, March 13, 2020). The 0.25 ha of the trees remaining on the Site (Figure 2) was not accessible during the site visit on April 10, 2019. The trees are known to be a subset of the original tree list, which did not include any tree of notable size or species. Trees within the feature were noted as being generally healthy during the August 12, 2019 site visit. As 84% of the FOD4 ecosite has now been removed and the remaining portion is isolated within an extensive area of active construction, the ecological function of the remaining trees has been severely reduced. The trees have no connection to other natural features limiting their ability to contribute to local wildlife.

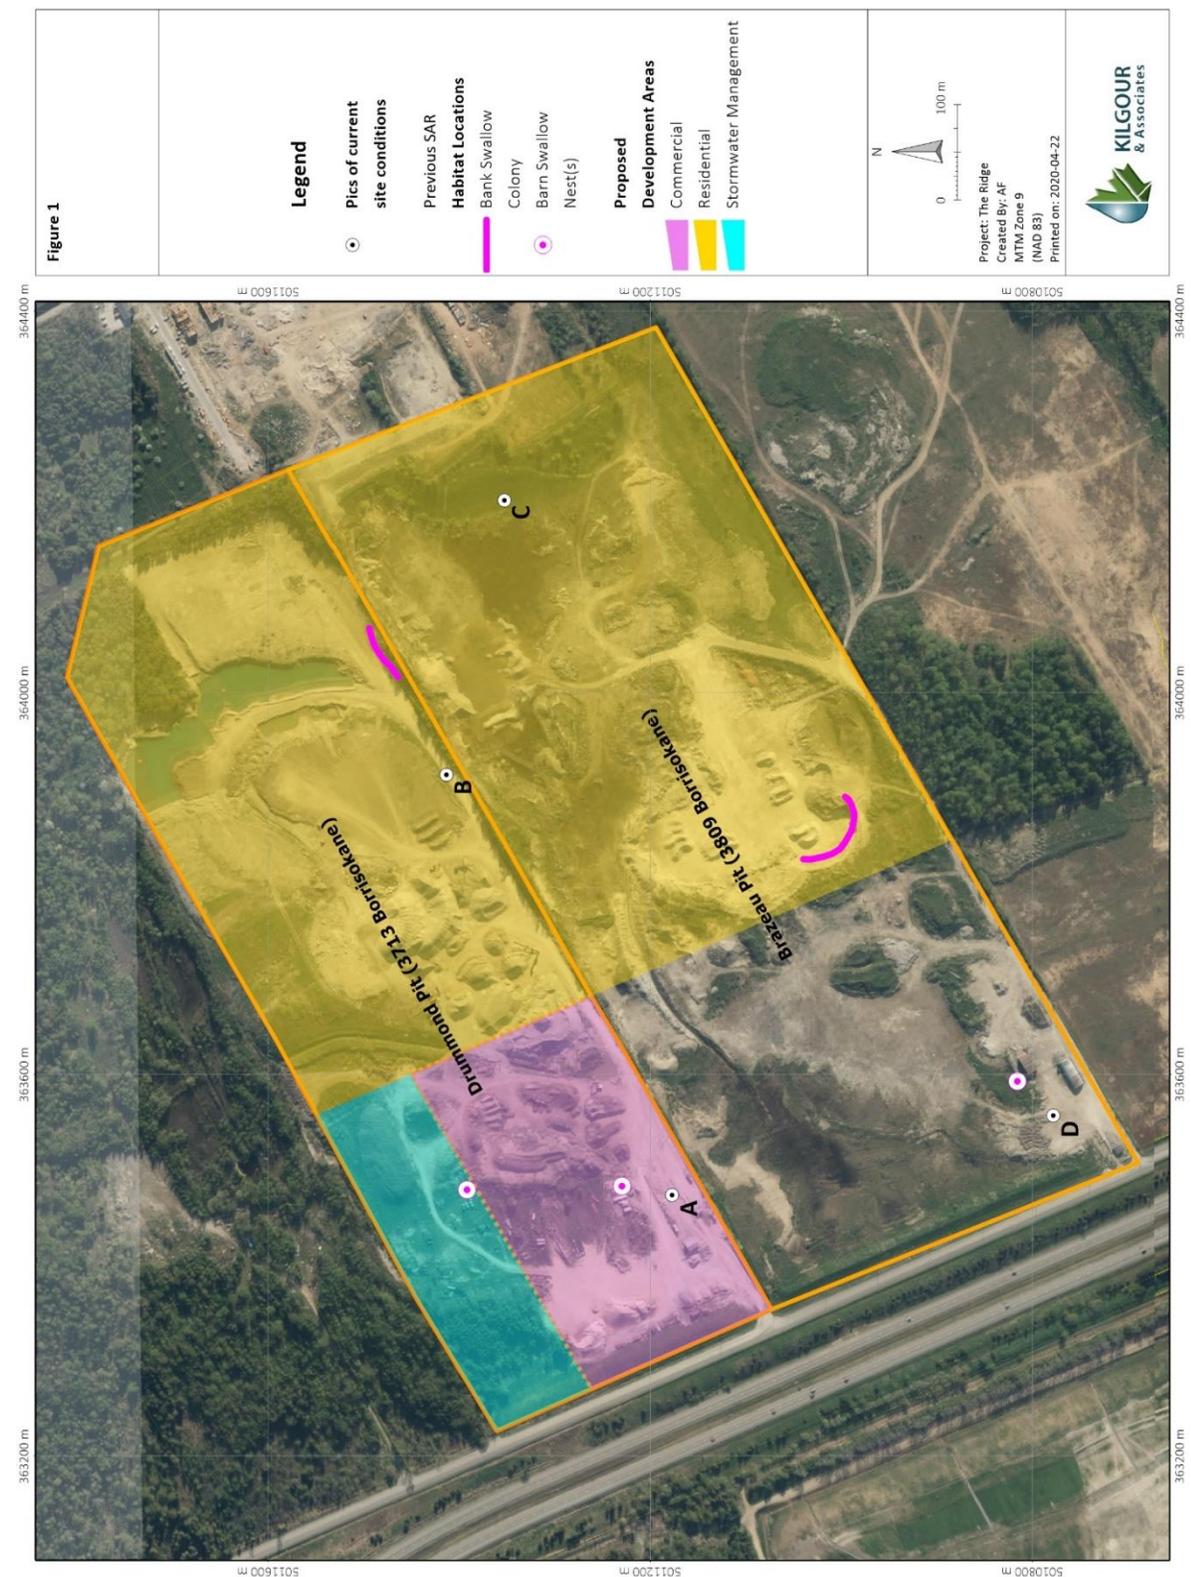
Figure 1. Map of area showing locations of SAR bird nests prior to pit closure. The air photo background is from 2017. Vegetation has now been removed from the site and from lands north of it. Coloured areas indicate proposed development. The southwest corner of the Brazeau pit is not currently subject to any development applications.

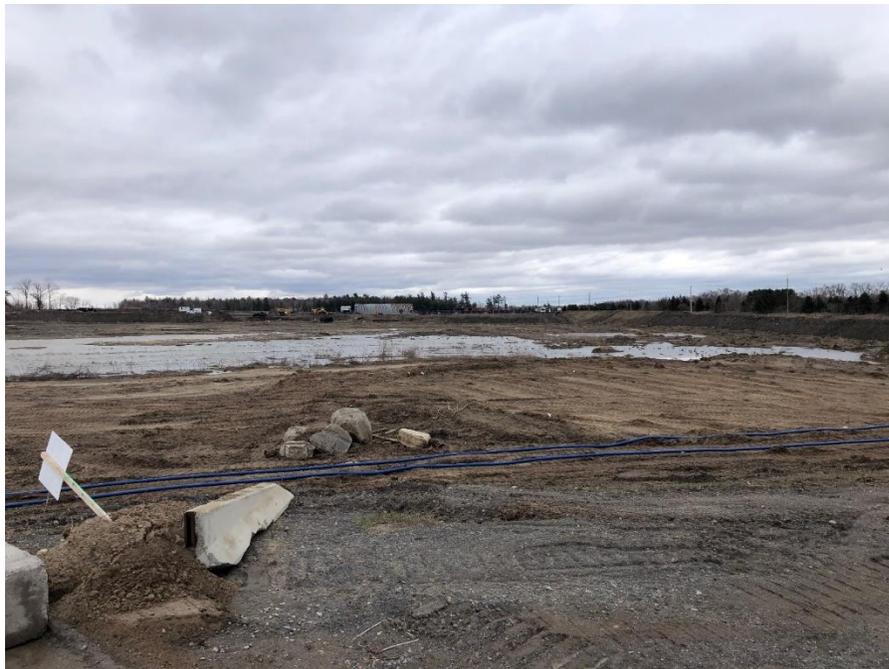
Photo A1. Southward across the Brazeau site. The Quonset hut and gatehouse (in the distance) of the former pit operation are still present in the southwest corner of the site. They are being used as staging/work areas for the site construction. Both structures are located more than 200 m away from any proposed development.

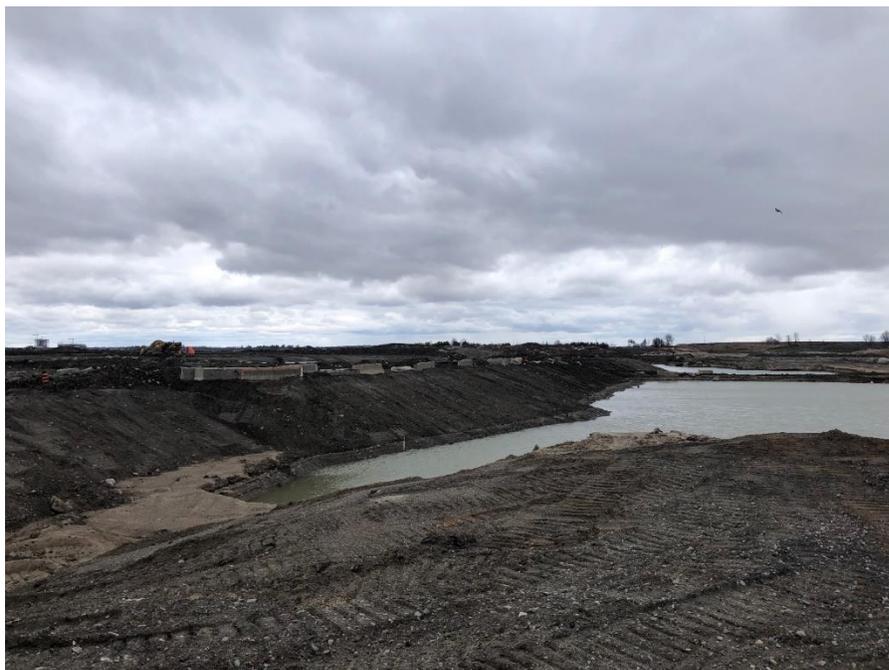
Photo A2. Westward view along the former access road for the Drummond site (following the concrete barriers). The ground along the south (right) side of the road had previously been significantly higher towards the rear of the site, such that a northward facing ridge was present there that supported a Barn Swallow colony (see Figure 1). That ridge is now gone. The south-facing slopes in the foreground have been flattened to shallow angles.

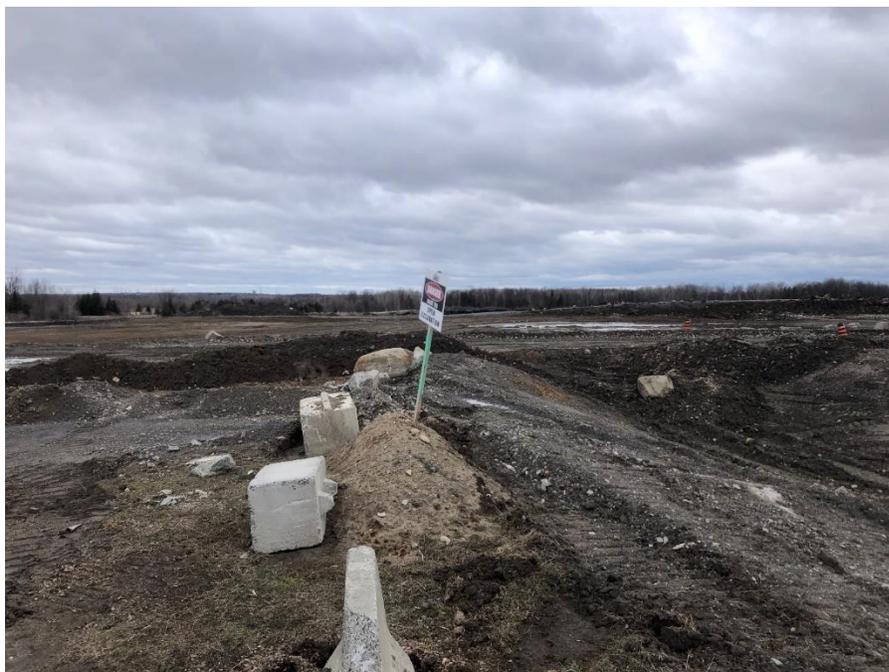
Photo A3. Northward across the west end of the Drummond Site. Trees in the distance are part of the Cambrian Woods, located 300 m beyond the north property line of the Drummond site. The Drummond site is being regraded with the pit closures. The intervening land is owned and has been cleared by other land development companies and is currently being prepared for construction.

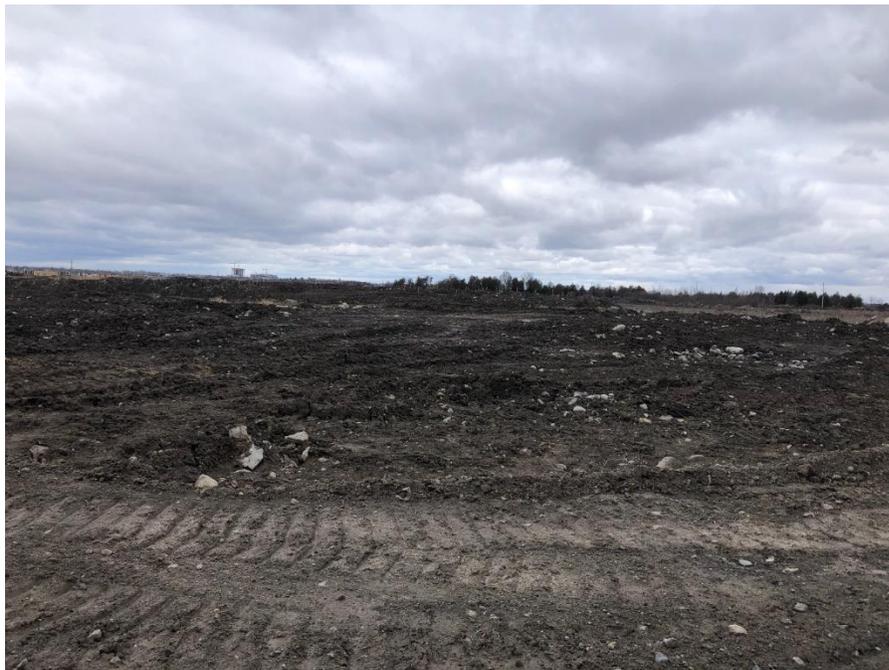
Photo B1. View north-northeastward across the eastern end of the Drummond site.

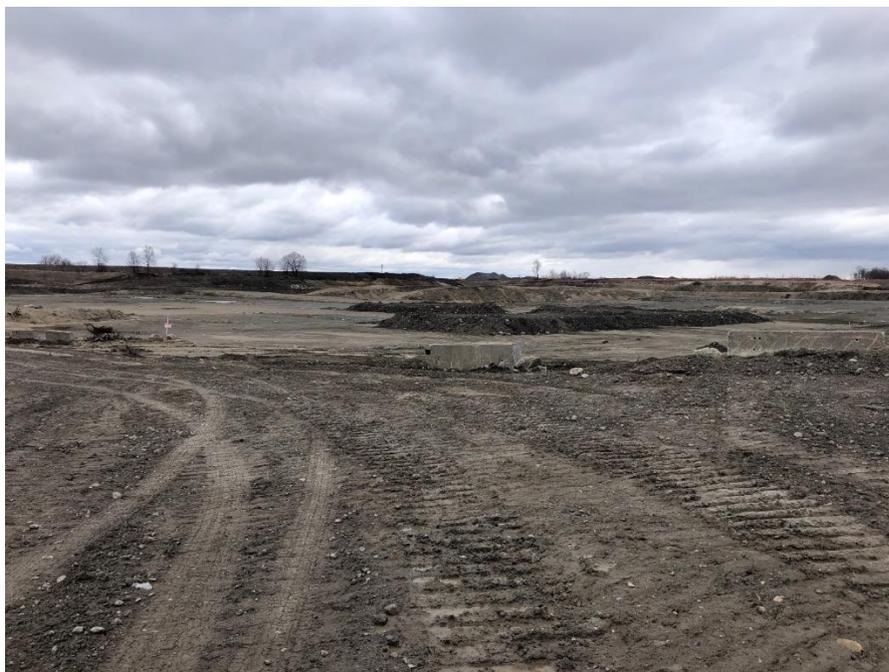
Photo B2. Eastward toward the rear of the sites. A vertical ridge previously located just to the right-of-center has been completely levelled. The shallow slopes in the distance mark the easterly end of the site.

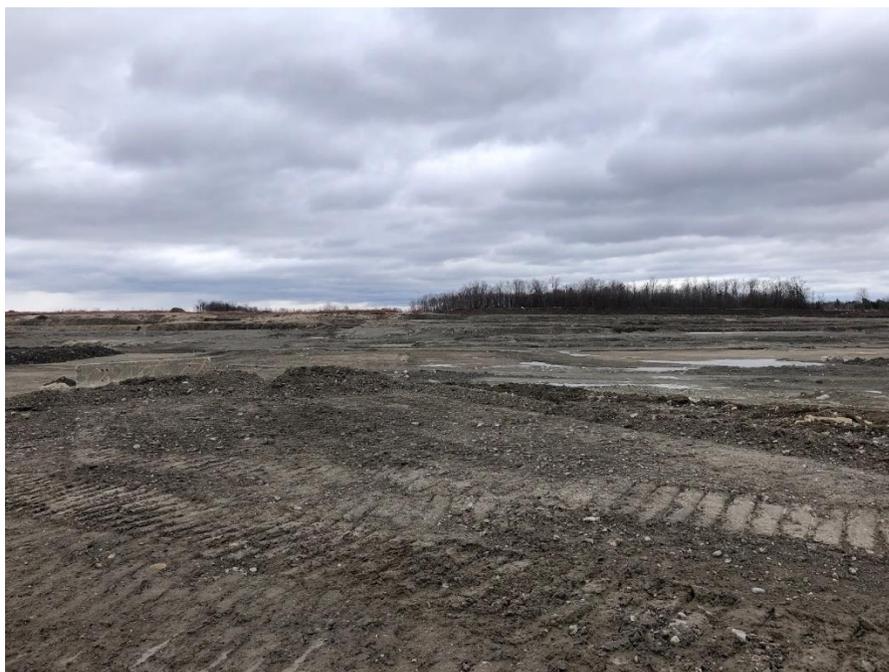
Photo B3. Southward view across the east end of the Brazeau site. The small slopes along the southern lot line are new features temporarily created as material is moved around the site. The slopes there are being maintained at a low angle and will disappear as fill is added to the foreground.

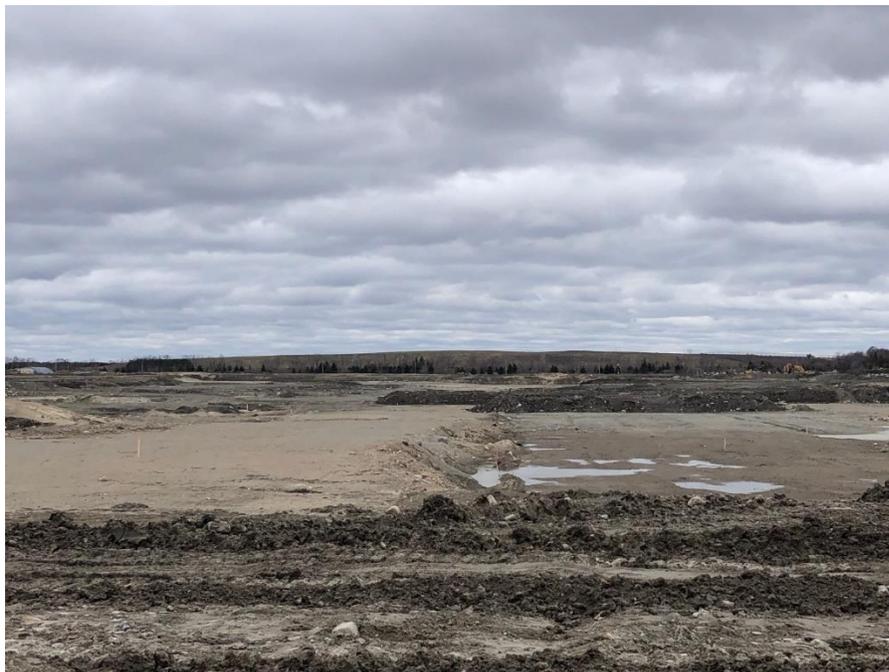
Photo C1. Westward view. The entire site is generally flat with no remaining prominent vertical ridges. No structures remain on site except for in the southwest most corner (left side of photo). The trees in the distance are located on the other side of Borrisokane Road. No vegetation currently remains.

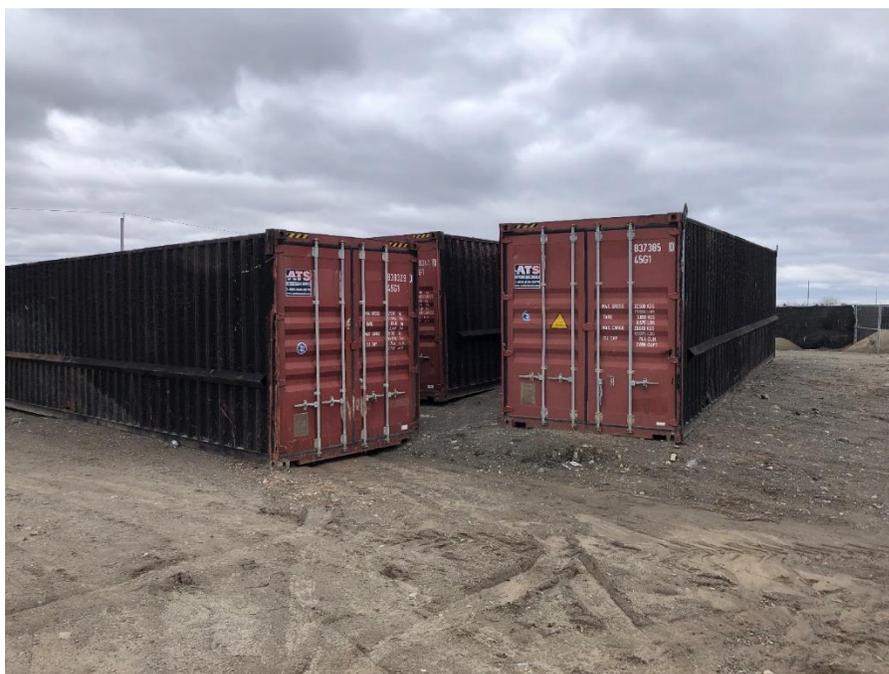
Photo D1. Remaining Sea Cans on site prepared for removal from the area. These units had previously been stacked in sets of six, with two stacked pairs forming right and left walls, and the final two cans sideways on top forming a roof. These large “shed” type structures had provided ideal nesting supports for Barn Swallows. The “sheds” have all been disassembled.

The management plans did call for the creation of new nesting structures for Barn Swallows. The Sea Can maintenance sheds have been disassembled (Appendix B). A new nest structure has been erected on land owned by the Rideau Valley Conservation Authority (RVCA) at 3889 Rideau Valley Drive (Appendix E). Monitoring reports for this structure will be filed with the MNRF later this year, per the management plans.

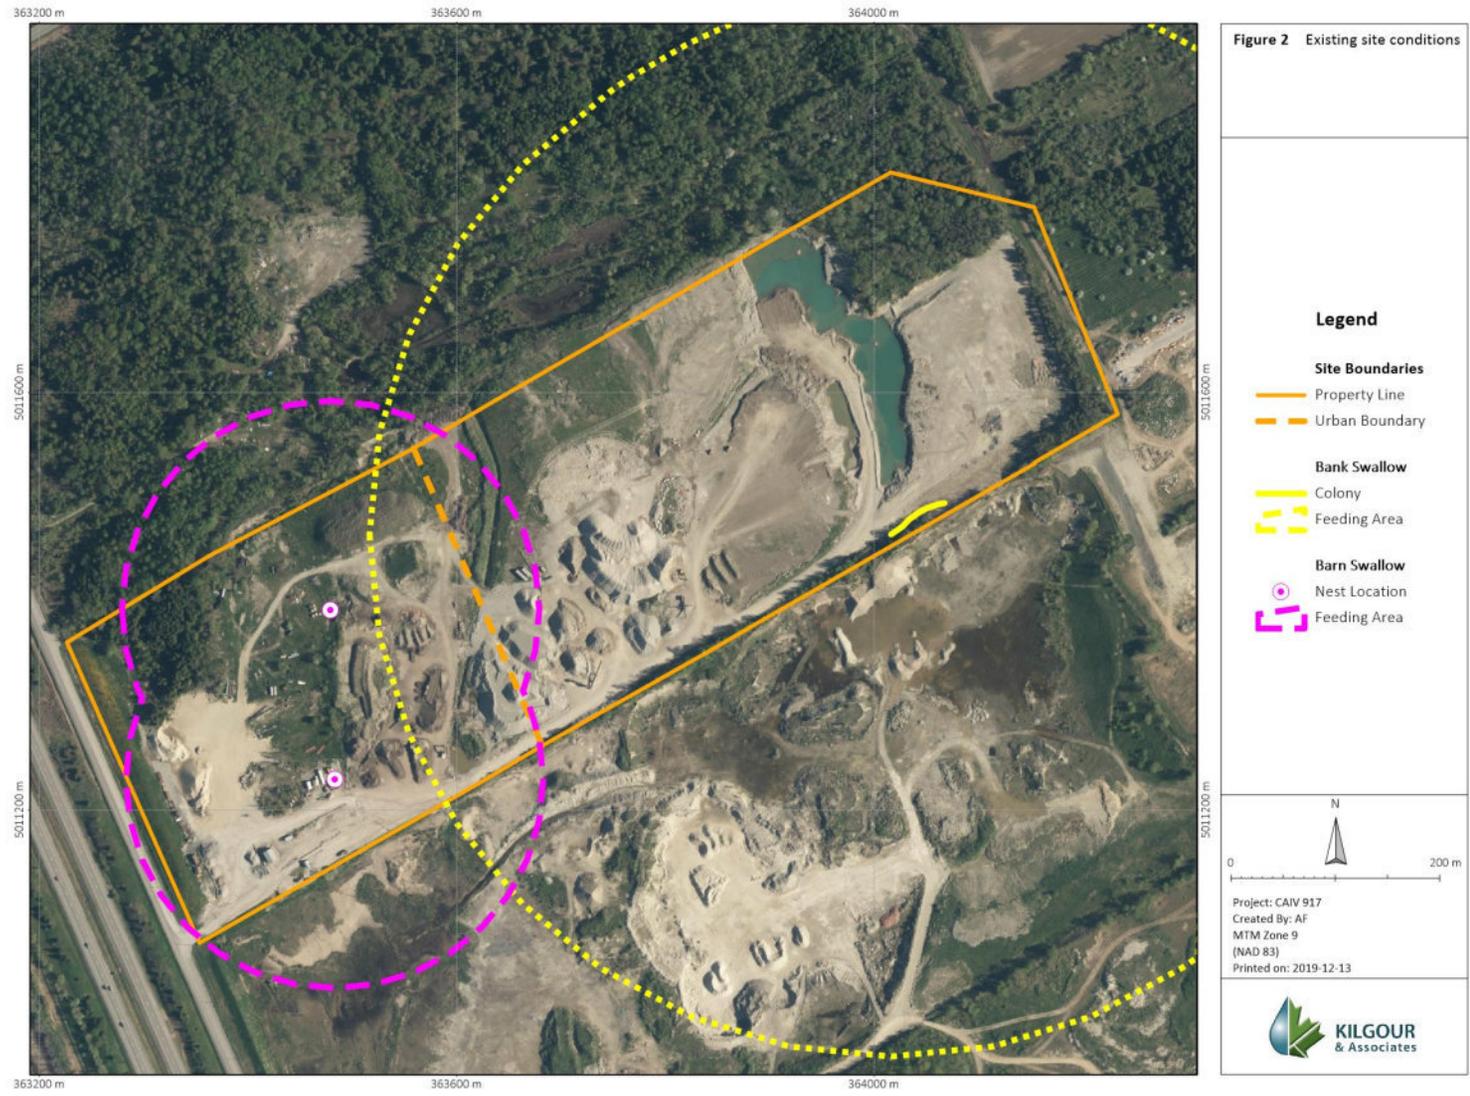
Figure 2. Map showing the location of Bank and Barn Swallow nests and associated foraging areas as of July 2019.

shipping containers constitute the breeding habitat for this species on site. Figure 2 illustrates the locations of Bank and Barn Swallow nests on site as well as their associated foraging areas based on their Category 3 habitats defined by the MNRF (2015) and the Ministry of Environment, Conservation and Parks (MECP; 2019), respectively.

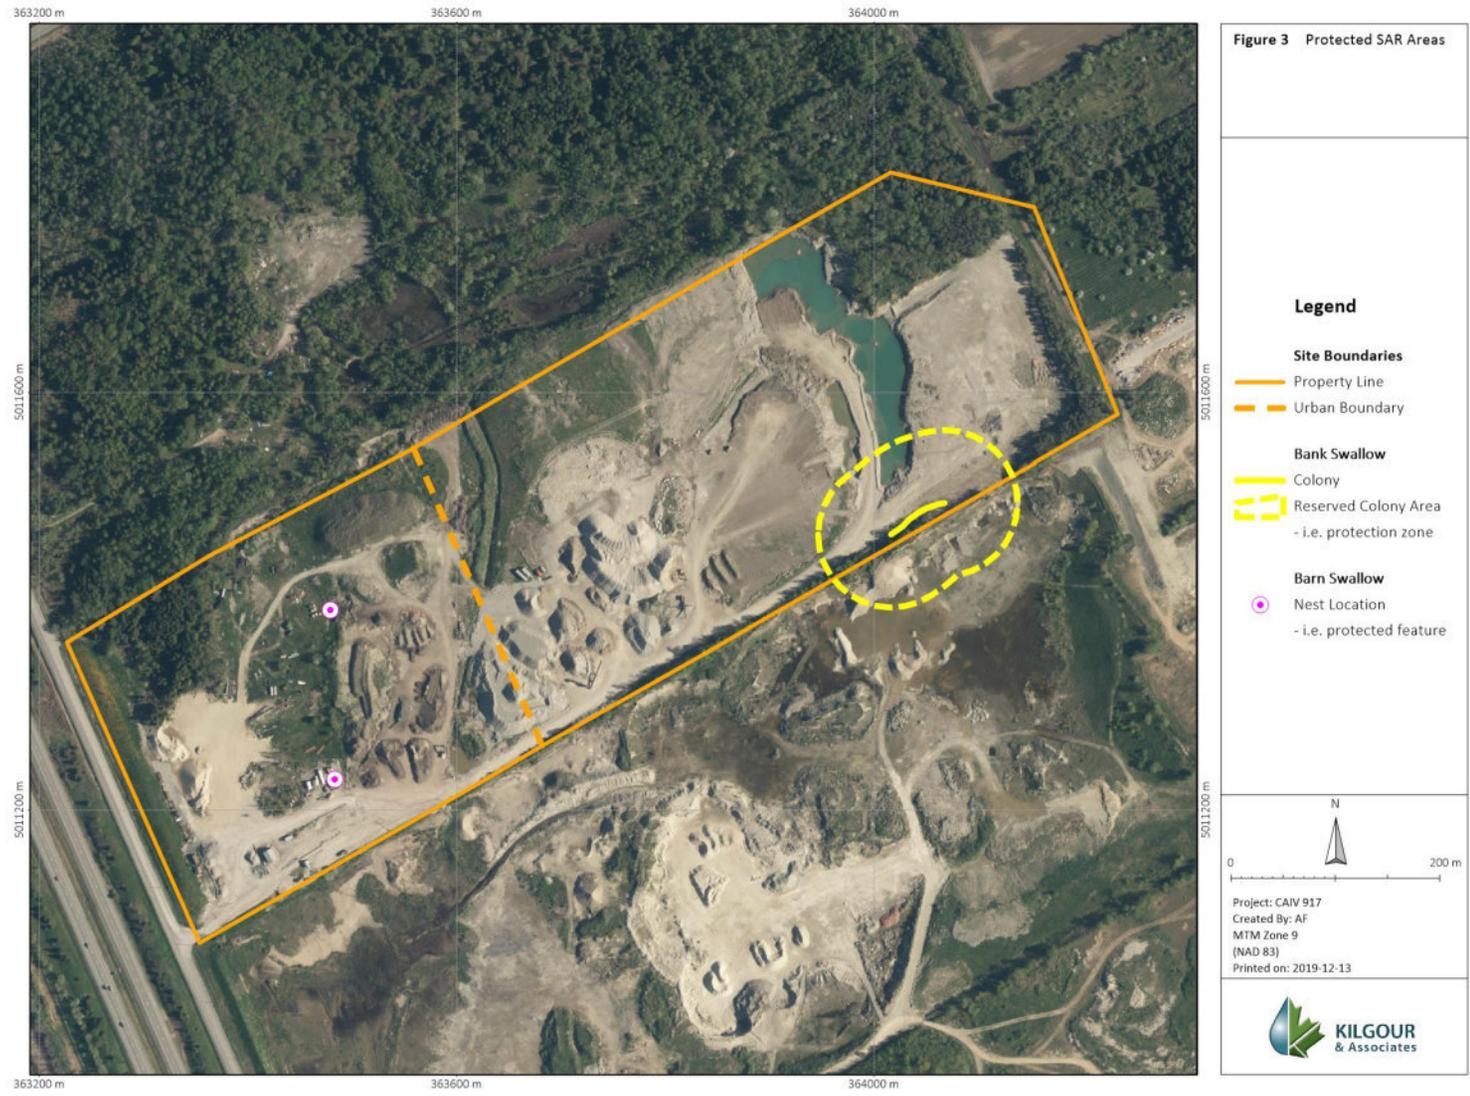
Figure 3. Map showing the areas to be maintained and protected as reserved habitat for swallows.

If ongoing pit development does not require the relocation of a breeding colony area from a given location between two consecutive years, the breeding colony area shall be maintained during the winter (i.e. in the non-breeding season from September through April) as required, to keep cliff faces vertical between 75° and 105° and thereby attractive to Bank Swallows. The established area must be maintained to provide a minimum colony space 200 m in length with at least 10 m of vertical facing. The total vertical height of the colony area including toe slopes will be higher.

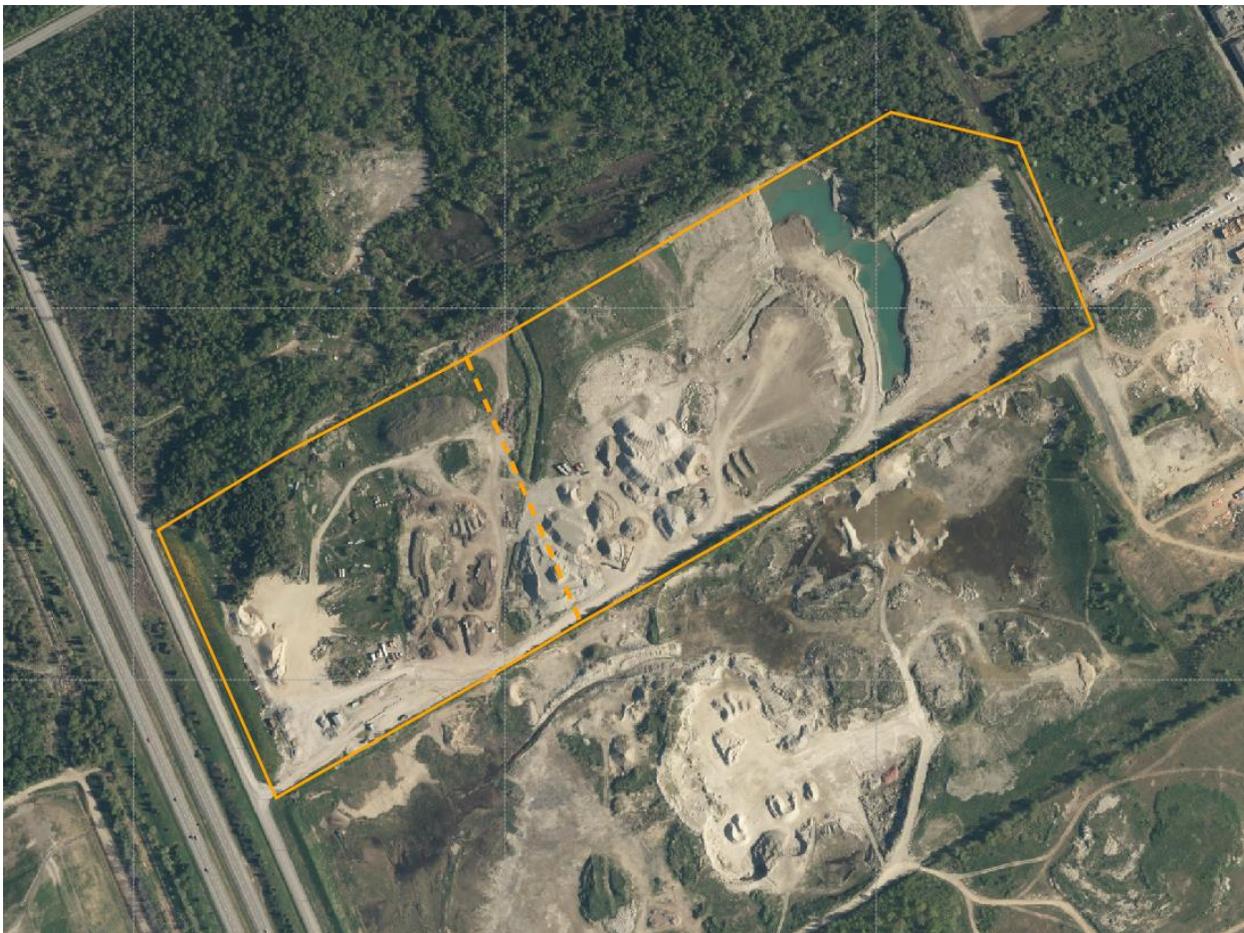
A Bank Swallow colony area has been reserved within the Drummond Sandpit that has been deemed inactive from excavation activities. Banks in this area have been contoured to between 75° and 105° making this attractive to Banks Swallows for breeding colony habitat. In the remaining sandpit, the cliff faces have been contoured to less than 70° thereby making them unattractive as potential breed colony habitat. This area is defined in Figure 2 and is composed of approximately _____(minimum 100)_____ meters of cliff face for breeding colony establishment. The vertical portion of this cliff face (i.e. excluding toe slope areas inclined) averages _____(minimum 10) metres in height. A _____(minimum 50) metre buffer projecting outward from the cliff face has also been established, within which only limited access and work is permitted by personnel trained in the recognition of Bank Swallows.

**Figure 2: Location of the reserved Bank Swallow colony area in the Drummond Sandpit.
Mark the reserved colony Area in the map**

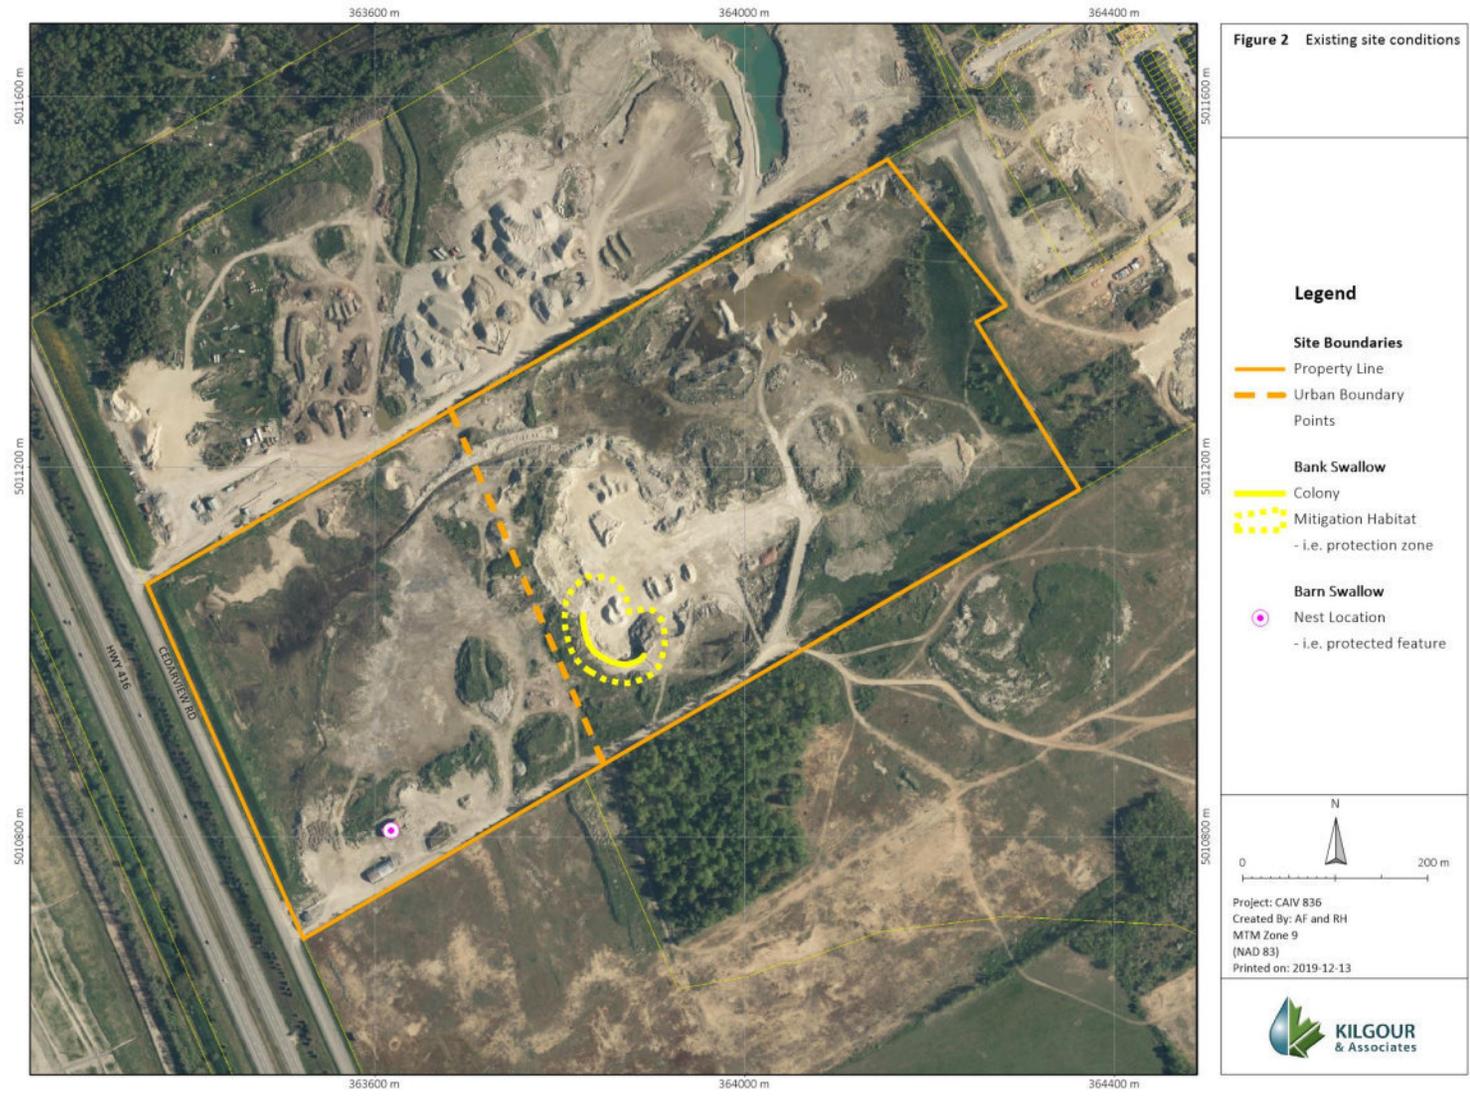
Figure 2. Map showing the location of Bank and Barn Swallow nests and associated foraging areas as of July 2019.

shipping containers constitute the breeding habitat for this species on site. Figure 2 illustrates the locations of Bank and Barn Swallow nests on site as well as their associated foraging areas based on their Category 3 habitats defined by the MNRF (2015) and the Ministry of Environment, Conservation and Parks (MECP; 2019), respectively.

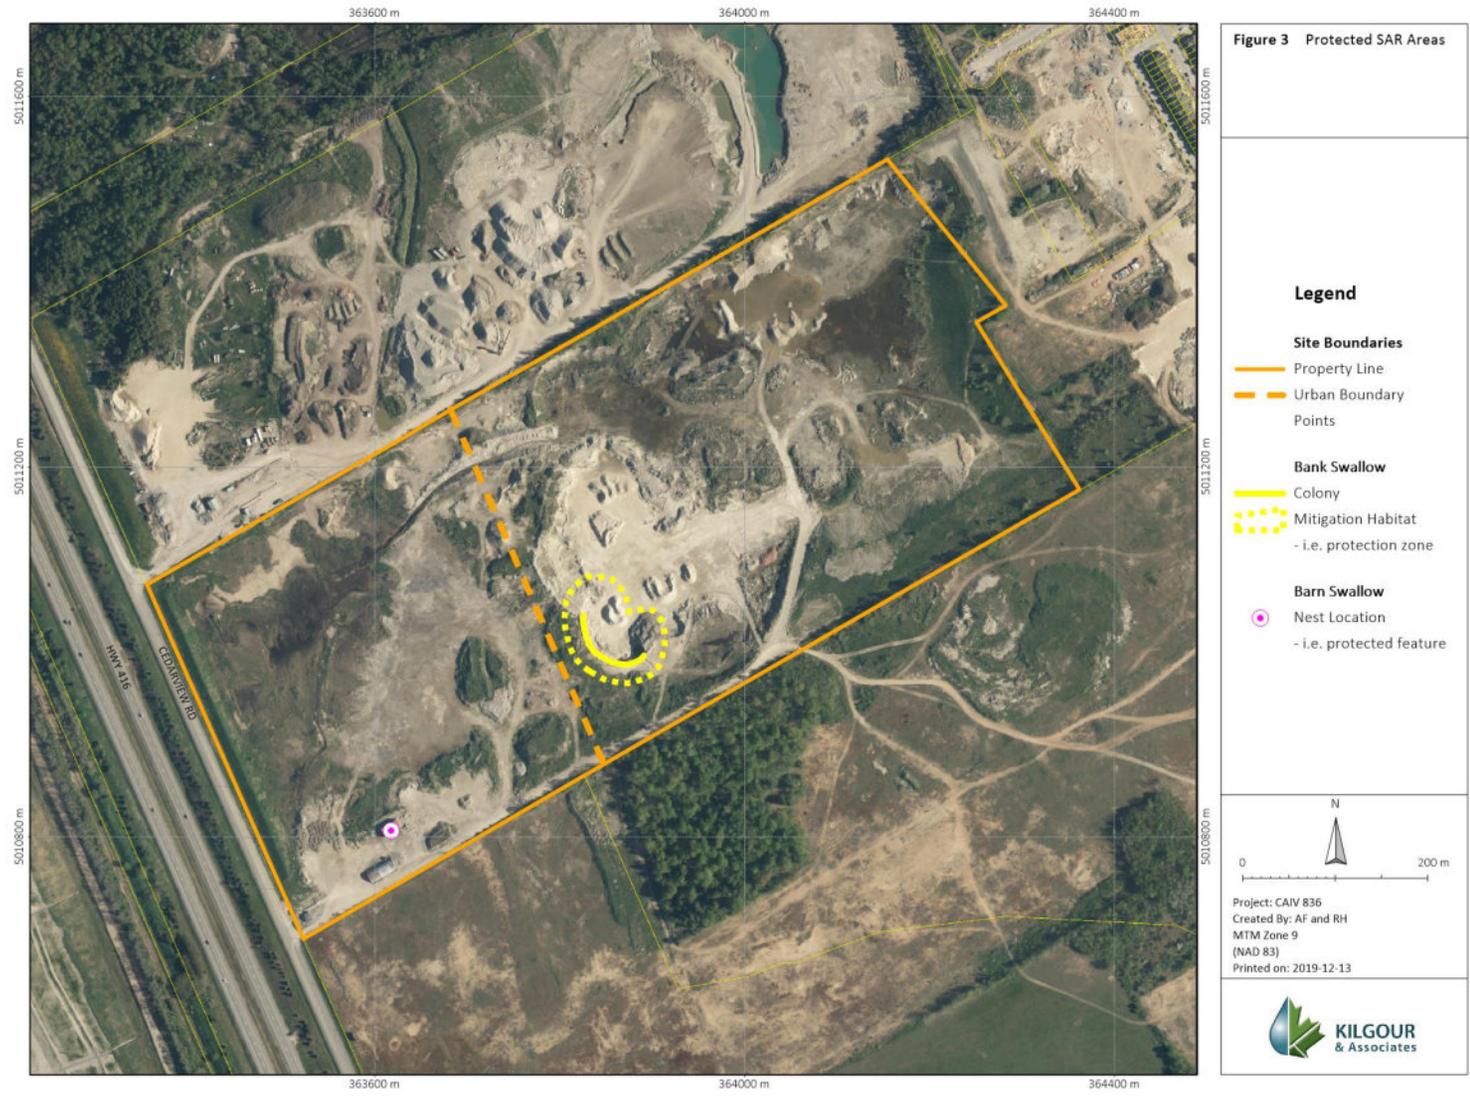
Figure 3. Map showing the area to be maintained and protected as mitigation habitat for swallows.

If ongoing pit development does not require the relocation of a breeding colony area from a given location between two consecutive years, the breeding colony area shall be maintained during the winter (i.e. in the non-breeding season from September through April) as required, to keep cliff faces vertical between 75° and 105° and thereby attractive to Bank Swallows. The established area must be maintained to provide a minimum colony space 200 m in length with at least 10 m of vertical facing. The total vertical height of the colony area including toe slopes will be higher.

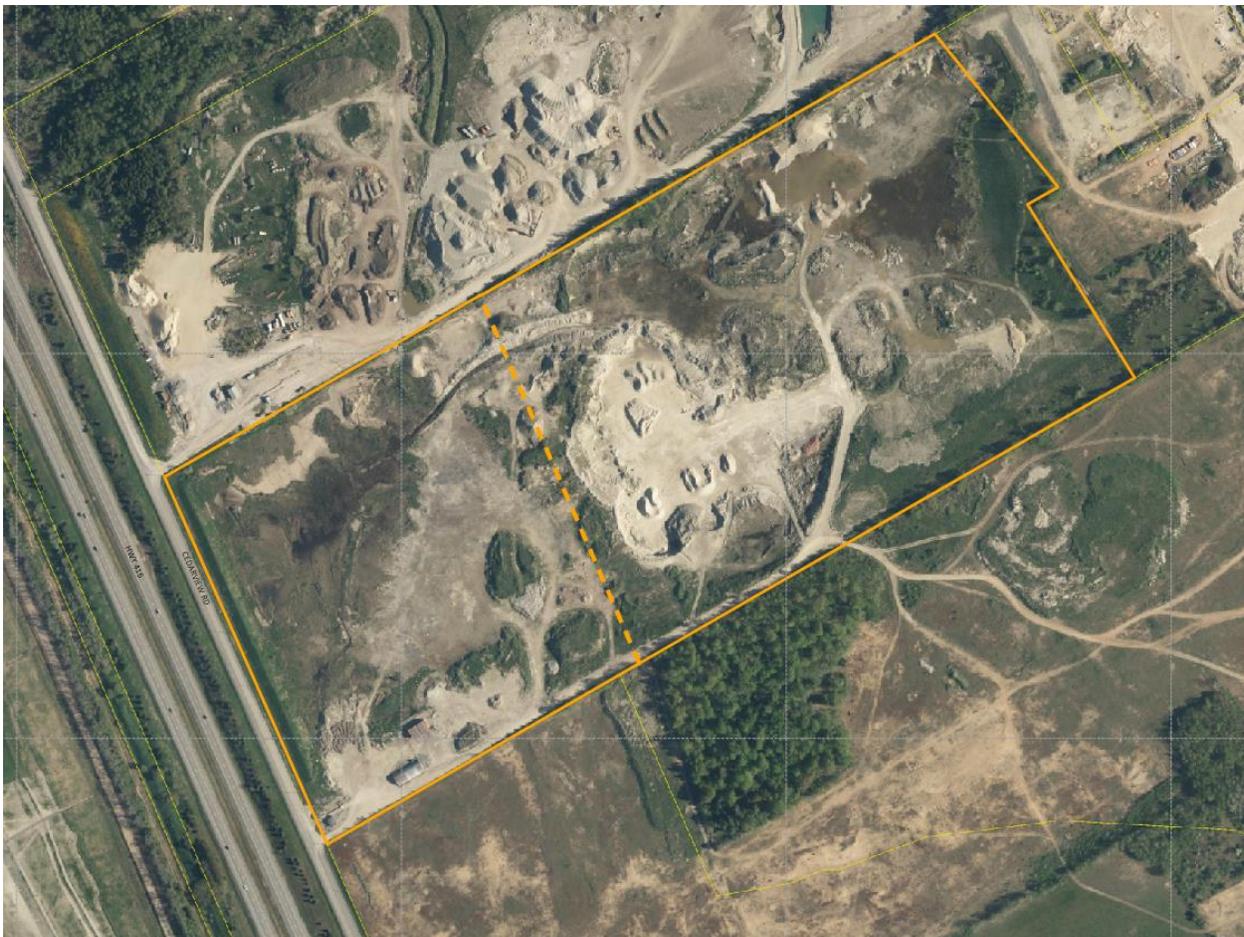
A Bank Swallow colony area has been reserved within the Brazeau Sandpit that has been deemed inactive from excavation activities. Banks in this area have been contoured to between 75° and 105° making this attractive to Banks Swallows for breeding colony habitat. In the remaining sandpit, the cliff faces have been contoured to less than 70° thereby making them unattractive as potential breed colony habitat. This area is defined in Figure 2 and is composed of approximately _____(minimum 100)____ meters of cliff face for breeding colony establishment. The vertical portion of this cliff face (i.e. excluding toe slope areas inclined) averages _____(minimum 10) metres in height. A _____(minimum 50) metre buffer projecting outward from the cliff face has also been established, within which only limited access and work is permitted by personnel trained in the recognition of Bank Swallows.

**Figure 2: Location of the reserved Bank Swallow colony area in the Brazeau Sandpit.
Mark the reserved colony Area in the map**
