FINAL REPORT

Phase One Environmental Site Assessment

PIN 045891862, PIN 045890409, and Part of PIN 045890405

Golder Associates Ltd.

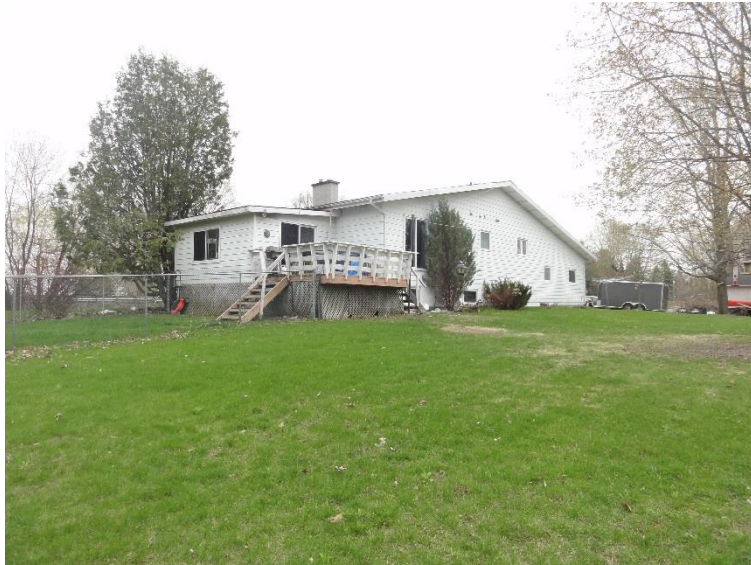
Photo 1 – View of the residential building (#788 River Road) on northeast corner of the Site, looking southeast.

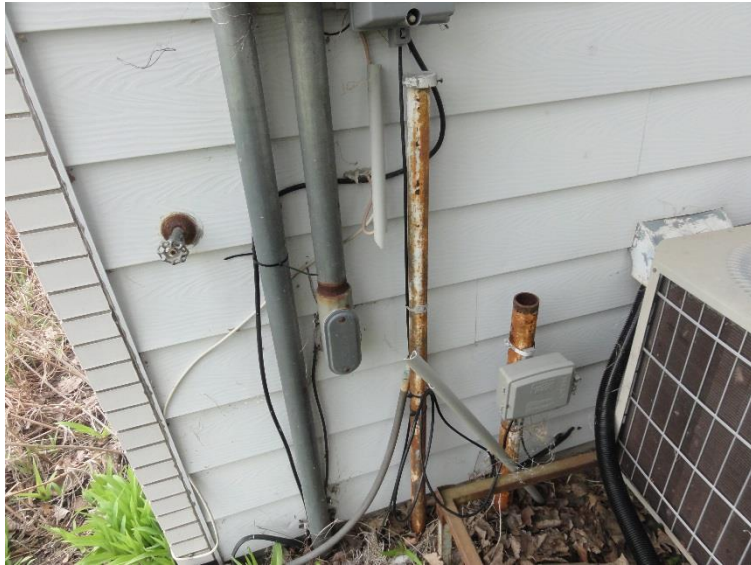
The Site Building, reportedly constructed in 1960s, included vent and fill pipes going into the ground along the northeast elevation of the building and were located adjacent to the furnace room in the basement. Two copper feeder pipes, known to supply furnace oil from associated USTs, were observed along the interior wall of the furnace room (adjacent to the vent and fill pipes). Furthermore, one of the Site Representative indicated that the building previously used furnace oil for heating purposes; however, natural gas has been used for the furnace since the current owners acquired the residential property in the early 2000s. The presence or location of former UST associated with heating of the Site Building could not be confirmed at the time of the Site. As such, presence of former and/or current furnace oil UST is considered a PCA that will result in an APEC for the Site.

Photo 3 – View of vent and fill pipes, likely associated with former UST, entering the ground on the northeast corner of the residential building.

Based on the information obtained as part of this Phase One ESA, the presence of former and/or current furnace oil UST associated with the Site Building is considered an APECs for the Site. A Phase Two ESA is recommended to investigate soil and groundwater quality on the northeast portion of the Site near the residence for potential impacts related to the furnace oil UST.

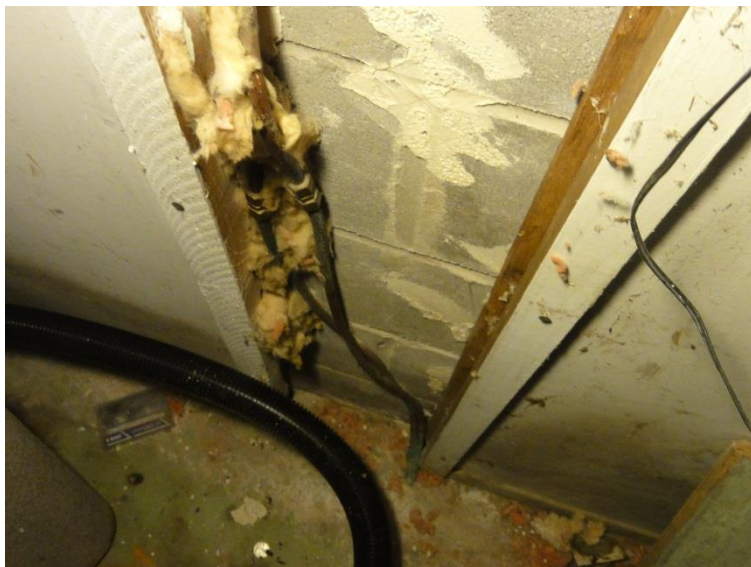
Photo 4 – View of potential UST feeder line observed in the basement furnace room of the residence, located along the inside wall adjacent to exterior vent/fill pipes.

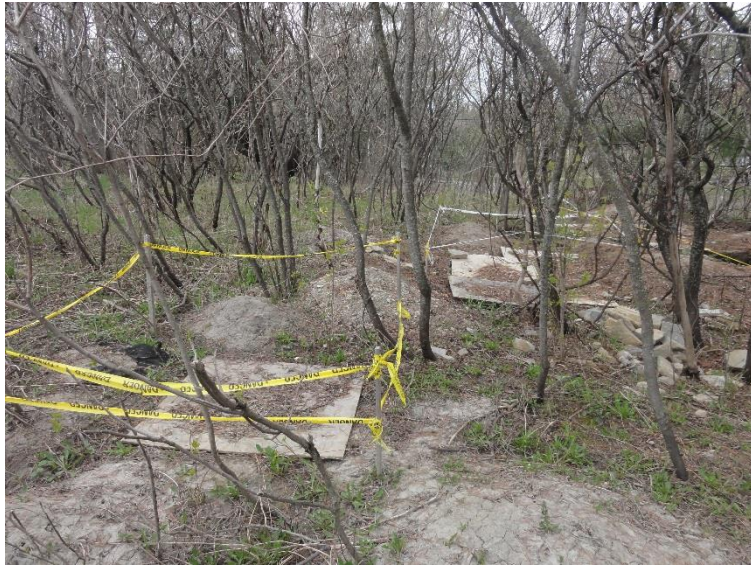
Photo 7 – View of the archaeological features identified on the southwest corner of the Site.

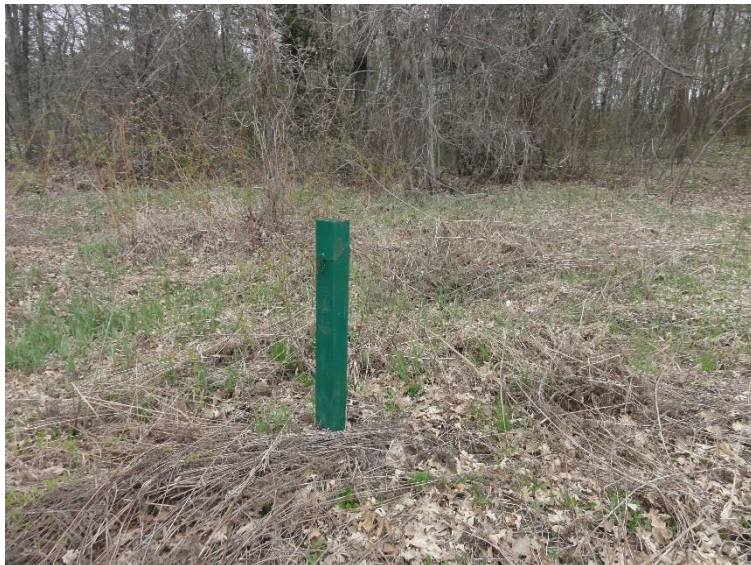
Photo 8 – View of a monitoring well on the northwest corner of the Site from a geotechnical investigation.

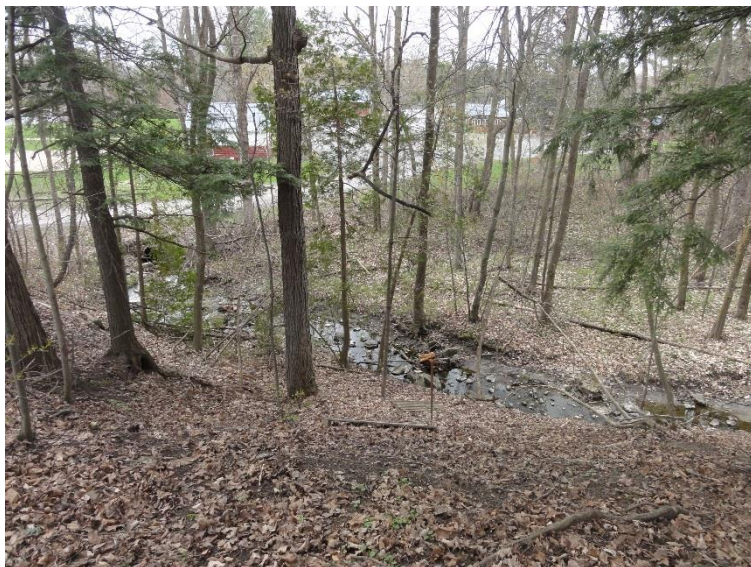
A ditch was observed extending from central portion of the Site to the northeast corner, where it discharges into the ravine flowing along the northern Site boundary. A steep slope going down to this ravine was observed along the northern Site boundary. The overall slope of the Site is downwards to the west, towards the Rideau River located approximately 100 m west of the Site. No evidence of stressed vegetation or stains were observed at the time of the Site visit. No evidence of fill materials at the Site were observed or reported by the Site Representative.

Photo 10 – View of ravine flowing along the north Site perimeter at a lower elevation from the Site, looking northwest.
