RE: Findlay Creek Stage 5 Lands
Tree Conservation Report and Environmental Impact Statement - Revised

This combined Tree Conservation Report (TCR) and Environmental Impact Statement (EIS) assesses the Findlay Creek Stage 5 lands, which are in the northwest portion of the Findlay Creek area, to the south of Leitrim Road and west of Kelly Farm Drive and portions of the Barrett urban residential development under construction.

# **CURRENT VEGETATION**

# PROPOSED CONSERVED VEGETATION

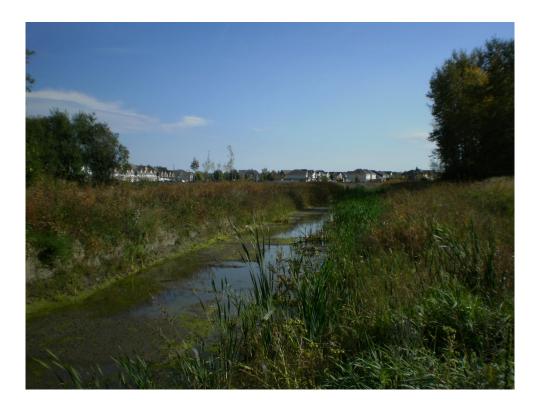
Photo 1 – Recently constructed north-south swale immediately to the east of the site. View looking south.

A north-south channel immediately adjacent to the east edge of the site has been constructed (Photo 1) and will collect the surface runoff from north of the site once swale realignments are completed to the north of Leitrim Road. The north-south channel is shown with a blue line on Map 2 and identified as the 'North-South Swale'. The north-south swale was enhanced with instream structure and plantings of native trees and shrubs along the swale corridor. The on-site channels to be removed are shown with blue lines on Map 1. These channels were part of the Hope Municipal Drain until the Drain was removed from the authority of the *Drainage Act* as part of decommissioning process completed by Stantec Consulting around 2000. A Department of Fisheries and Oceans Authorization issued on June 26<sup>th</sup>, 2006 (File Number 5250-100A, attached as Appendix A) covered the destruction of these channels as tributaries of Findlay Creek as part of the overall Findlay Creek Village development. The geographical scope of the Authorization extended from Leitrim and Albion Roads south to the Rideau Carleton Raceway and east to Bank Street. The culverts required for the subdivision road crossings were installed at the time of the north-south swale construction.

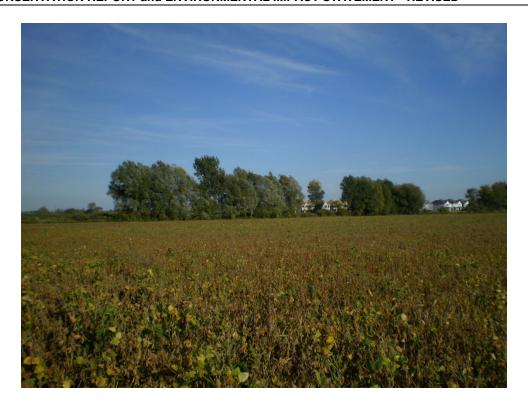
Photo 2 – Cultivated field planted in soybeans in 2019 in the central portion of the site. View looking southeast to an intermittent deciduous hedgerow

Much of the site remains in agricultural use, with the topsoil now stripped from the east field, which is scrapped clear with no ground vegetation of note. In 2019, the remaining agricultural fields in the central and north portions of the site were planted in soybeans (Photo 2).

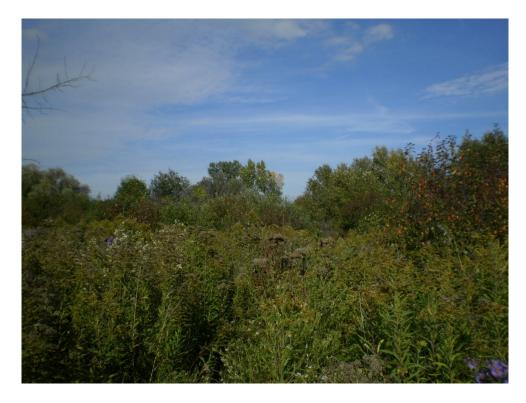
Photo 3 – Typical cultural meadow habitat in the southeast corner of the site. View looking northeast to a deciduous hedgerow

Cultural thickets and meadows are in the south portion of the site, south of the agricultural fields (Photos 3 and 4, Map 1). Glossy buckthorn and common buckthorn are dominant shrubs in the thicket habitats, with red raspberry, blackberry, slender willow, red raspberry and Bebb's willow also present in the cultural meadow and thickets. Regenerating poplar and ash stems are well represented in areas. The largest poplars were eastern cottonwood up to 30cm diameter at breast height (dbh), with balsam poplar, white ash, white birch, and trembling aspen up to 25cm dbh and green ash and Manitoba maple generally less than 20cm dbh.. A couple of crack willows were in the range of 40cm – 50cm dbh. These were likely part of former deciduous hedgerows. Many of the ash trees appeared dead or in very poor condition from the emerald ash borer.

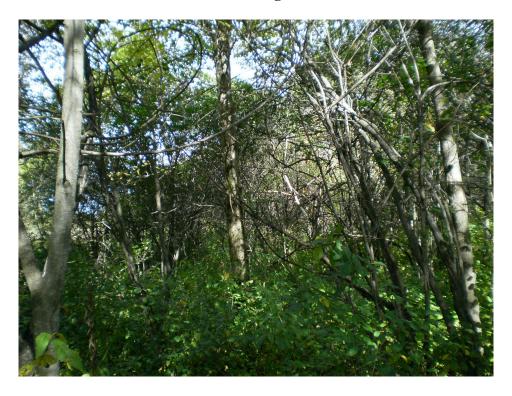
Photo 5 – Upland poplar deciduous forest in the southwest corner of the site. View looking east

Trembling aspen up to 35cm dbh dominate an upland forested area in the southwest portion of the site (Photo 5, Map 1). Smaller balsam poplar, Manitoba maple, green ash, and white ash are also present. As with the balance of the site, this area was an agricultural field in 1976. Fungus was on many of the poplars and the trunks of the ash were often impacted by emerald ash borer. The understory is very thick in most areas with common buckthorn, glossy buckthorn, and regenerating ash stems (Photo 5). Prickly gooseberry, red raspberry, and regenerating Manitoba maple stems were also present. Common ground flora in the upland deciduous forest include June meadow grass, helleborine, wild grape, field horsetail, motherwort, white avens, Canada goldenrod, narrow-leaved goldenrod, joe-pye-weed, New England aster, white bedstraw, sensitive fern, violet, Pennsylvania sedge, and common strawberry.

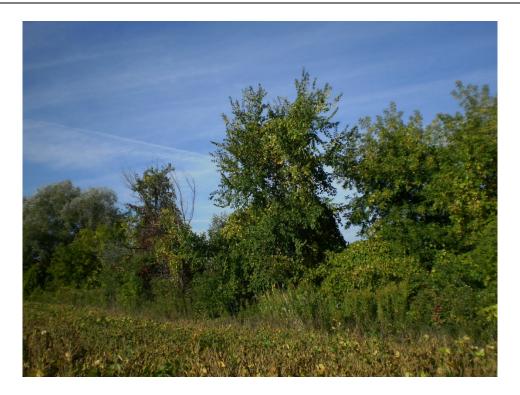
Photo 6 – Typical intermittent north-south deciduous hedgerow. This example is in the south-central portion of the site, with view looking northeast

Intermittent deciduous hedgerows (Photo 6) are common in the central and north portions of the site, between agricultural fields and along the west and south periphery of the fields. Trembling aspen and crack willow are dominant in areas, with white elm, eastern cottonwood, grey birch,

white ash, green ash, and Manitoba maple common in areas. Many of the crack willows are coppice (multi-stem), with individual stems up to 50cm dbh. The larger limbs of the crack willows were often broken or almost horizontal along the ground. Many of the ash appeared dead or had reduced leaf-out.

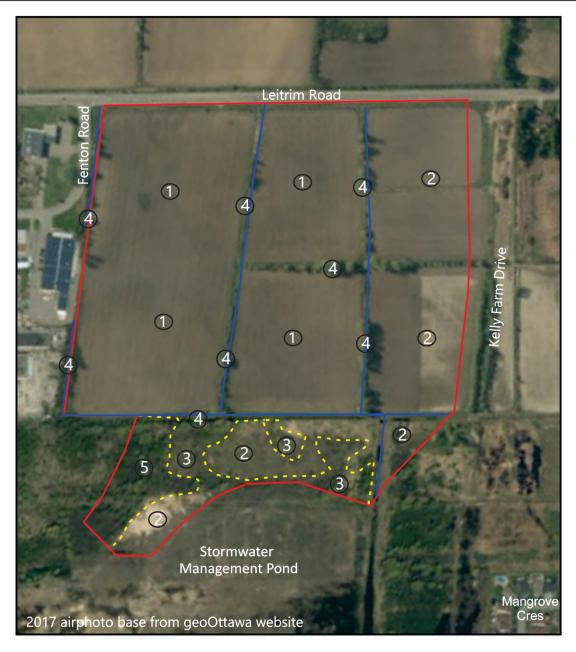
Map 1

Regenerating upland deciduous treed areas are in the southwest corner of the site, along with cultural habitats, also with regenerating vegetation on former agricultural lands (Map 1). Cultural Thicket and Meadows

Any aquatic habitat in the on-site and adjacent agricultural diches (see blue lines on Map 1) will be replaced with the new north-south swale recently constructed immediately east of the site and west of the Kelly Farm Drive. The swale was designed to enhance the extent of amphibian, fish and other wildlife habitat through creation of pools, placement of boulders and root wads, native seed mixes and plantings of native trees and shrubs. The north-south swale width and other components were approved as part of the earlier Phase 1 of Stage 4 of the Findlay Creek development and all required compensation was completed with the construction of the swale.

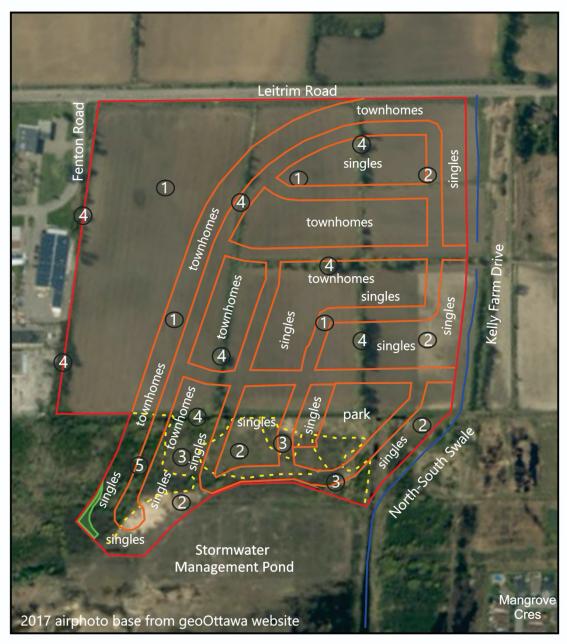
Map 2

The proposed development will accommodate approximately 388 units which include 169 single detached family homes (44% of total units) and 219 townhouse units (56% of total units) (Map 2). All units will be on full urban municipal services and the stormwater management pond immediately to the south of the site will be utilized. A 0.9 hectare park block is proposed for the southeast portion of the site. A 25 metre wide open space corridor immediately to the east of the site and west of Kelly Farm Drive includes a channel conveying overland flow originating from north of the site, north of Leitrim Road. Access to the site will be via two streets west off Kelly Farm Drive. Theses streets will connect to internal crescents throughout the site.

Due to the adjacent developments, the southwest corner is the only area where the critical root zones of adjacent trees may extend onto the site. As indicated above and on Map 2, there is the potential for tree retention in this area. This tree retention would also protect the critical root zones of the adjacent trees. If tree retention in this area is not possible, no grade changes should occur within three metres of the site boundary where the critical root zones of adjacent tree may extend onto the site.
