## Geotechnical Investigation

Proposed Residential Development  
Riverside South - Phase 12  
750 River Road  
Ottawa, Ontario

January 14, 2021

Report: PG3320-3

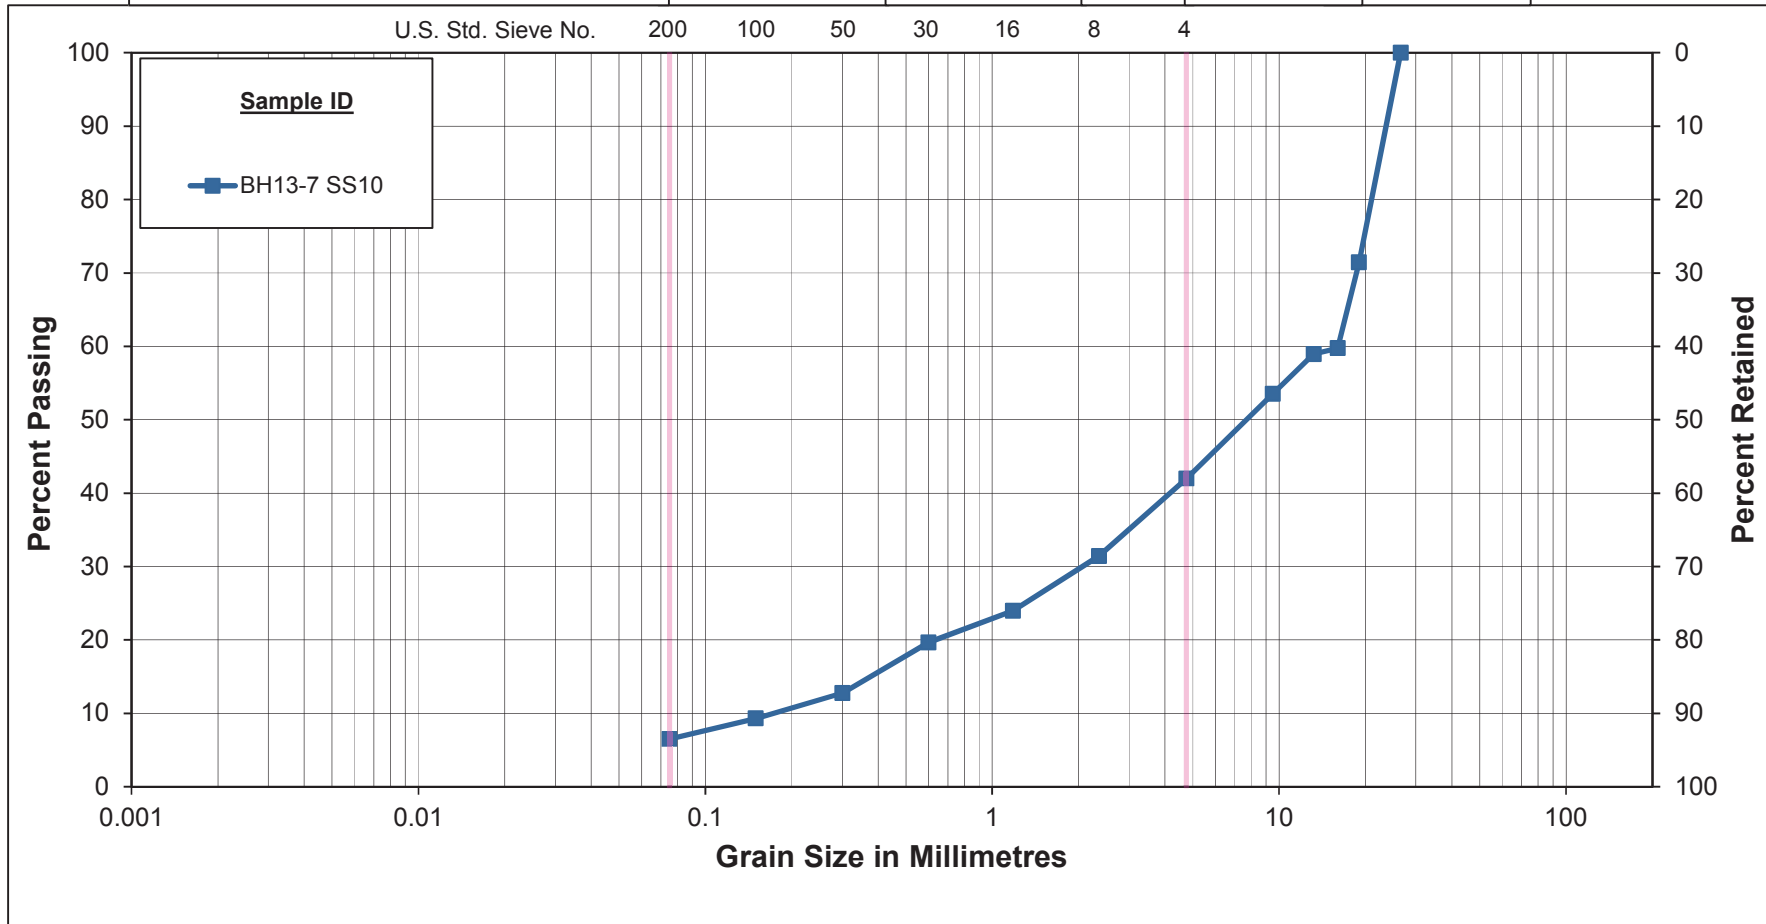
Figure No. 5

**GRAIN SIZE DISTRIBUTION**  
Gravel with Silty Clay and Sand: TILL

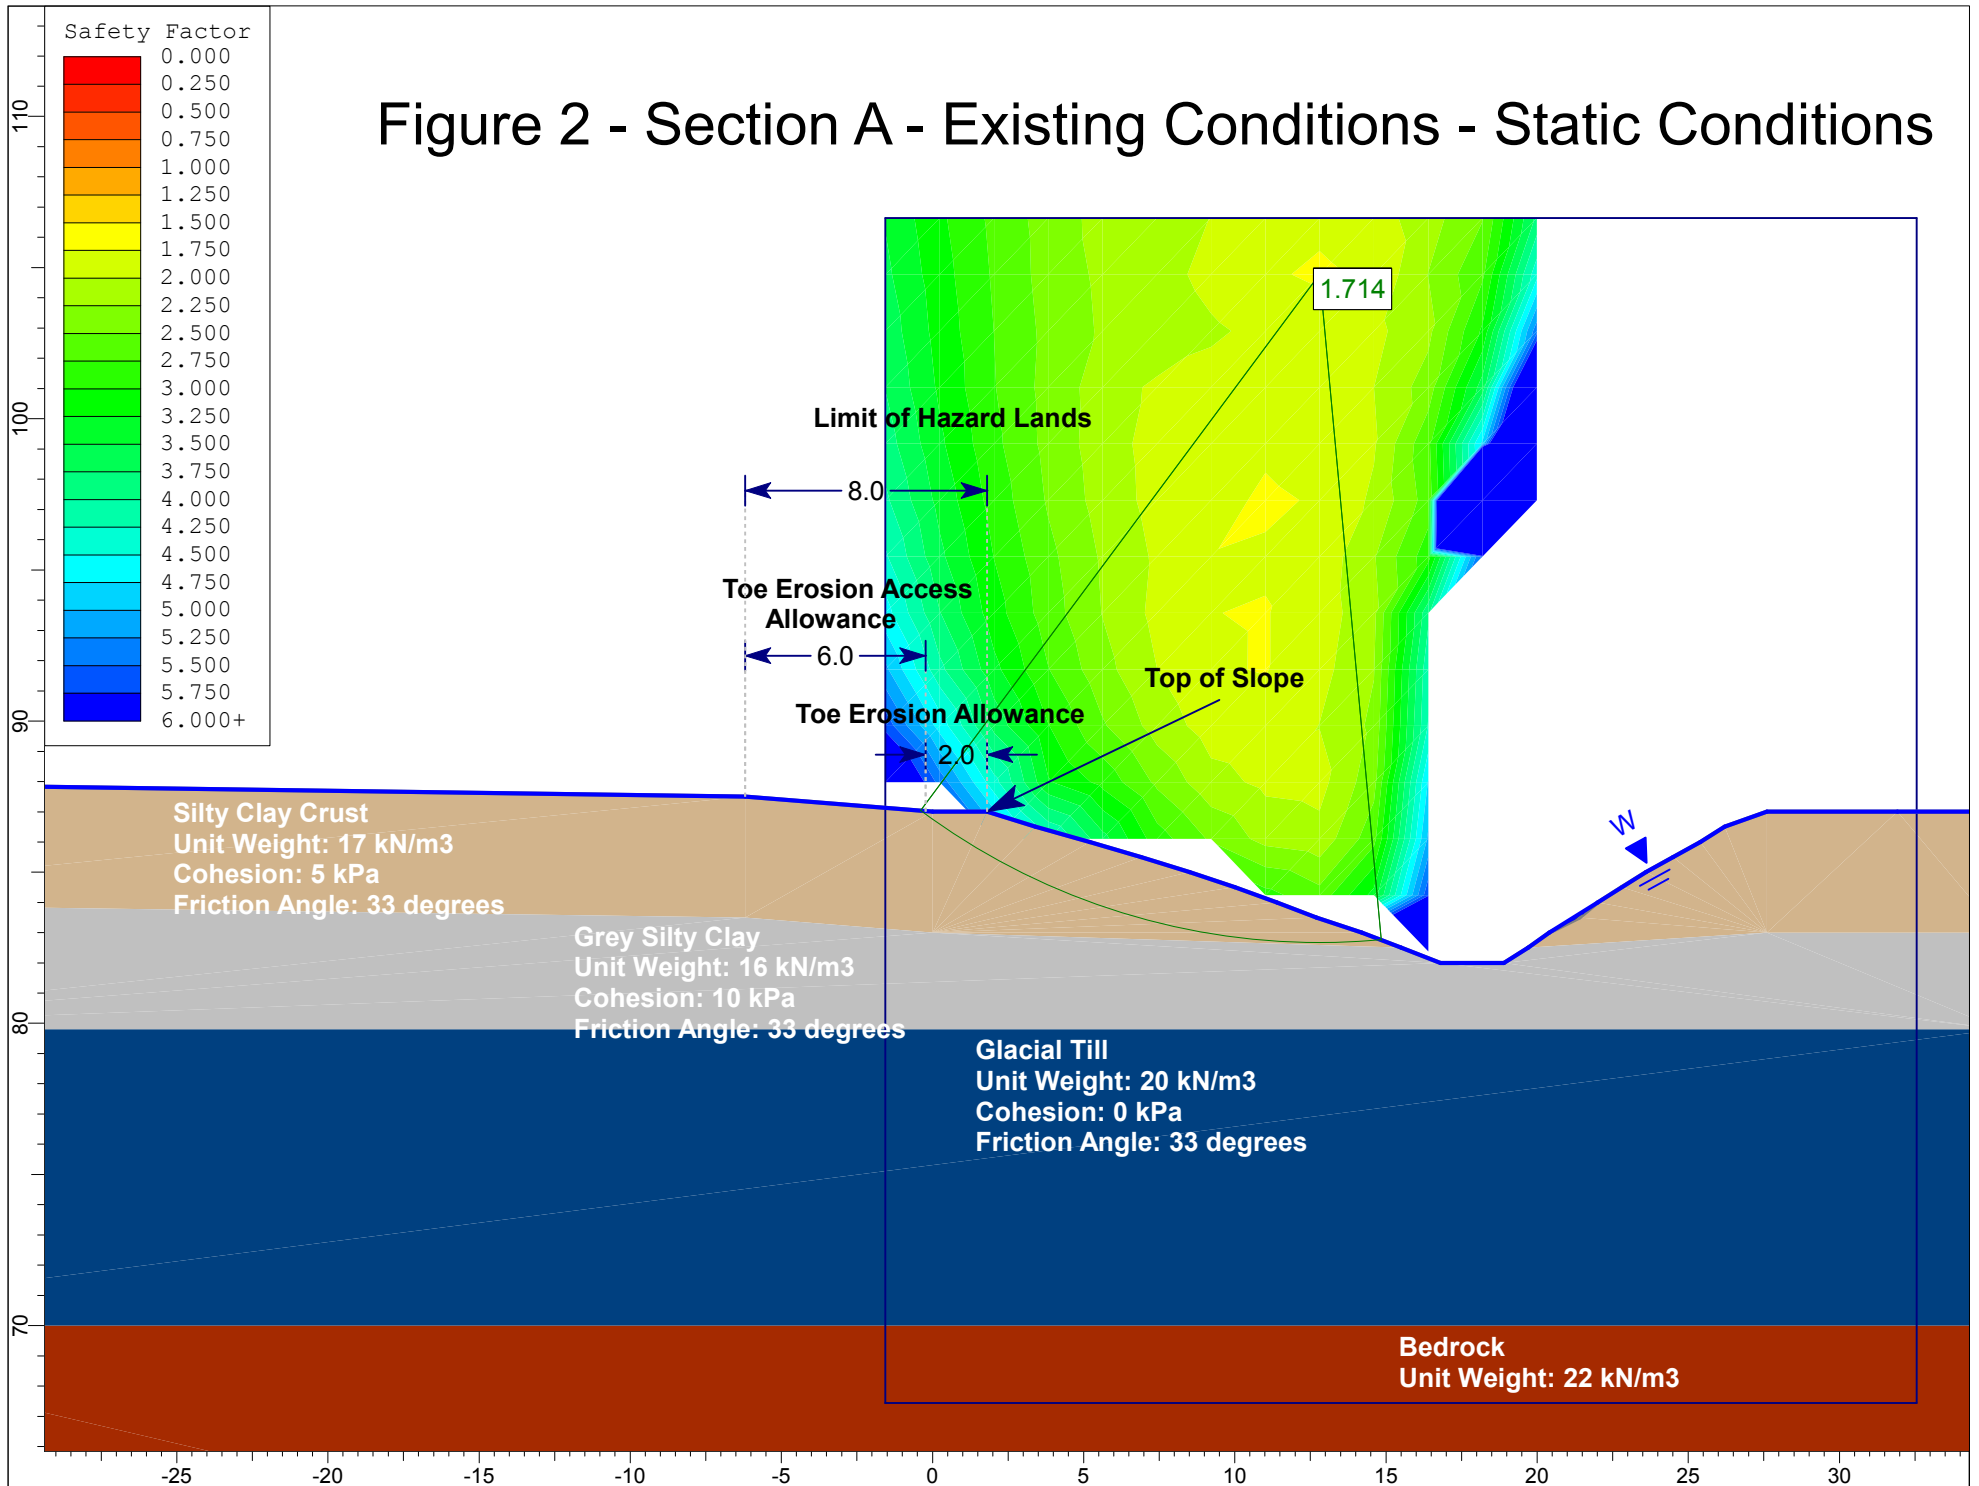
# Figure 2 - Section A - Existing Conditions - Static Conditions

The results for the slope stability analyses under static conditions at Sections A, B, C, and D are shown on Figures 2, 4, 6, and 8 attached to the present report. The factor of safety was found to be greater than 1.5 at Sections A and B. However, Section D requires a setback of 13.2 m from the top of slope to obtain a factor of safety greater than 1.5. The factor of safety at Section C was found to be less than 1.5, however, a negligible (less than 0.5 m) setback from the top of slope would be required to achieve a factor of safety of 1.5.

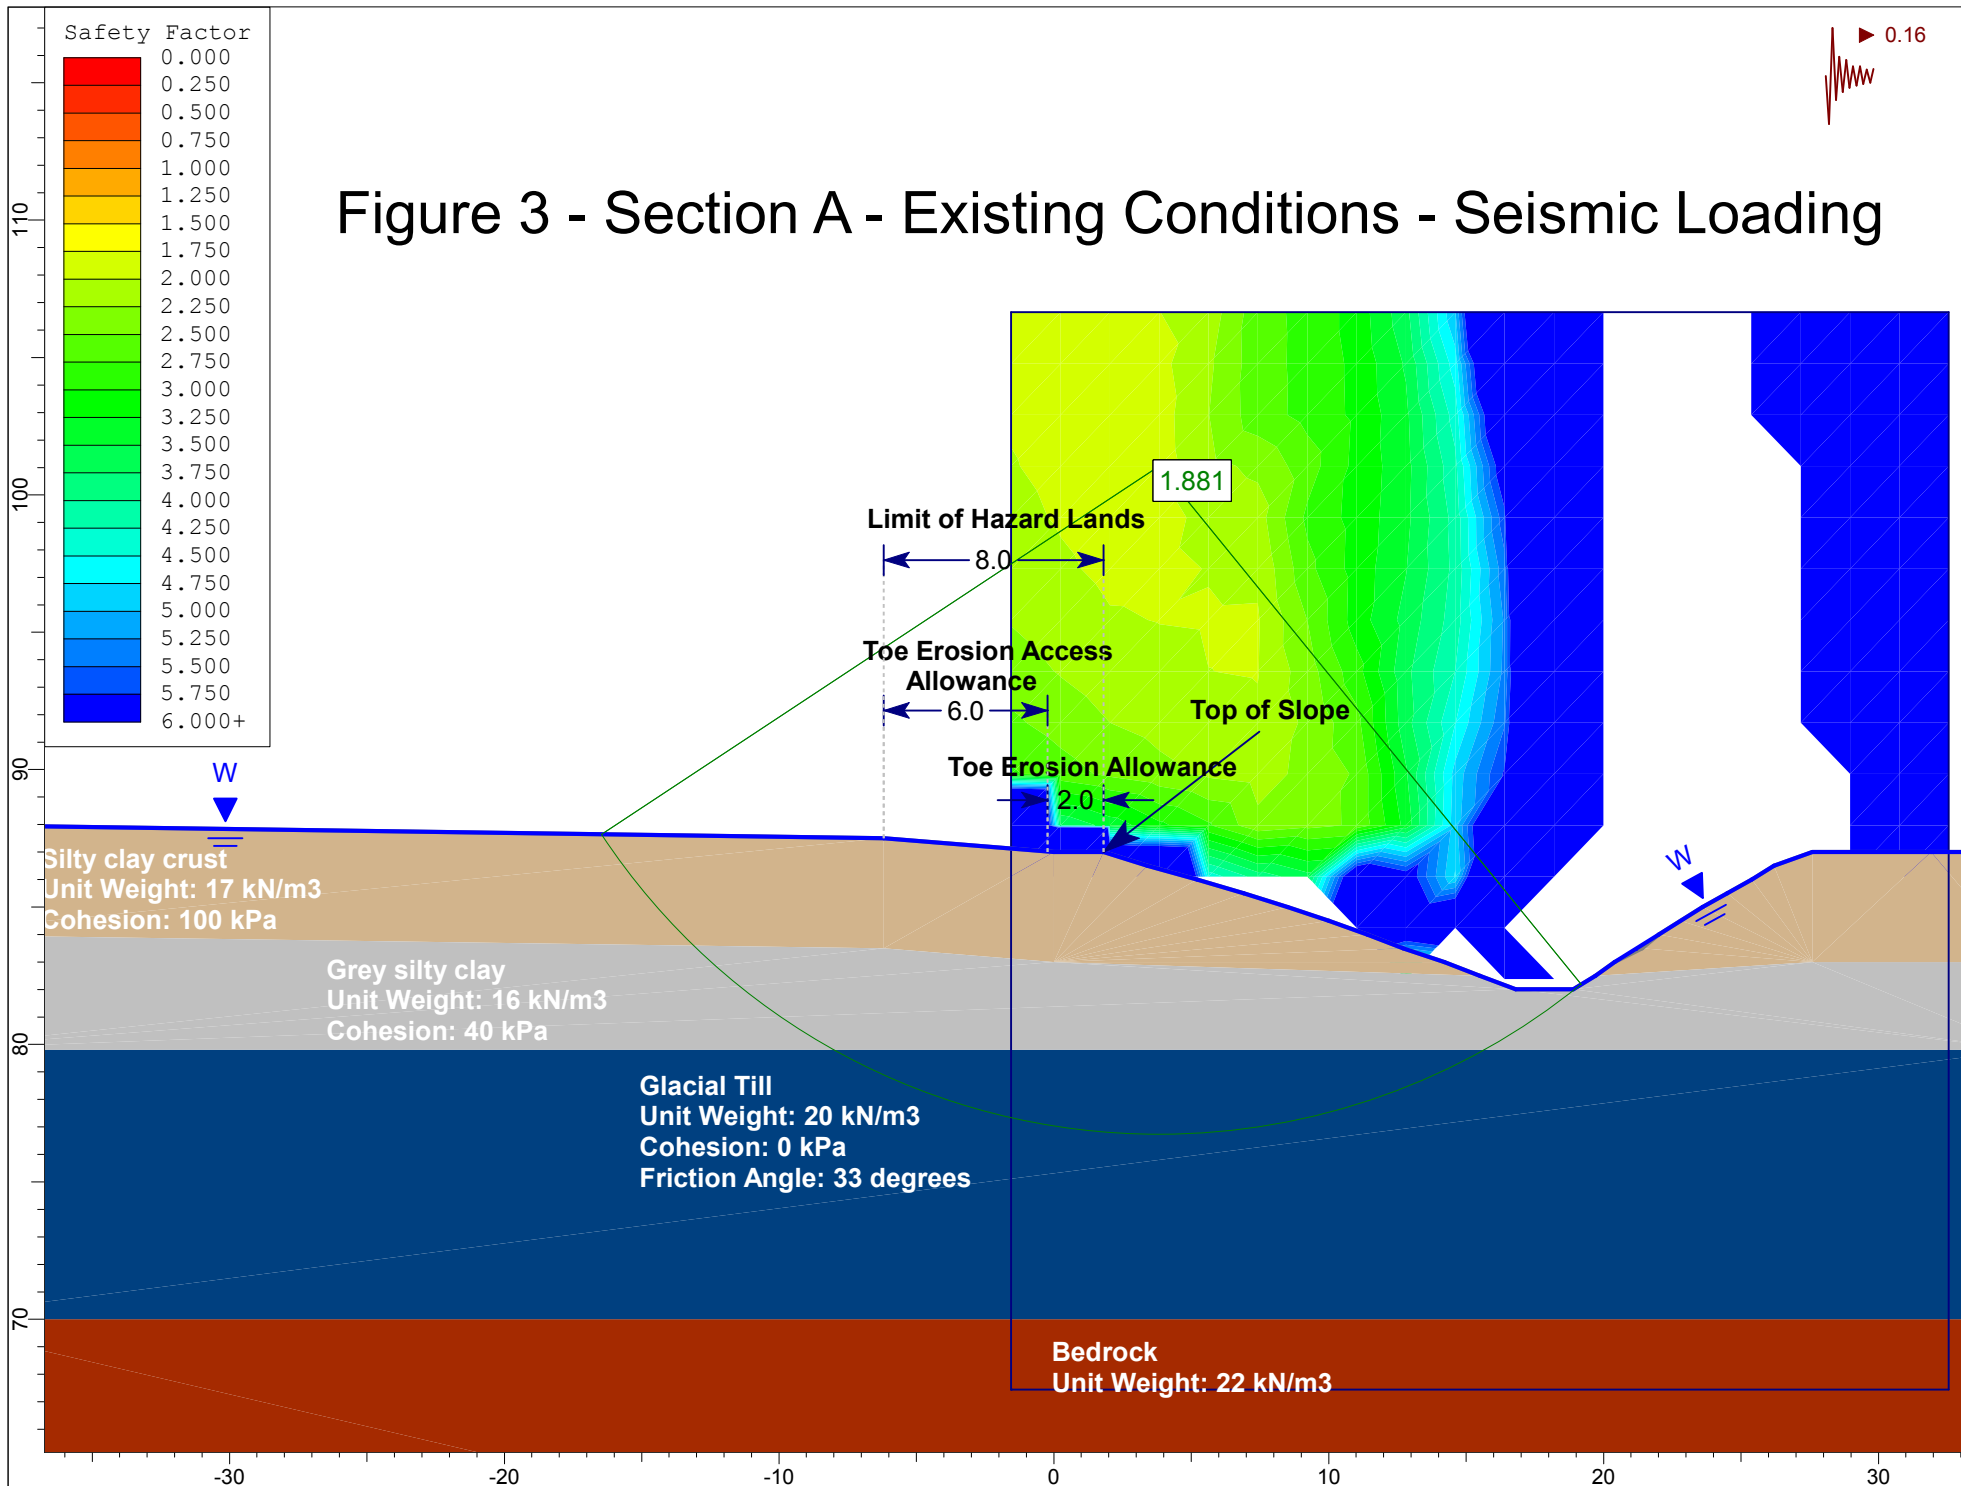
The results of the slope stability analyses under seismic conditions are shown on Figures 3, 5, 7, and 9 in Appendix 2. The results indicate that the factors of safety are greater than 1.1 under seismic conditions. Based on these results, the slopes are considered to be stable under seismic loading. Therefore, when considering seismic loading, no stable slope allowance is required from the top of the slope to achieve a factor of safety of 1.1 for the Limit of the Hazard Lands.

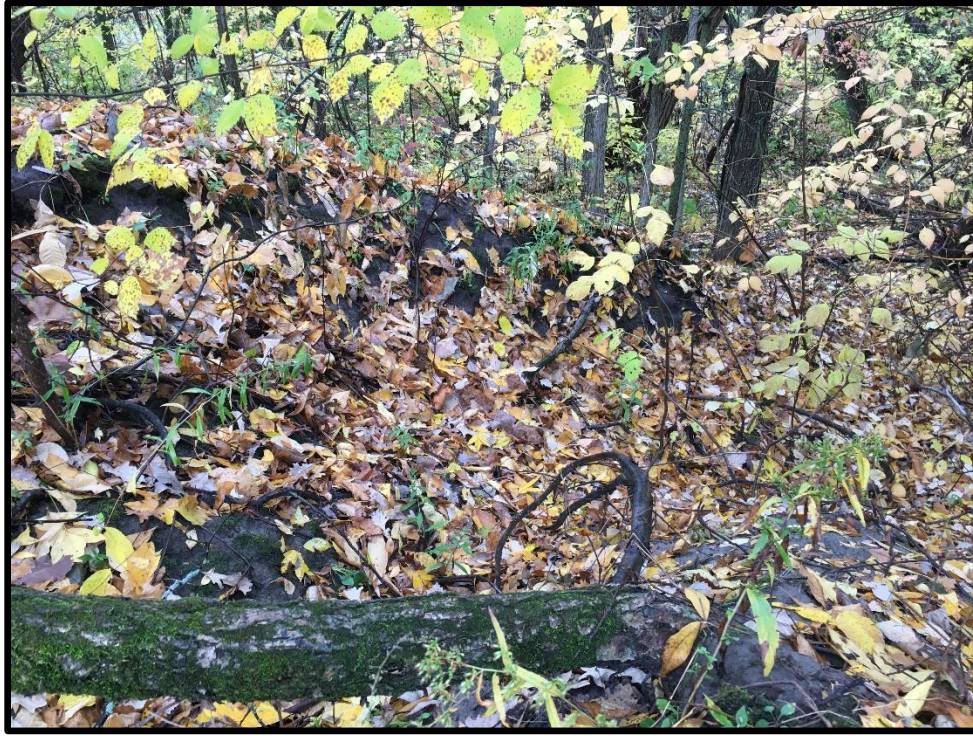
Photo 1: Existing conditions of western slope face, looking downslope, facing west. (October 16, 2020)

Signs of erosion were noted along the slope face that confines the Rideau River located along the western boundary of the subject site. Some minor sloughing failures were noted in the lower portion of the slope, leaving some exposed tree roots.

Although signs of historic erosion were observed during our site review, the watercourse is dam controlled and within a confined channel which is able to support routine flows. Further, the slope face was observed to be in a stable condition and signs of active erosion were not observed.

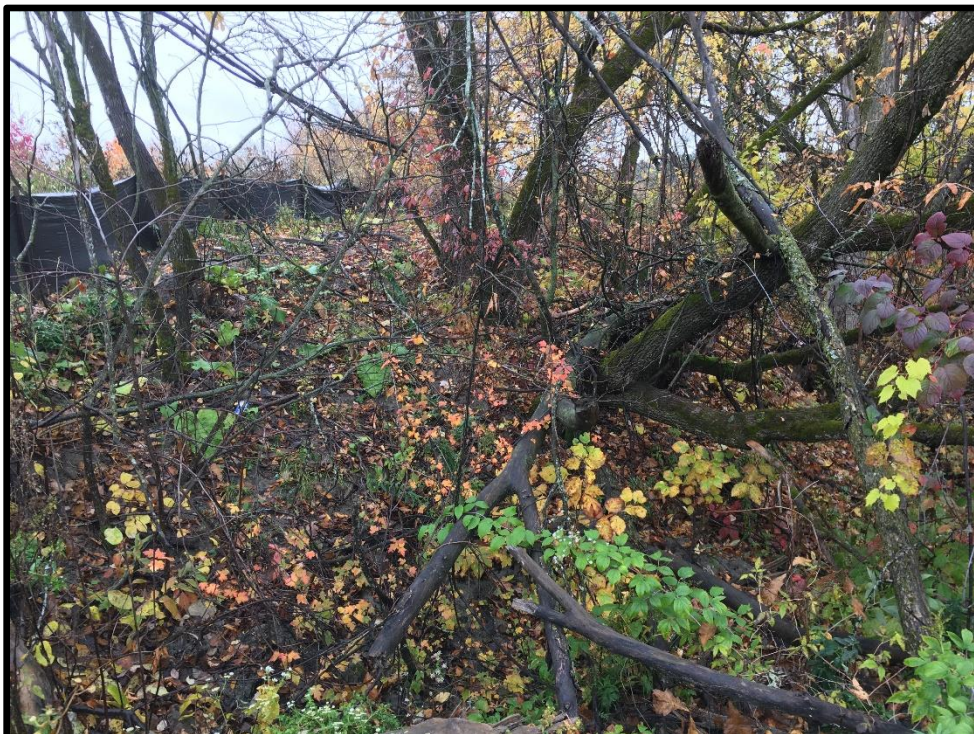
Photo 2: Existing conditions of western slope face, looking upslope, facing east. (October 16, 2020)

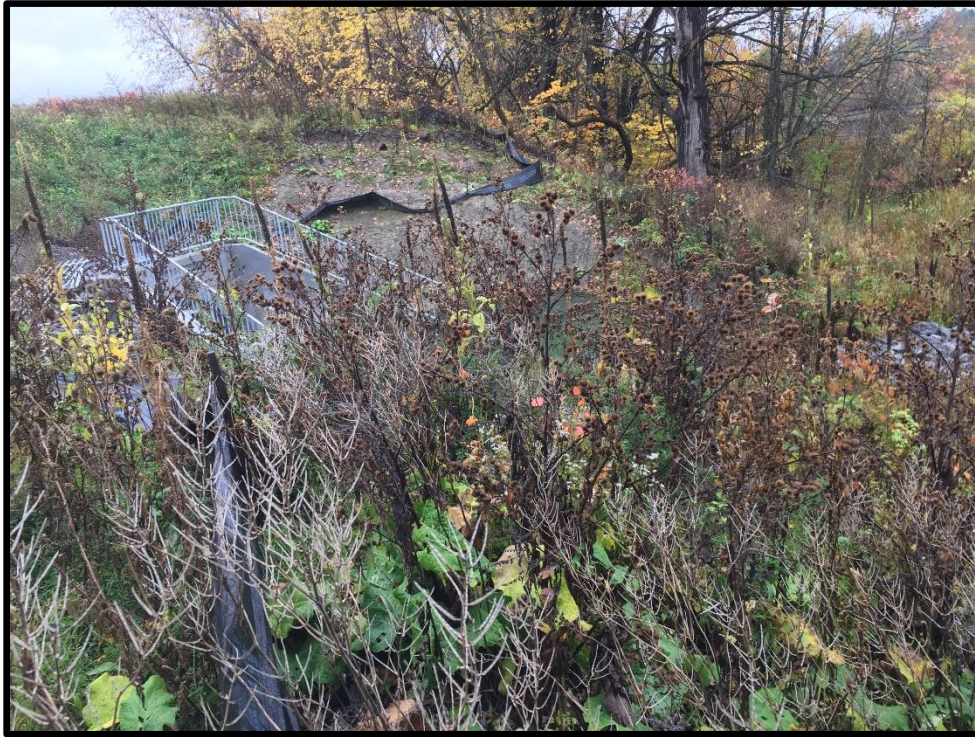
Photo 3: Existing conditions of western slope face at SWMP outlet structure, facing southeast. (October 16, 2020)

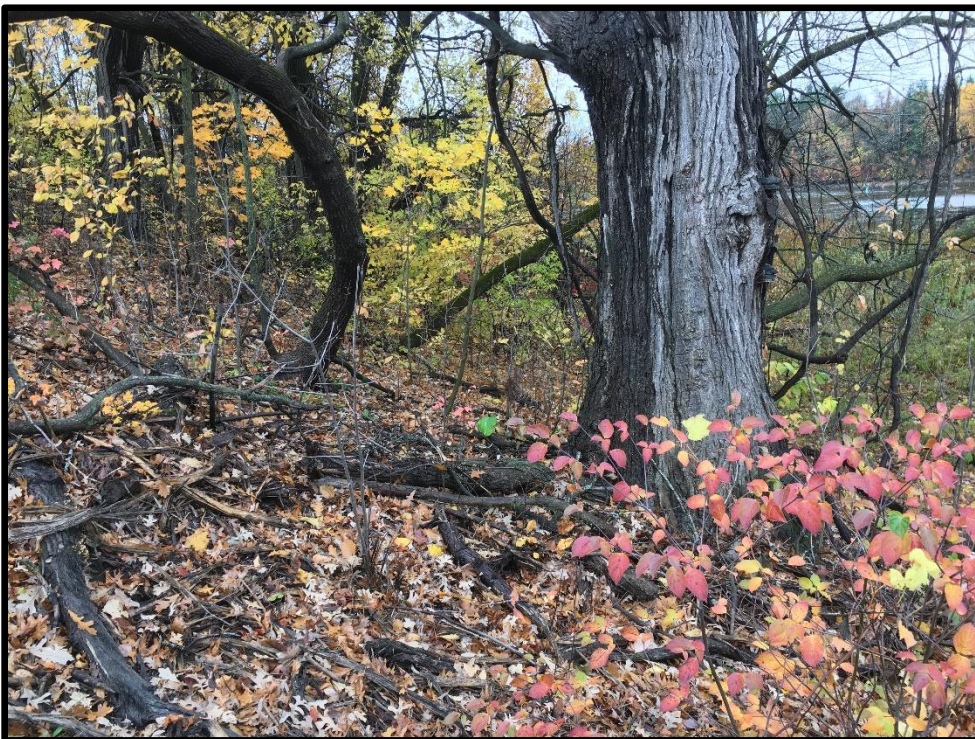
Photo 4: Existing conditions at toe of western slope face, facing southwest. (October 16, 2020)

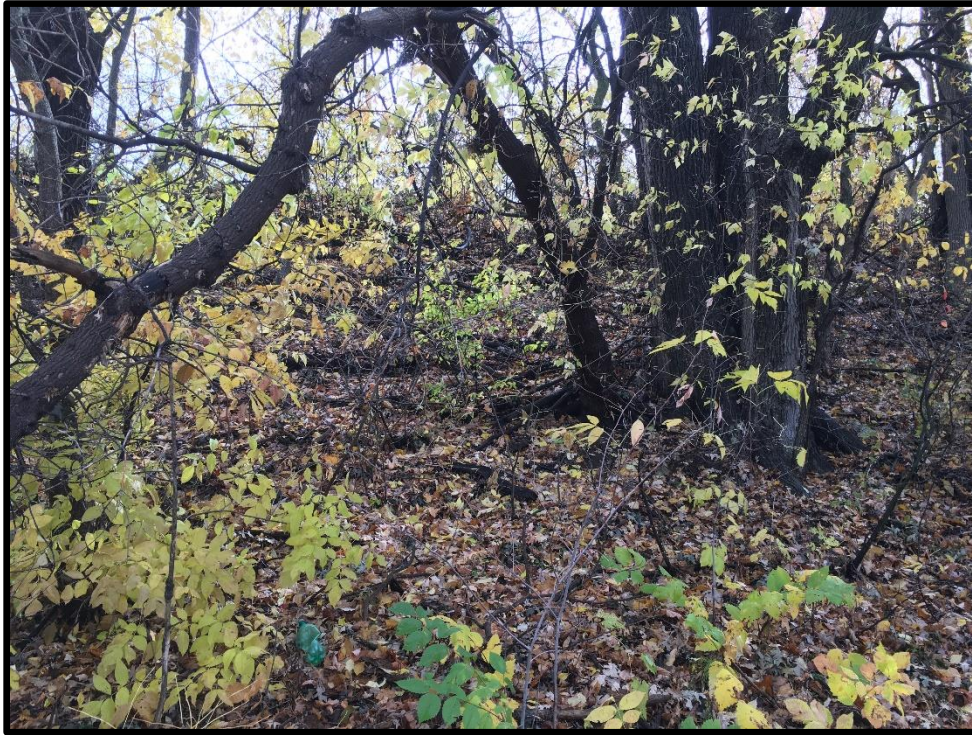
Photo 5: Existing conditions of western slope face, looking upslope, facing east. (October 16, 2020)

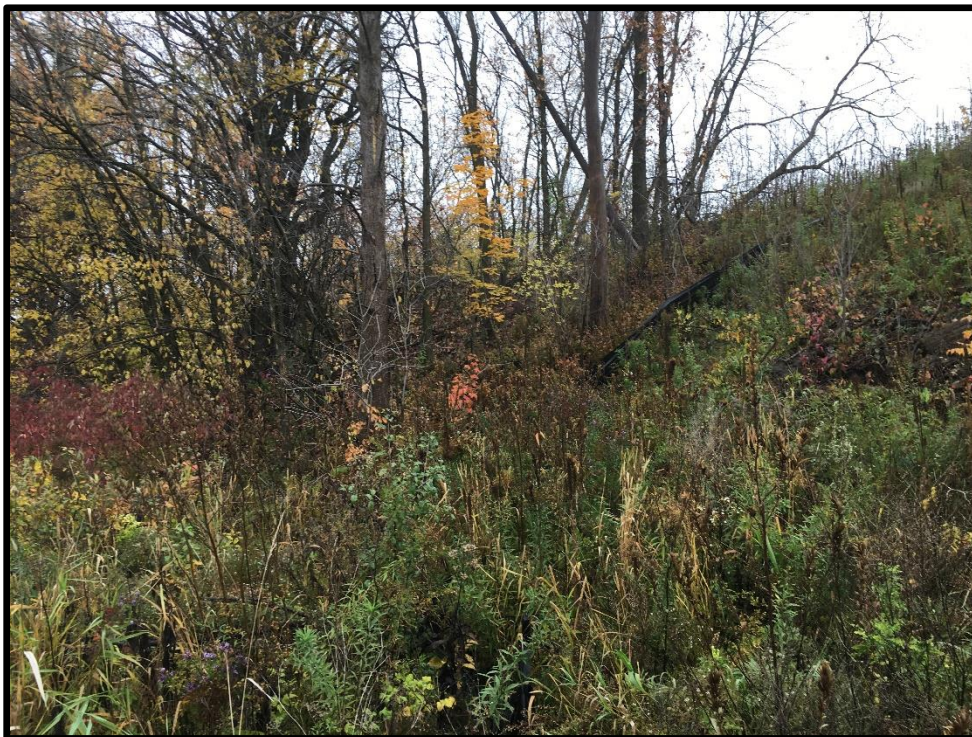
Photo 6: Existing conditions of western slope face, looking upslope, facing east. (October 16, 2020)

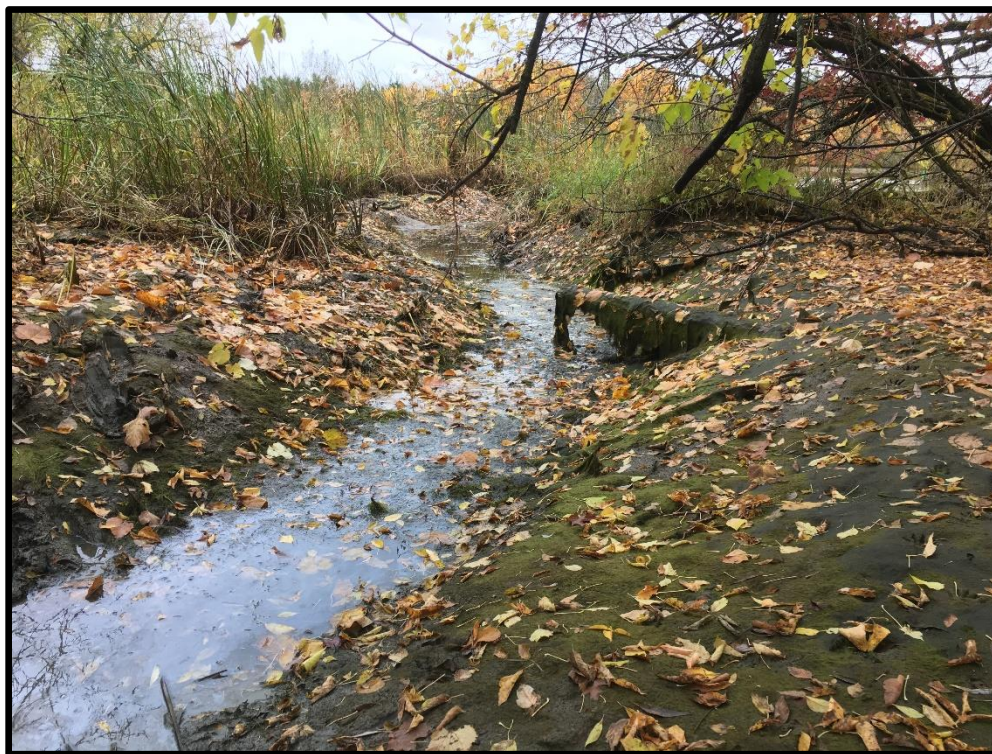
Photo 7: Existing Conditions of northern ravine at the western portion of the subject site, facing west.

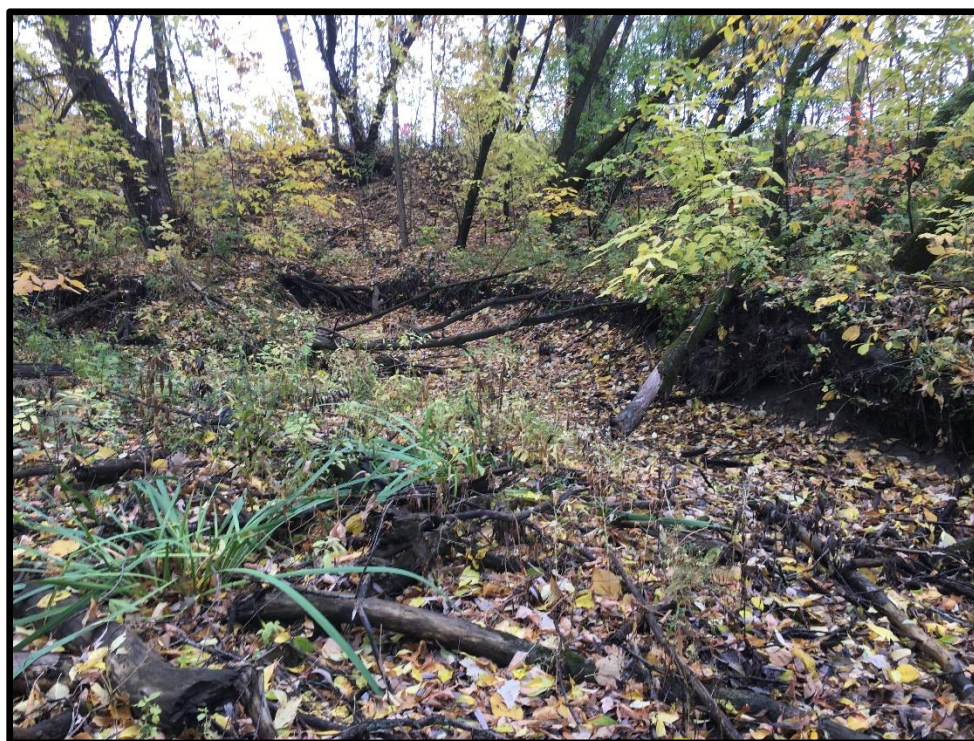
Photo 8: Existing conditions of northern ravine at the western portion of the subject site, facing east. (October 16, 2020)
