Phase Two Environmental Site Assessment

6171 Hazeldean Road, Ottawa, Ontario

OTT-00258780-C0

April 30, 2021

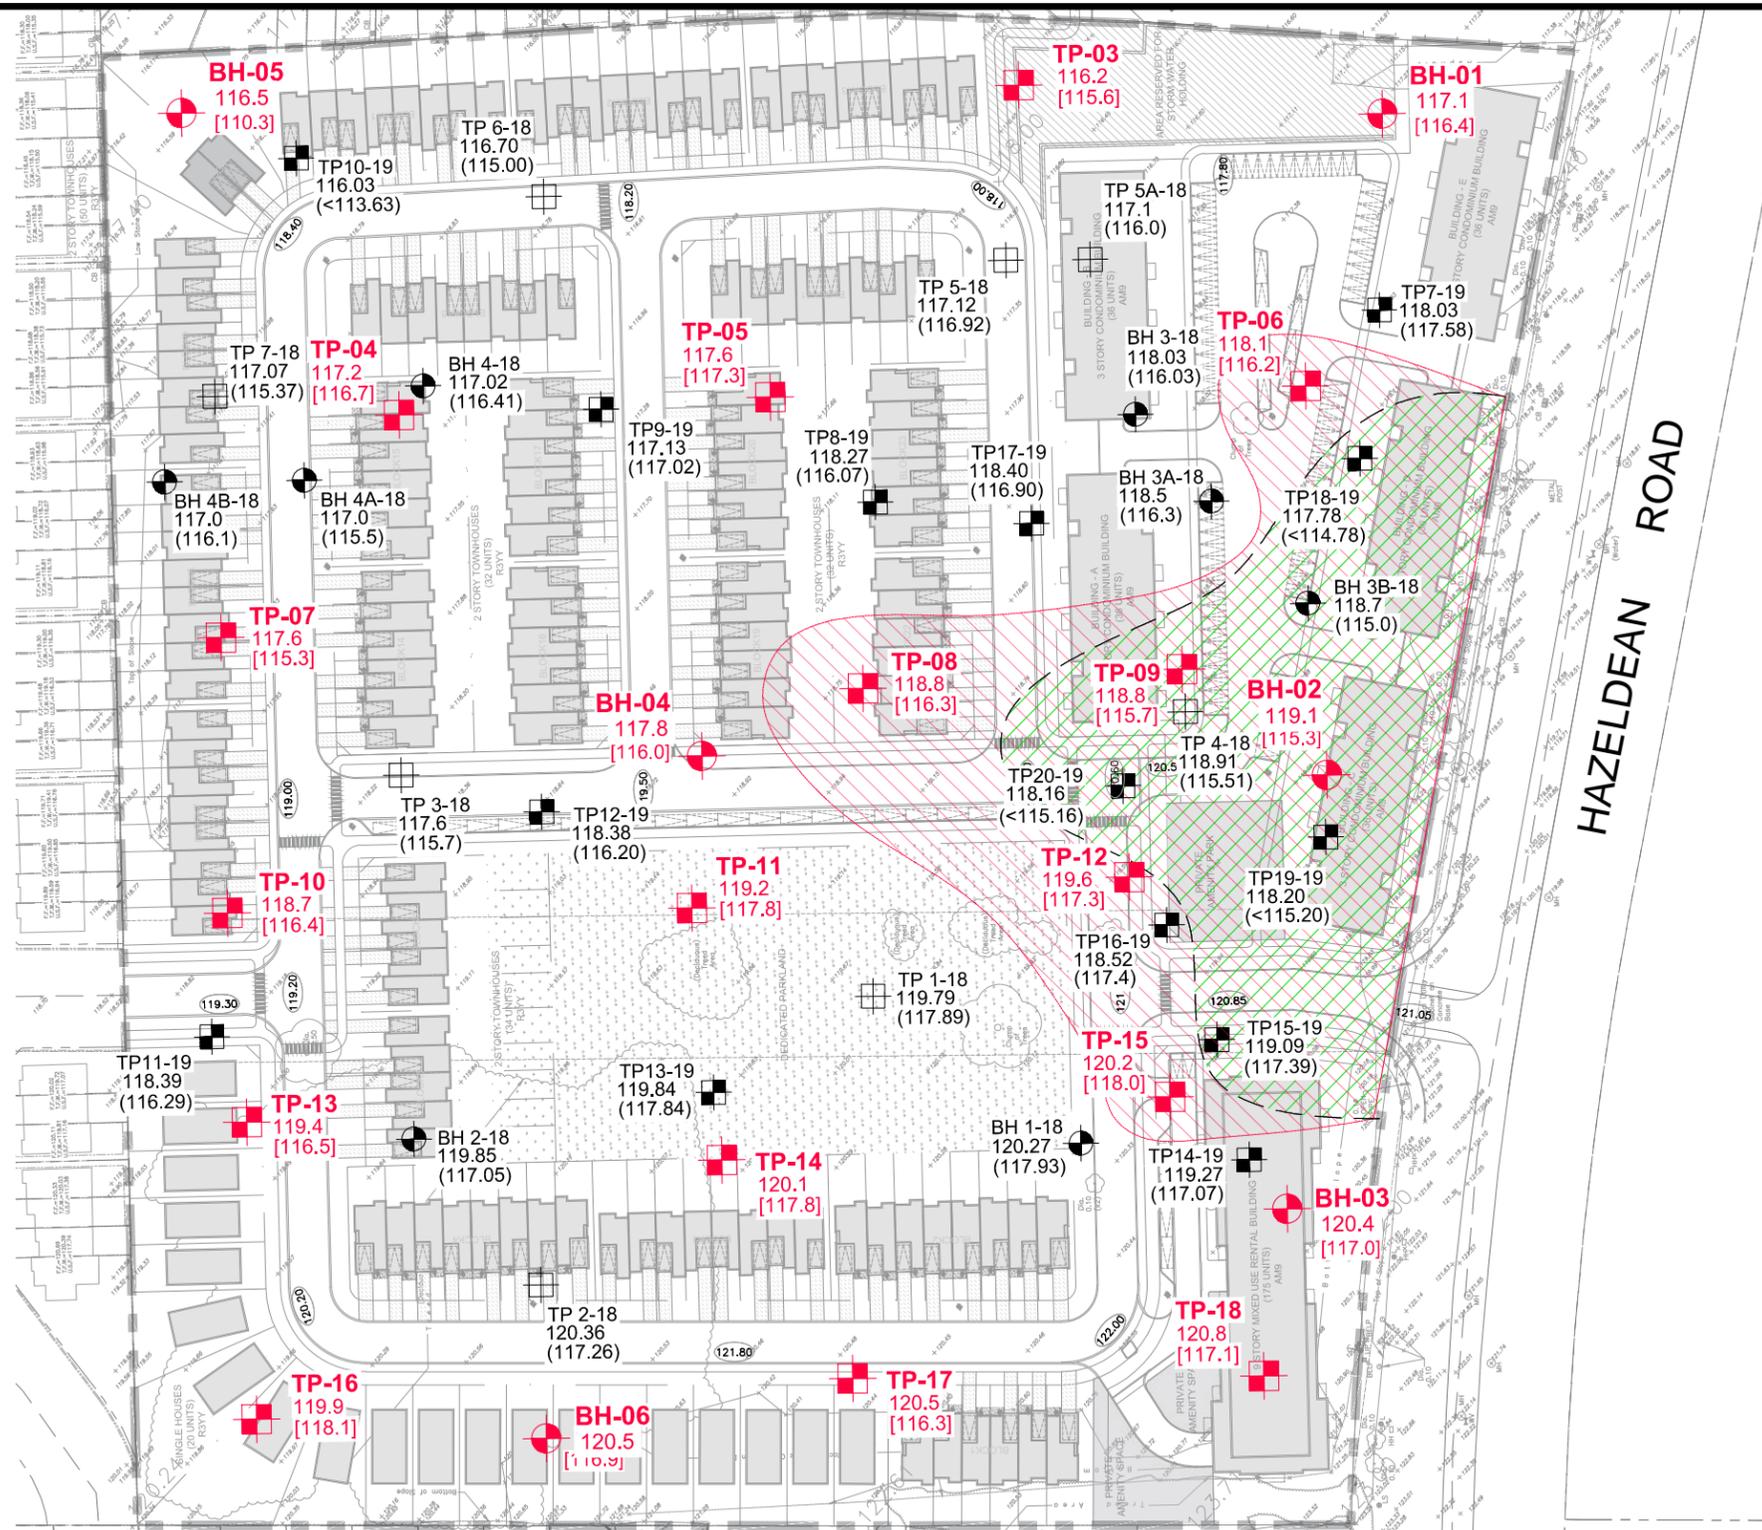
- BH-01** TESTHOLE NUMBER AND LOCATION (EXP, MARCH 2020)
- TP-03** TEST PIT NUMBER AND LOCATION (EXP, MARCH 2020)
- TP 1-19** TEST PIT NUMBER AND LOCATION (PREVIOUS PATTERSON GROUP INVESTIGATION PG4917-1 DATED MAY 2019)
- BH 1-18** TESTHOLE NUMBER AND LOCATION (PREVIOUS PATTERSON GROUP INVESTIGATION PG4706 DATED OCT. 2018)
- TP 1-18** TEST PIT NUMBER AND LOCATION (PREVIOUS PATTERSON GROUP INVESTIGATION PG4706 DATED OCT. 2018)
- 117.0** **116.2** GEODETIC ELEVATION (m)
- (115.5)** **[116.6]** BEDROCK ELEVATION (m)
- APPROXIMATE EXTENT OF PEAT BELOW FILL LAYER (PREVIOUS PATTERSON GROUP INVESTIGATION PG4917-1 DATED MAY 2019)
- ADDITIONAL EXTENT OF PEAT BELOW FILL LAYER

DATE	JUNE 2020	CLIENT:	11654128 CANADA INC
DESIGN	I.T.	CHECKED	I.T.
DRAWN BY	S.K.		
TITLE:		TESTHOLE LOCATION PLAN PROPOSED RESIDENTIAL DEVELOPMENT 6171 HAZELDEAN ROAD, OTTAWA, ON	
project no.			OTT-00258780-B0
scale			1:1,500
			FIG 3

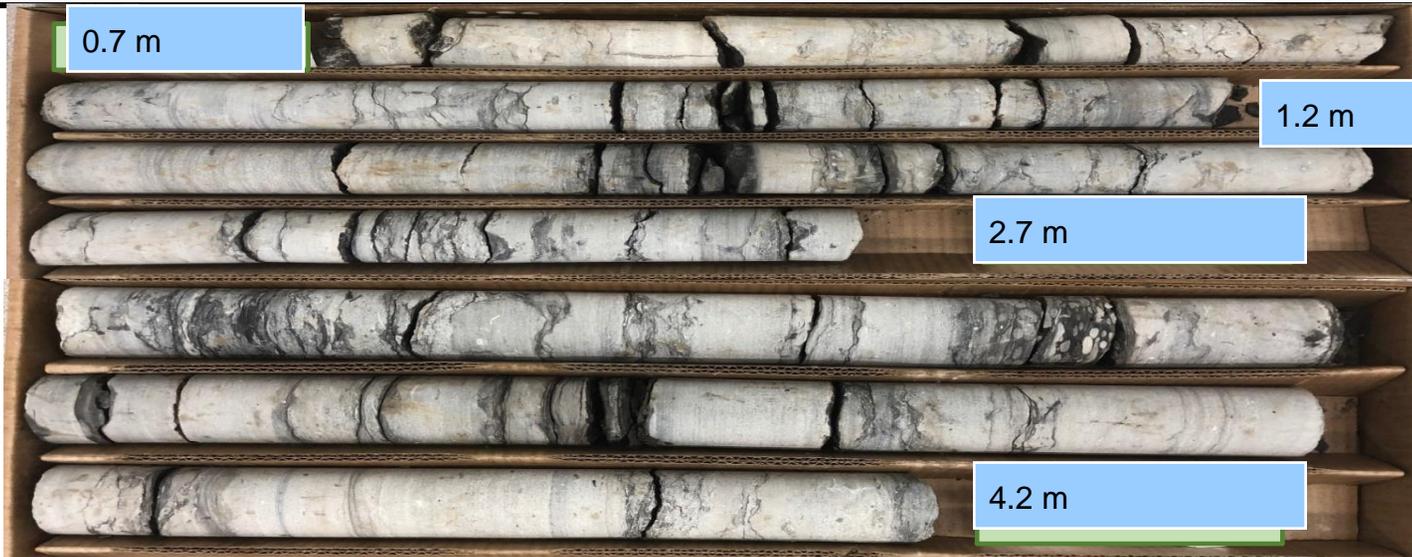
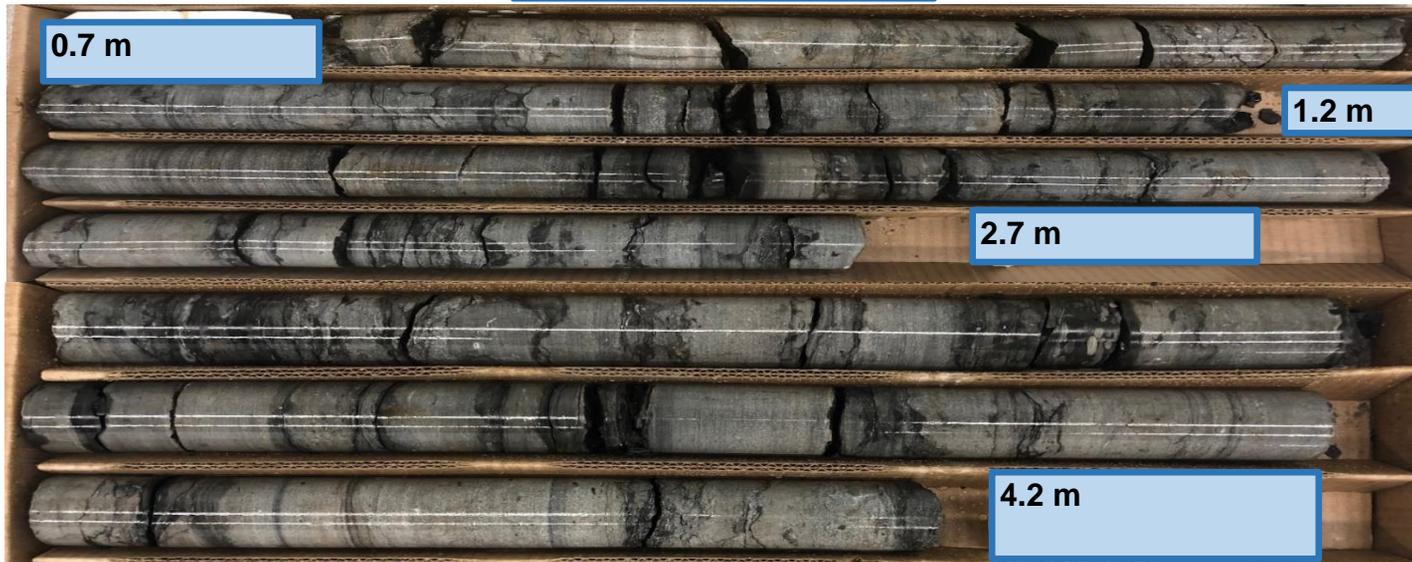
DRY BEDROCK CORES

WET BEDROCK CORES

Borehole No. BH-1	Core Runs Run 1: 0.7 - 1.2 m Run 2: 1.2 - 2.7 m Run 3: 2.7 - 4.2 m	Project Name: Propsoed Residential Development. 6171 Hazeldean Road, Ottawa, ON	Project No: OTT-000258780-B0
		ROCK CORE PHOTOGRAPHS
