Muncaster
Environmental
Planning Inc.

April 1, 2021

RE: 3200 Reids Lane, Osgoode
Tree Conservation Report and Environmental Impact Statement

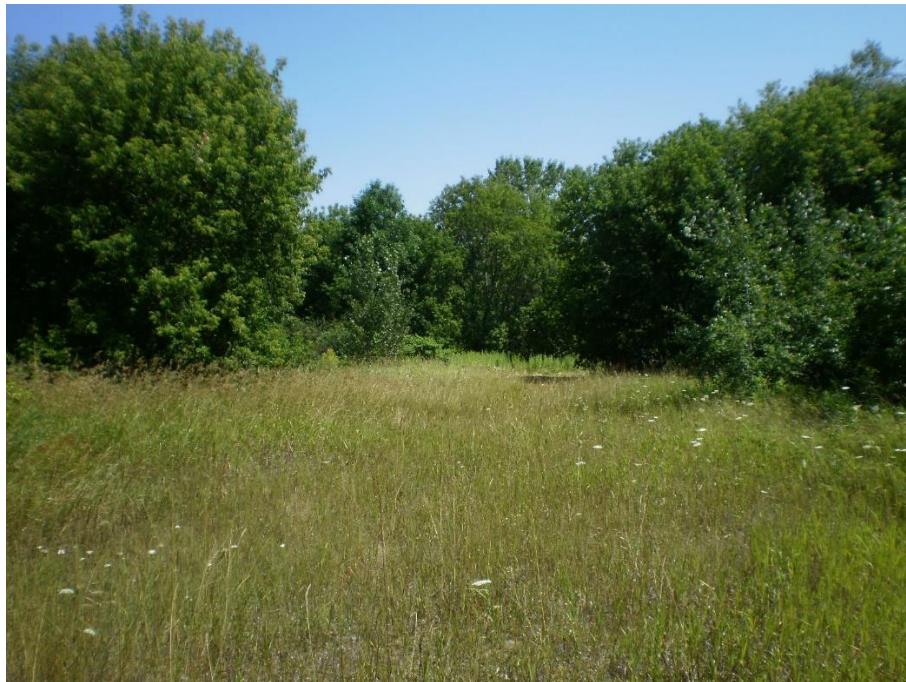
Areas of cultural meadow in the south portion of the site were dominated by Canada goldenrod, with orchard grass, reed canary grass, June meadow grass, field horsetail, wild carrot, common milkweed, common mugwort, thicket creeper, common yarrow, bladder campion, evening

primrose, white clover, white-sweet clover, hoary alyssum, black-eyed susan, common ragweed, heal-all, ground ivy, silvery cinquefoil, bluebell, yellow goat's-beard, bouncing bet, and common mullein also present (Photo 1). Shrubs species in the meadow habitat included tartarian honeysuckle, chokecherry, red raspberry, staghorn sumac, Bebb' willow, and glossy buckthorn, along with regenerating Manitoba maple, grey birch, and balsam poplar stems. A mature two-stem white spruce is in the meadow habitat in the southeast corner of the site (Photo 2). The largest stem was 50cm diameter at breast height (dbh). This tree is proposed for retention.

*Photo 1 – Small area of cultural meadow habitat in the southeast portion of the site.
View looking east (August 8th, 2019)*

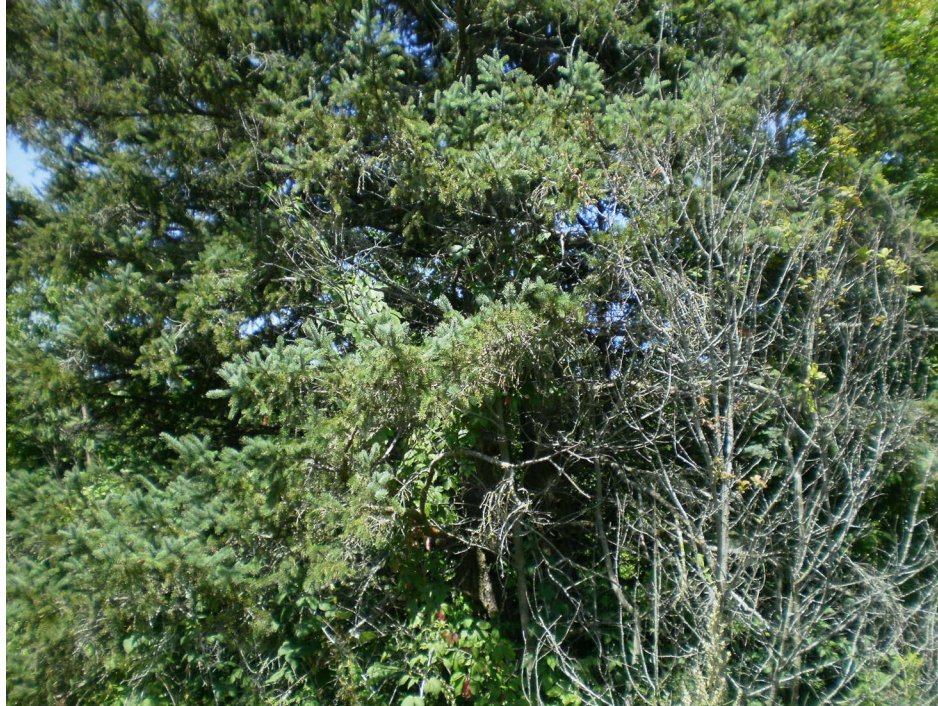
*Photo 2 – Mature white spruce in the southeast corner of the site.
View looking north (August 8th, 2019)*

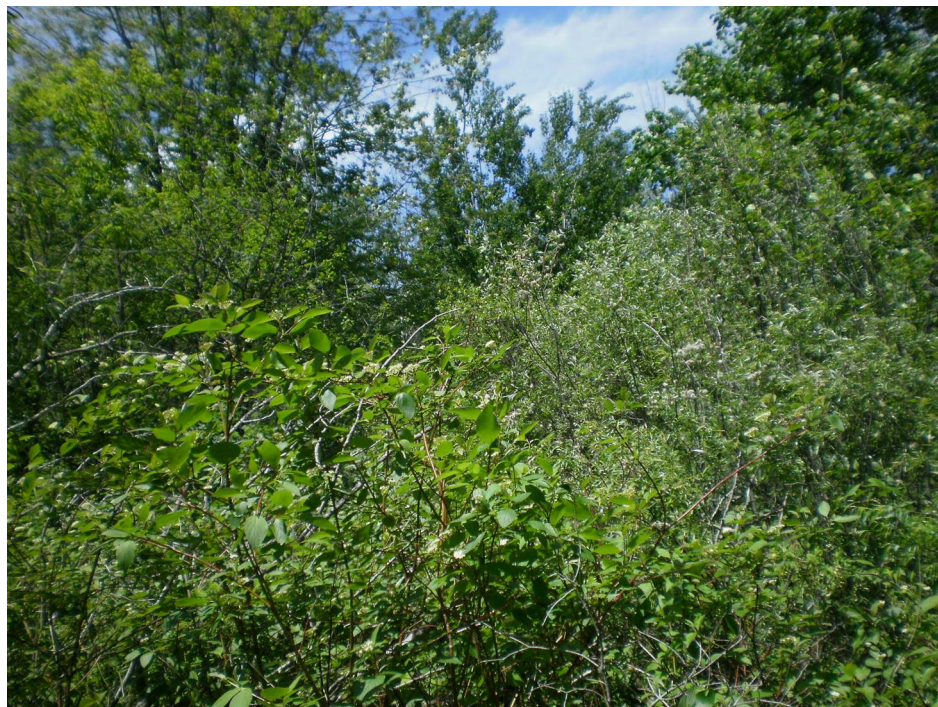
A cultural thicket is in the northwest portion of the site (Photo 3). Red raspberry, red-osier dogwood, black currant, slender willow, Bebb's willow, narrow-leaved meadowsweet, nannyberry and tartarian honeysuckle were representative of the shrub species, with regenerating trembling aspen, red maple, and green ash up to 8cm dbh also present. Ground flora species included wild carrot, meadow horsetail, blue grass, orchard grass, reed canary grass, common strawberry, tall buttercup, joe-pye-weed, Canada goldenrod, wild grape, common ragweed, and sensitive fern.

*Photo 3 – Cultural thicket in the northwest portion of the site.
View looking north (June 12th, 2019)*

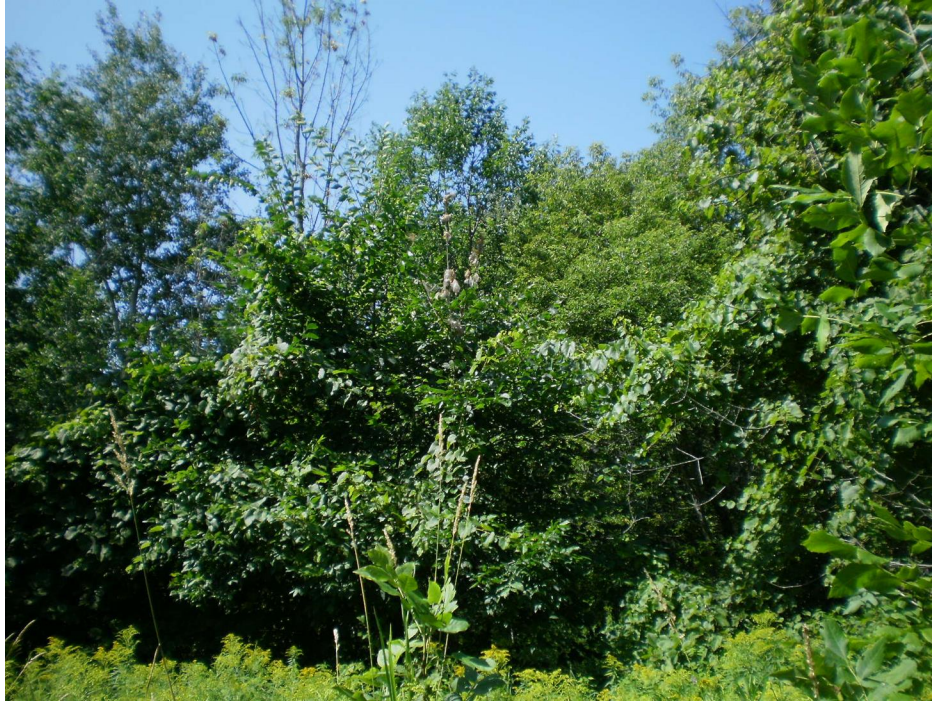
Cultural woodlands are around the periphery of the site (Photo 4). Manitoba maples were dominant in areas, with white elm, Scot's pine, sugar maple, red maple, white ash, green ash, and eastern cottonwood also present. The largest trees were cottonwoods up to 60cm dbh, with Manitoba maples and red maple cultivars up to 45cm dbh. A variety of shrubs were in the understory, including red raspberry, common buckthorn, glossy buckthorn, staghorn sumac, black currant, apple, hawthorn, serviceberry, grey dogwood, red cedar, tartarian honeysuckle, steplebush, slender willow, and Bebb's willow. Regenerating ash, poplar, and Manitoba maple stems were also present in the understory of the cultural woodlands. Ground flora in the cultural woodlands included Canada goldenrod, June meadow grass, orchard grass, reed canary grass, wild parsnip, cow vetch, common plantain, dame's rocket, common strawberry, yellow violet, white avens, wild grape, thicket creeper, common mugwort, wild cucumber, celandine, stinging nettle, sensitive fern, wild grape, field horsetail, thicket creeper, and common dandelion.

Photo 4 – Cultural woodland in the northeast corner of the site. Note ash tree with very little leaf-out. View looking west (August 8th, 2019)

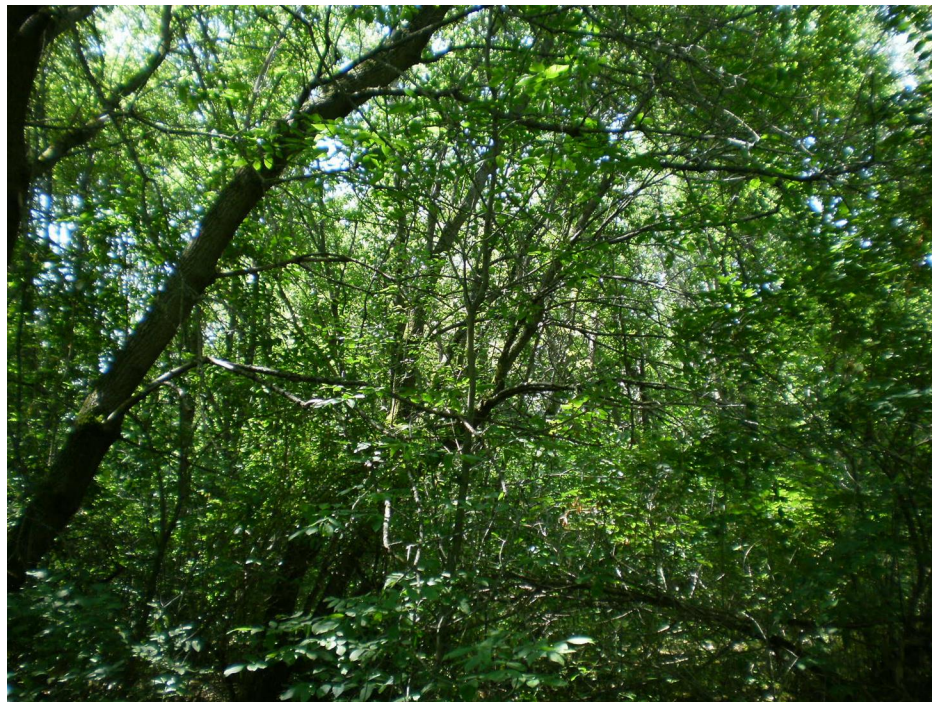
An upland deciduous forest dominates the centre and north portions of the site (Photo 5). This forest is generally young as the site was dominated by agricultural fields in 1976 aerial photography and generally clear of trees until the 1990s. Manitoba maple and trembling aspen were dominant, with sugar maple, red maple, white ash, green ash, white cedar, pin cherry, and white elm also present (Photo 3). The largest trees were poplars up to 35cm dbh. Most of the trees appeared to be in good condition, with the white ash either dead or with reduced leaf-out from emerald ash borer impacts. Grape vine coverage was extensive on many of the lower tree branches. Common buckthorn was dominant in portions of the understory of the upland deciduous forest, with glossy buckthorn, prickly gooseberry, grey dogwood, red raspberry, tartarian honeysuckle, red-osier dogwood, staghorn sumac, and Japanese knotweed other shrub species observed. Regenerating balsam fir, ash, white elm, black walnut, and sugar maple stems were also present. The ground flora in the upland deciduous forest was generally reflective of disturbed conditions including common dandelion, garlic mustard, common ragweed, ground ivy, Canada goldenrod, wild grape, thicket creeper, blue violet, common strawberry, wild parsnip, common plantain, yellow avens, wild cucumber, field horsetail, common burdock, yellow wood sorrel, meadow horsetail, and enchanter's nightshade, with false nettle and sensitive fern also present.

Photo 5 – Upland deciduous forest in the central-east portion of the site. View looking west (August 8th, 2019)

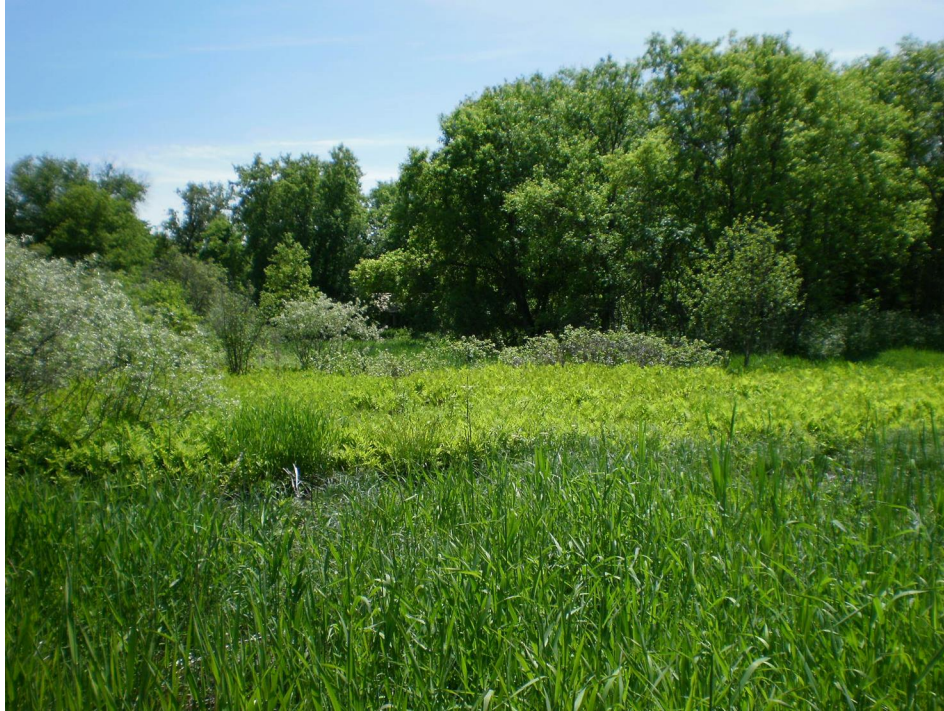
An area of meadow marsh is adjacent to the west-central site edge (Photo 6). This habitat has developed on former agricultural land against the recreational pathway. There appears to be no functional drainage under the recreational pathway in this area. Reed canary grass was dominant, with purple loosestrife common in areas. Sensitive fern, broad-leaved cattail, marsh fern, water parsnip, cow vetch, lady's thumb, water horehound, common burdock, boneset, joe-pye-weed, nodding beggar's tick, soft-stem bulrush, fowl manna grass, and spotted jewelweed were also present, along with slender willow, red-osier dogwood, tartarian honeysuckle, and narrow-leaved meadowsweet shrubs.

Photo 6 – Reed canary grass meadow marsh, with purple loosestrife common, along the central-west edge of the site. View looking southeast from recreational pathway (June 12th, 2019)

Along the west portion of the site, a setback from the Osgoode Link Pathway (a former rail corridor), will retain the meadow marsh except for a small portion needed for the pathway connection from the new cul-de-sac to the pathway in a six metre wide block. Tree retention along the north and south site edges will also protect adjacent trees to the north and south and their critical root zones. There are no trees currently along the east property line due to a gravel pathway. Thus, no impacts are anticipated on the trees to the east of the south half of the site. A new forest edge will be created to the north where the study area is expanded to the east, along the east side of the extension of Lombardy Drive. The impacts of the new forest edge are anticipated to be minor given the relatively young age of the trees and open canopy in many areas.

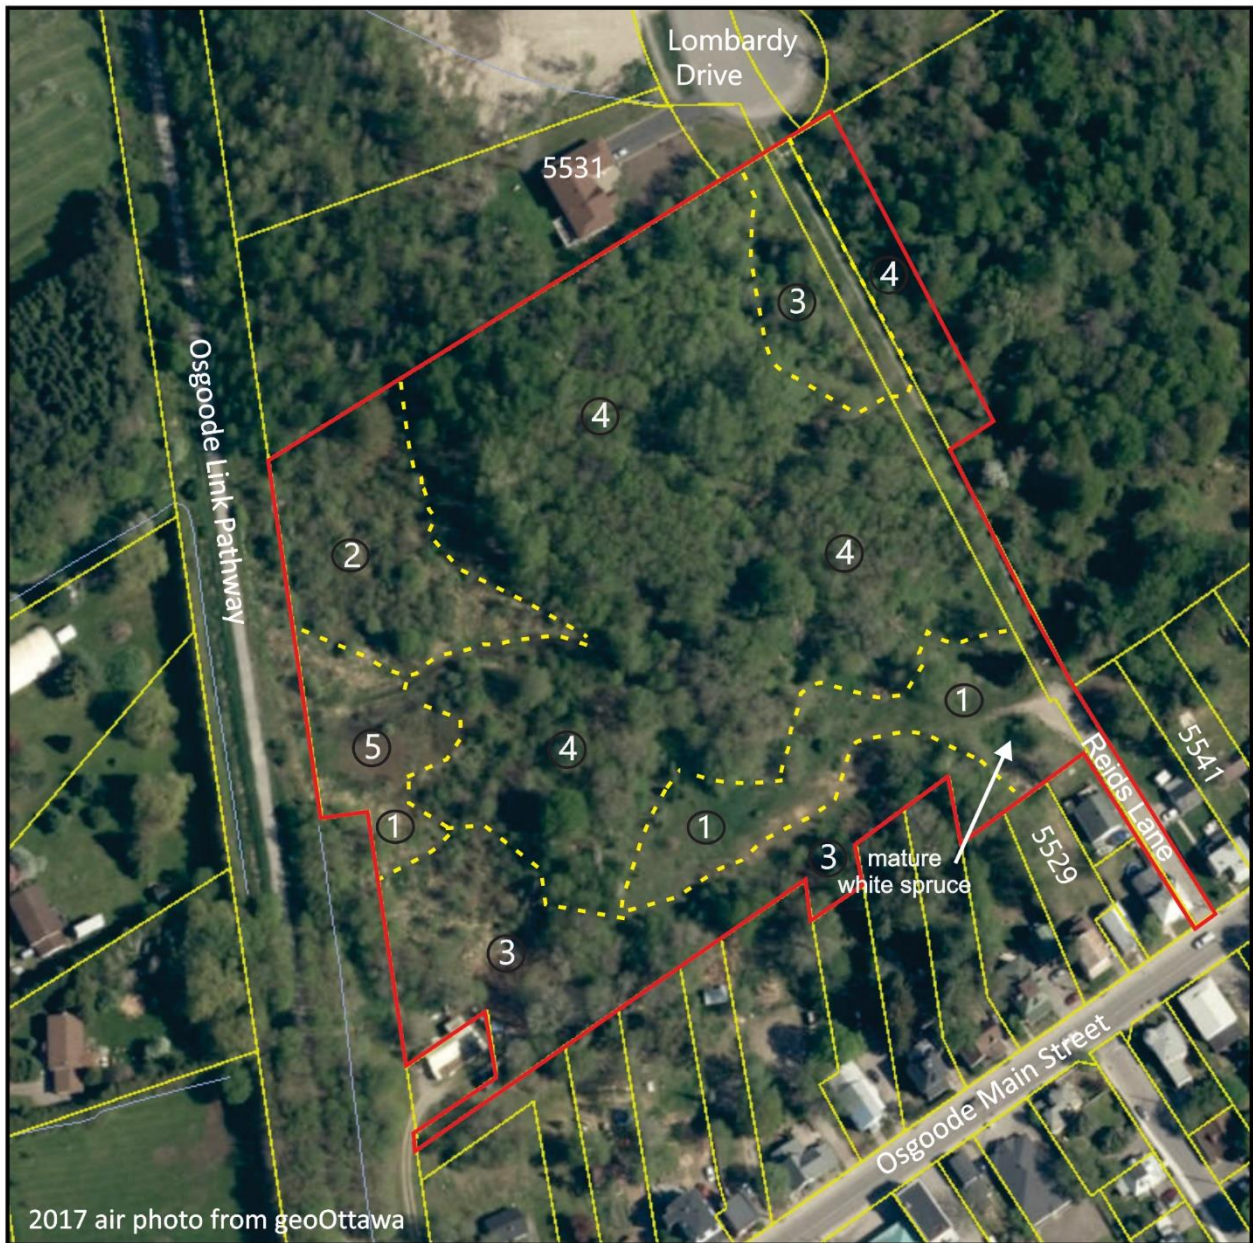
Map 1

- ① Cultural meadow
- ② Cultural thicket
- ③ Cultural woodland
- ④ Upland poplar-Manitoba maple deciduous forest
- ⑤ Reed canary grass meadow marsh

CURRENT VEGETATION

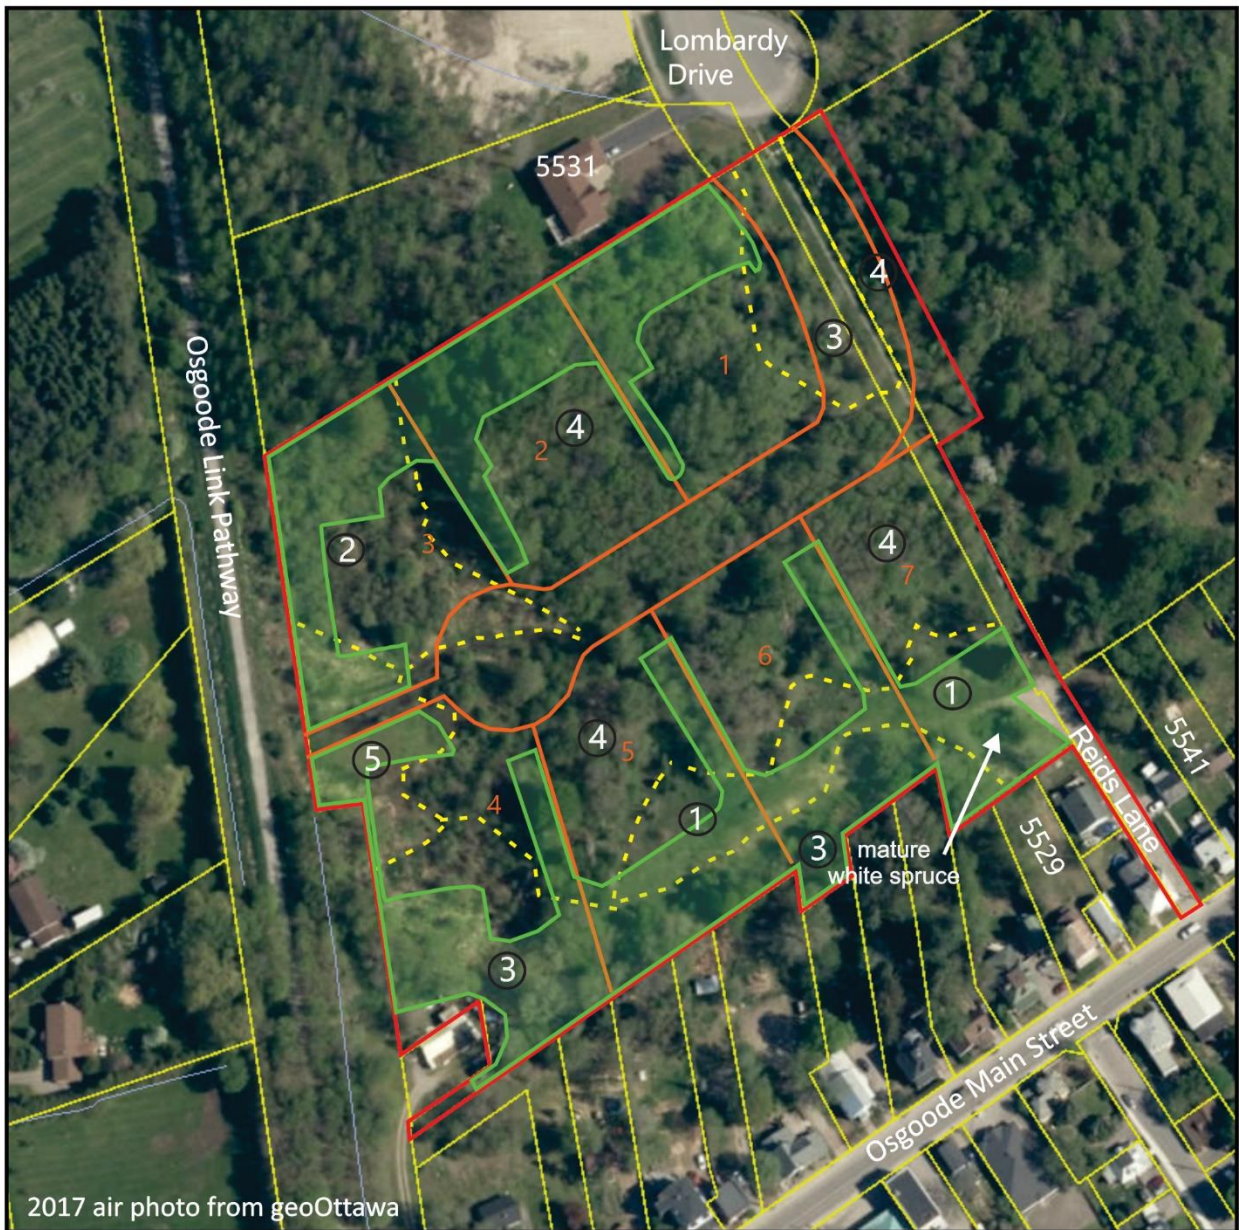
- Site
- Vegetation Communities
- Lot numbers
- Proposed Tree Retention

- Cultural meadow
- Cultural thicket
- Cultural woodland
- Upland poplar-Manitoba maple deciduous forest
- Reed canary grass meadow marsh

FILE: 18 - 32	Map 2	April 1, 2021
PROPOSED CONSERVED VEGETATION		
3200 Reids Lane Osgoode, City of Ottawa		
Prepared for: Crestview Innovation Inc.		
Prepared by:		  Muncaster Environmental Planning Inc.

As shown on Map 2 below, extensive tree retention is proposed for the one acre lots outside of the building envelopes. The Lot Development Plan prepared by NOVATECH (March 29th, 2021) was assessed to maximize tree retention, while providing for each lot a building envelope including a house footprint, a septic system, water well, amenity area, and access off the extension of Lombardy Drive. Grading and drainage requirements are anticipated to be minimal away from the building envelopes and septic systems.
