Geotechnical Investigation

Proposed Commercial Development Employment Lands – Riverside South

Ottawa, Ontario

Report PG4958-2 dated July 5, 2022

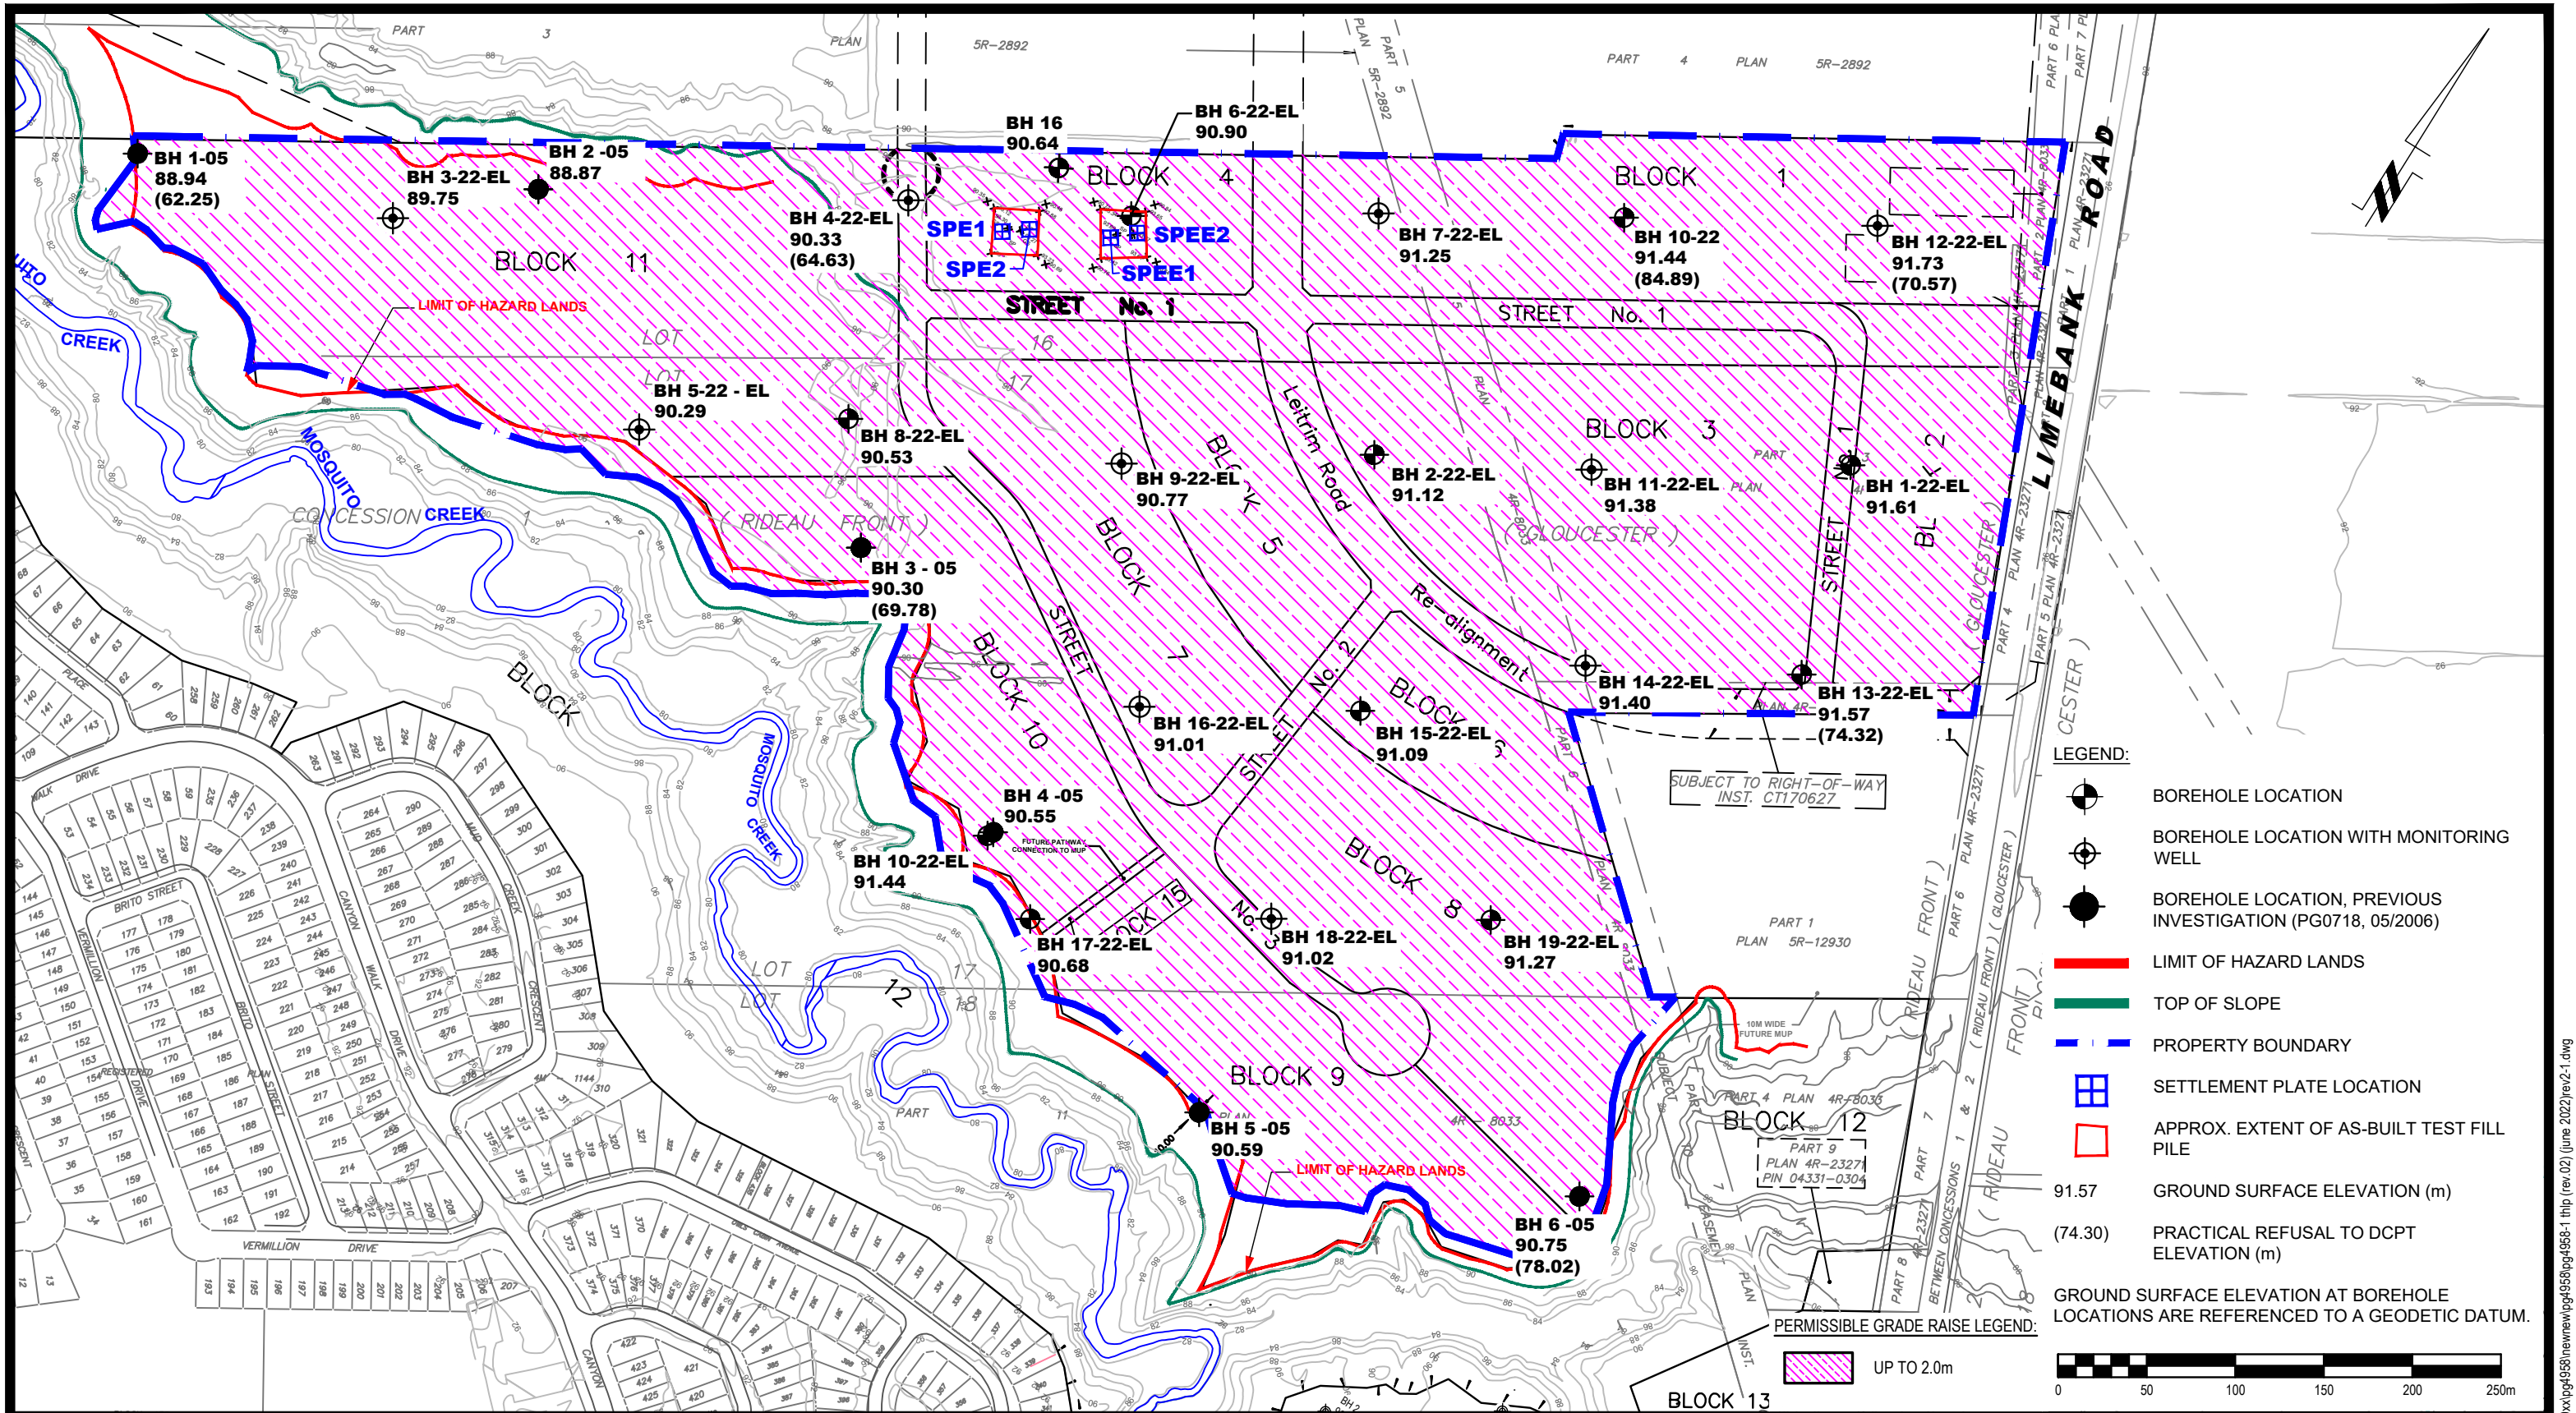
Scale:	1:4000	Date:	04/2022
Drawn by:	NFRV	Report No.:	PG4958-2
Checked by:	NP	Dwg. No.:	PG4958-9
Approved by:	DG	Revision No.:

Based on the undrained shear strength values of the silty clay deposit encountered throughout the subject site, the recommended permissible grade raise areas for buildings are defined in Drawing PG4958-9 - Permissible Grade Raise Plan in Appendix 2.

Due to the presence of the sensitive silty clay deposit, the proposed development will be subjected to grade raise restrictions. Permissible grade raise recommendations have been provided for the subject site. If higher than permissible grade raises are required, preloading with or without a surcharge, lightweight fill and/or other measures should be investigated to reduce the risks of unacceptable long-term post construction total and differential settlements.

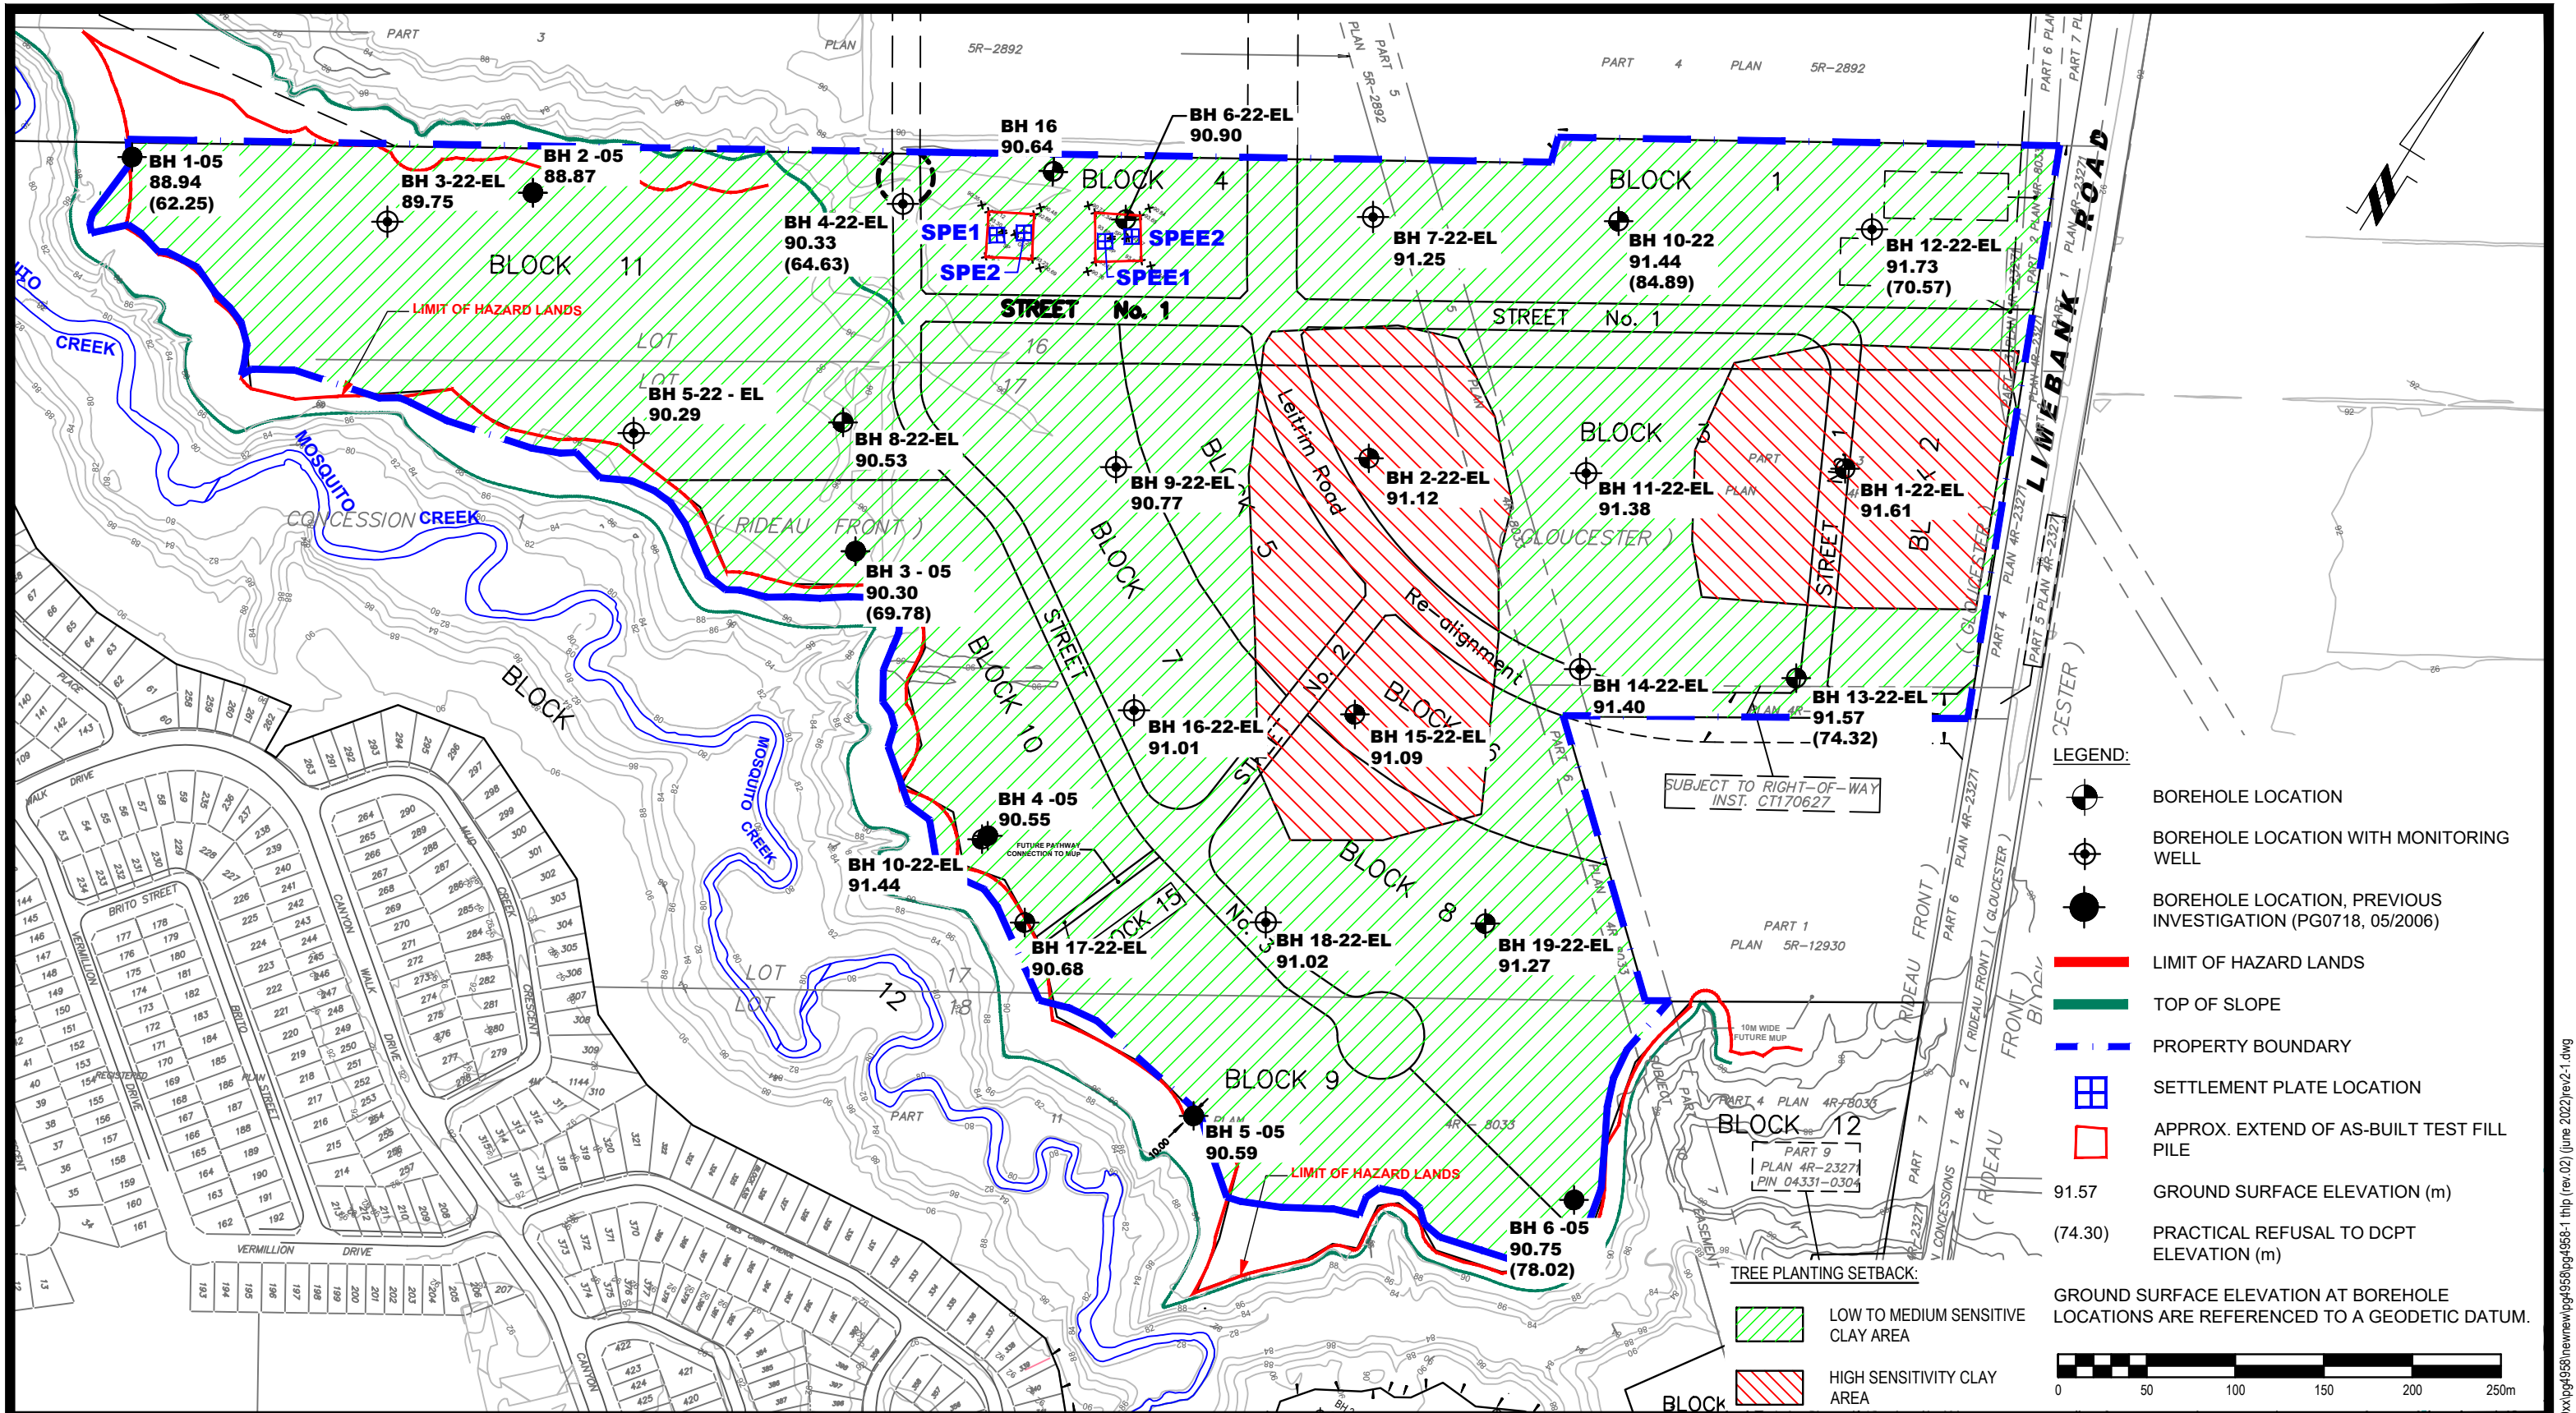
Based on the results of our review, two areas were defined within the subject site in which the tree planting restrictions are defined. The two areas are detailed below and are outlined in Drawing PG4958-10 - Tree Planting Setback Recommendations presented in Appendix 2.

A low to medium sensitivity clay soil was encountered between anticipated underside of footing elevations and 3.5 m below preliminary finished grade as per City Guidelines at the areas outlined in Drawing PG4958-10 - Tree Planting Setback Recommendations in Appendix 2. Based on our Atterberg Limits' test results, the modified plasticity limit does not exceed 40% in these areas. The following tree planting setbacks are recommended for the low to medium sensitivity area.

- Large trees (mature height over 14 m) can be planted within these areas provided that a tree to foundation setback equal to the full mature height of the tree can be provided.
- Tree planting setback limits may be reduced to 4.5 m for small (mature tree height up to 7.5m) and medium size trees (mature tree height 7.5 m to 14 m) provided that the conditions noted below are met.

Based on the results of our review, a high sensitivity clay soil was encountered between the anticipated design underside of footing elevation and 3.5 m below finished grade as per City Guidelines. Based on our Atterberg limits test results, the modified plasticity index generally exceeds 40% in these areas. The following tree planting setbacks are recommended for these areas provided a tree to foundation setback equal to the full mature height of the tree can be provided. Tree planting setback limits are 7.5 m for small (mature height up to 7.5 m) and medium size trees (mature tree height 7.5 to 14 m), provided that the following conditions are met.

- ❑ The foundation walls are to be reinforced at least nominally (minimum of two upper and two lower 15M bars in the foundation wall).
- ❑ Grading surrounding the tree must promote drainage to the tree root zone (in such a manner as not to be detrimental to the tree), as noted on the Grading Plan.
