Phase One Environmental Assessment

Proposed Development at Riverside Drive and Hunt Club Road, Ottawa Ontario

Golder Associates Ltd.

December 2022

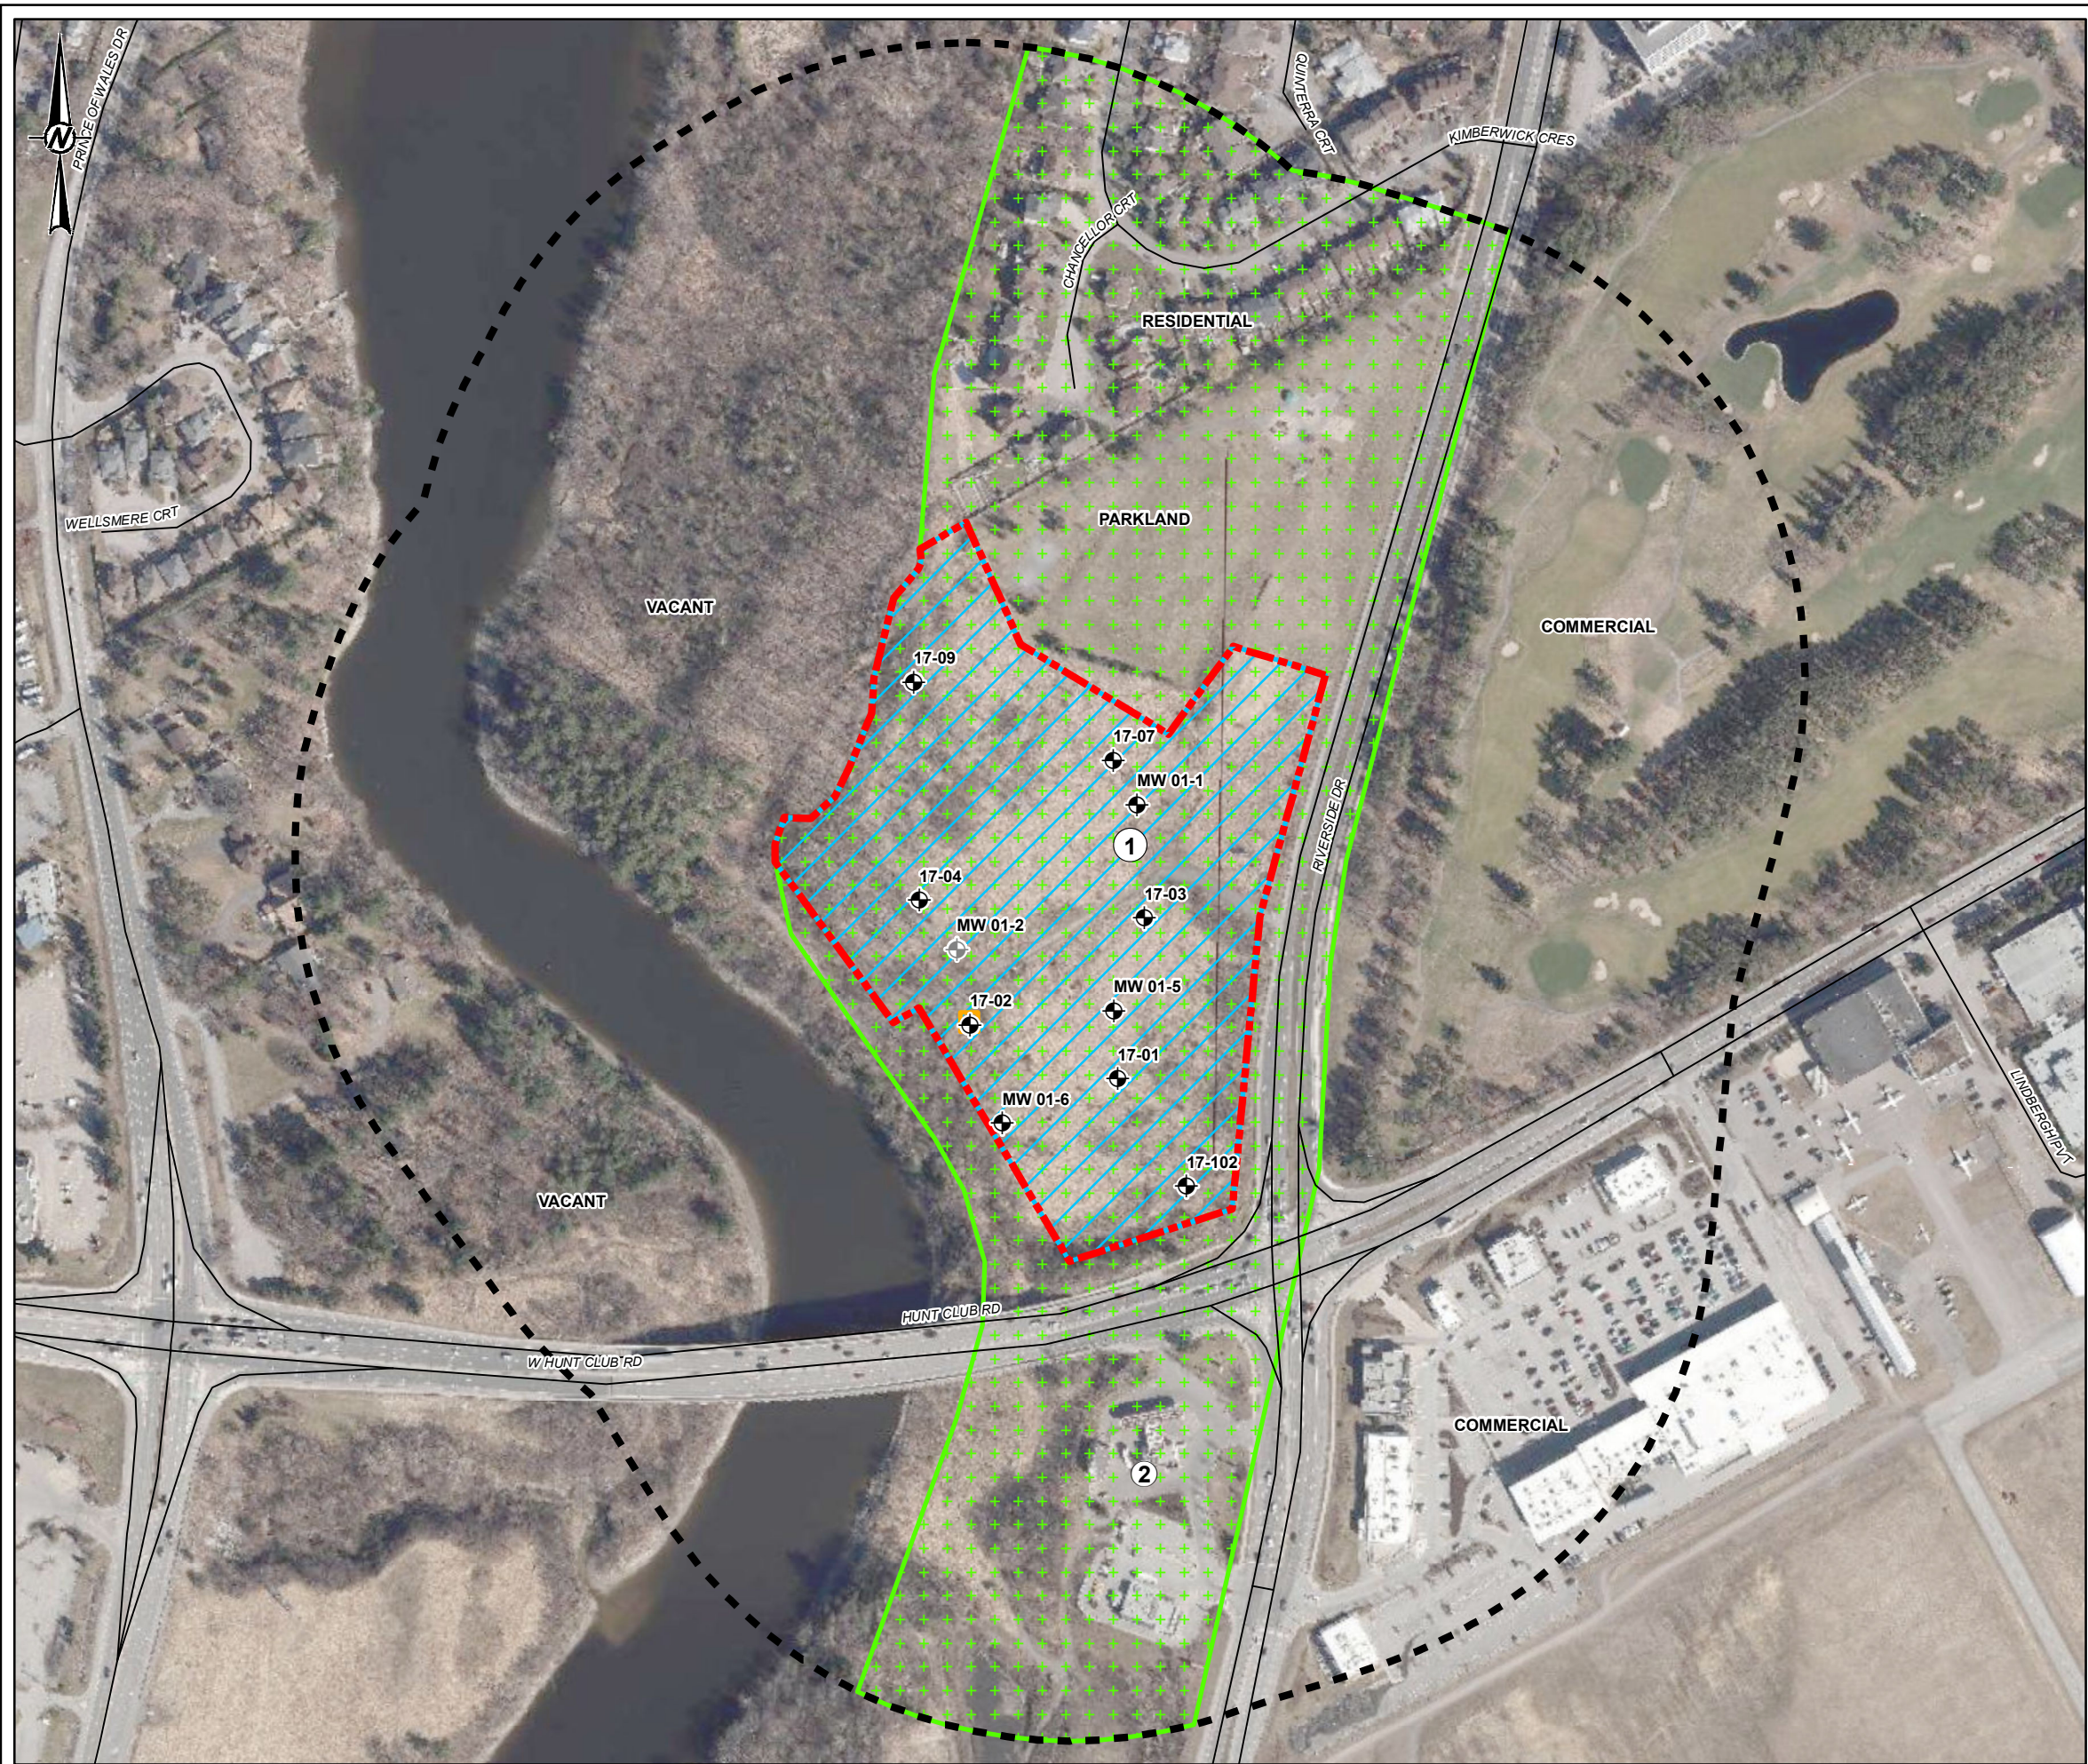
- EXISTING MONITORING WELL LOCATION OBSERVED DURING THE PHASE ONE ESA SITE VISIT
- EXISTING MONITORING WELL LOCATION NOT OBSERVED DURING THE PHASE ONE ESA SITE VISIT
- ROADWAY
- APPROXIMATE LIMIT OF FORMER REMEDIATION
- PHASE ONE SITE
- PHASE ONE STUDY AREA
- APEC 1 (SITE-WIDE)
- LOCATION OF PCA 1

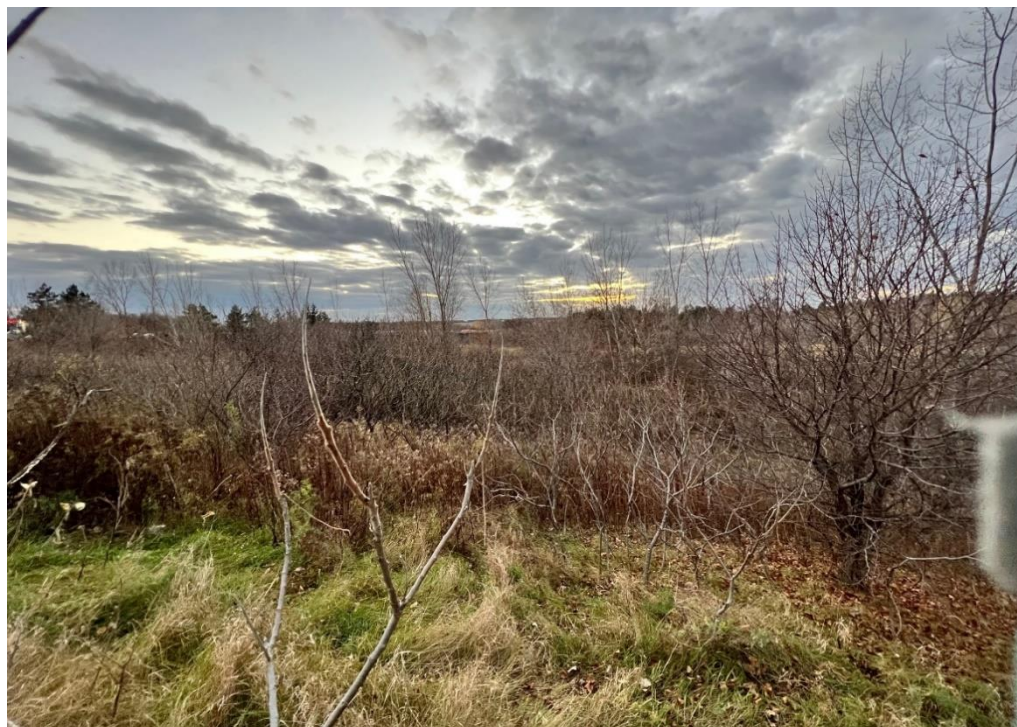
Photo 3: View of the eastern portion of the Site looking northwest.
