Muncaster
Environmental
Planning Inc.

**RE: Maple Forest Estates – Phases 4 and 5, North Gower
City of Ottawa File D07-16-08-0007, Your File 107137
Tree Conservation Report - Revised**

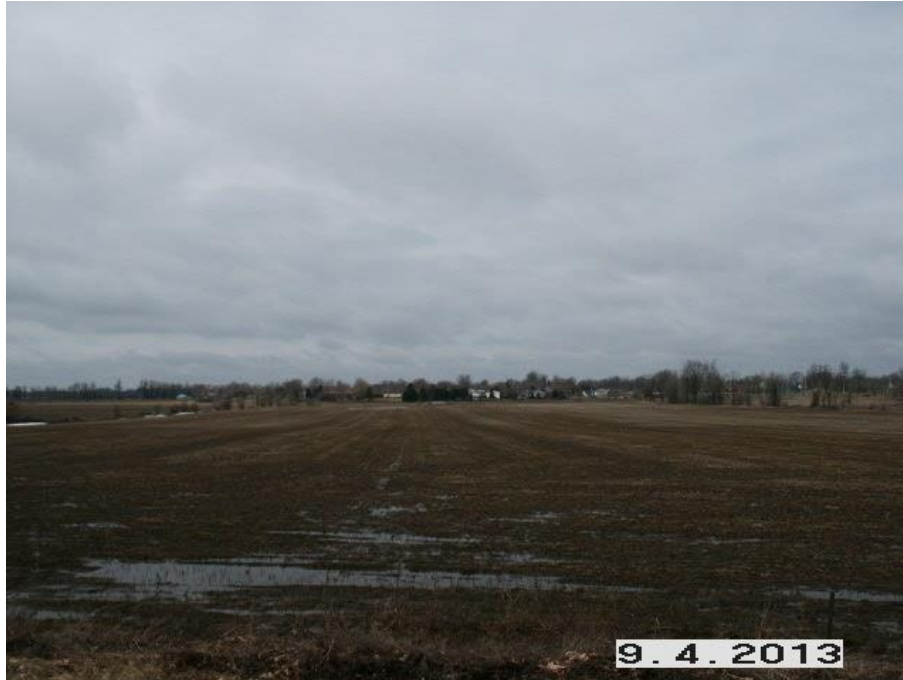
*Photo 1- Large cultivated fields dominate the site. This is the south portion of the site.
View looking west from the current terminus of Maple Forest Drive*

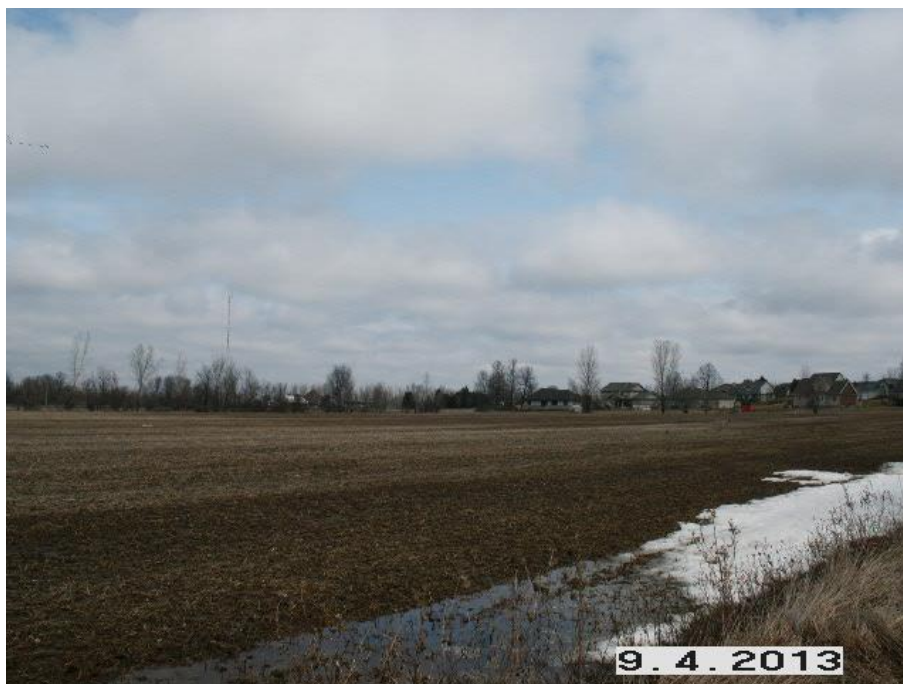
*Photo 2 – Cultivated field in the northeast portion of the site.
View looking northeast from the centre part of the site*

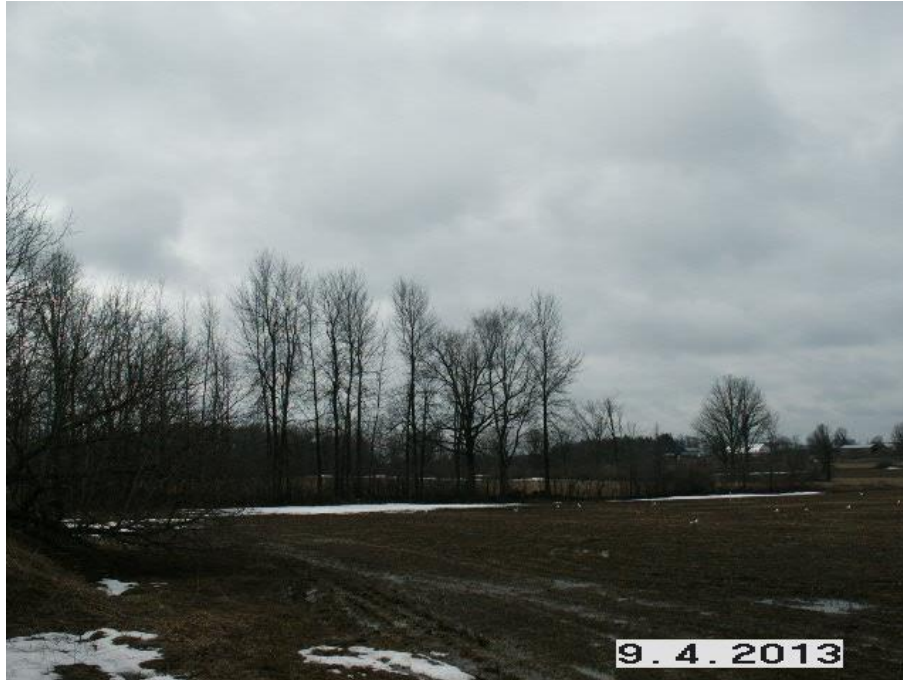
Two types of deciduous hedgerows, dominated by either poplar or bur oak, are present on the site (Map 1). The poplar hedgerows are east-west in orientation and are along the south and north site boundaries (Photos 3 and 4). The central bur oak hedgerow is also in an east-west orientation and is for the most part north of Phase 5, north of the rear boundary of Lots 2 -11 of Phase 5.

Photo 3- East edge of south poplar deciduous hedgerow along southeast edge of site

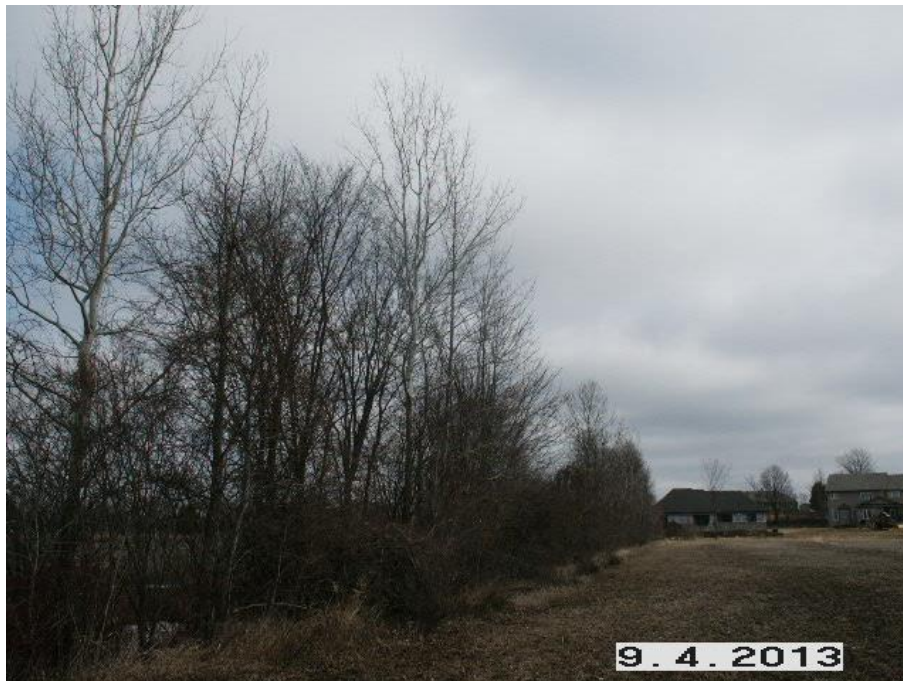
*Photo 4 – Poplar, white elm and ash in north east-west poplar deciduous hedgerow just to the north of the east portion of the site.
View looking east to existing houses on west side of Trailwood Drive*

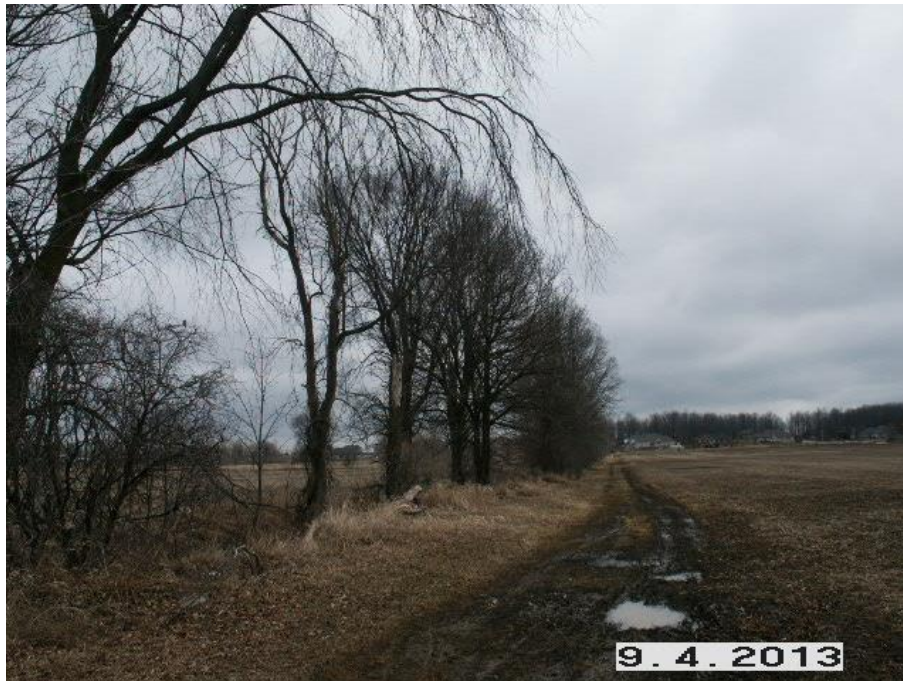
Bur oak is dominant in the west portion of the central east-west deciduous hedgerow. The largest bur oak was 78 cm dbh, with several bur oaks between 30cm and 42cm dbh also in the west portion of the central hedgerow (Map 1). Overall bur oak represented 55 percent of the trees in the central deciduous hedgerow with an average size of 34cm dbh. A 32cm and a 48cm dbh red maple are also present in the west portion of the central hedgerow (Map 1), although overall red maple represents less than five percent of the trees in the hedgerow. White elm is common in the east portion of the central deciduous hedgerow and overall represents 30 percent of the hedgerow. The largest white elm is 52cm dbh, with an average size of 28cm dbh. White ash and Manitoba maple are also present, each representing less than 5 percent of the trees present. The largest ash and Manitoba maple are 38cm dbh and 35cm dbh, respectively. The bur oaks and red maples appear to be in relatively good condition (Photo 5), however many of the white elms in the east portion of the central hedgerow are either dead or with significant trunk damage (Photo 6). There is major trunk damage on a 35cm dbh Manitoba maple in the east portion of the hedgerow. Common buckthorn, red-osier dogwood and red raspberry shrubs are in portions of the central bur oak deciduous hedgerow.

Photo 5 – Bur oak and white elm in central east-west deciduous hedgerow just north of the west portion of the site. View looking east

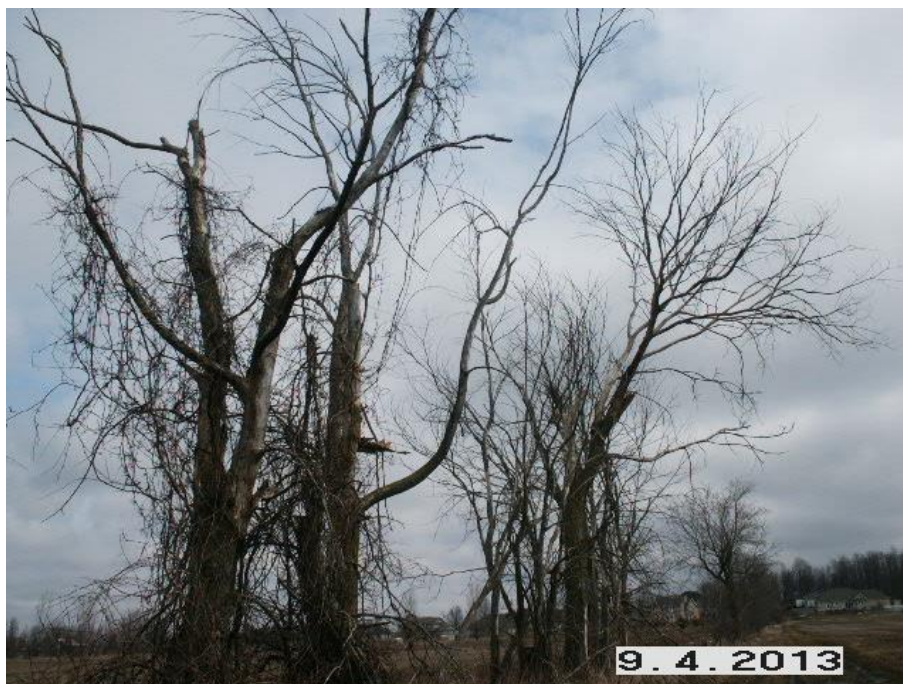
Photo 6 – White elms in poor condition in east portion of central east-west deciduous hedgerow.

No tree removal is anticipated for the drainage swale north of Lots 4 and 5 (Phase 5) other than two regenerating Manitoba maple stems, 7cm and 8cm dbh. A 37cm dbh bur oak is to the west of the proposed drainage swale location. No excavations should take place within four metres of the oak trunk to protect the critical root zone of this tree. There is approximately 15 metres between large-toothed aspens up to 42cm dbh for the drainage swale north of Lots 3 and 4 (Phase 4). The drainage swale should be placed approximately in the centre between these two trees. In this area four regenerating poplar stems between 2cm and 10 cm dbh will be removed along with up to six white elms between 10 and 25cm dbh. Many of the elms are in poor condition with major trunk damage.

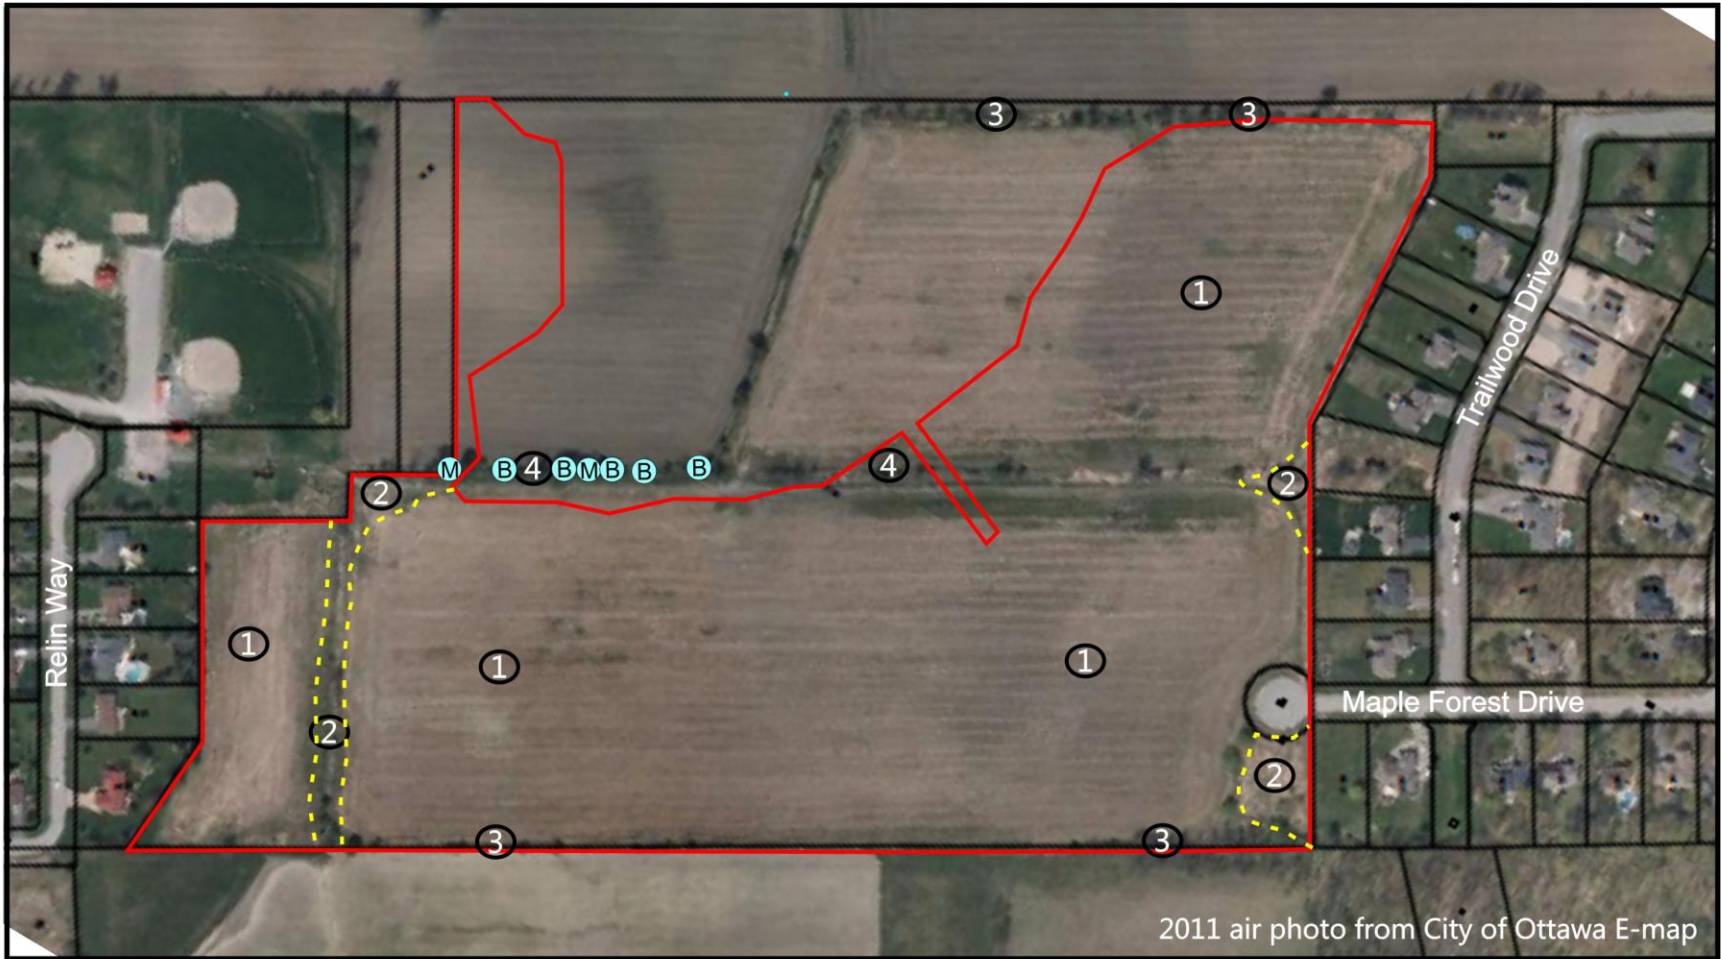
Map 1

**MAPLE FOREST ESTATES, PHASES 4 & 5
CURRENT VEGETATION**

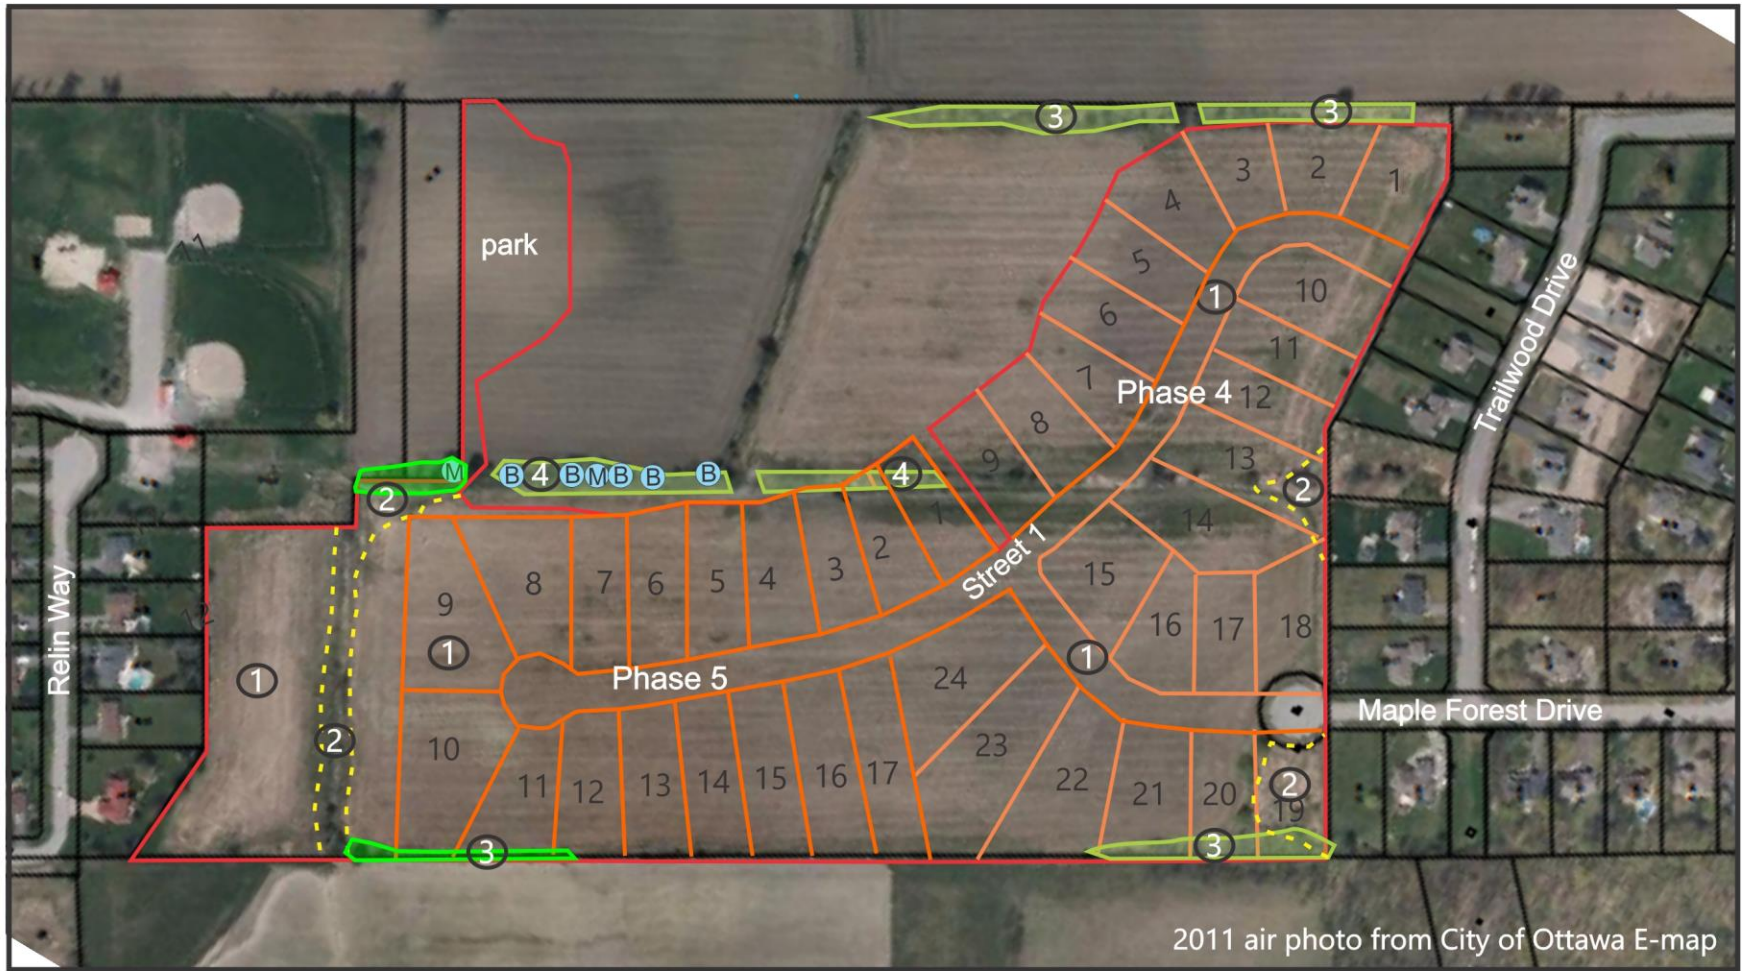
Map 2

The vast majority of the east-west deciduous hedgerows will be retained including (Map 2):

- In the south hedgerow poplar, bur oak, sugar maple, white elm and green ash at the rear of Lots 19 -21 (Phase 4) and Manitoba maple, sugar maple and white elm at the rear of Lots 10 and 11 (Phase 5);
- In the central hedgerow bur oak, red maple, white elm, Manitoba maple and green ash, including mature examples of the first three species, just to the north of the rear of Lots 1 – 9 (Phase 5);
- In the north hedgerow poplar, Manitoba maple and green ash just to the north of the rear of Lots 1 - 4 (Phase 4).

**MAPLE FOREST ESTATES, PHASES 4 & 5
PROPOSED CONSERVED VEGETATION**

The trees to be retained are to be protected with sturdy fencing installed a distance of ten times the trunk diameter from the trunk of the closest trees to the work area. No grading or activities that may cause soil compaction such as heavy machinery traffic and stockpiling of material are permitted within the fencing. No machinery maintenance or refuelling, storage of construction materials or stockpiling of earth is to occur within five metres of the outer edge of the dripline of the trees to be retained and protected. The existing grade is not to be raised or lowered within the fencing and no digging is permitted within the fencing. The root system, trunk or branches of the trees to be retained must not be damaged. Exhaust fumes from all equipment during future construction will not be directed towards the canopy of the retained trees. If any roots of trees to be retained are exposed during site alterations, the roots shall be immediately reburied with soil or covered with filter cloth or woodchips and kept moist until the roots can be buried permanently.
