# Preliminary Geotechnical Investigation Report

Proposed Development - 1495 Heron Road

Ottawa, Ontario

Project No. 160410368

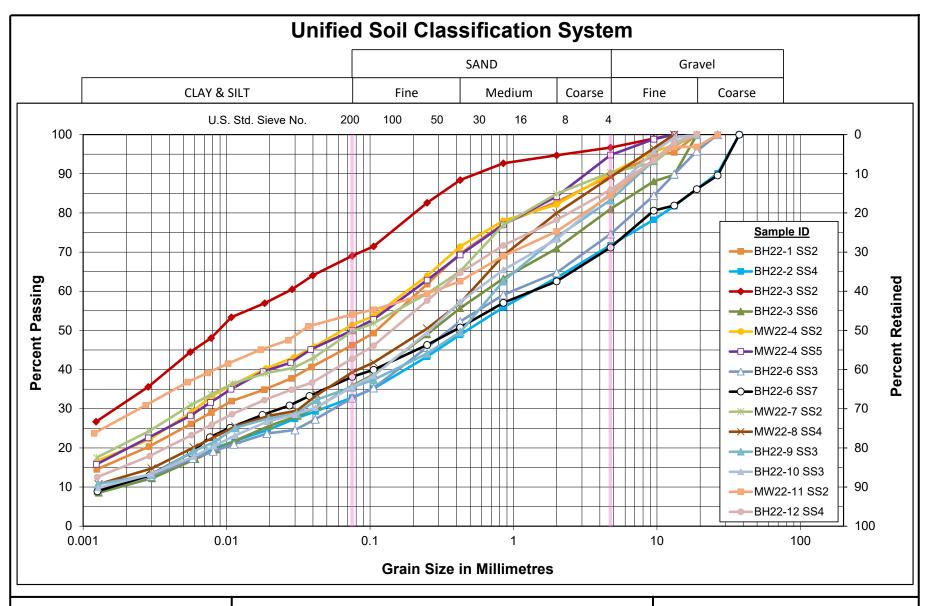
Figure No. 1

# **GRAIN SIZE DISTRIBUTION**

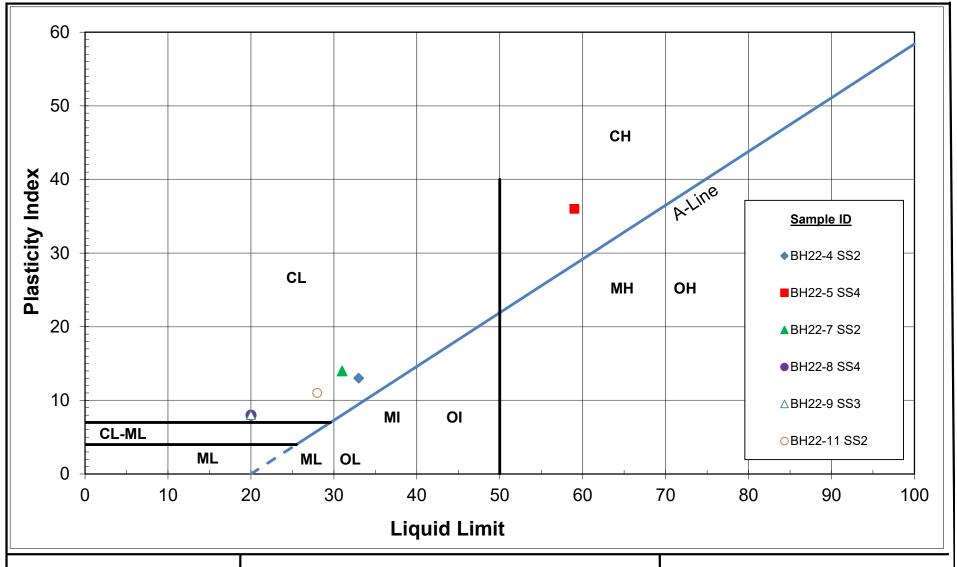
Figure No. 2

# **PLASTICITY CHART**

Borehole /Monitoring Well No.	Sample No.	Depth (m)	Moisture Content, w <sub>n</sub> (%)	Liquid Limit, LL	Plastic Limit, PL	Plasticity Index	Liquidity Index, LI (%)
MW22-4	SS2	0.8 – 1.4	14.8	33	20	13	0.4
MW22-7	SS2	0.8 – 1.4	15.1	31	17	14	0.1
MW22-8	SS4	2.3 - 2.9	7.9	20	12	8	0.5
BH22-9	SS3	1.5 – 2.1	8.0	20	12	8	0.5
MW22-11	SS2	0.8 – 1.4	13.9	28	17	11	0.3
BH22-12	SS4	2.3 – 2.9	10.9	25	15	10	0.4
