Kollaard Associates

**HYDROGEOLOGICAL INVESTIGATION  
AND TERRAIN EVALUATION  
PROPOSED RESIDENTIAL SUBDIVISION  
3200 REIDS LANE  
OSGOODE WARD, CITY OF OTTAWA  
ONTARIO**

FILE # 210064

REVISION 1                  May 10, 2023

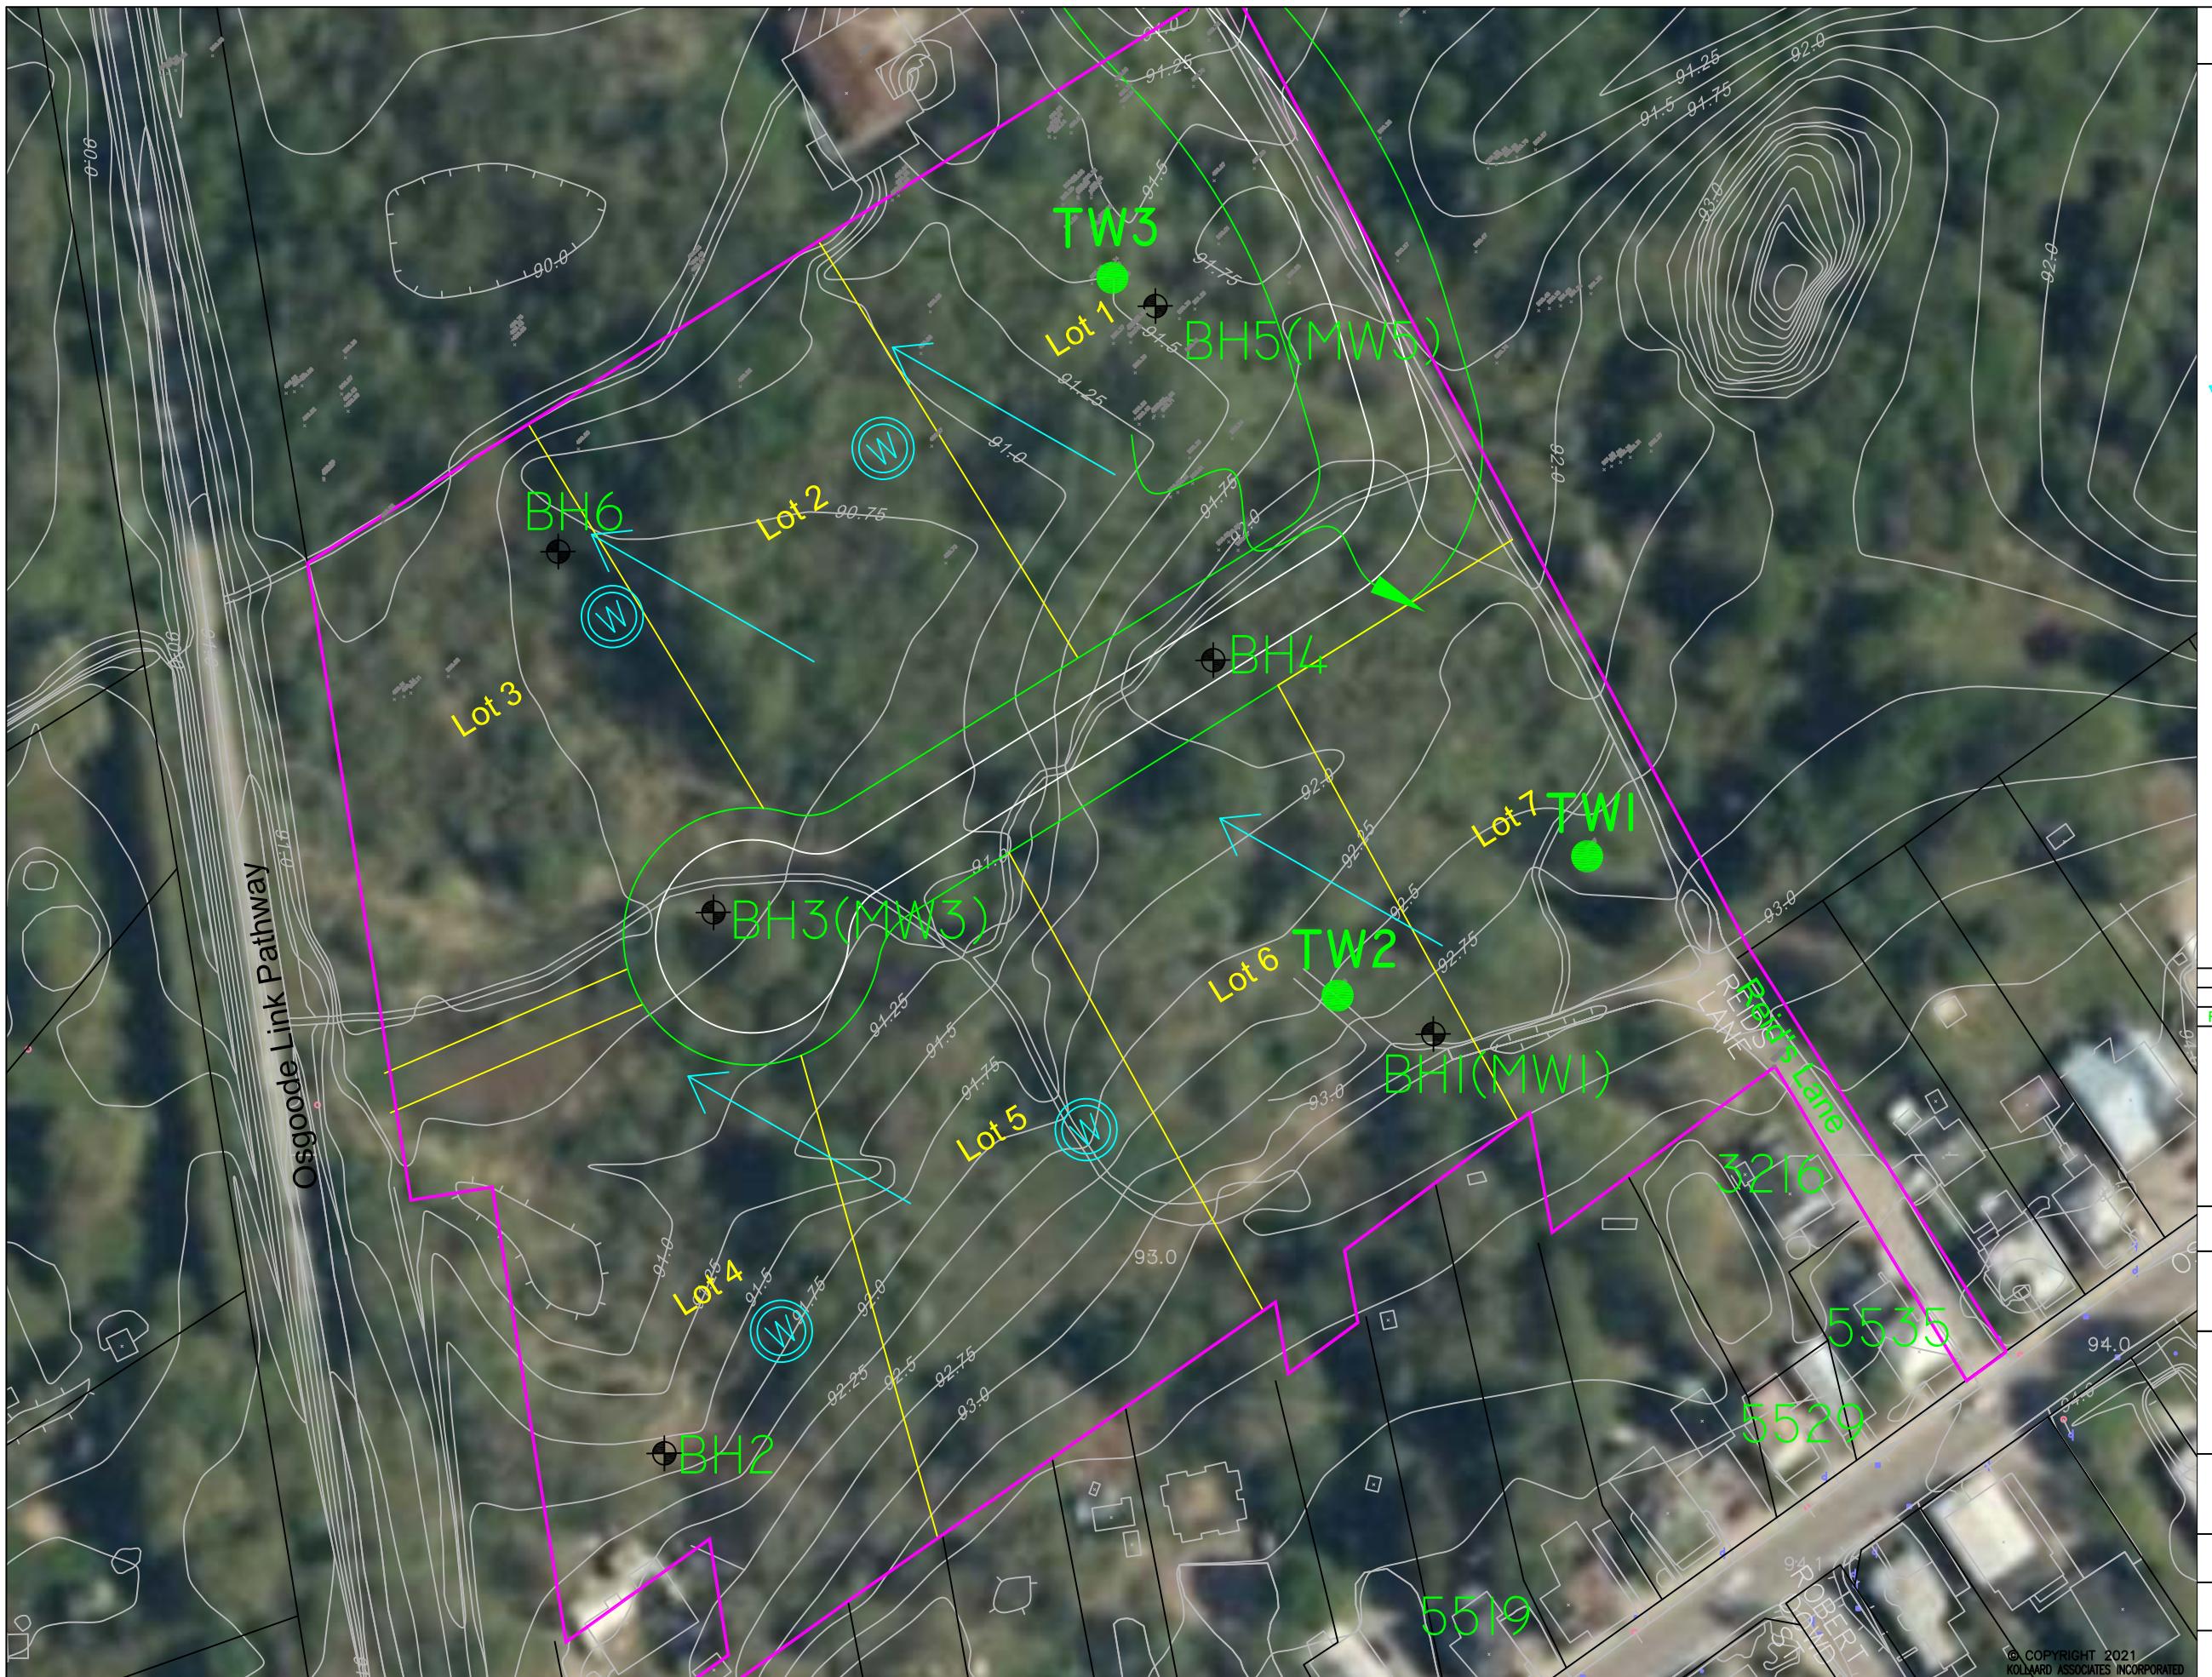
## FIGURE 2

In order to evaluate the background water quality conditions in the receiving aquifer, three shallow monitoring wells were installed at the site and tested for nitrogen species. The construction details are provided in Section 2.1, the Records of Boreholes are appended to the report and groundwater levels are reported in Section 3.1. Background nitrogen concentrations from the shallow groundwater receiving effluent were reported (Section 3.1.1) and the original laboratory testing results are in Attachment D. The Site Plan, Figure 2, shows the locations of the monitoring wells.

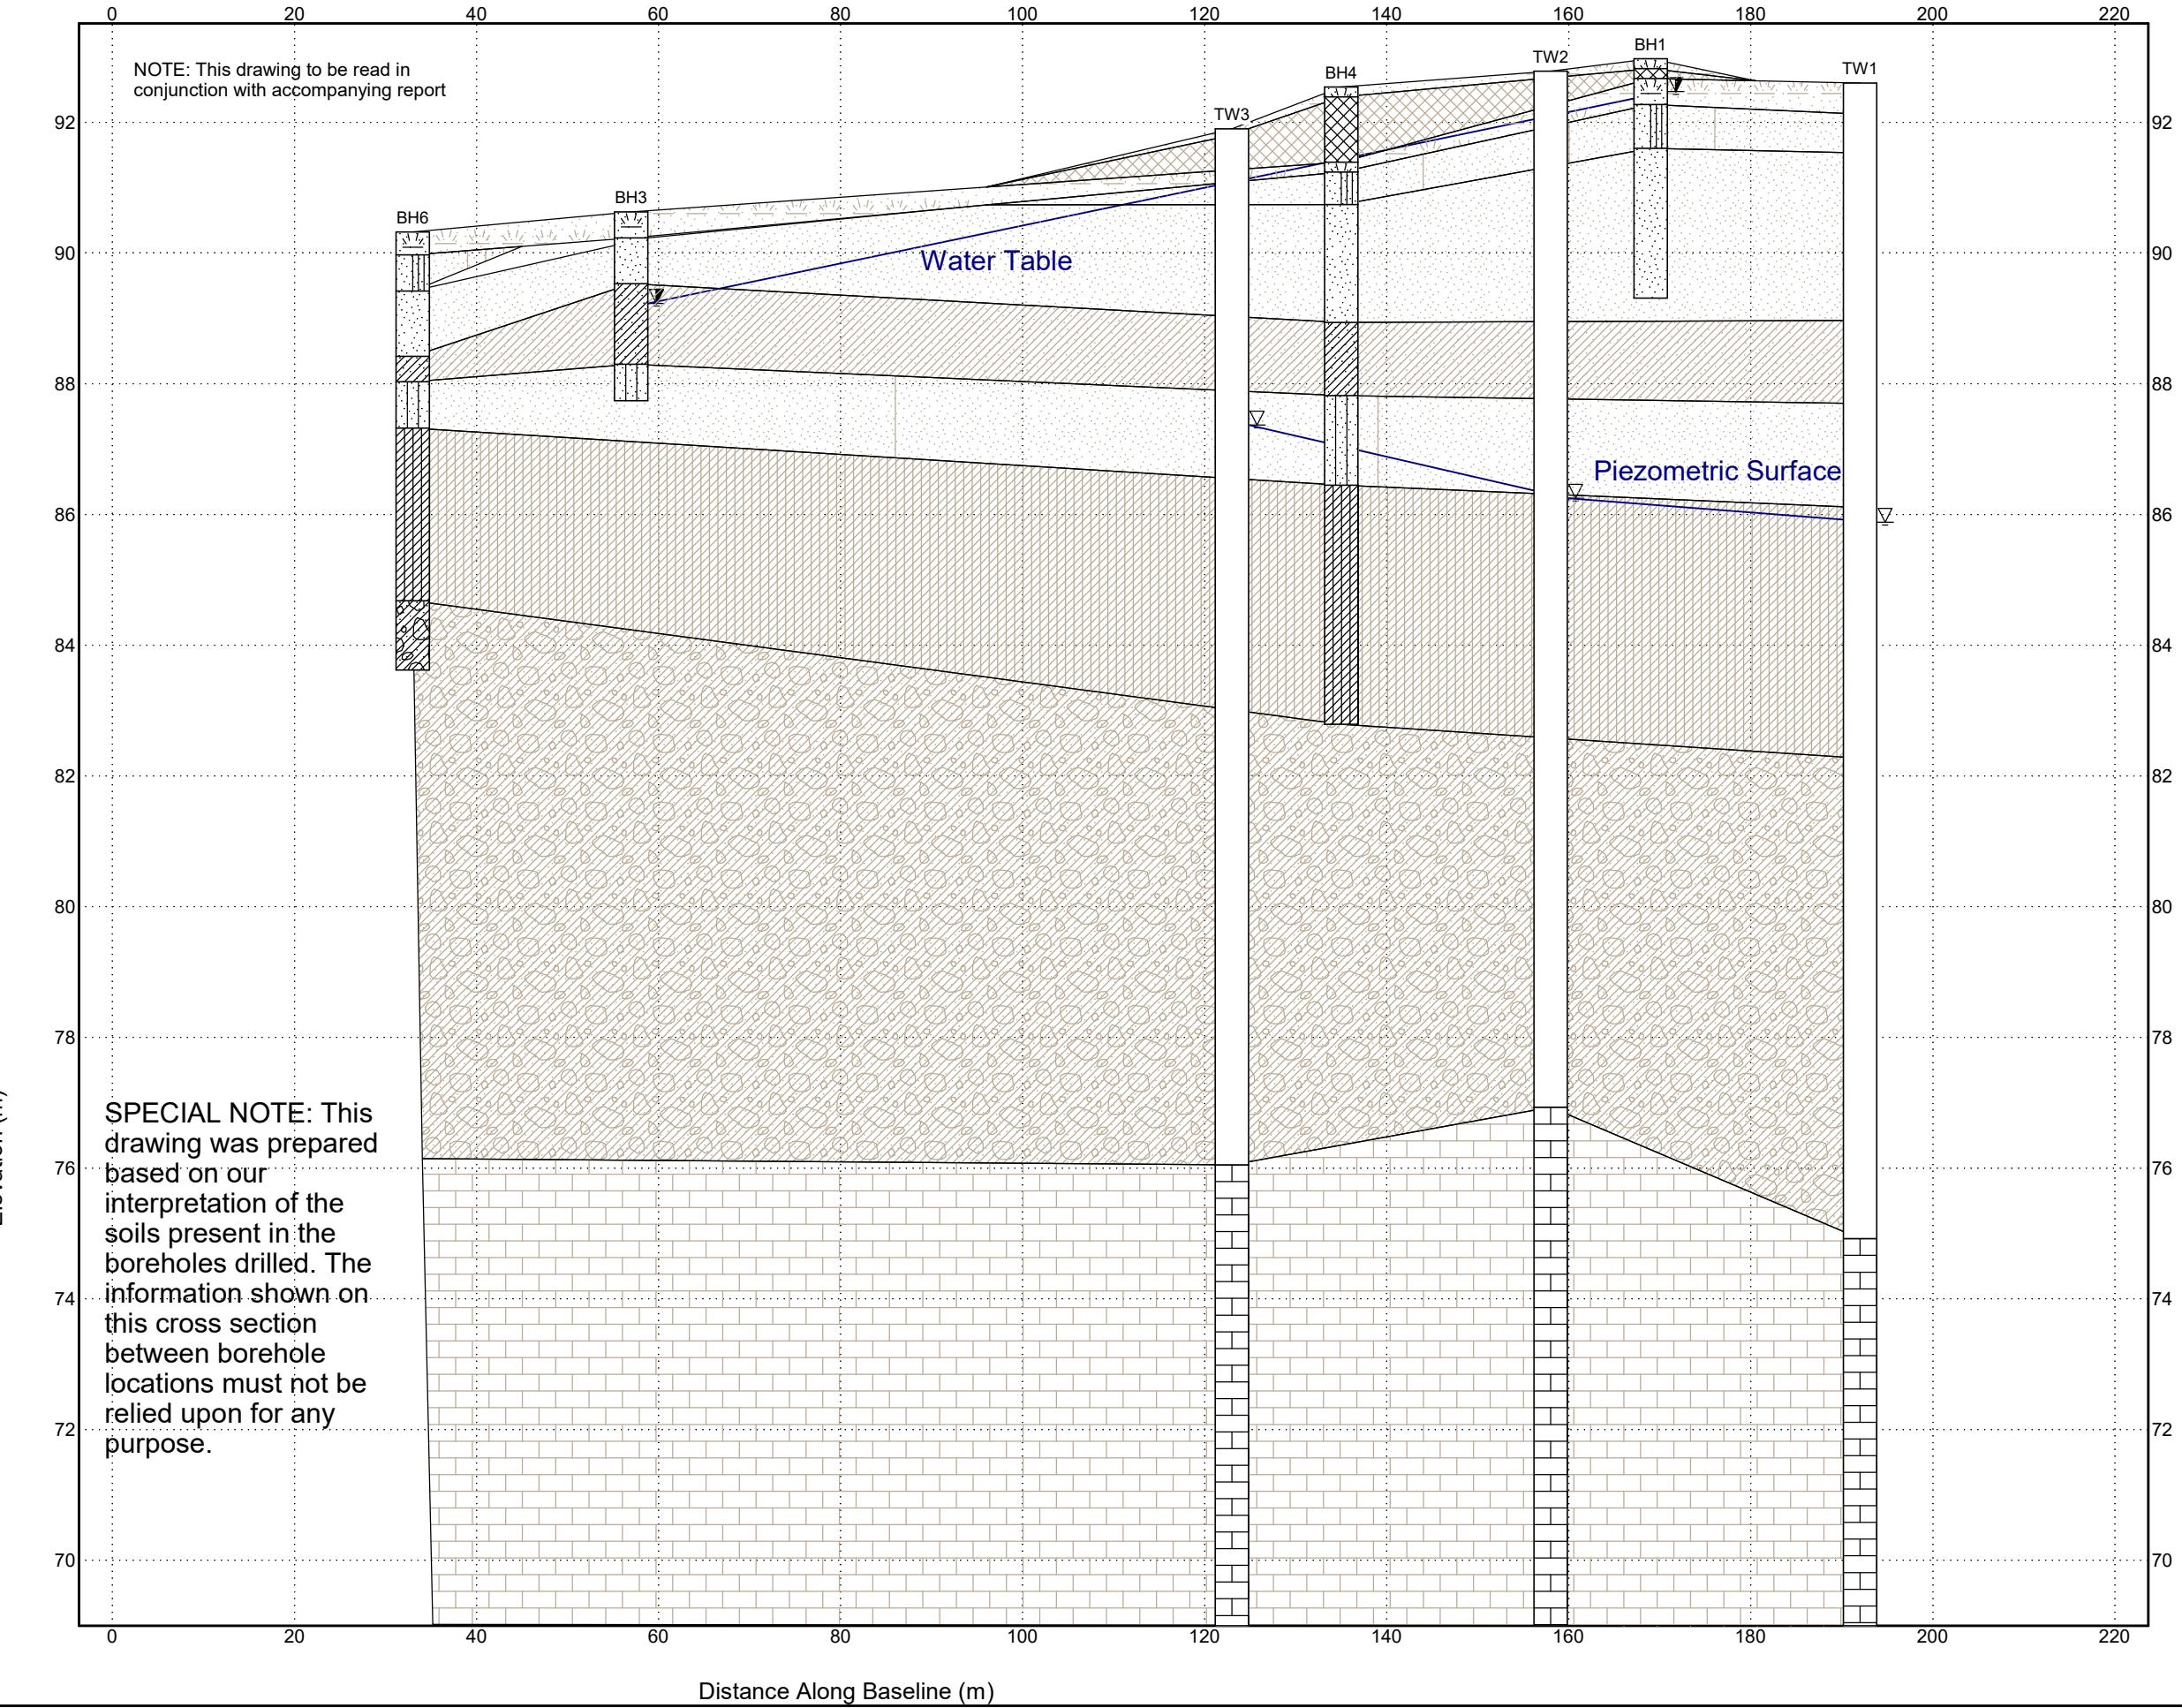
**FIGURE 4**

- The piezometric surfaces in the three water supply wells (see cross sections, Figures 4 and 5) are above the top of the aquifer (bedrock elevation); and
- the shape of the drawdown response curve observed in the pumping tests closely resembles the ideal response of a confined aquifer; and
- the storativity coefficient calculated using the drawdown response in adjacent wells is  $\sim 2.0 \times 10^{-4}$ , whereas specific yield in an unconfined aquifer is typically orders of magnitude higher; and
- Based on the depth and type of soils onsite, there is a confining unit consisting of silty clay and/or glacial till which are some 9 metres to 15 metres in thickness.

TOPSOIL
	Yellow brown sand and gravel (FILL)
	Red brown fine to medium SAND, trace silt
	Grey fine to medium SAND
	Grey sandy CLAY, trace silt
	Grey SILTY SAND
	Grey SILTY CLAY
	Grey silty sand, trace to some gravel, cobbles and boulders, trace clay (GLACIAL TILL)
	LIMESTONE BEDROCK

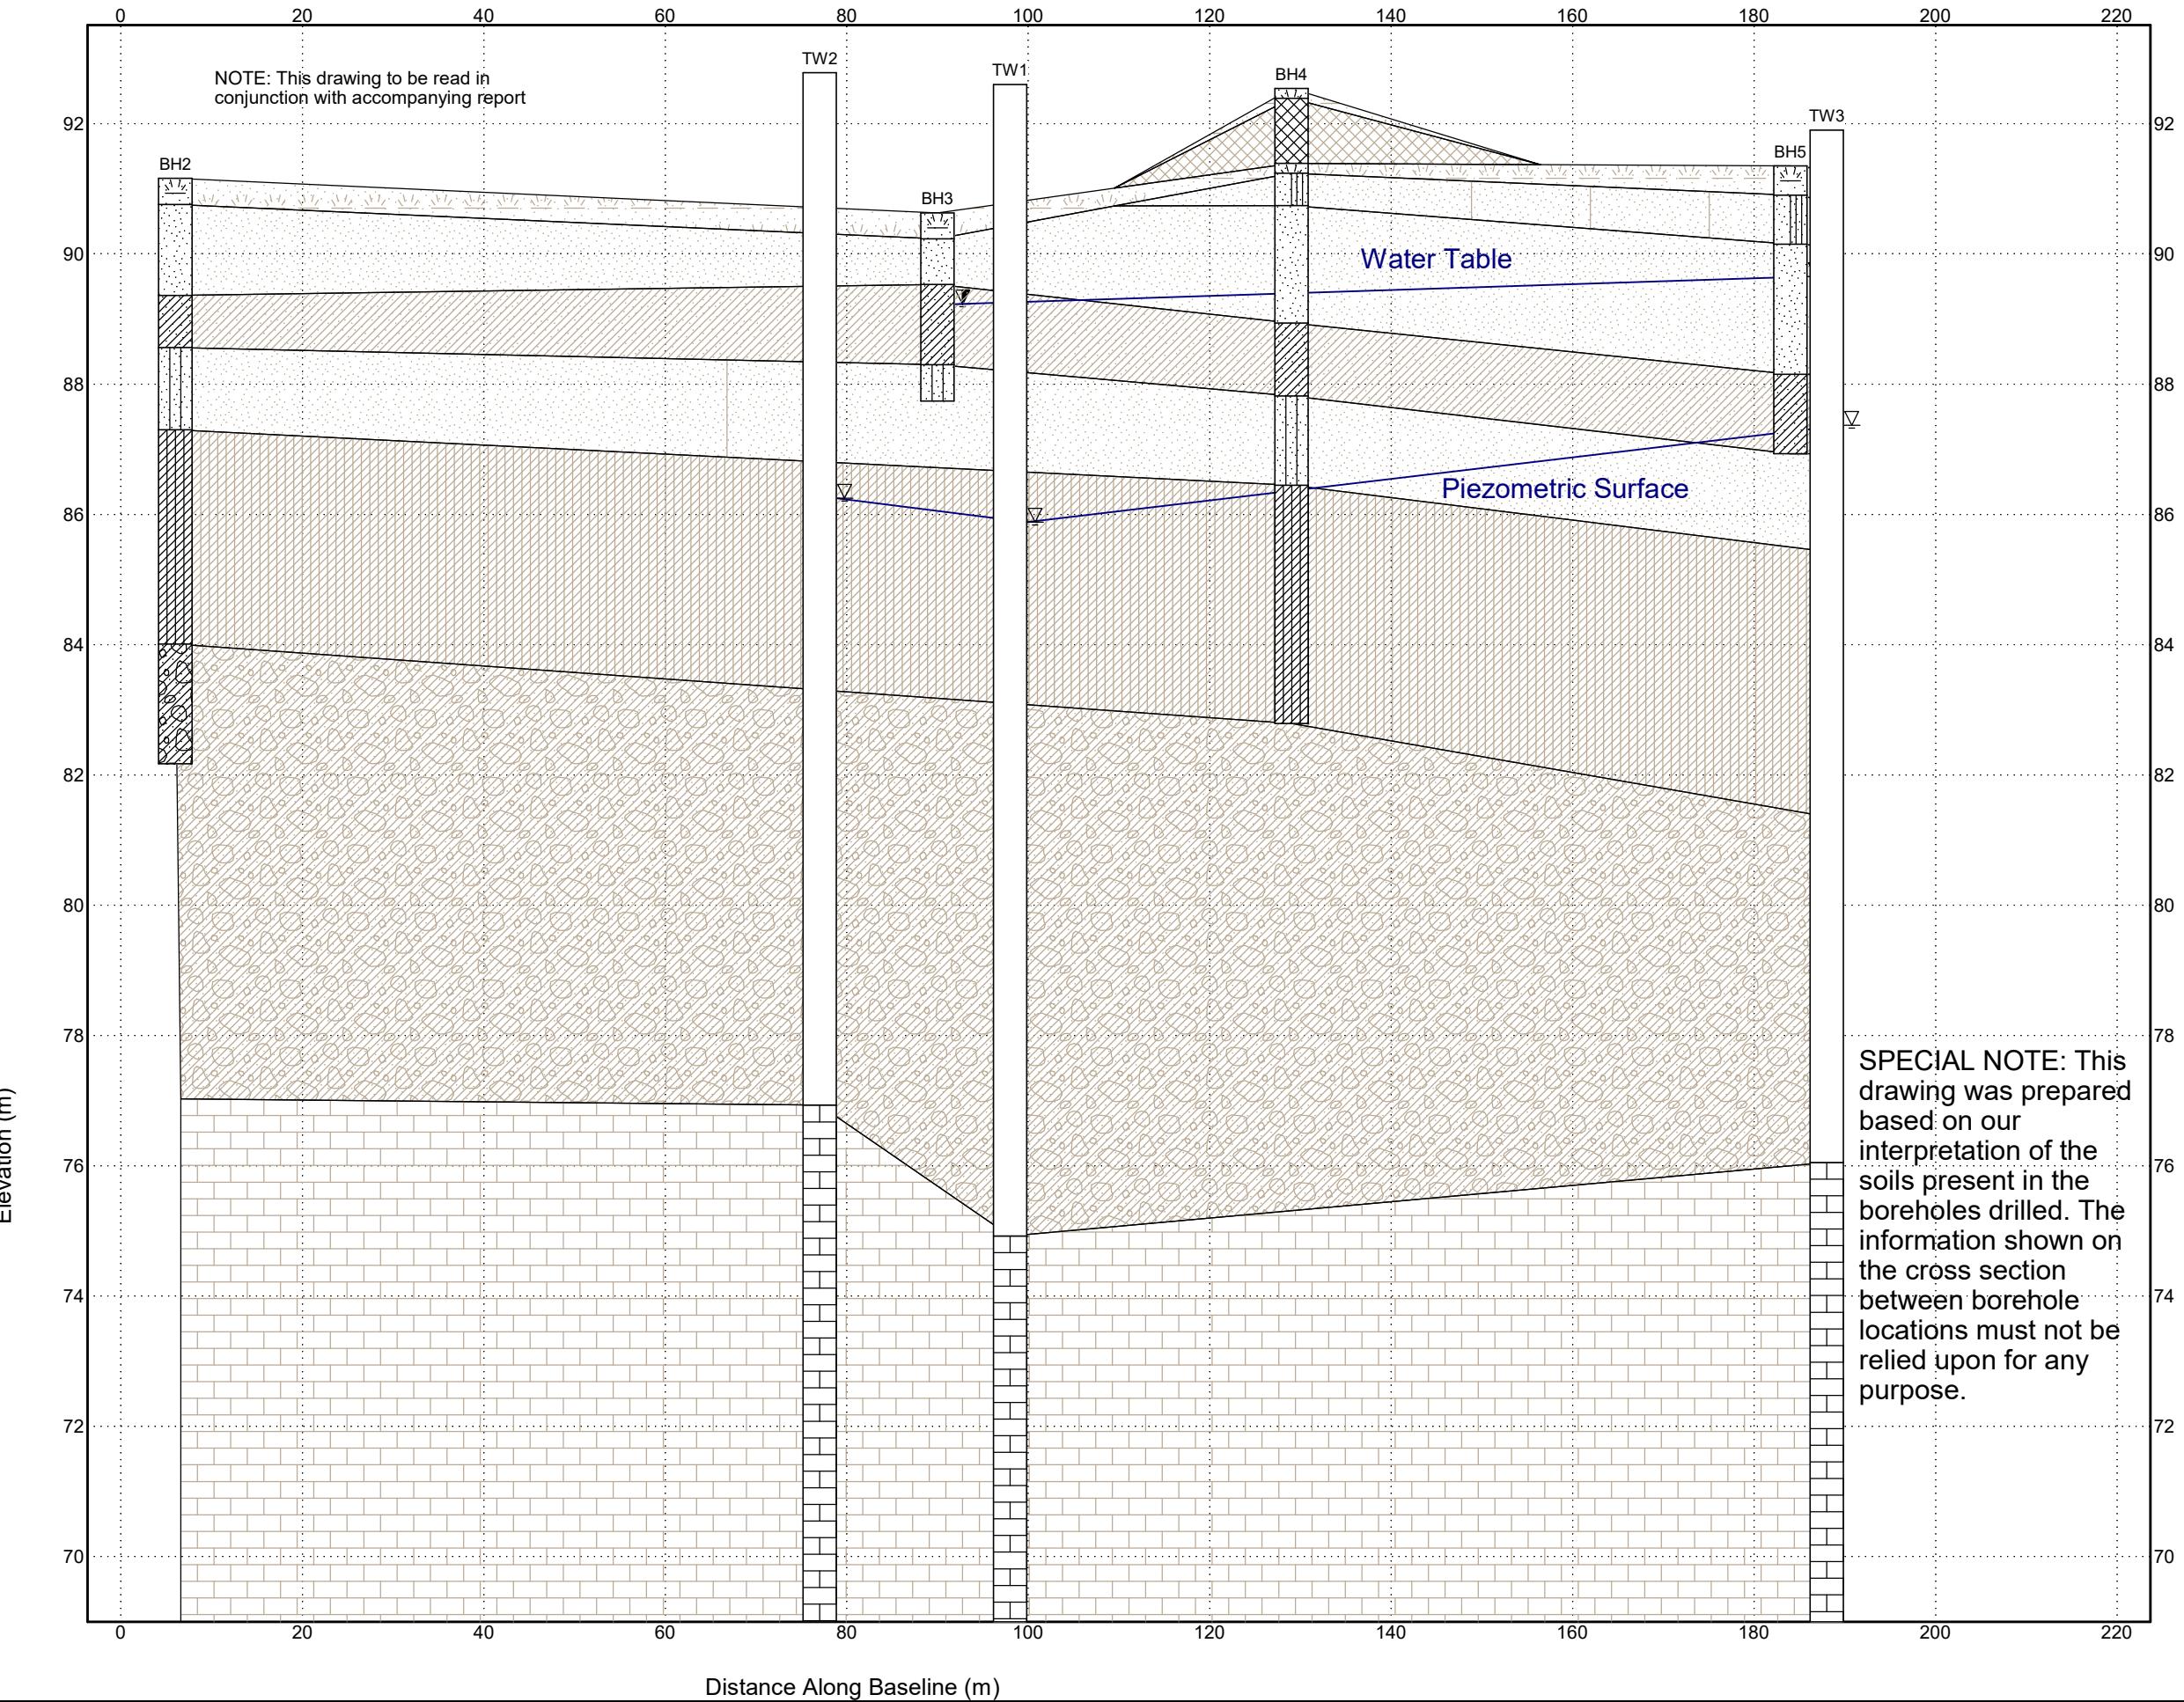
**FIGURE 5**

<b>TOPSOIL</b>
	Yellow brown sand and gravel (FILL)
	Red brown fine to medium SAND, trace silt
	Grey fine to medium SAND
	Grey sandy CLAY, trace silt
	Grey SILTY SAND
	Grey SILTY CLAY
	Grey silty sand, trace to some gravel, cobbles and boulders, trace clay (GLACIAL TILL)
	LIMESTONE BEDROCK

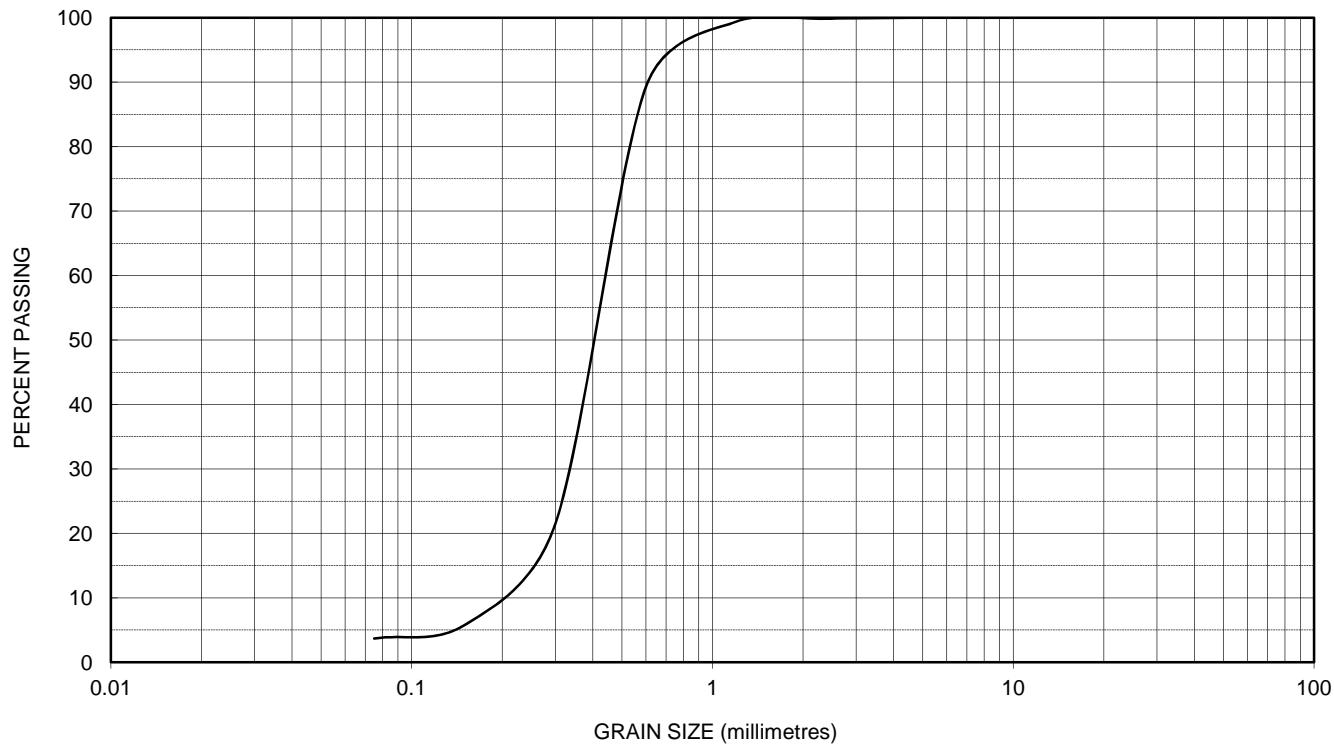
SIEVE SIZE (mm)	76.2	53	26.5	19.0	16	13.2	9.5	4.75	2.36	1.180	0.600	0.300	0.15	0.075	
SAMPLE PASSING									100.0	99.8	99.3	89.2	21.4	5.8	3.7

CLIENT:	Crestview Innovations Inc.		
PROJECT:	3200 Reids Lane, Ossgoode	OUR REF.:	210064
TYPE OF MATERIAL:	Sand	INTENDED USE:	Residential
DATE SAMPLED:	February 3, 2021	DATE TESTED:	February 11, 2021
SOURCE:	BH1 - 0.76-1.37	SAMPLE NO:	SS2
REMARKS:	<hr/> <hr/>

Based on the above noted information, the hydraulic conductivity of the soil is expected to be  $\sim 2.6 \times 10^{-2}$  cm/s. The soil can be characterized as poorly graded sand. This is considered to be a soil of medium permeability.

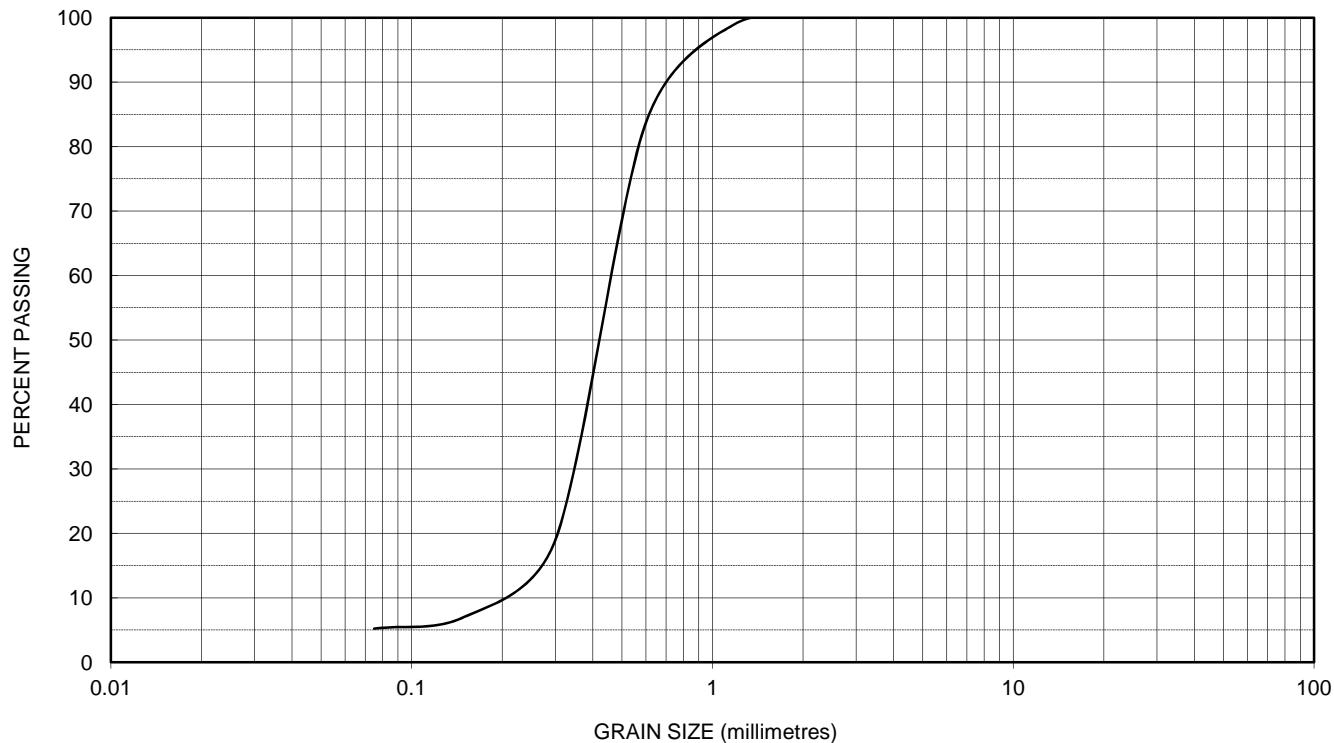
SIEVE SIZE (mm)	76.2	53	26.5	19.0	16	13.2	9.5	4.75	2.36	1.180	0.600	0.300	0.15	0.075	
SAMPLE PASSING										100.0	99.0	83.7	19.0	7.1	5.2

CLIENT:	Crestview Innovations Inc.		
PROJECT:	3200 Reids Lane, Ossgoode	OUR REF.:	210064
TYPE OF MATERIAL:	Sand	INTENDED USE:	Residential
DATE SAMPLED:	February 3, 2021	DATE TESTED:	February 11, 2021
SOURCE:	BH3 - 0.76 - 1.37	SAMPLE NO:	SS2
REMARKS:	<hr/> <hr/>

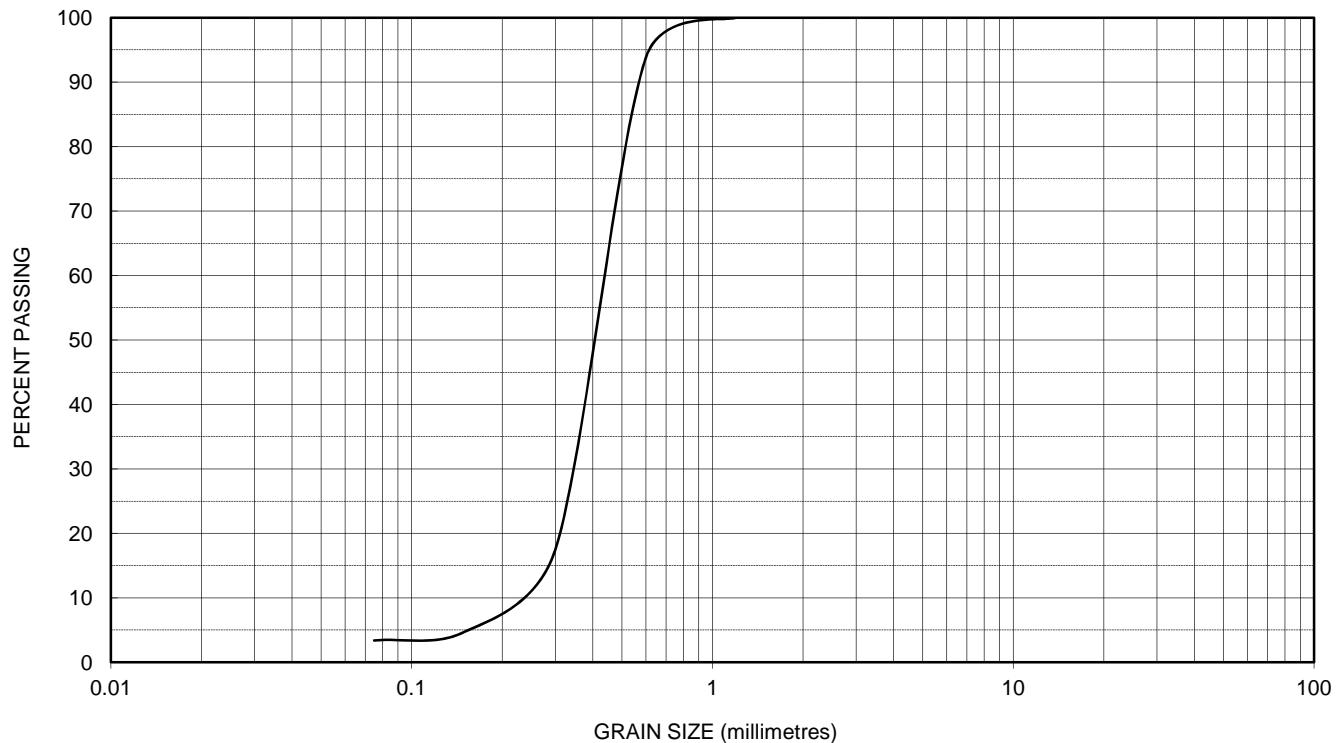
SIEVE SIZE (mm)	76.2	53	26.5	19.0	16	13.2	9.5	4.75	2.36	1.180	0.600	0.300	0.15	0.075	
SAMPLE PASSING										100.0	99.9	93.8	17.5	4.7	3.4

CLIENT:	Crestview Innovations Inc.		
PROJECT:	3200 Reids Lane, Ossgoode	OUR REF.:	210064
TYPE OF MATERIAL:	Sand	INTENDED USE:	Residential
DATE SAMPLED:	February 3, 2021	DATE TESTED:	February 11, 2021
SOURCE:	BH5 - 0.76 - 1.37	SAMPLE NO:	SS2
REMARKS:	<hr/> <hr/>

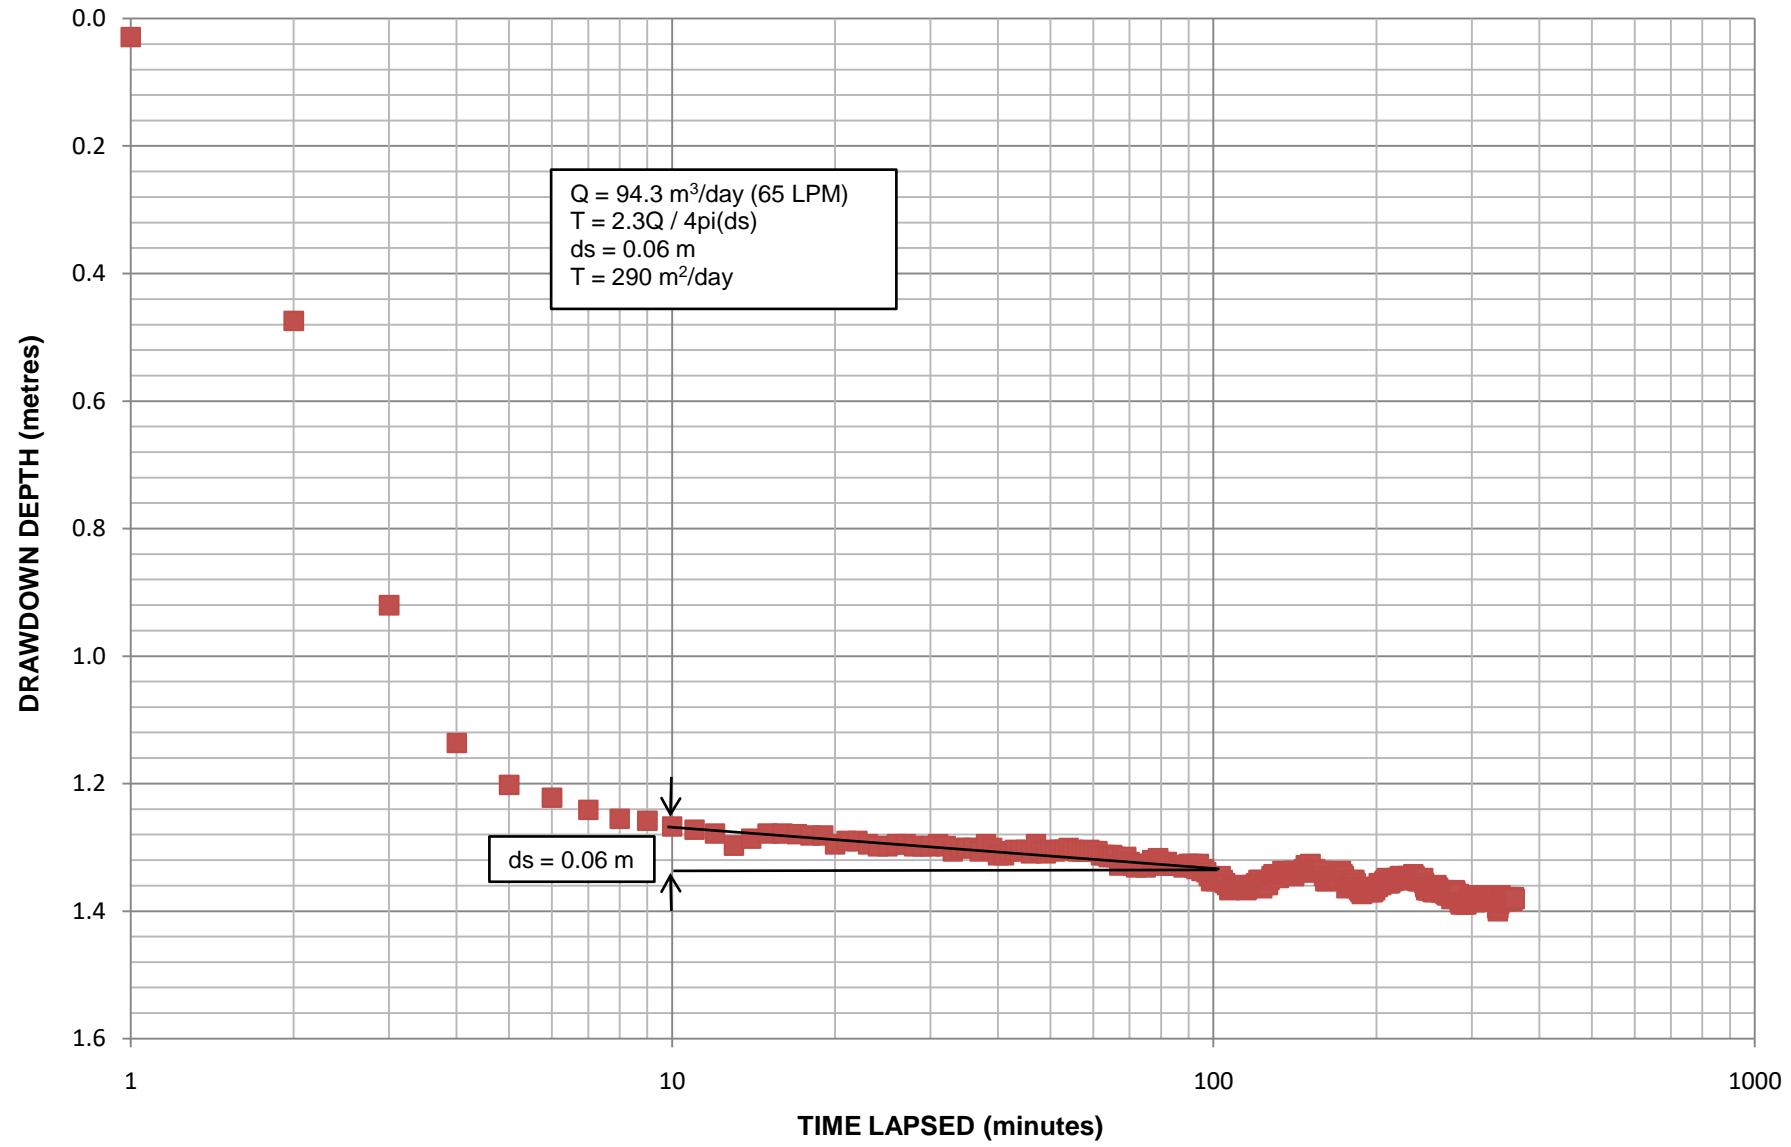
## TW1-WELL DRAWDOWN VS. TIME-KOLLAARD FILE 210064

**PUMPING TEST DATA FOR TW1**

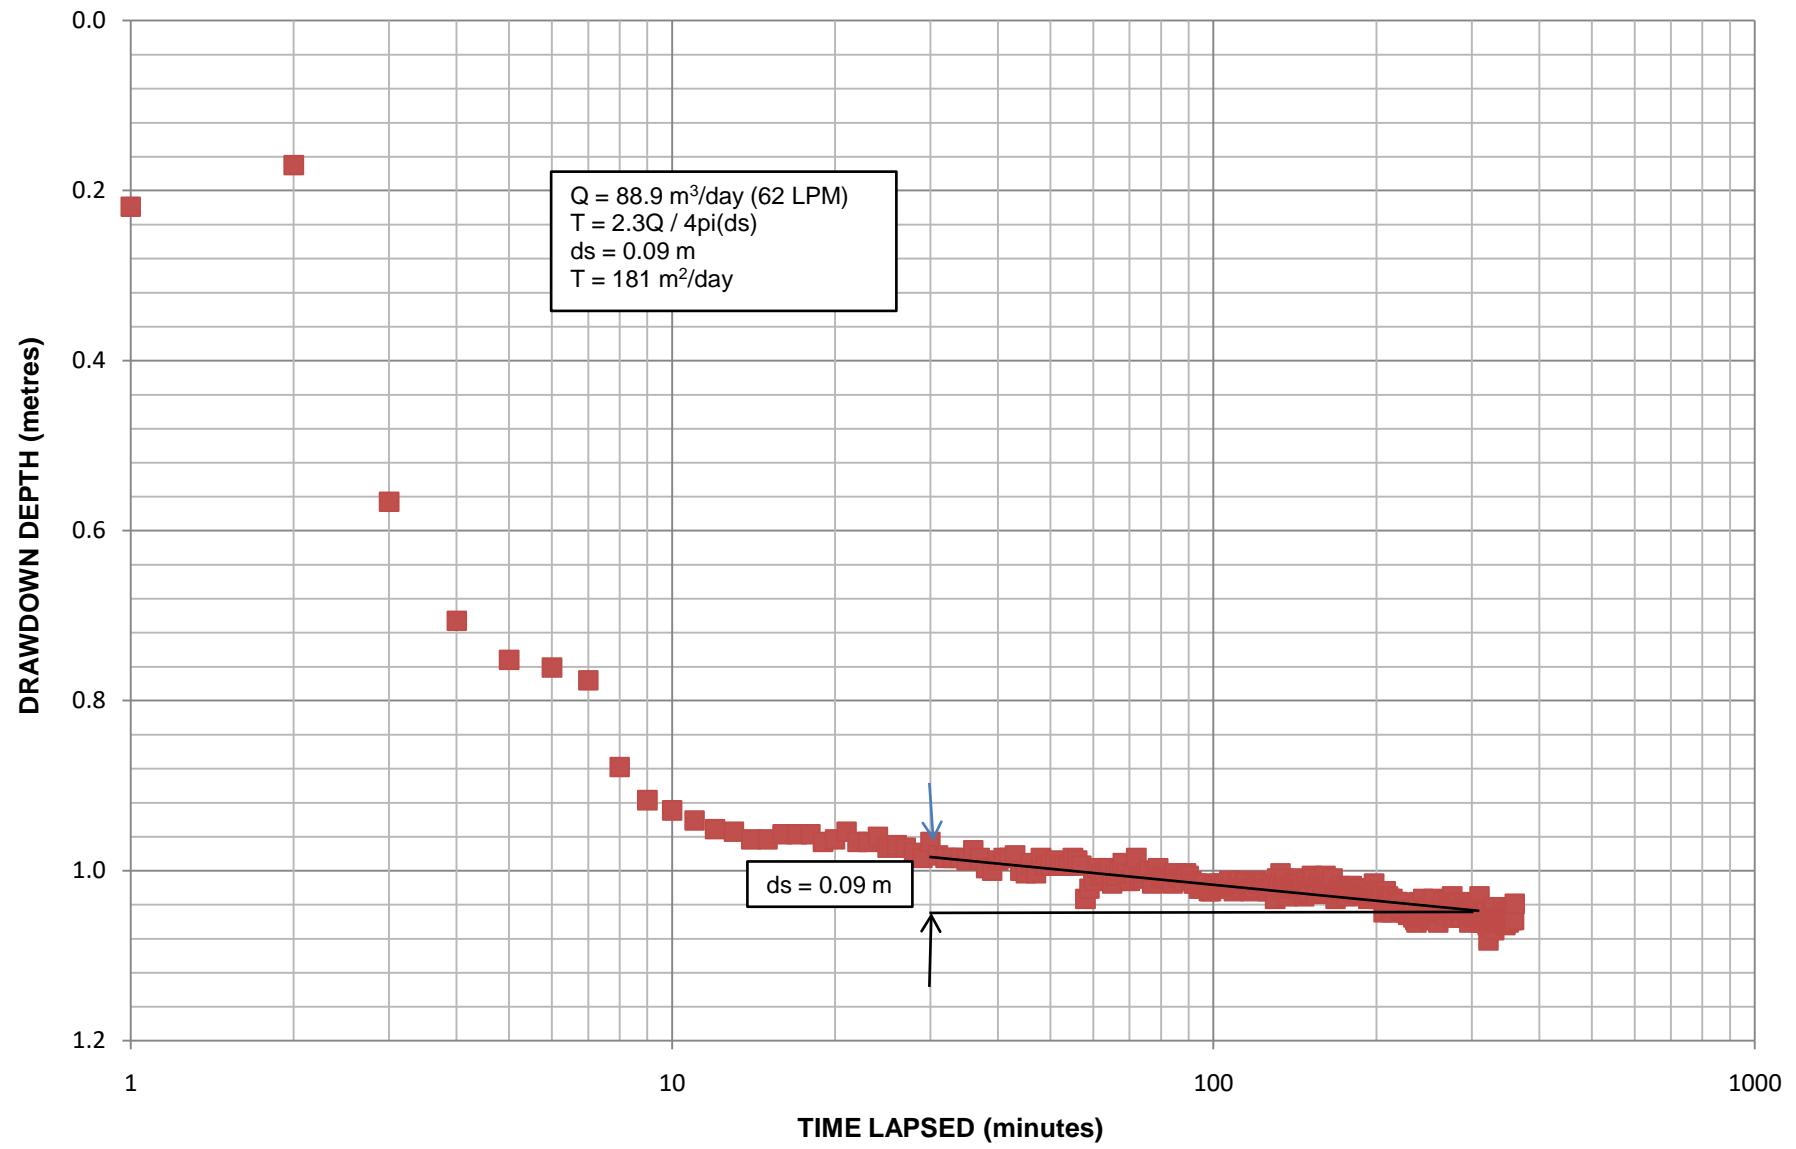
## TW2-WELL DRAWDOWN VS. TIME-KOLLAARD FILE 210064

**PUMPING TEST DATA FOR TW2**

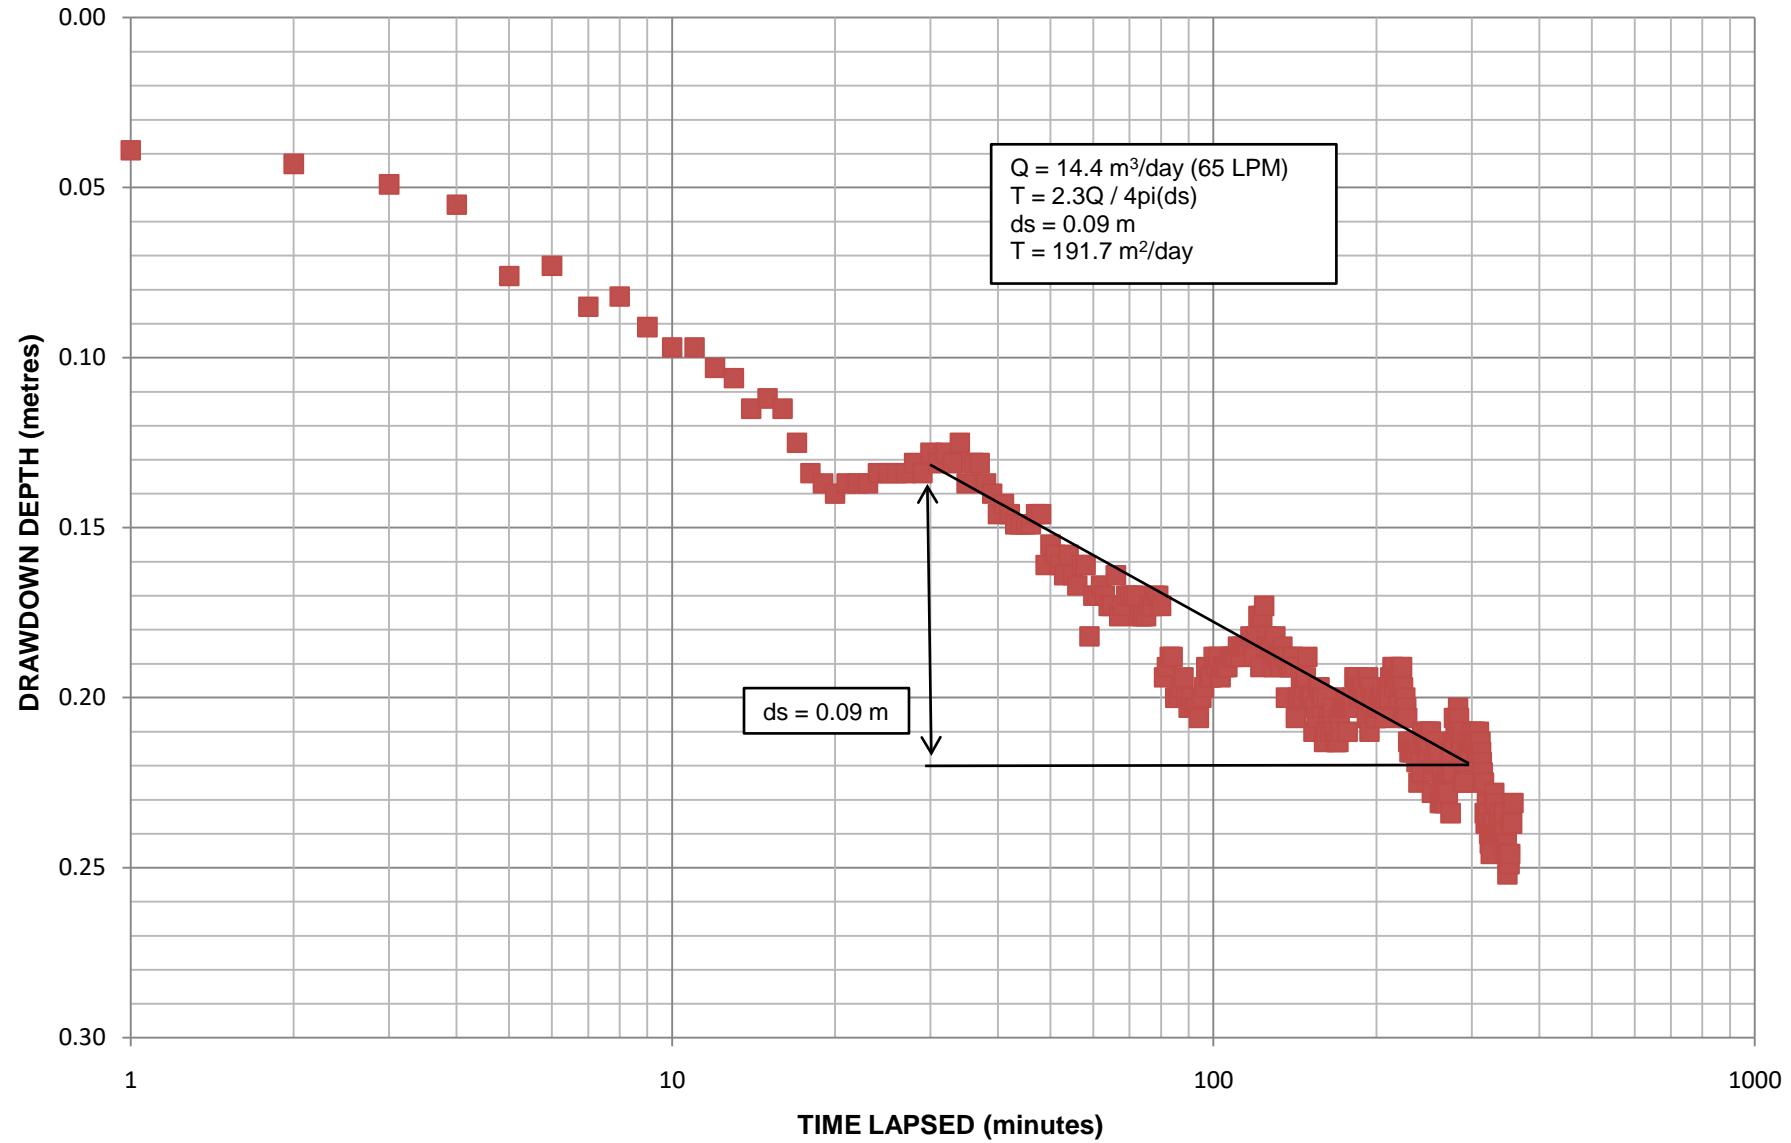
## TW3-WELL DRAWDOWN VS. TIME-KOLLAARD FILE 210064

**PUMPING TEST DATA FOR TW3**
