Kollaard Associates

**HYDROGEOLOGICAL INVESTIGATION  
AND TERRAIN EVALUATION  
PROPOSED RESIDENTIAL SUBDIVISION  
3200 REIDS LANE  
OSGOODE WARD, CITY OF OTTAWA  
ONTARIO**

FILE # 210064

REVISION 1                  May 10, 2023

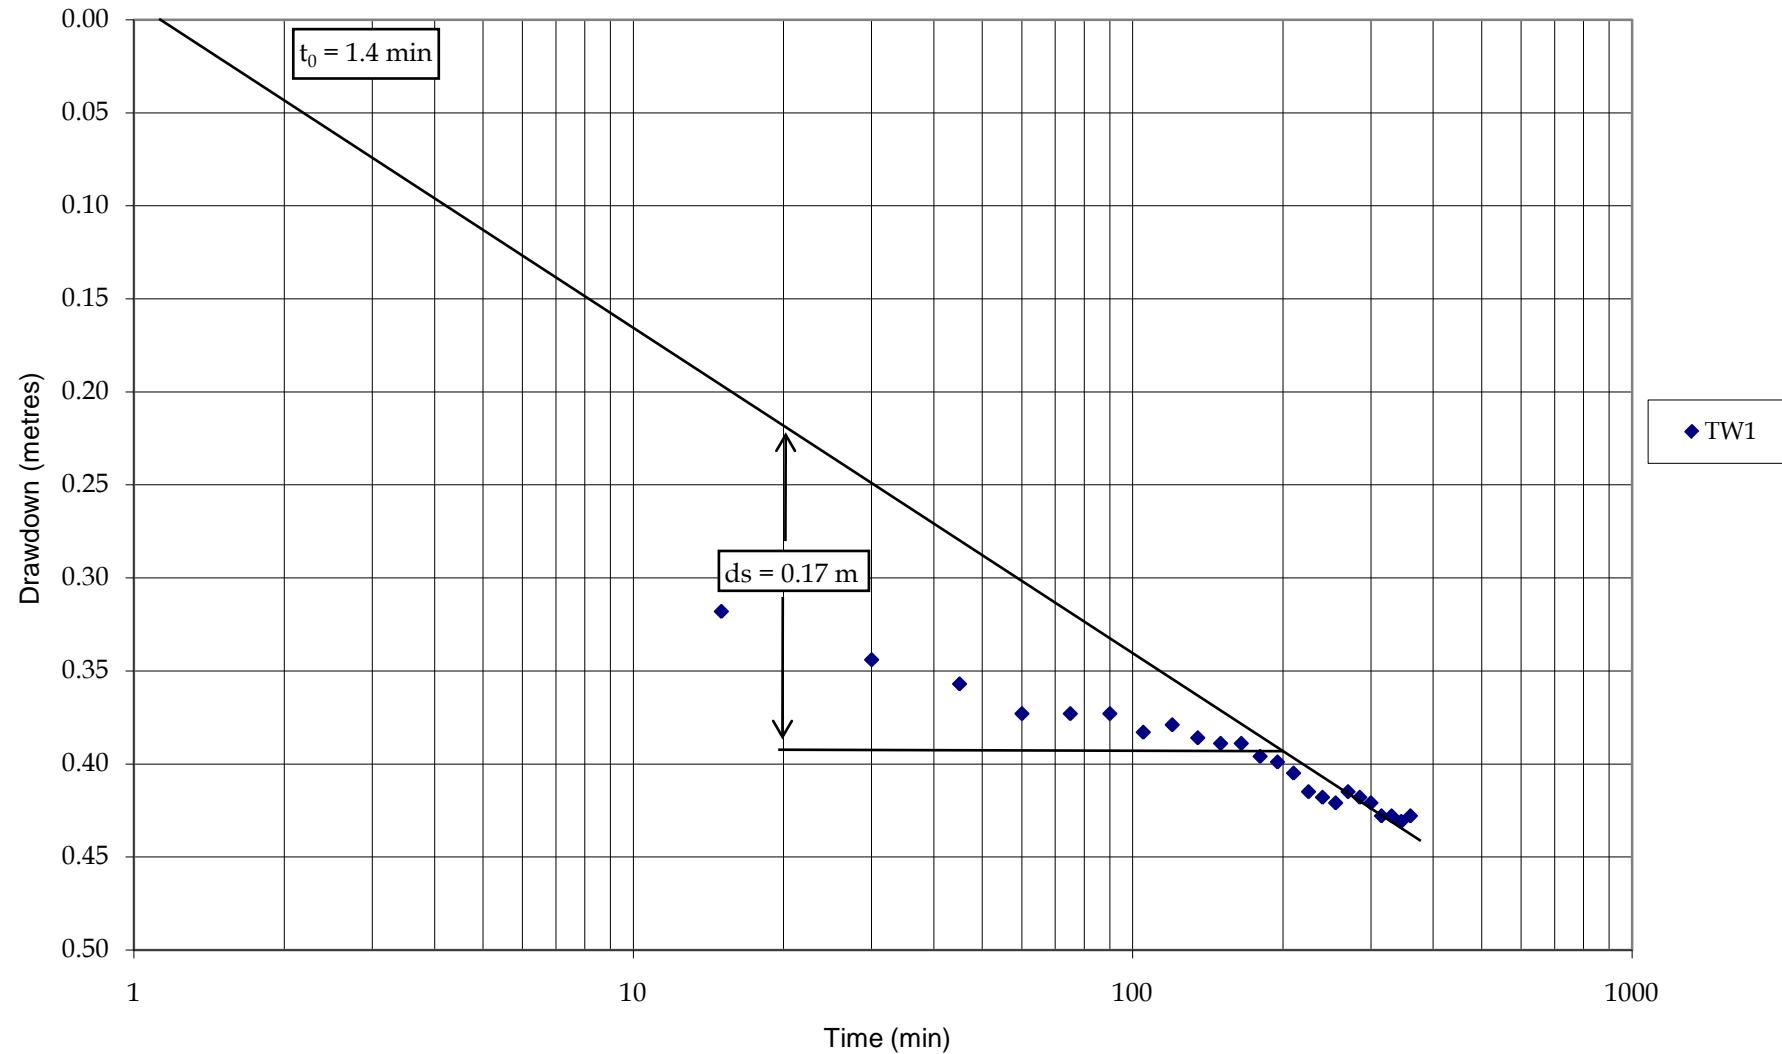
### Drawdown vs. Time in Observation Well During Pumping Test for TW2

#### OBSERVATION WELL DATA USING PRESSURE TRANSDUCER LOGGERS

During the pumping of TW2, pressure transducer logging was carried out at TW1 and TW3, located some 45 metres and 117 metres distance, respectively, from TW2. Total drawdown observed at TW1 and TW3 was about 0.42 metres and 0.04 metres, respectively.
