REPORT ON

**PHASE II
ENVIRONMENTAL SITE ASSESSMENT
3200 REIDS LANE
CITY OF OTTAWA, ONTARIO**

Crestview Innovations Inc.
12 Escade Drive
Nepean, ON
K2G 6R9

DATE: January 24, 2023

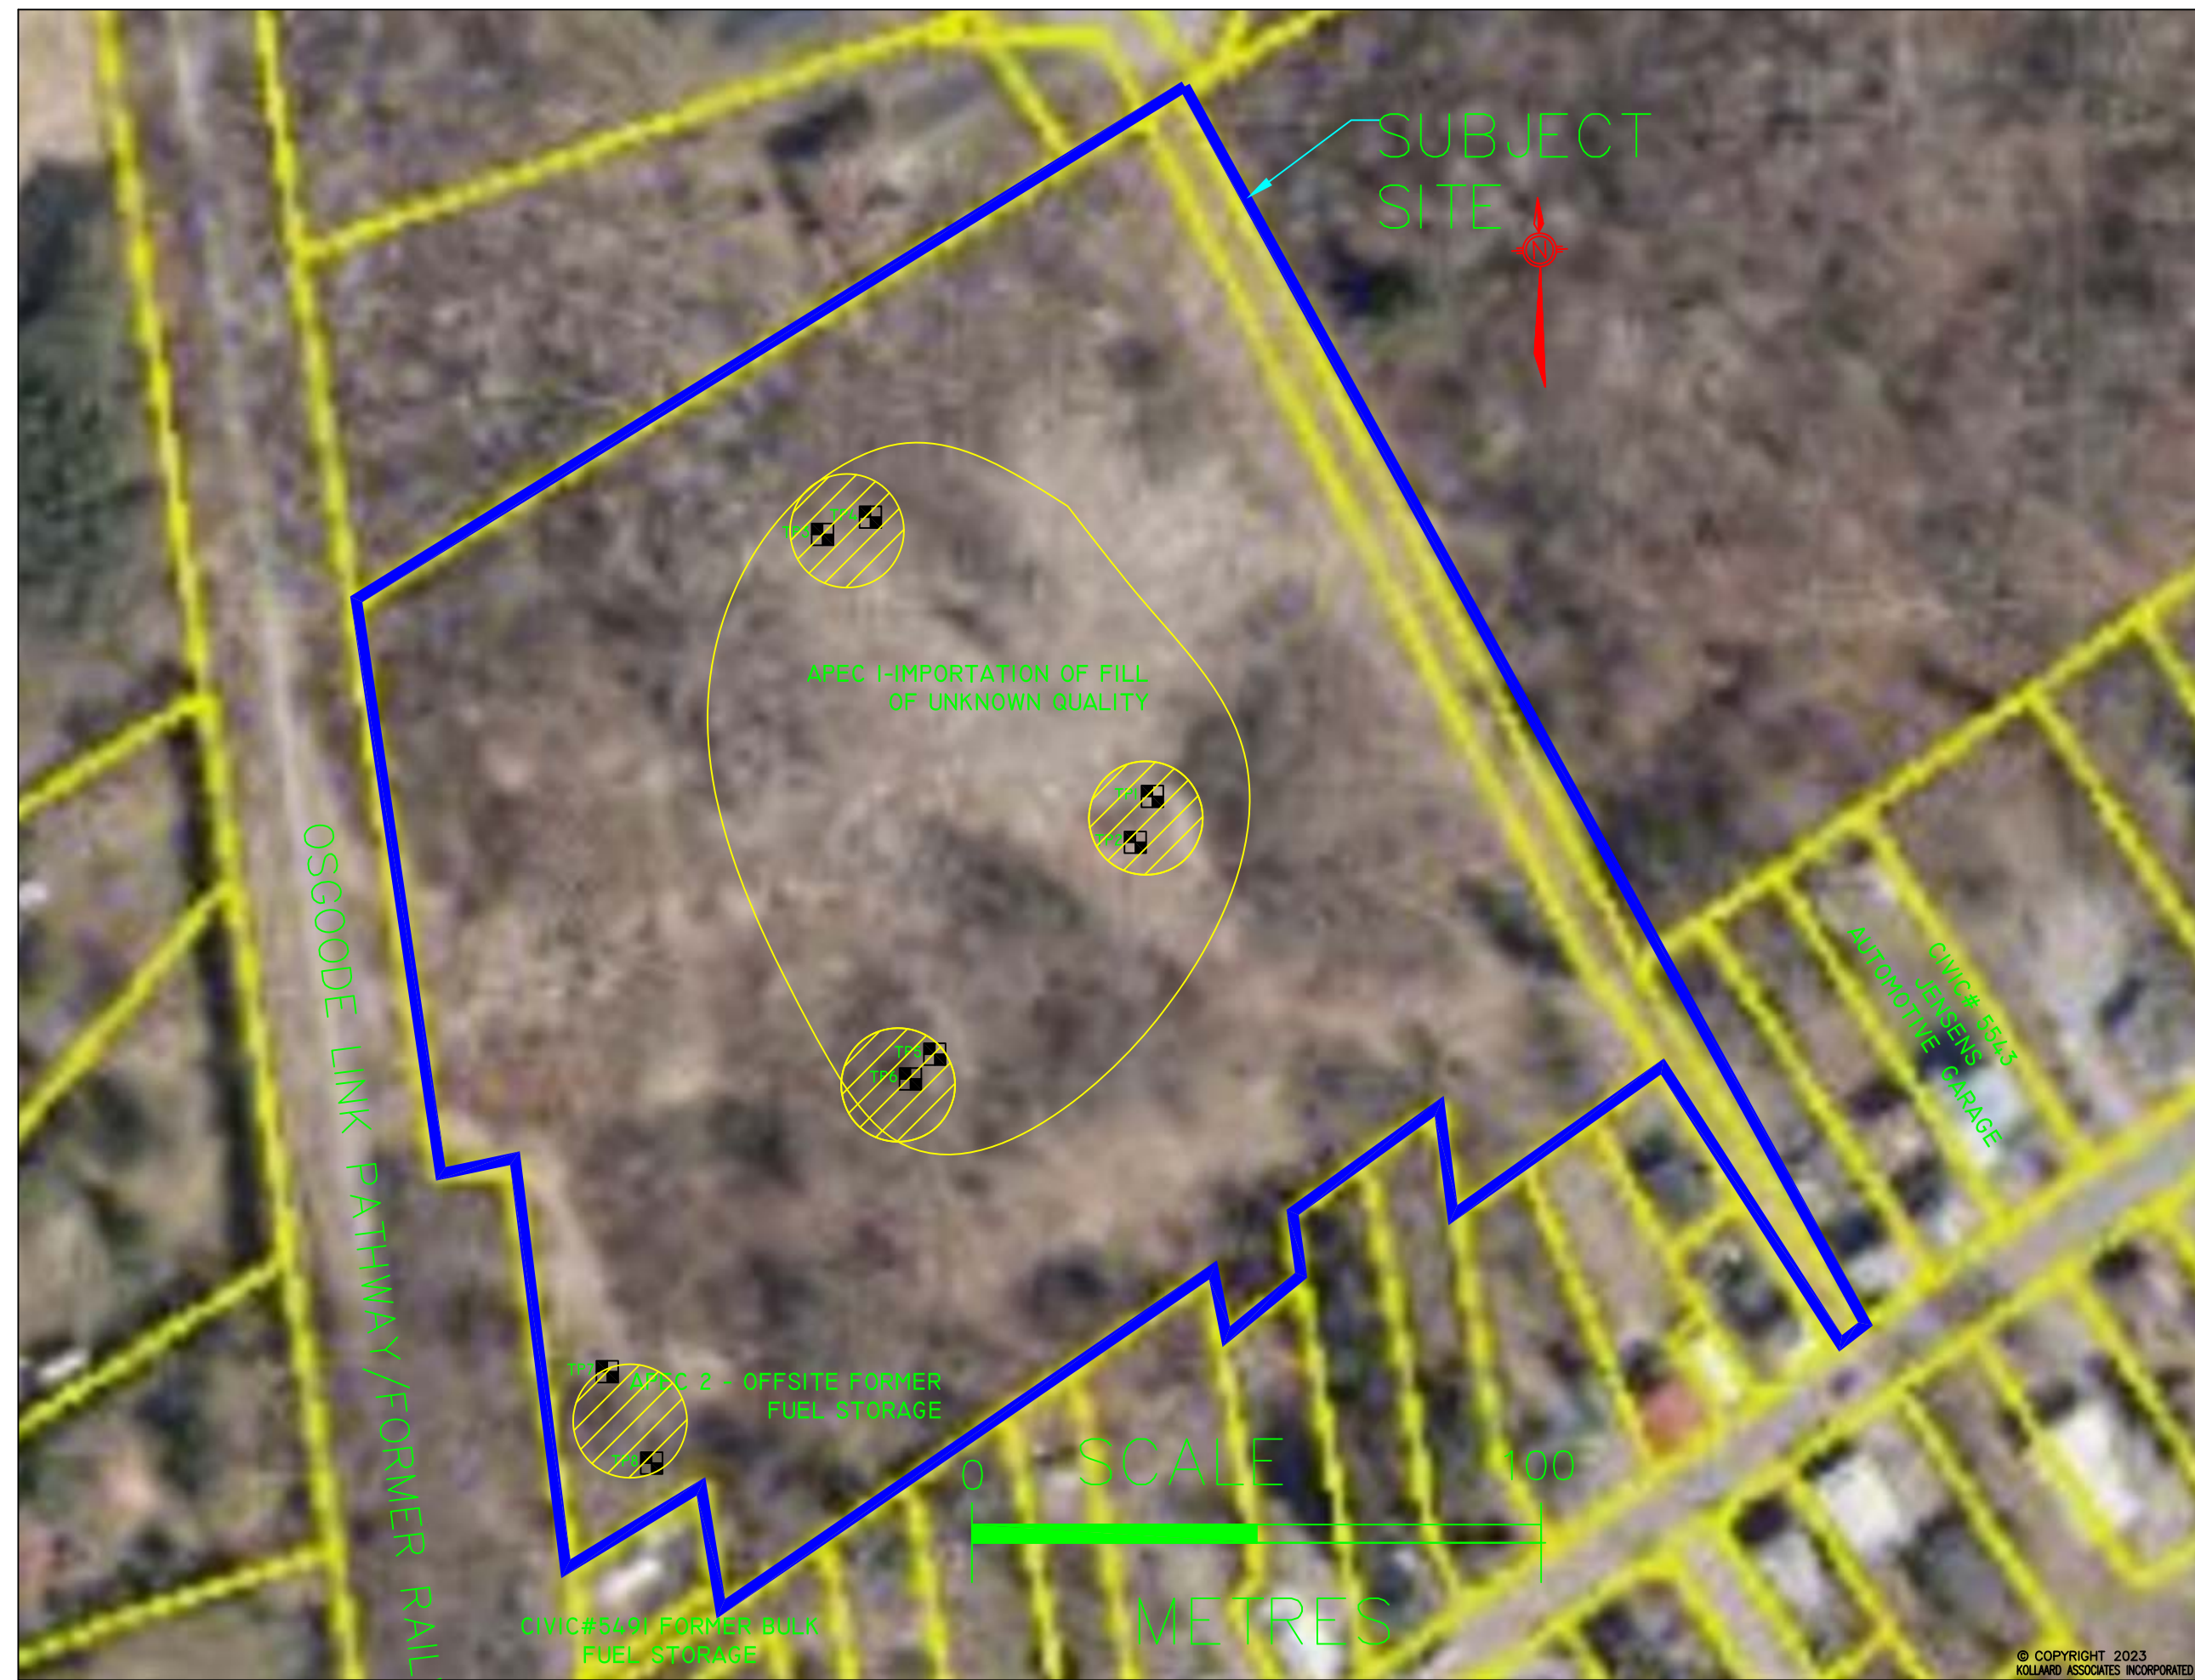
Figure 2 – Conceptual Site Model with APECs and Sample Locations

The locations of the samples are provided on the attached Figure 2. The cross sections (Figures 4 and 5) show the fill areas and underlying native soil and bedrock conditions at the site.

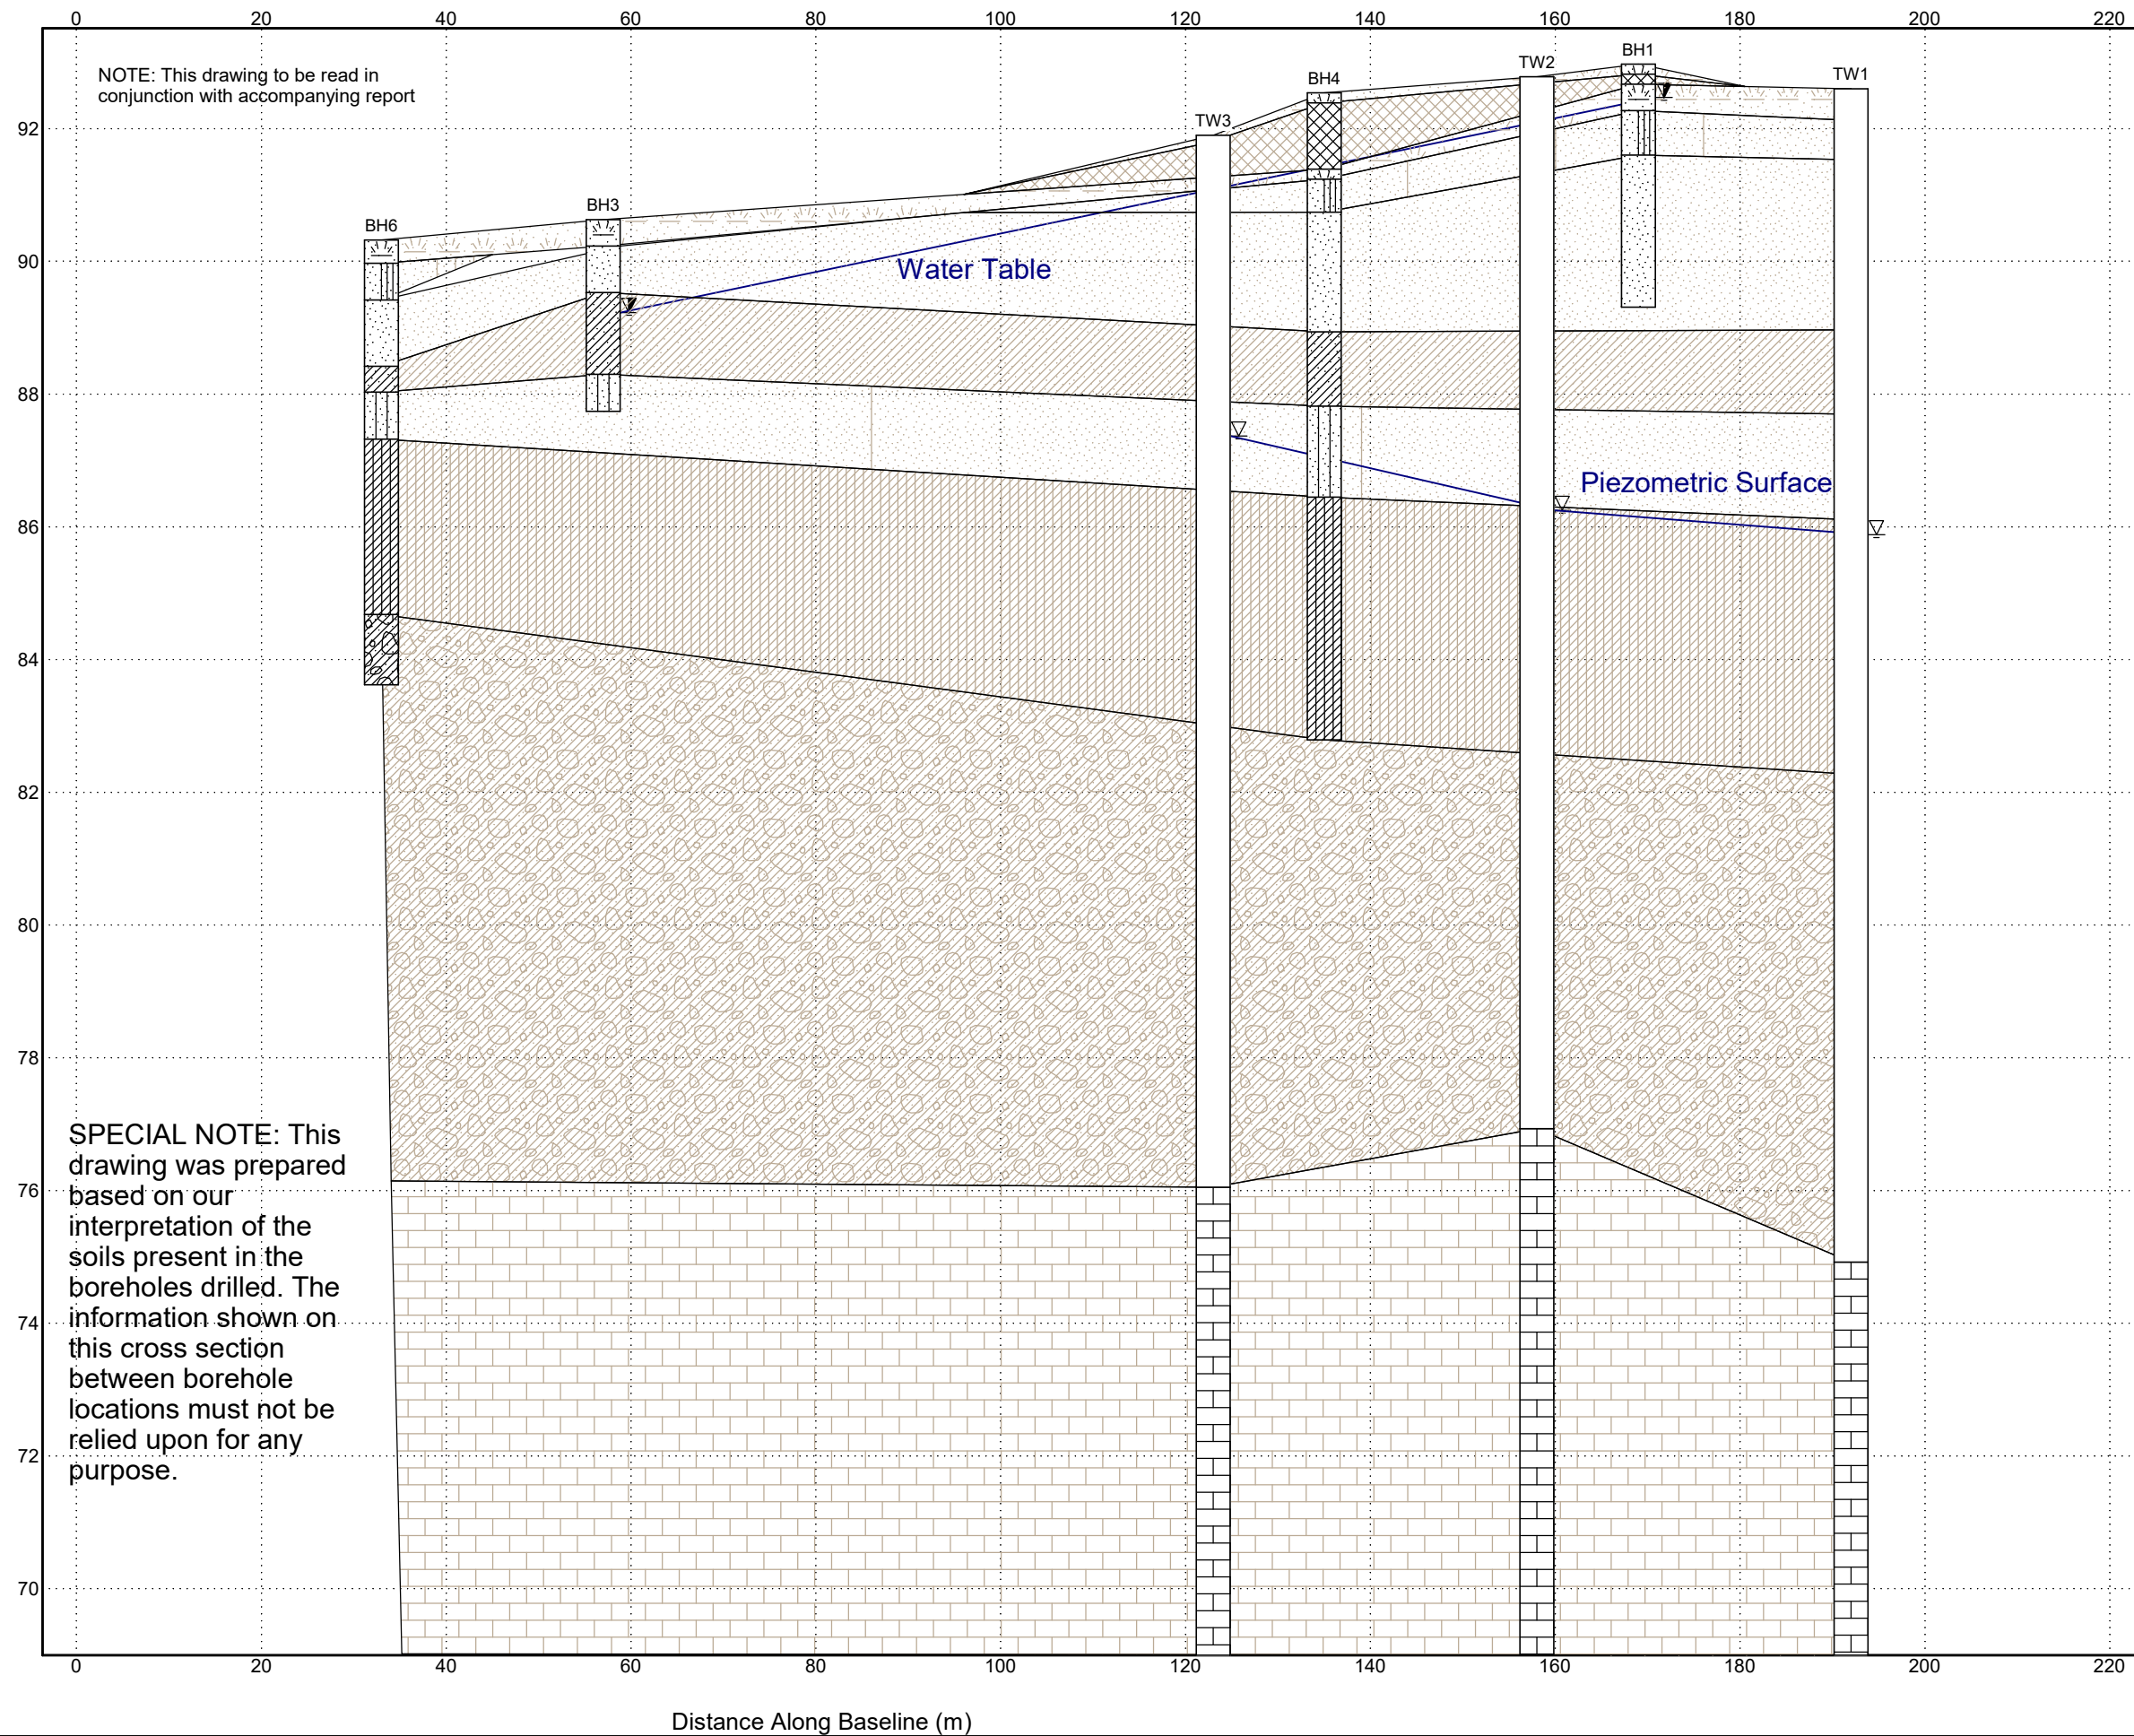
SPECIAL NOTE: This drawing was prepared based on our interpretation of the soils present in the boreholes drilled. The information shown on this cross section between borehole locations must not be relied upon for any purpose.

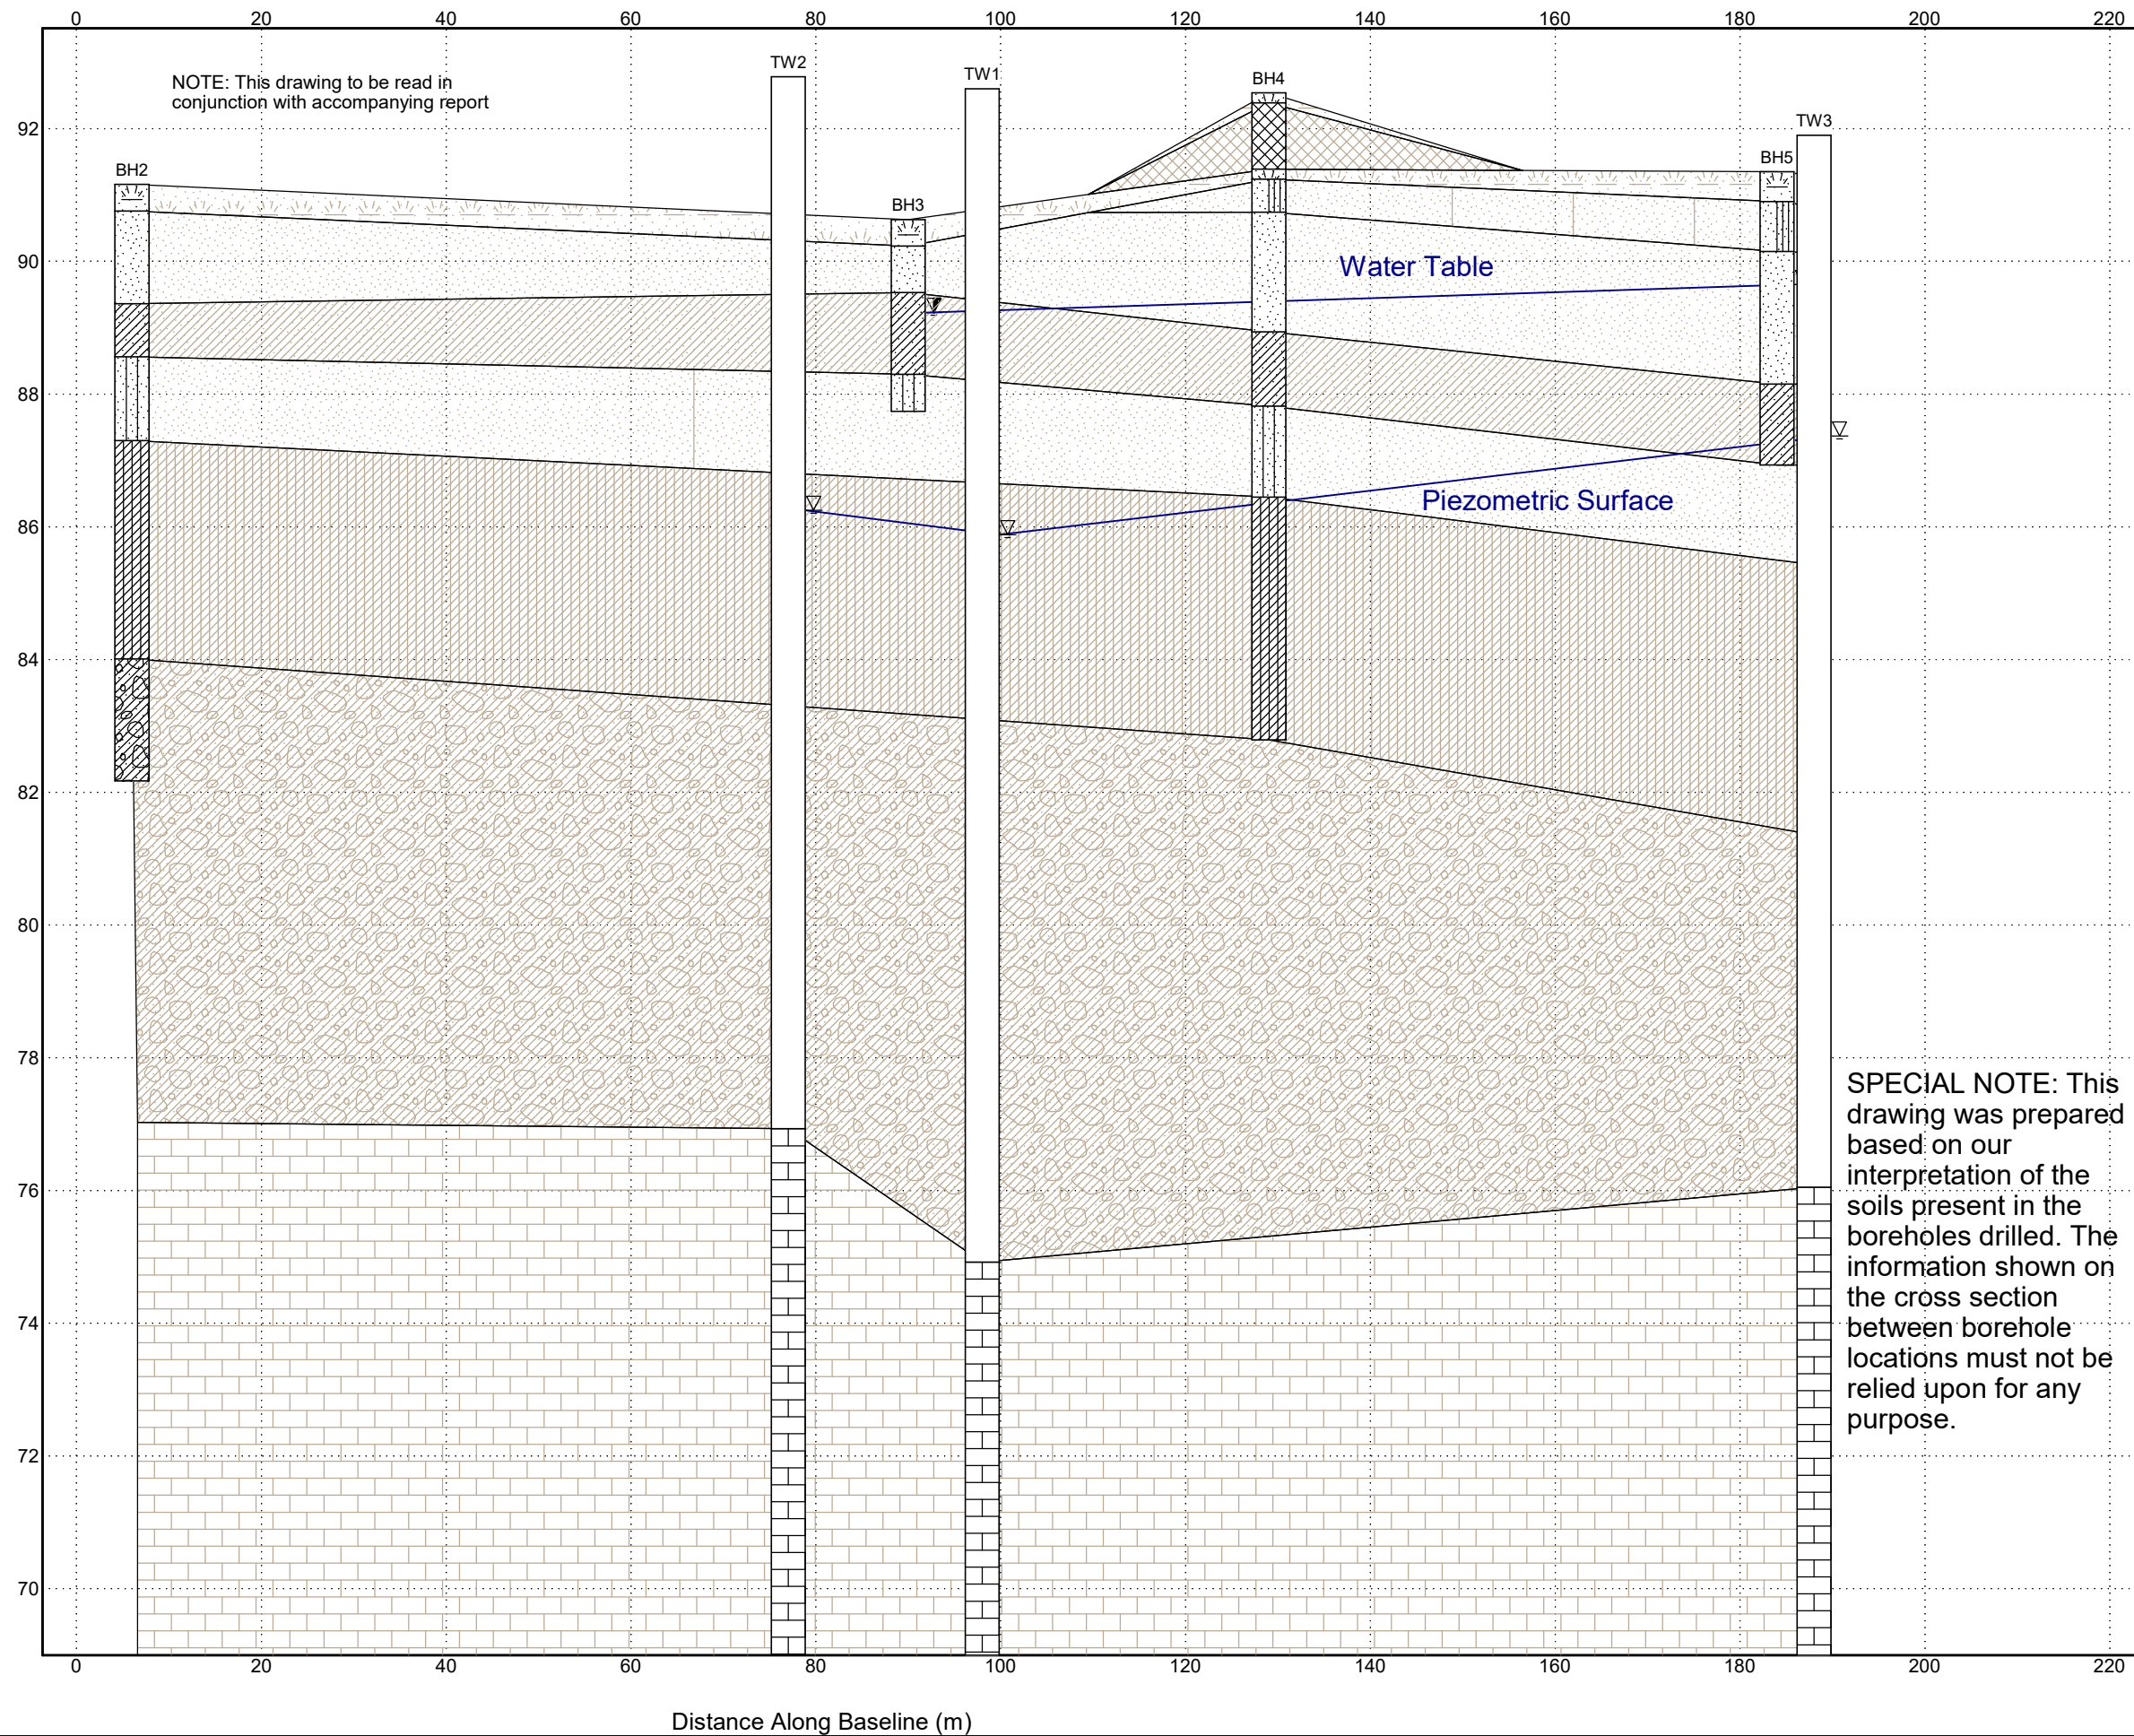
FIGURE 5

- TOPSOIL**
- Yellow brown sand and gravel (FILL)**
- Red brown fine to medium SAND, trace silt**
- Grey fine to medium SAND**
- Grey sandy CLAY, trace silt**
- Grey SILTY SAND**
- Grey SILTY CLAY**
- Grey silty sand, trace to some gravel, cobbles and boulders, trace clay (GLACIAL TILL)**
- LIMESTONE BEDROCK**
