**RE: Karson Holdings Inc.  
3711, 3715, 3719 and 3725 Carp Road  
Updated Environmental Impact Statement**

I have completed an update to our 2010 Environmental Impact Statement (EIS) for a proposed mixed-use development at 3711, 3715, 3719 and 3725 Carp Road in the southwest portion of the Village of Carp. This EIS is prepared in support of an application for Draft Plan of Subdivision approval for the redevelopment of the site.

**NATURAL ENVIRONMENT FEATURES**

**3711, 3715, 3719, and 3725 Carp Road  
Carp, City of Ottawa**

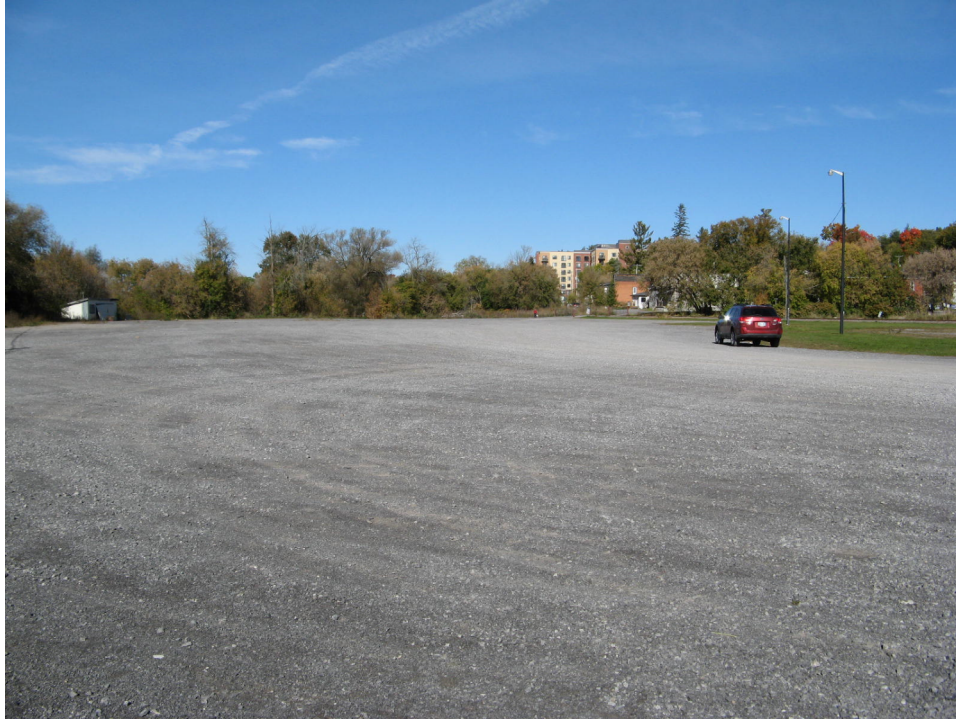
The balance of the site outside of the riparian corridor is highly disturbed with a single layer of pea gravel over a compressed base (Photos 1 and 2). The residences along the west side of Carp Road, other structures save for one shed at edge of riparian corridor, and trees among the former residences have been removed. Some areas have been seeded with grass (Photo 2), with no vegetation on the majority. The only woody vegetation remaining in the central and west portions of the site is a small regenerating coppice green ash, with individual stems less than 5 cm dbh.

*Photo 1 – Core of the site looking north from south-central portion*

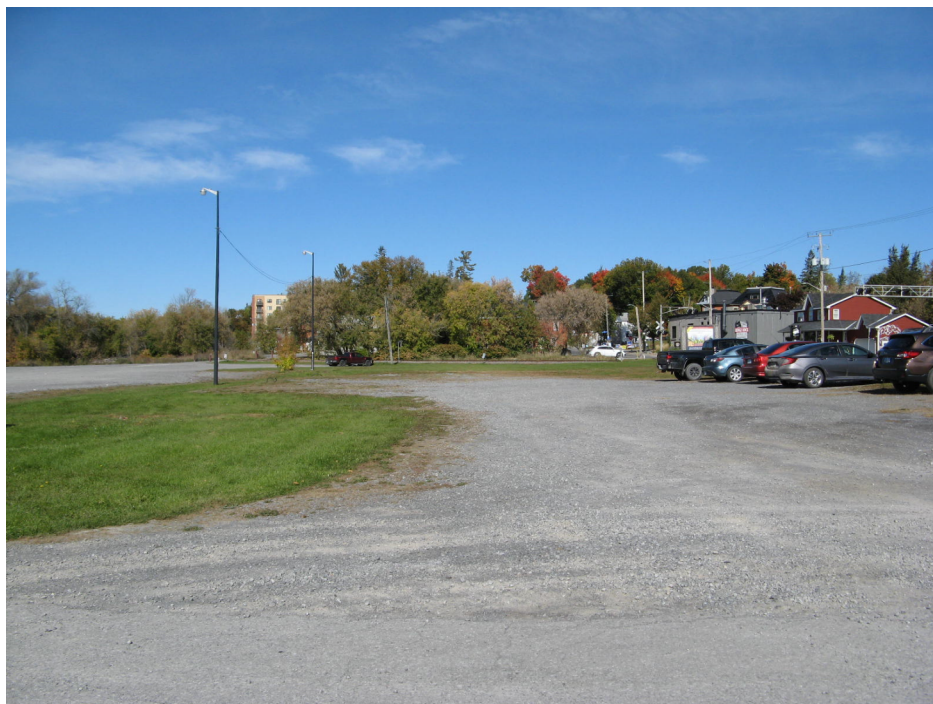
*Photo 2 – East portion of the site, adjacent to Carp Road. Some areas have been seeded with others used for parking. View looking north*

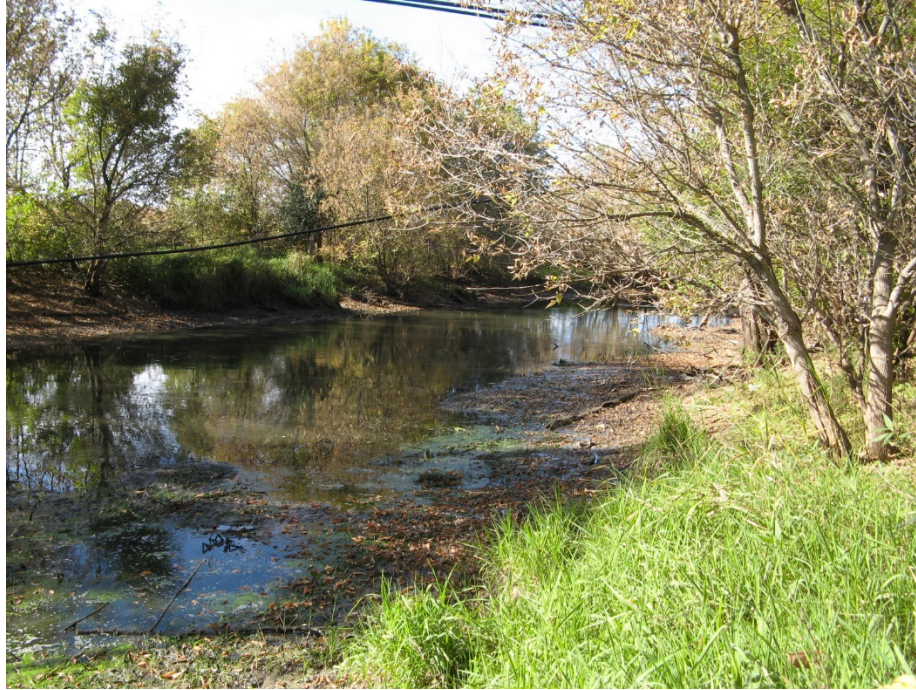
*Photo 3 –Carp River adjacent to the southeast portion of the site. View looking northwest*

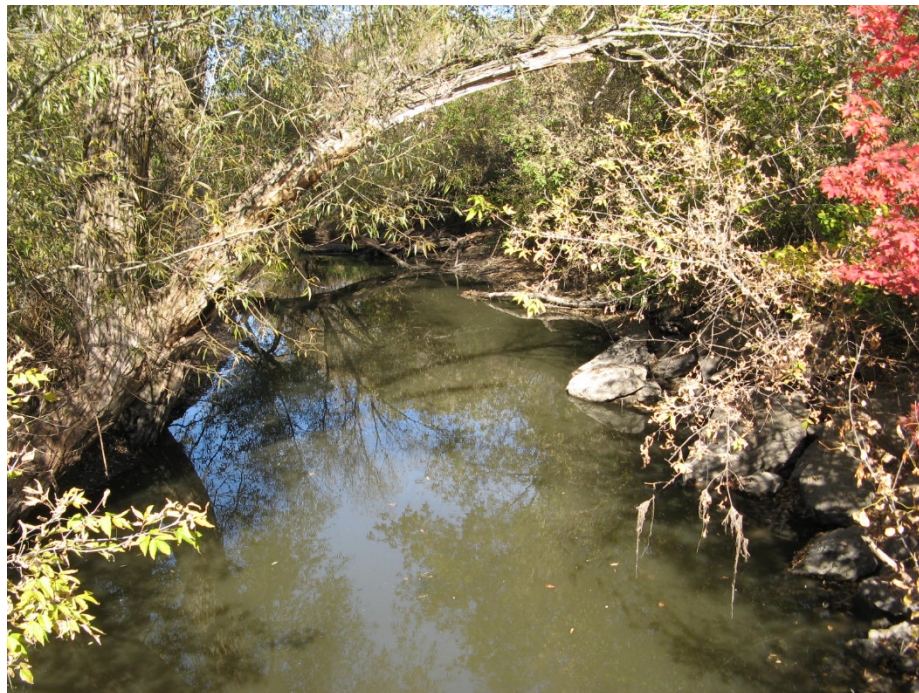
The riparian corridor of the Carp River in the vicinity of the site is generally described by Robinson (2004) as non-vegetated, though as described here there is good canopy cover at the site. The extent of woody vegetation in the portions of the corridor closest to the shoreline, along the north and east sides of the river, has increased since 2010 and the entire corridor where vegetation is present is now referred to as a cultural woodland on Figure 1. To the west of the Carp River, the land use is dominated by agricultural activity, including cultivated fields and hayfields. An access lane/footbridge crosses the Carp River adjacent to the north portion of the site.

*Photo 4 – Good cover provided by riparian vegetation on both sides of the Carp River adjacent to the north portion of the site. Note rock protection along east shoreline. View looking north*

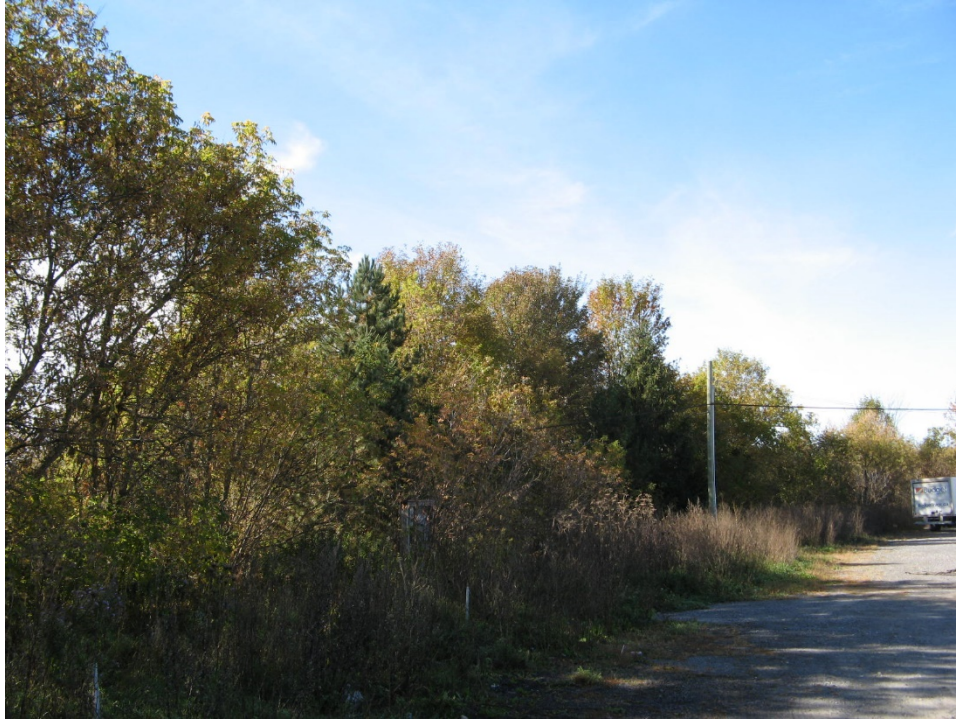
*Photo 5 – Manitoba maples along the riparian corridor in the west portion of the site and east of the Carp River. View looking north*

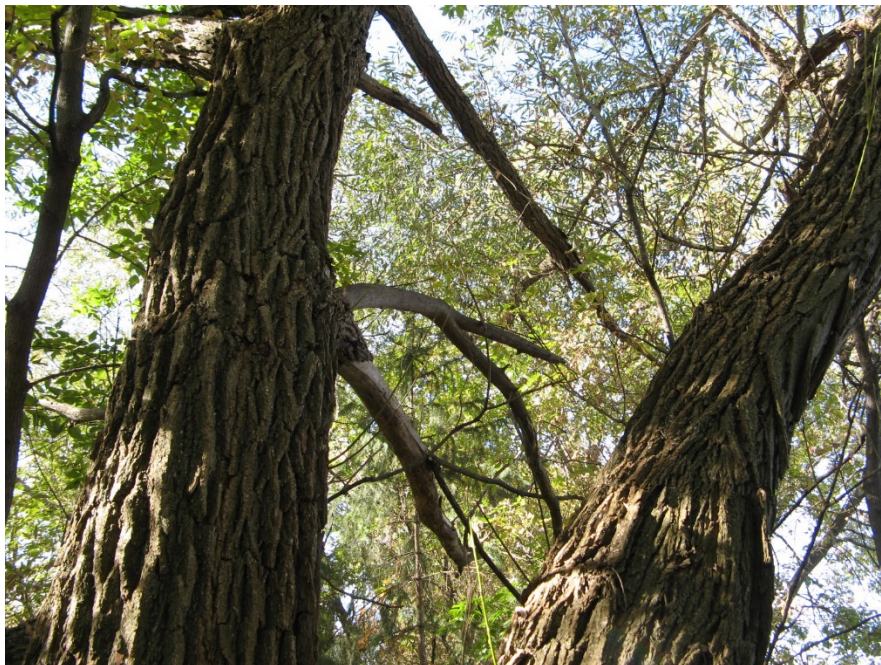
Woody vegetation within the riparian corridor along the periphery of the site includes mature crack willows and a dominance of younger Manitoba maple. The crack willows are coppice (multi-stem), with the larger individuals stems up to 70cm diameter at breast height (dbh) (Photo 6). The Manitoba maples are also generally coppice examples in the range of in the range of 30 - 35cm dbh (Photo 5). Many of the crack willow and Manitoba maple have major broken or dead limbs. Although Manitoba maple is generally not a desired tree species due to its poor form, susceptibility to damage and short life span, the trees along the Carp River shoreline provide important functions in the riparian corridor associated with aquatic and terrestrial cover, bank stability and a food source. White ash, up to 45cm dbh, are along the east side of the Carp River in the north portion of the site, along with Manitoba maple, white elm, red maple, and crack willow. Since 2010 the ash appear impacted by the emerald ash borer and the trees are now dead or have greatly reduced leaf-out (Photo 7). Green ash and white elm up to 30cm dbh are scattered through the vegetated portion of the riparian corridor. Most of these trees are dead or have reduced leaf-out. Conifer representation in the riparian corridor includes a few white spruce and red pine in the south portion of the site, with stems up to 28 and 20cm dbh respectively.

*Photo 6 – Mature crack willow in the southeast portion of the site, north of the Carp River and west side Carp Road. View looking southwest*

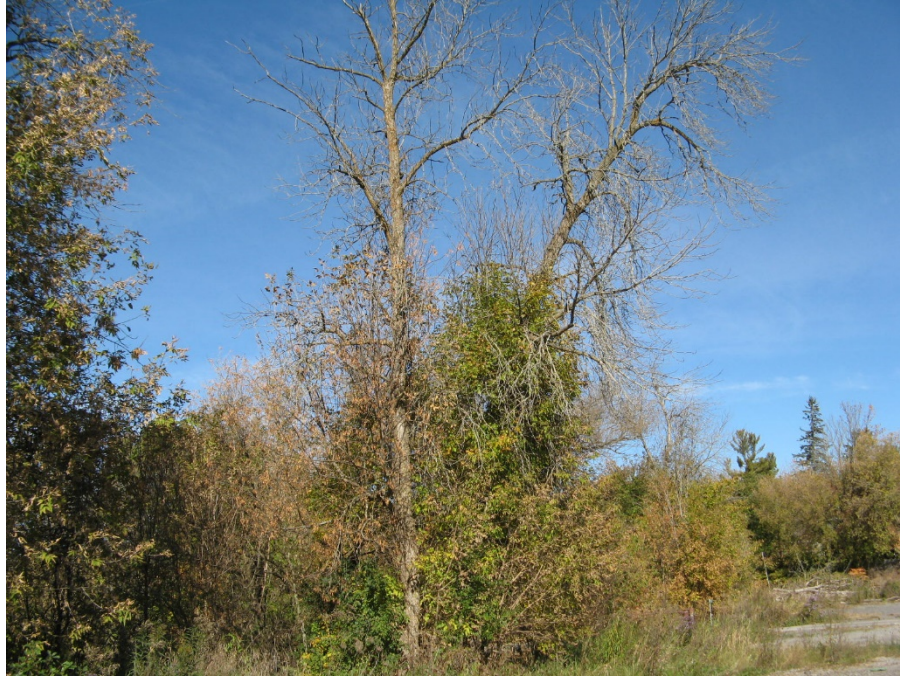
*Photo 7 – White ash in very poor condition in the northwest corner of the site, to the east of the Carp River. View looking north.*

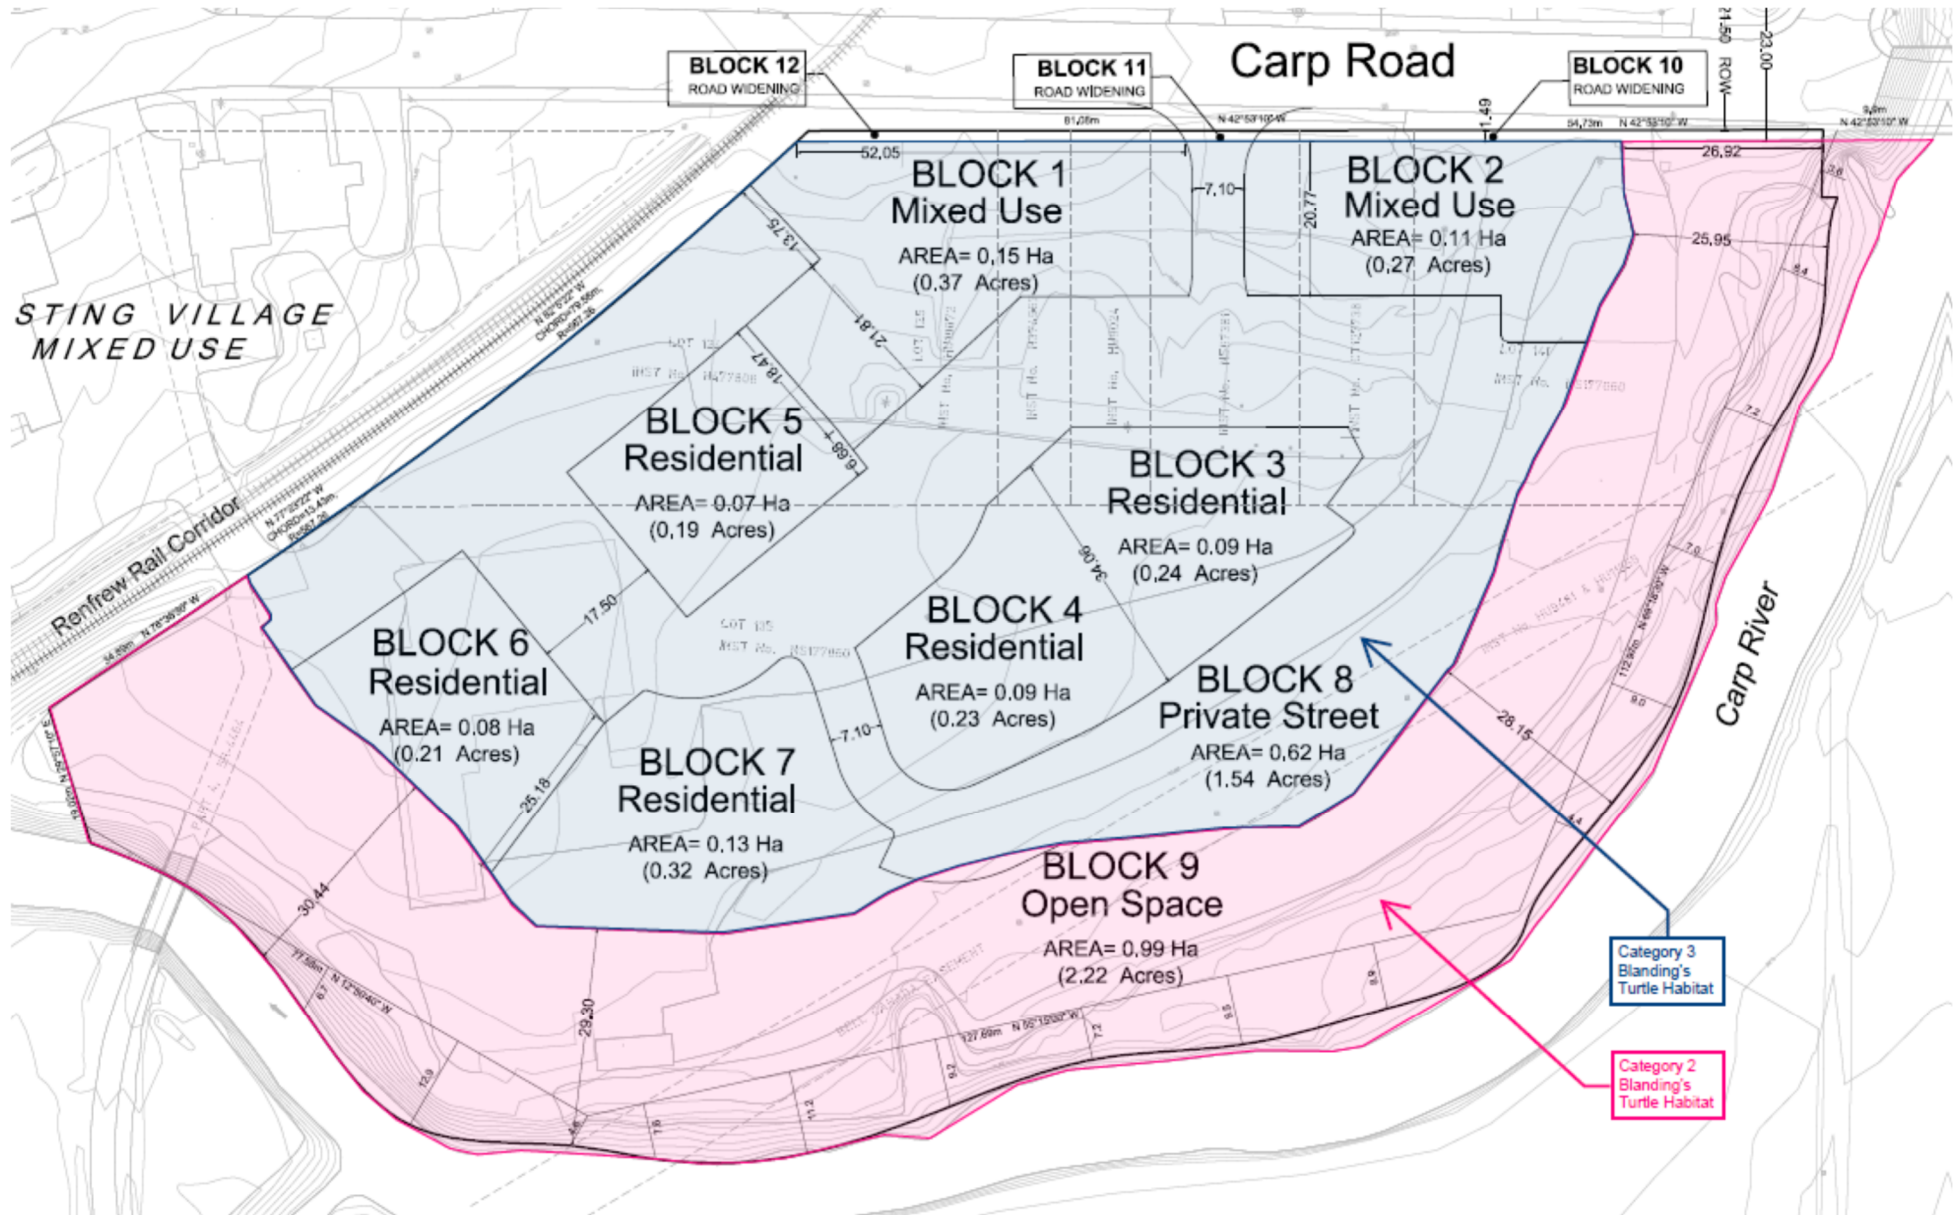
FIGURE 2 – BLANDING’S TURTLE HABITAT

The Category 2 and 3 Blanding's turtle habitat has been mapped for the site on Figure 2. All of the Category 2 habitat (red shading on Figure 2) within and adjacent to the ravine corridor will be retained with the exception of a very small amount, approximately 23 m<sup>2</sup>, for surface parking. This small intrusion will be more than offset by extensions beyond 30 metres of other portions of the retained Carp River corridor. Portions of the Category 2 habitat that extend beyond the floodplain will be permeable landscape areas and provide better environmental conditions than the current single layer of pea gravel over a compressed base. The compressed base is very solid and does not represent potential nesting habitat for turtles. Mitigation measures are presented

below to protect any turtle utilization of the site. Although the development portion of the site represents Category 3 Blanding's turtle habitat (grey shading on Figure 2) per the General Habitat Description, no suitable wetland habitat for turtles was observed on the site and no adjacent wetland habitat is present to which Blanding's may utilize the site to reach suitable habitat. No suitable turtle nesting habitat was observed on the site. A loss of approximately 1.34 hectares of Category 3 habitat is projected, though the migrating function of Category 3 habitat is not anticipated for the site. Given the very small amount of impacted Category 2 habitat and the improvement over much larger areas of Category 2 habitat and the lack of functional Category 3 habitat, this assessment concludes that an Overall Benefit Authorization under the Endangered Species Act would not be required for Blanding's turtle.

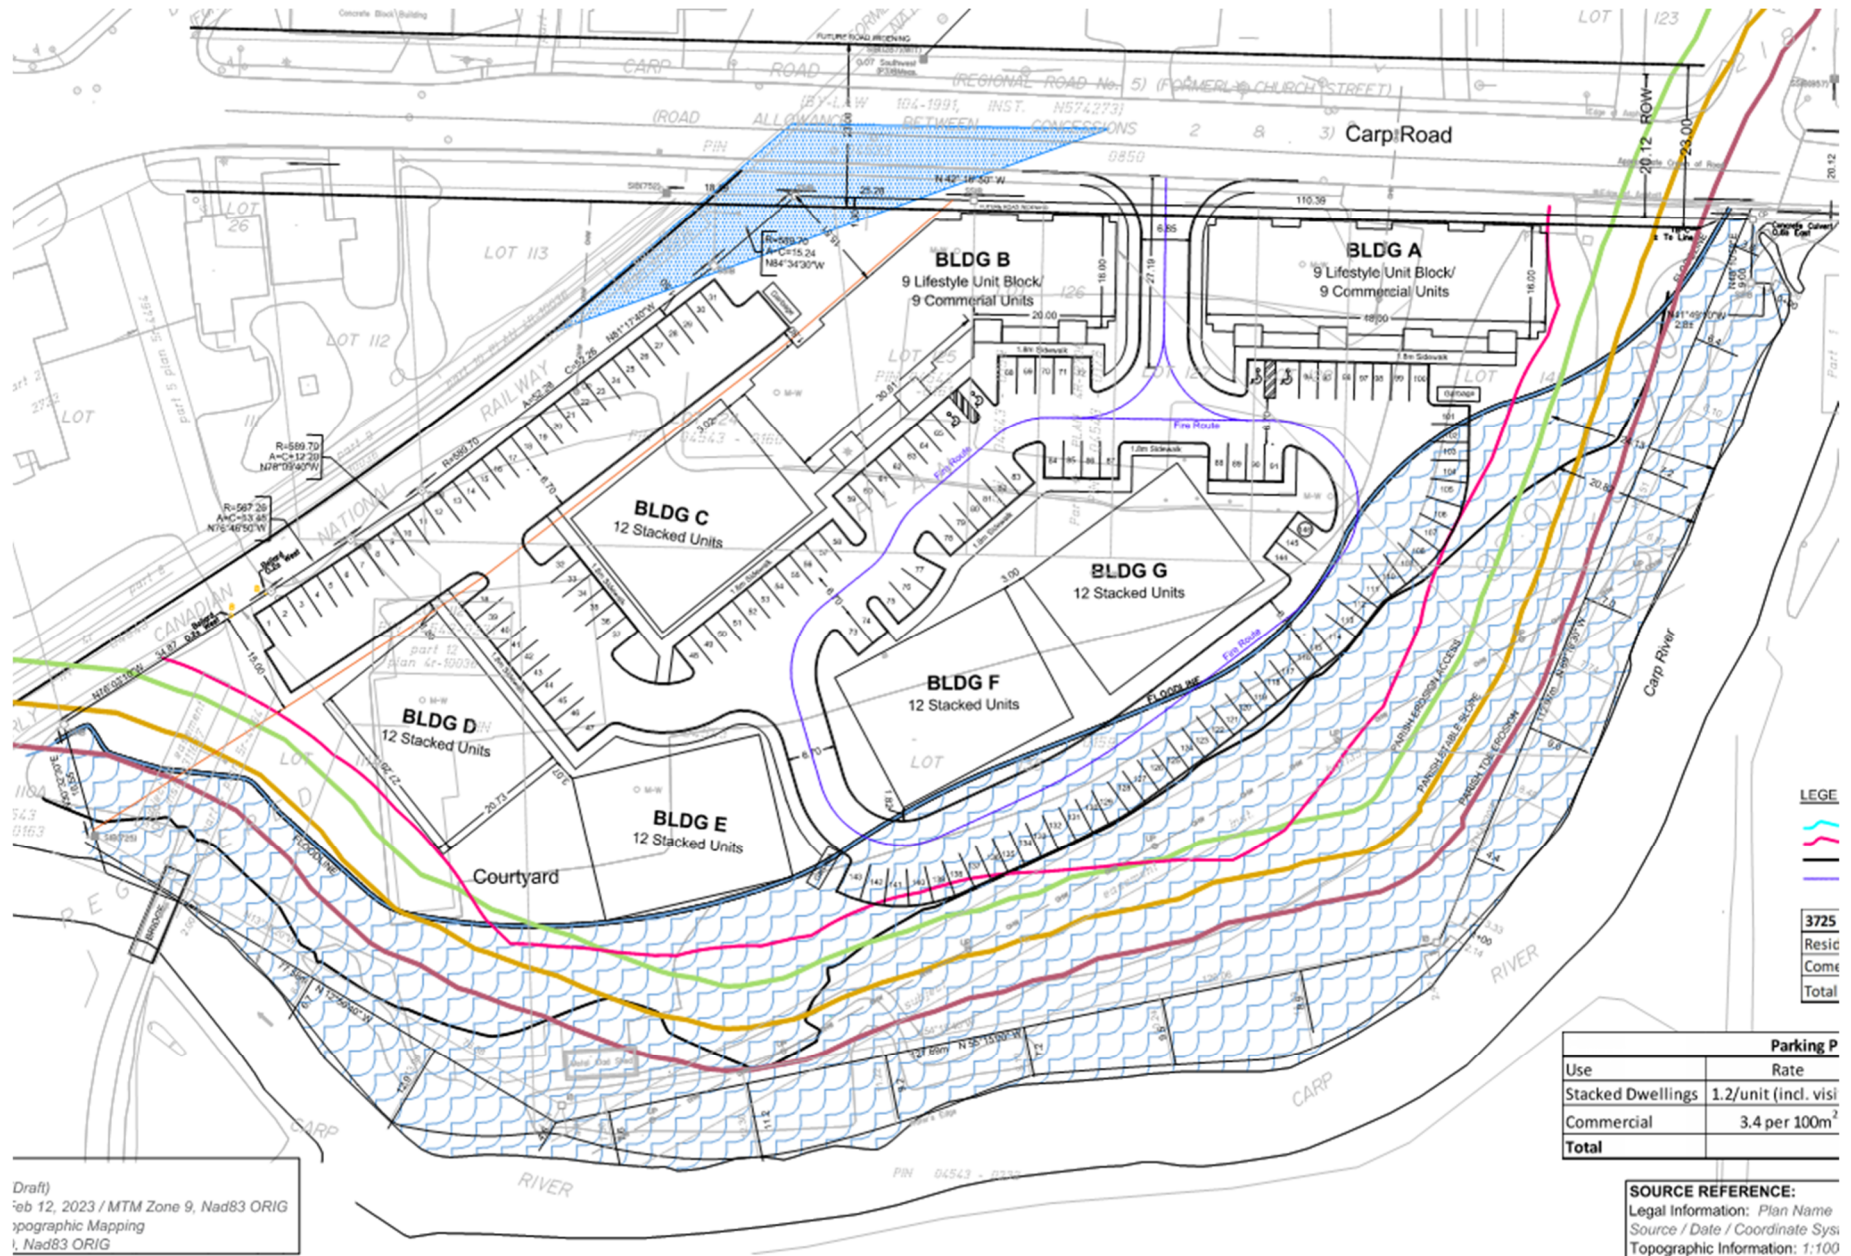
FIGURE 3 – CONCEPT PLAN of SUBDIVISION with CONSTRAINTS (from NOVATECH)

A total of 96 units are proposed for the site, represented by 78 residential units and 18 commercial units (Figure 3). The units will be in seven buildings, with a combination of residential and commercial units in the buildings fronting onto Carp Road. In keeping with the Village of Carp Community Design Plan, the buildings will be built adjacent to and closer to Carp Road and the required parking lot will be constructed between the rear of the buildings and the Carp River. The 146 parking surface parking spaces will be setback from the Carp River as a result the Carp River's meander belt width, erosion hazard limit and the depth of the flood plain. The erosion hazard limit was delineated by PARISH Geomorphic (2009). The toe erosion allowance was calculated as 13.5 metres, measured perpendicular from the bankfull edge of channel. The stable slope allowance and the erosion access allowance are each 6 metres (PARISH Geomorphic, 2009), with the potential to utilize the proposed parking lot for the erosion access allowance. The total erosion hazard limit and the individual components are

The proposed redevelopment shown on Figure 3 is setback from the Carp River through a combination of the Carp River's meander belt width, erosion hazard limit and the depth of the floodplain. The greater of these limits is more than 15 metres from the top of slope and 30 metres from the normal high water mark, except for one short section of surface parking less than 20 metres in width where the setback from the edge of the parking to the normal high water mark will be in the range of 27 metres.
