Date: October 5, 2009

Project: 03-09-02

Subject: Erosion Hazard Limit for Karson Kartage Konstruction Head Office in Carp, ON

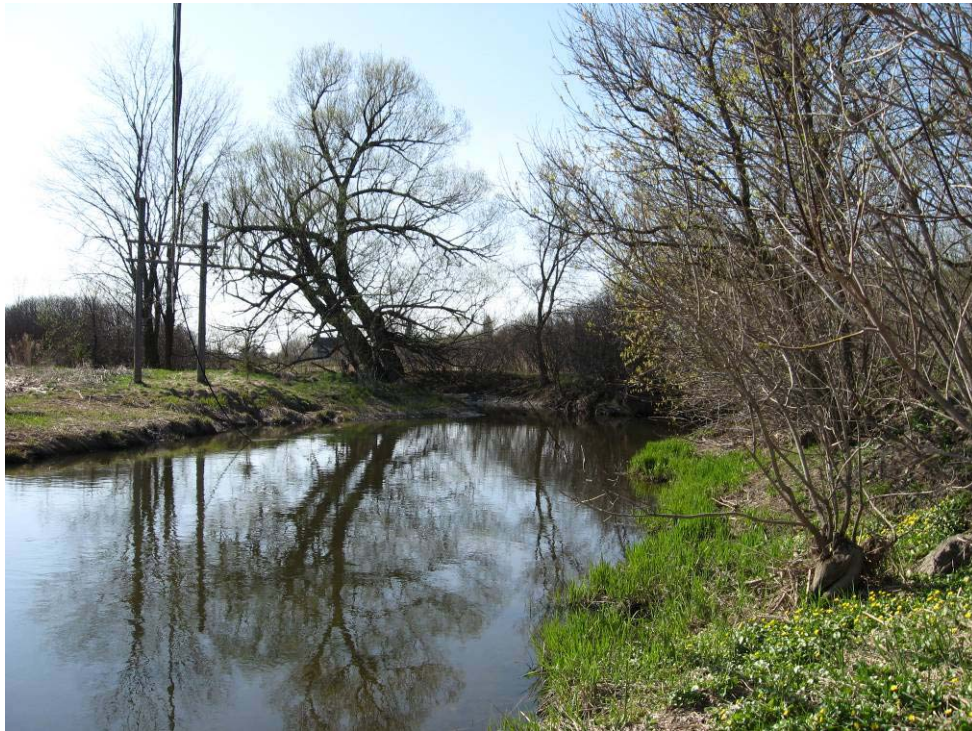
Figure 3: Looking downstream, partially confined conditions on right bank

Field reconnaissance was completed by Parish Geomorphic on April 29, 2009 to assess site conditions. The Carp River was walked the length of the Karson Kartage Konstruction property. The water level at the time of the visit was 0.75 to 1.25m below the bankfull level. Photographs of the site are shown in **Figures 3 and 4**.
