## **Phase I-Environmental Site Assessment**

3252 Navan Road  
Ottawa, Ontario

December 9, 2019  
Report: PE4588-1

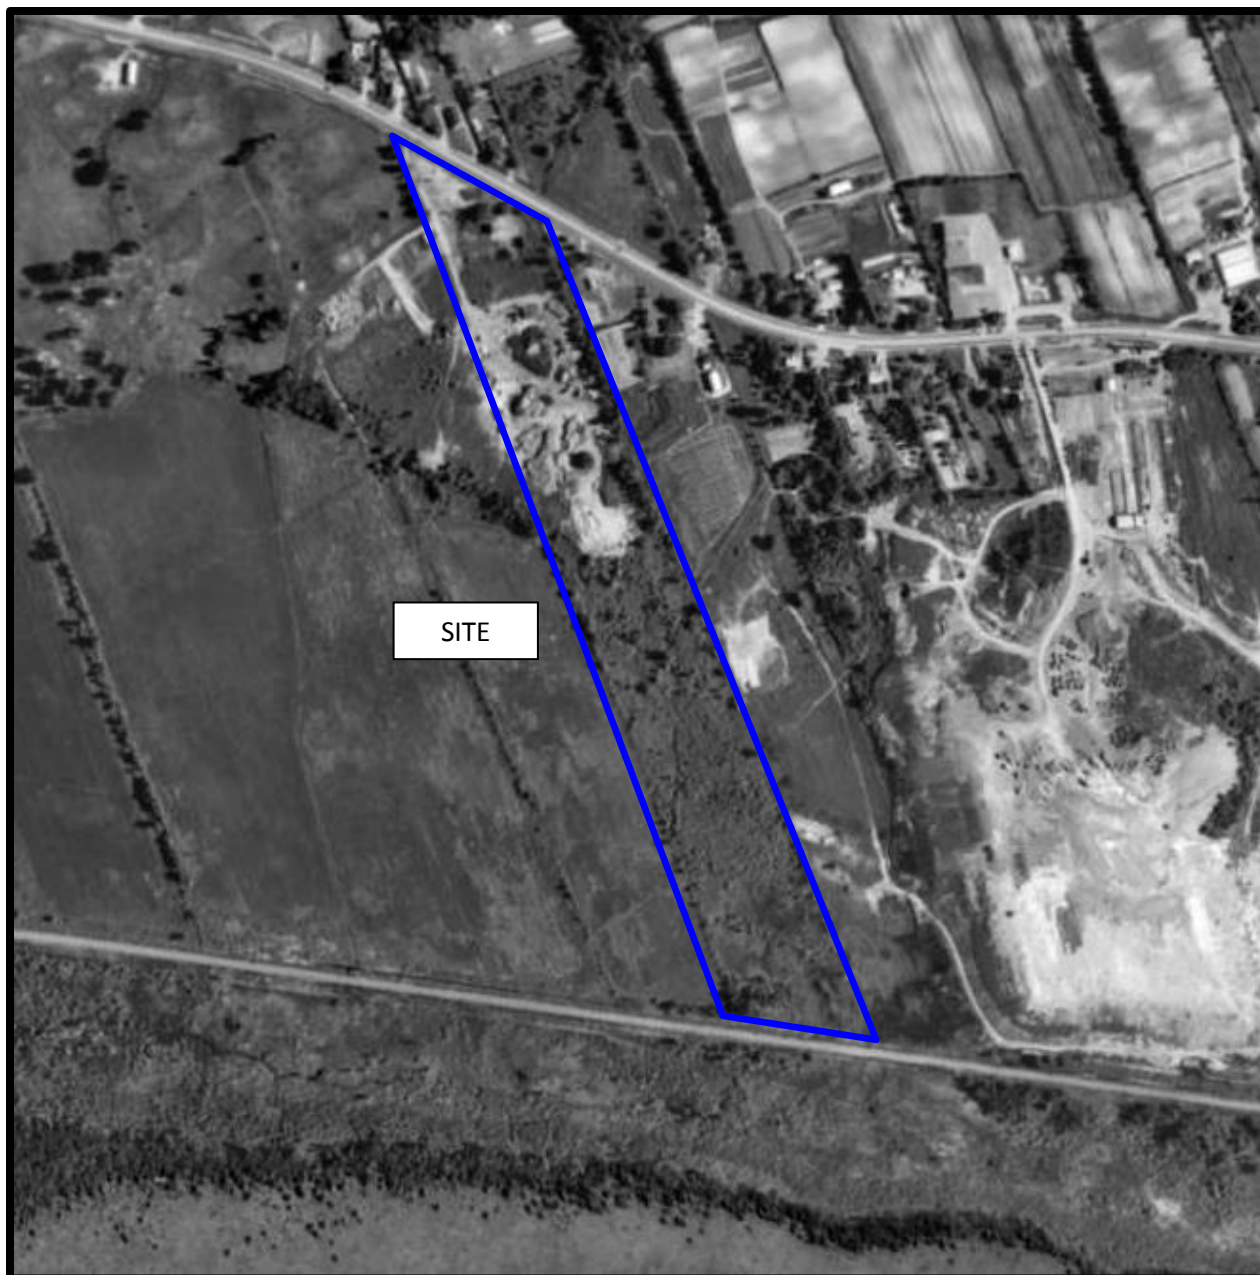
AERIAL PHOTOGRAPH  
1991

- 1991      The northern portion of the subject site appears to show some grading, excavation and/or stockpiling of material. To the east, the landfill extends between Navan Road to the north and the former railway to the south. Some residential development is also noted north of Navan Road.

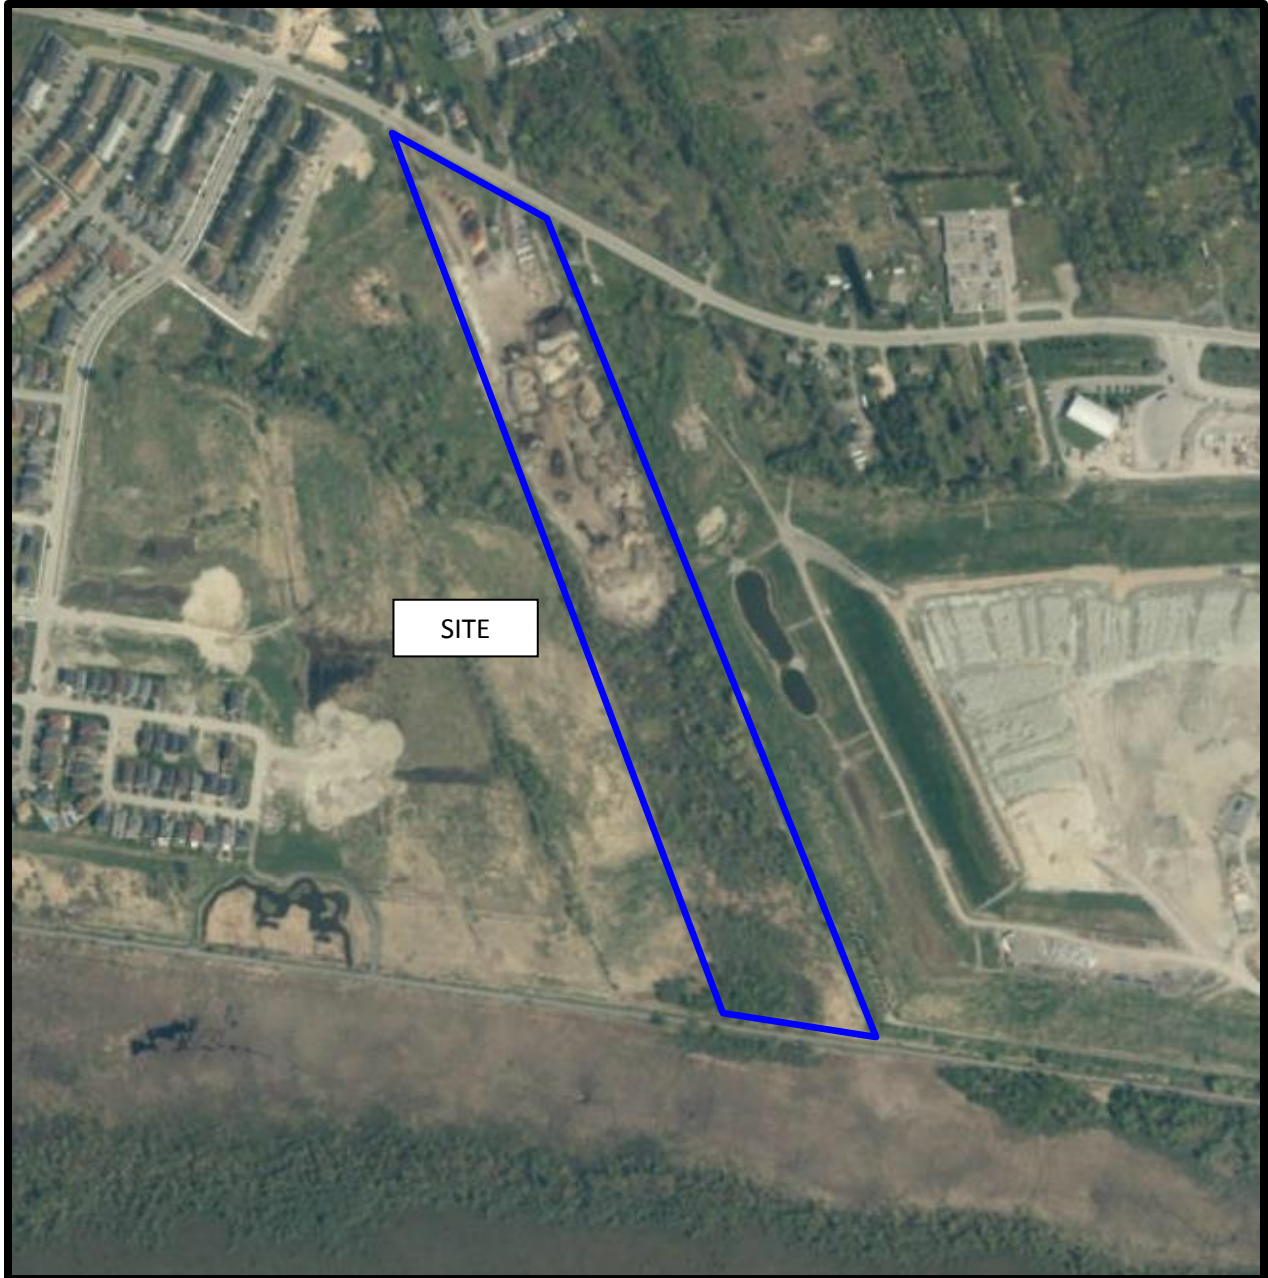
AERIAL PHOTOGRAPH  
2017

- 2017      The landfill east of the site continues to be developed. To the west of the subject site, residential development is underway.
