Phase One Environmental Site Assessment

1495 Heron Road, Ottawa, ON

Canada Lands Company CLC Limited
Final Report
Reference no. 02111459.000

November 2022

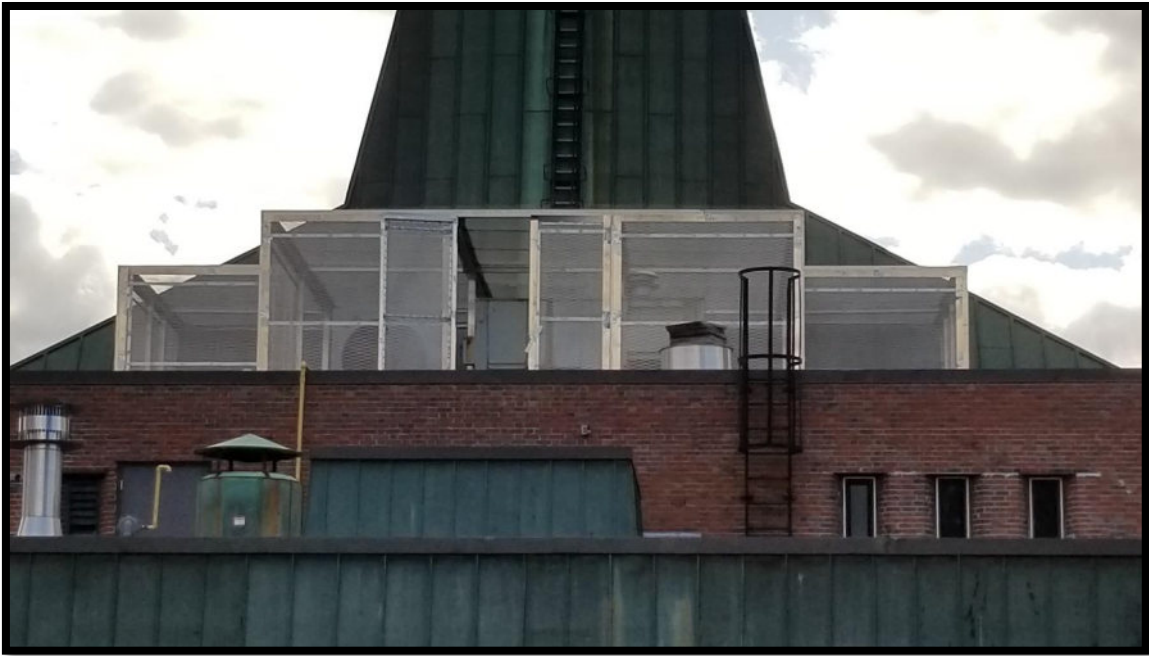
Photograph 4: View of the rear of Building A of the Site, facing south. Rooftop mechanical equipment is present on top of the building.

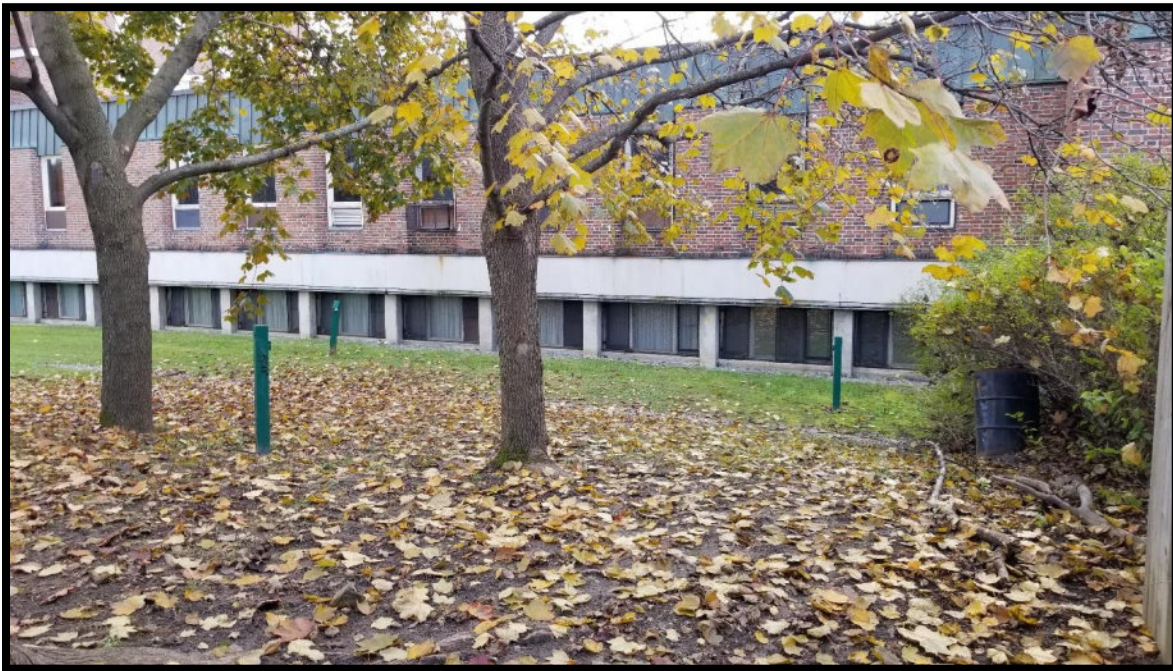
Photograph 5: View of a northern side of Building B. Three (3) monitoring wells, installed by DST in 2015, can be seen (facing south).

There were three (3) monitoring wells observed on the Site exterior and one (1) monitoring well observed within Building A during the Site reconnaissance. These monitoring wells were installed during the DST Phase Two ESA in 2015 (see Section 3.1.5).

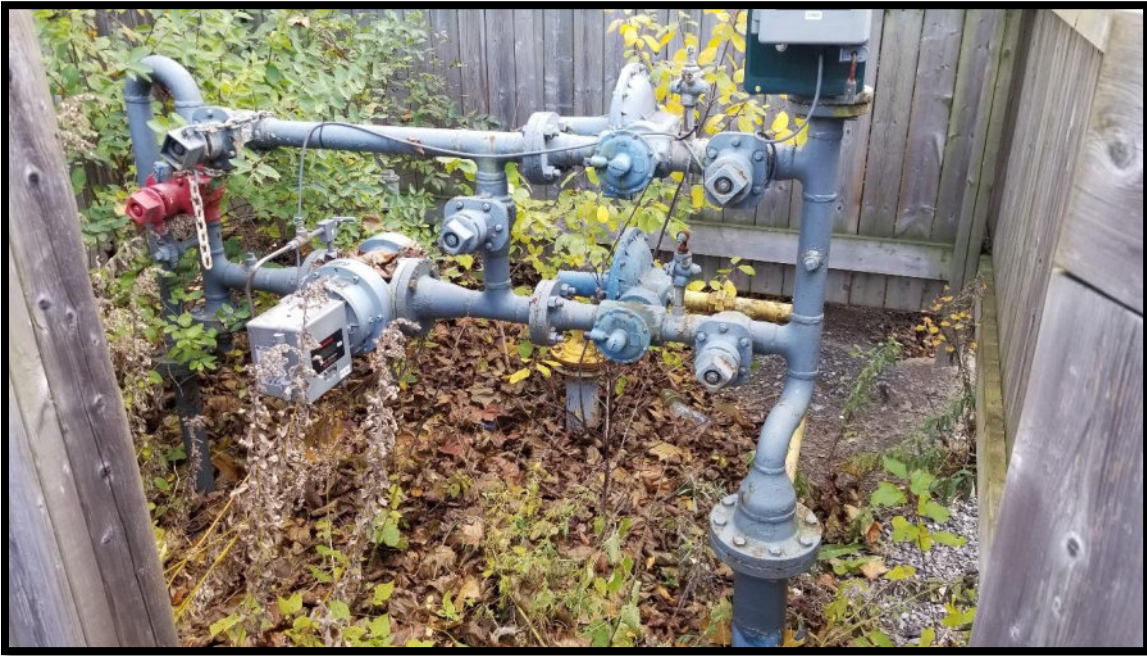
Photograph 7: Natural gas enclosure, observed between Buildings B and M. Site utilities are present underground, throughout the complex.

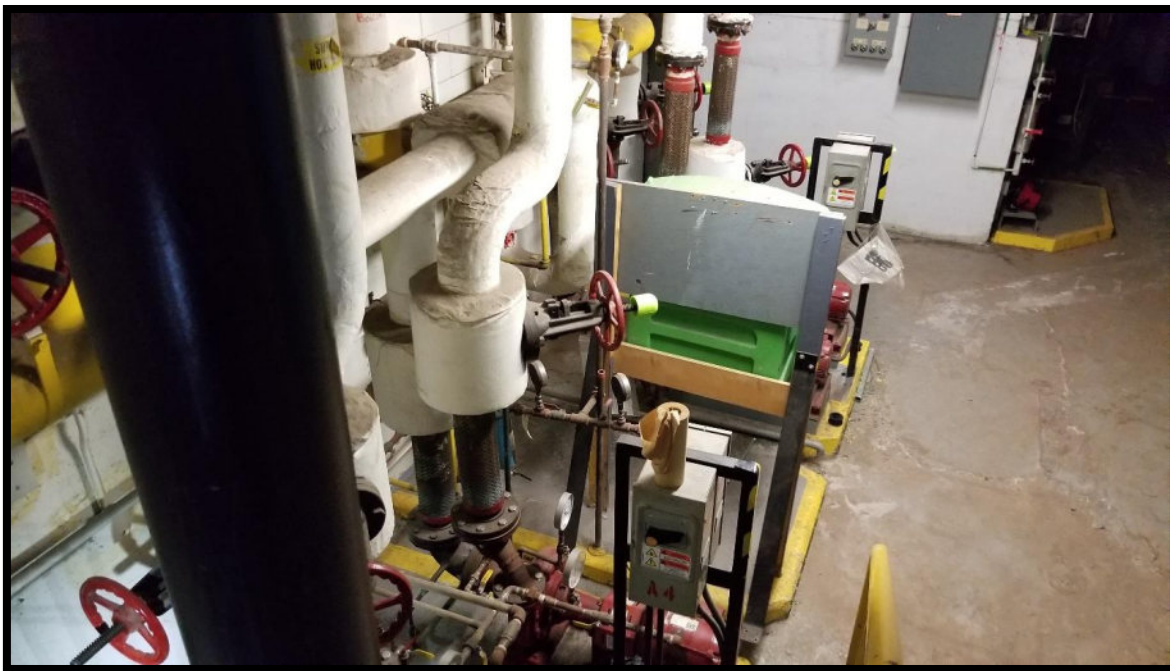
Photograph 8: View of the mechanical room within Building A.

The Site buildings at 1495 Heron Road are heated by boilers and cooled by heating, ventilation and air conditioning (HVAC) units, as well as portable window air conditioners in select locations. Rooftop and ground-level HVAC units were observed.

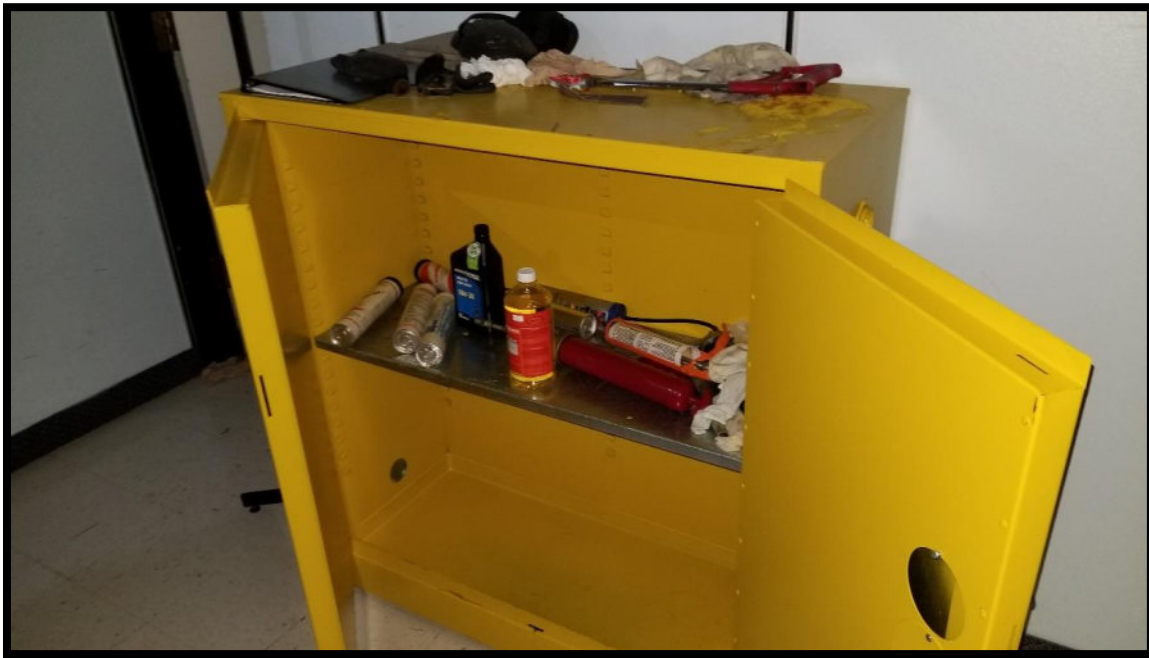
Photograph 9: View of miscellaneous stored chemicals, observed within the basement of Building A.

Minor quantities of chemicals were observed on Site during the Site reconnaissance, including commercial cleaning and maintenance chemicals. No evidence of spills or stains were observed in the vicinity of any chemical storage areas.

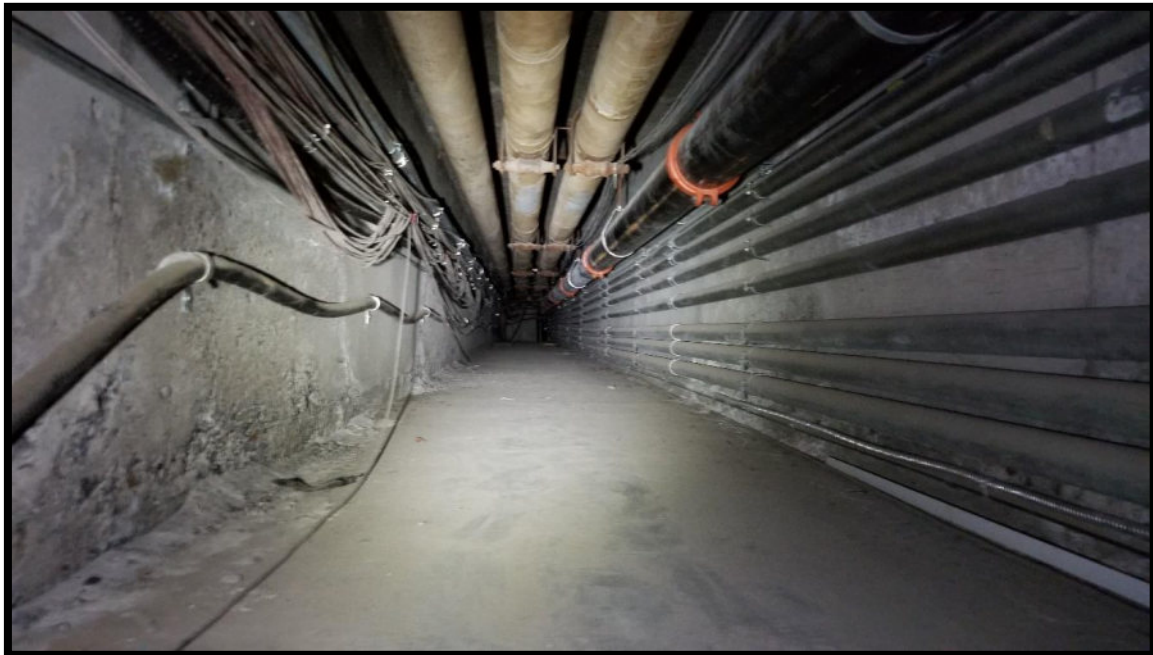
Photograph 10: View of a utility tunnel between two buildings within the complex (July 2019).

All site buildings except Building M are developed with basements. Below-ground utility tunnels were observed connecting several buildings on Site. Further, a below-ground tunnel connects Buildings A, E, and J for underground travel and utility servicing.
