# **Terrain Analysis and Hydrogeological Study**

## **Proposed Residential Development**

1934 Stagecoach Road  
Ottawa, Ontario

Report PH3745-1 dated June 21, 2023 Updated June 1, 2024

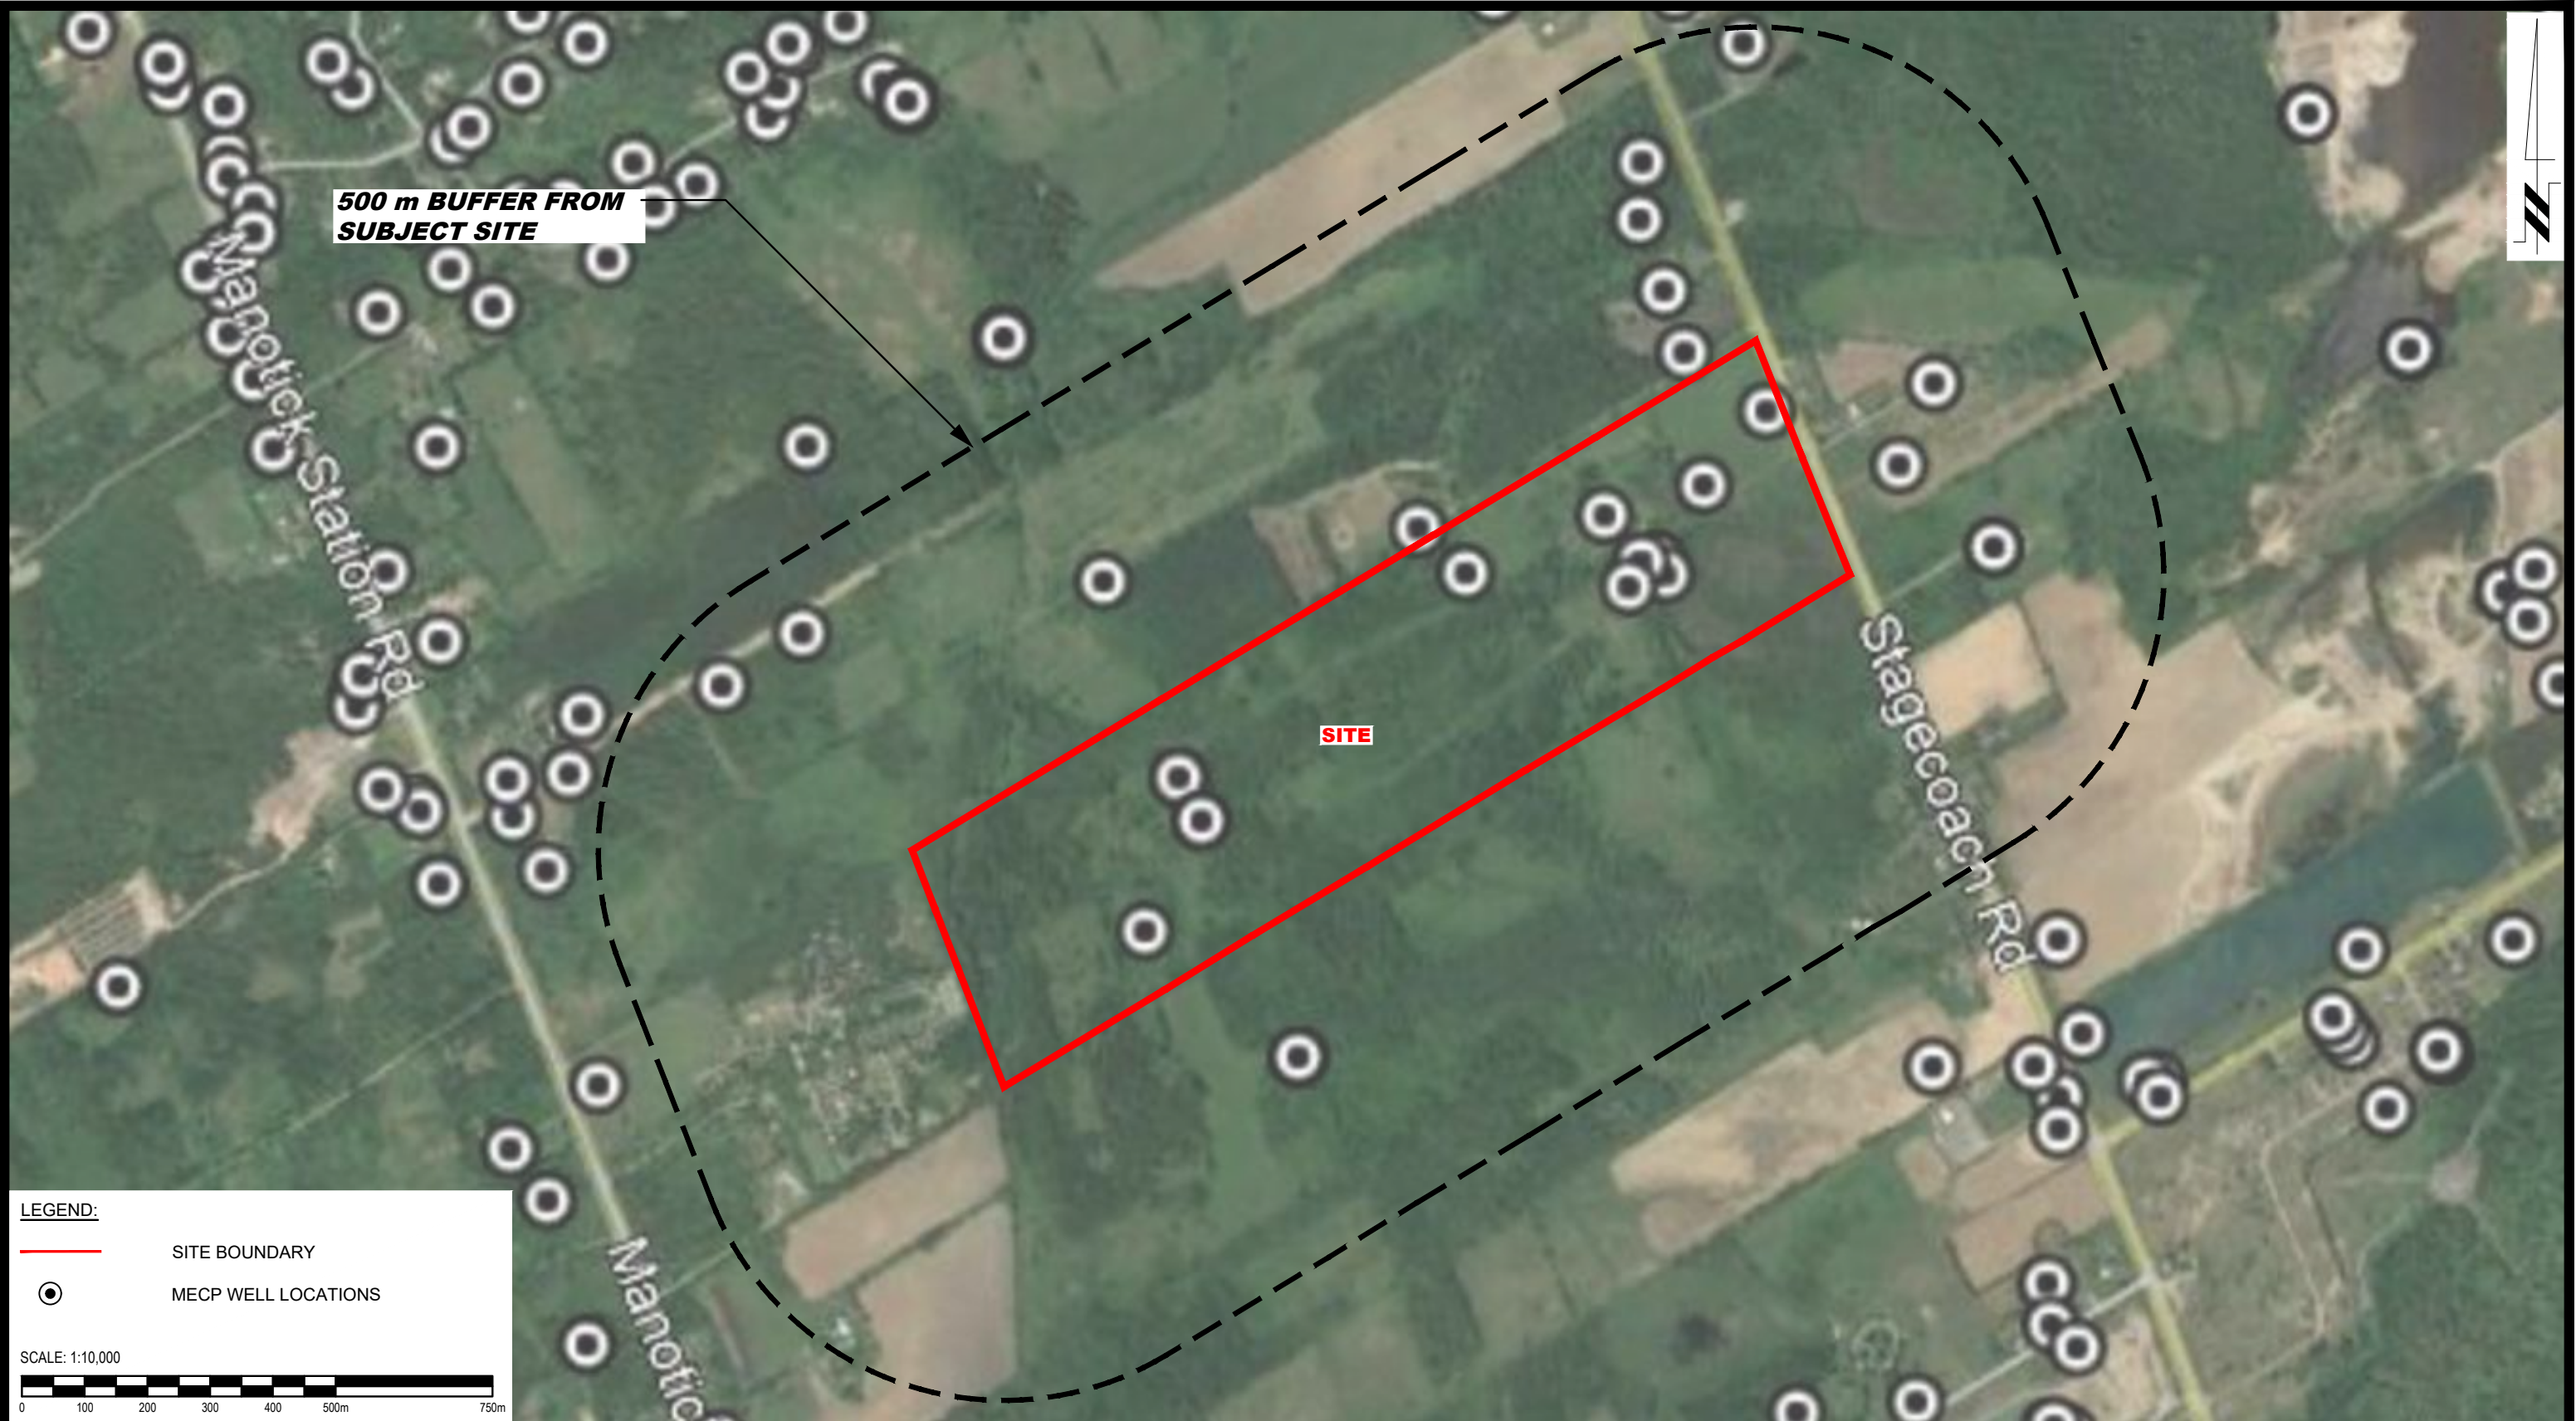
Title: **SITE PLAN**

**500 m BUFFER FROM  
SUBJECT SITE**

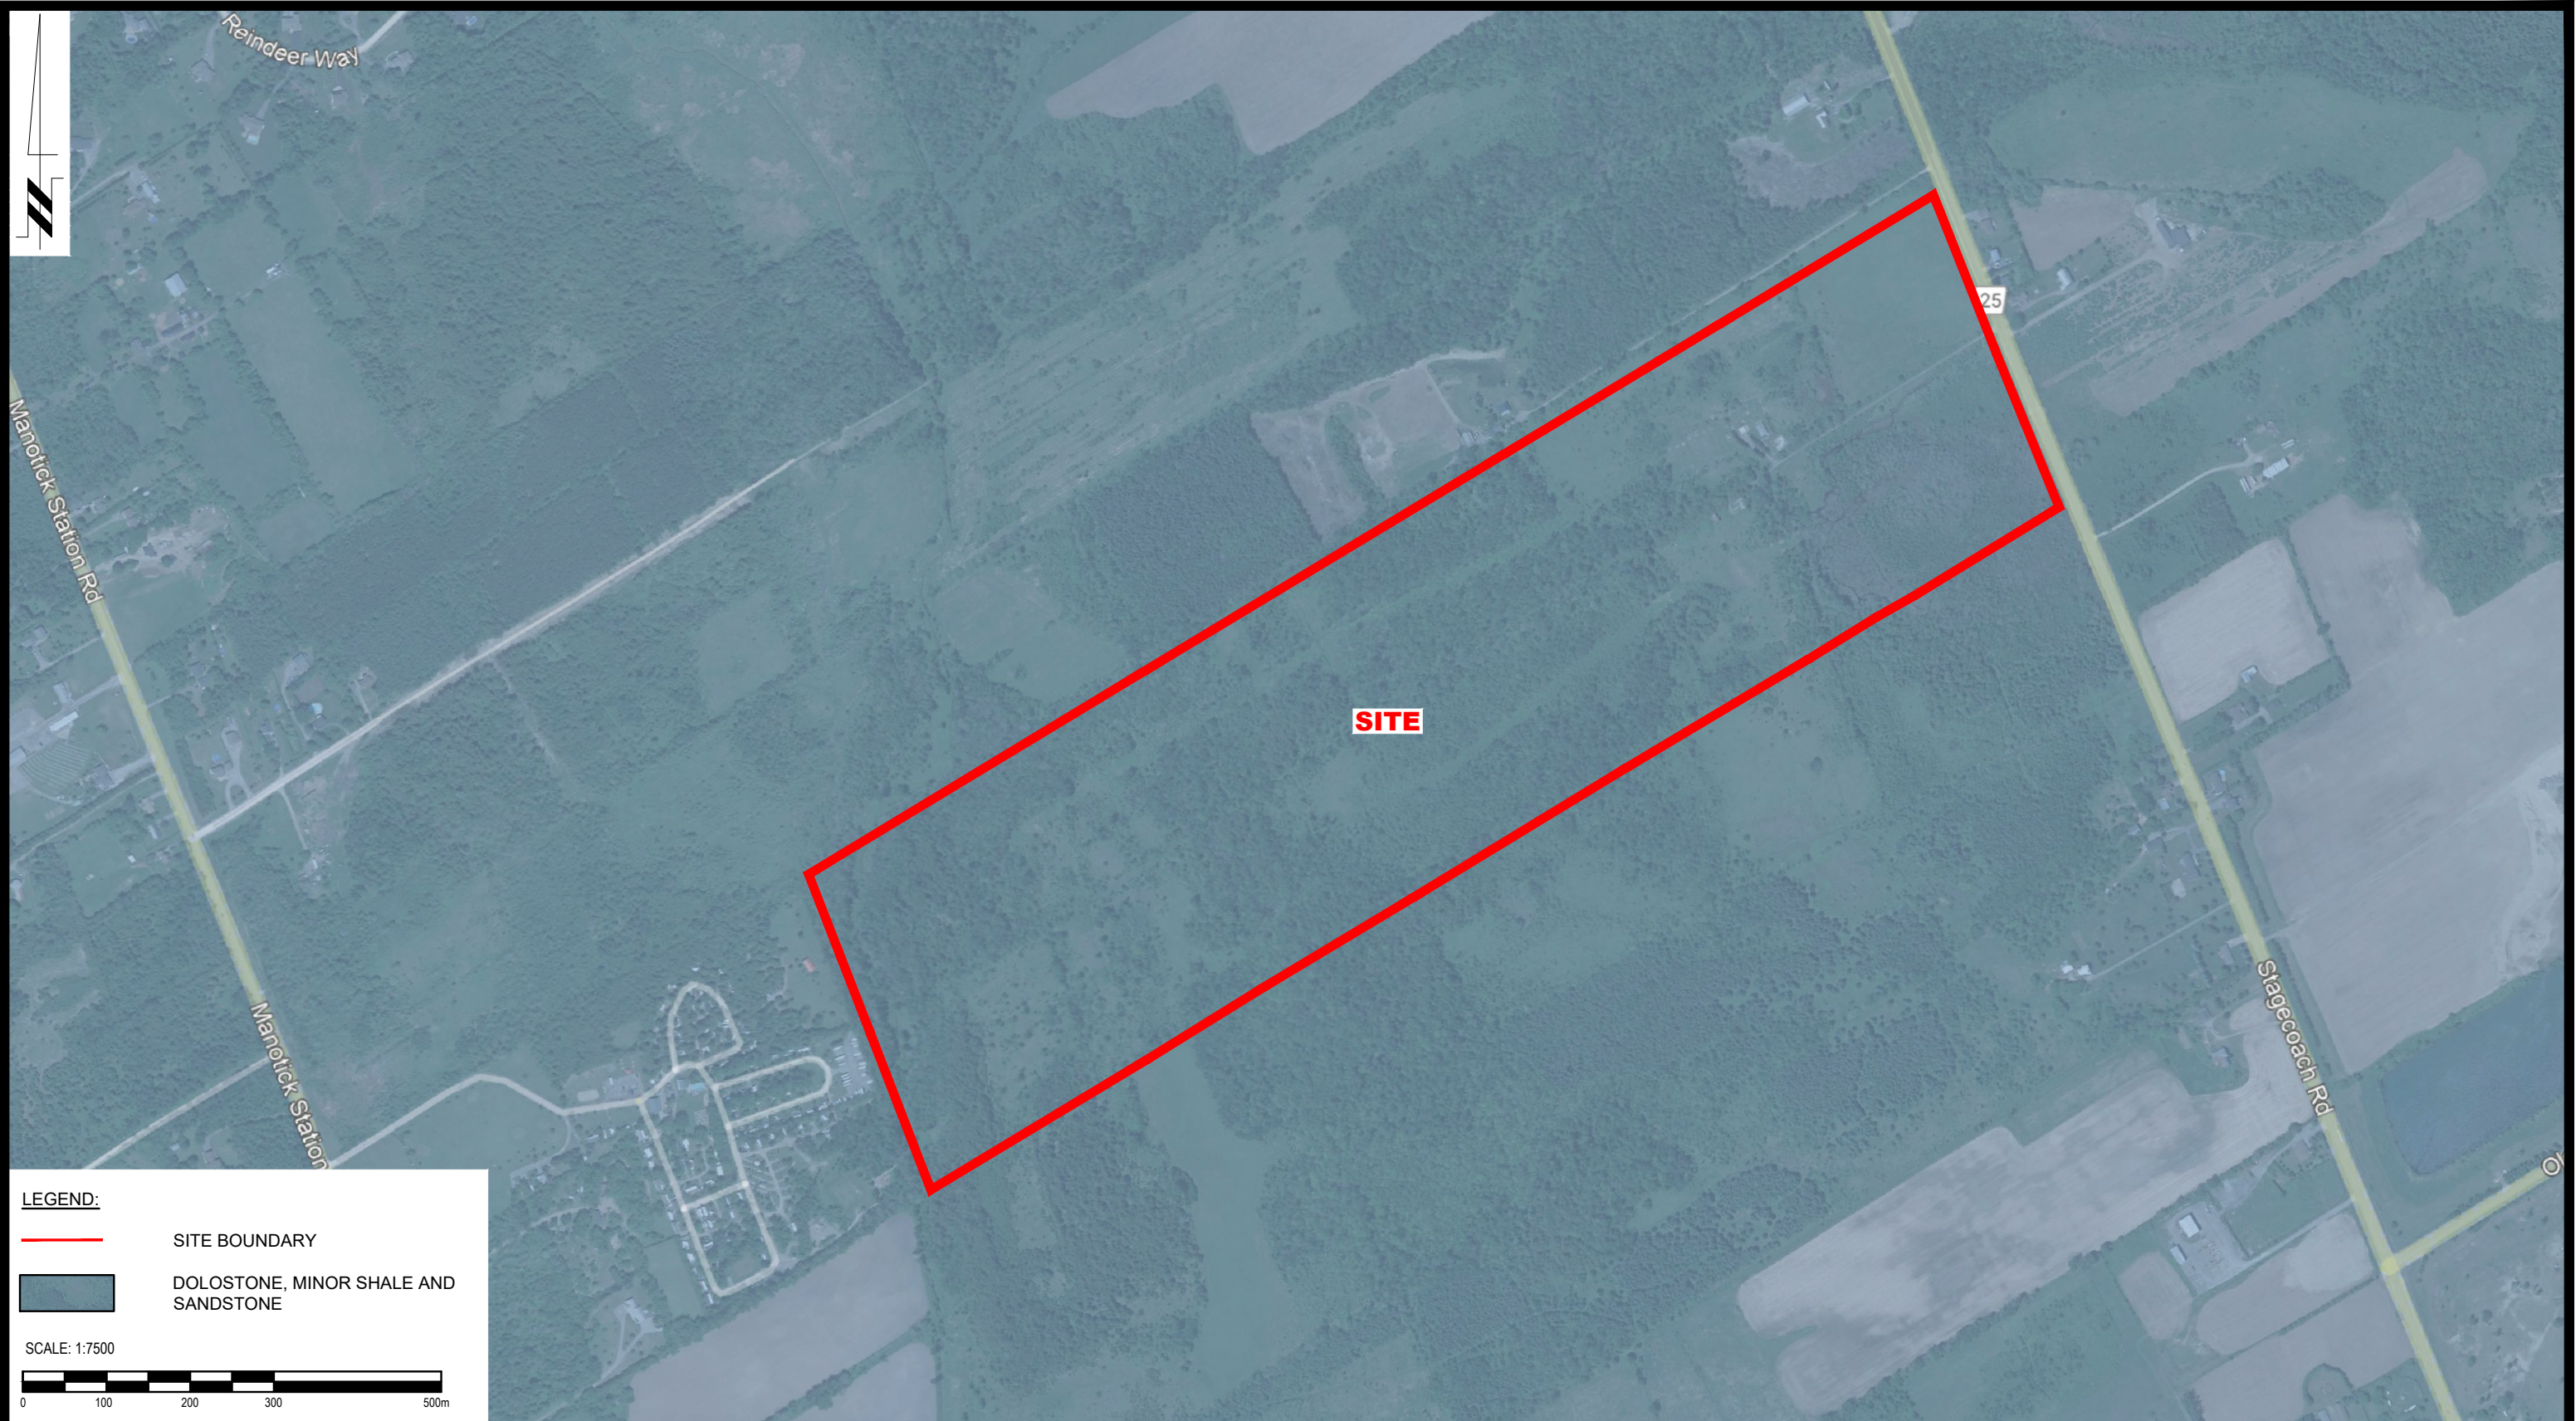
**SURFICIAL GEOLOGY PLAN**

- SITE BOUNDARY
- COARSE-TEXTURED GLACIOMARINE DEPOSITS
- GLACIOFLUVIAL DEPOSITS
- ORGANIC DEPOSITS
- TILL

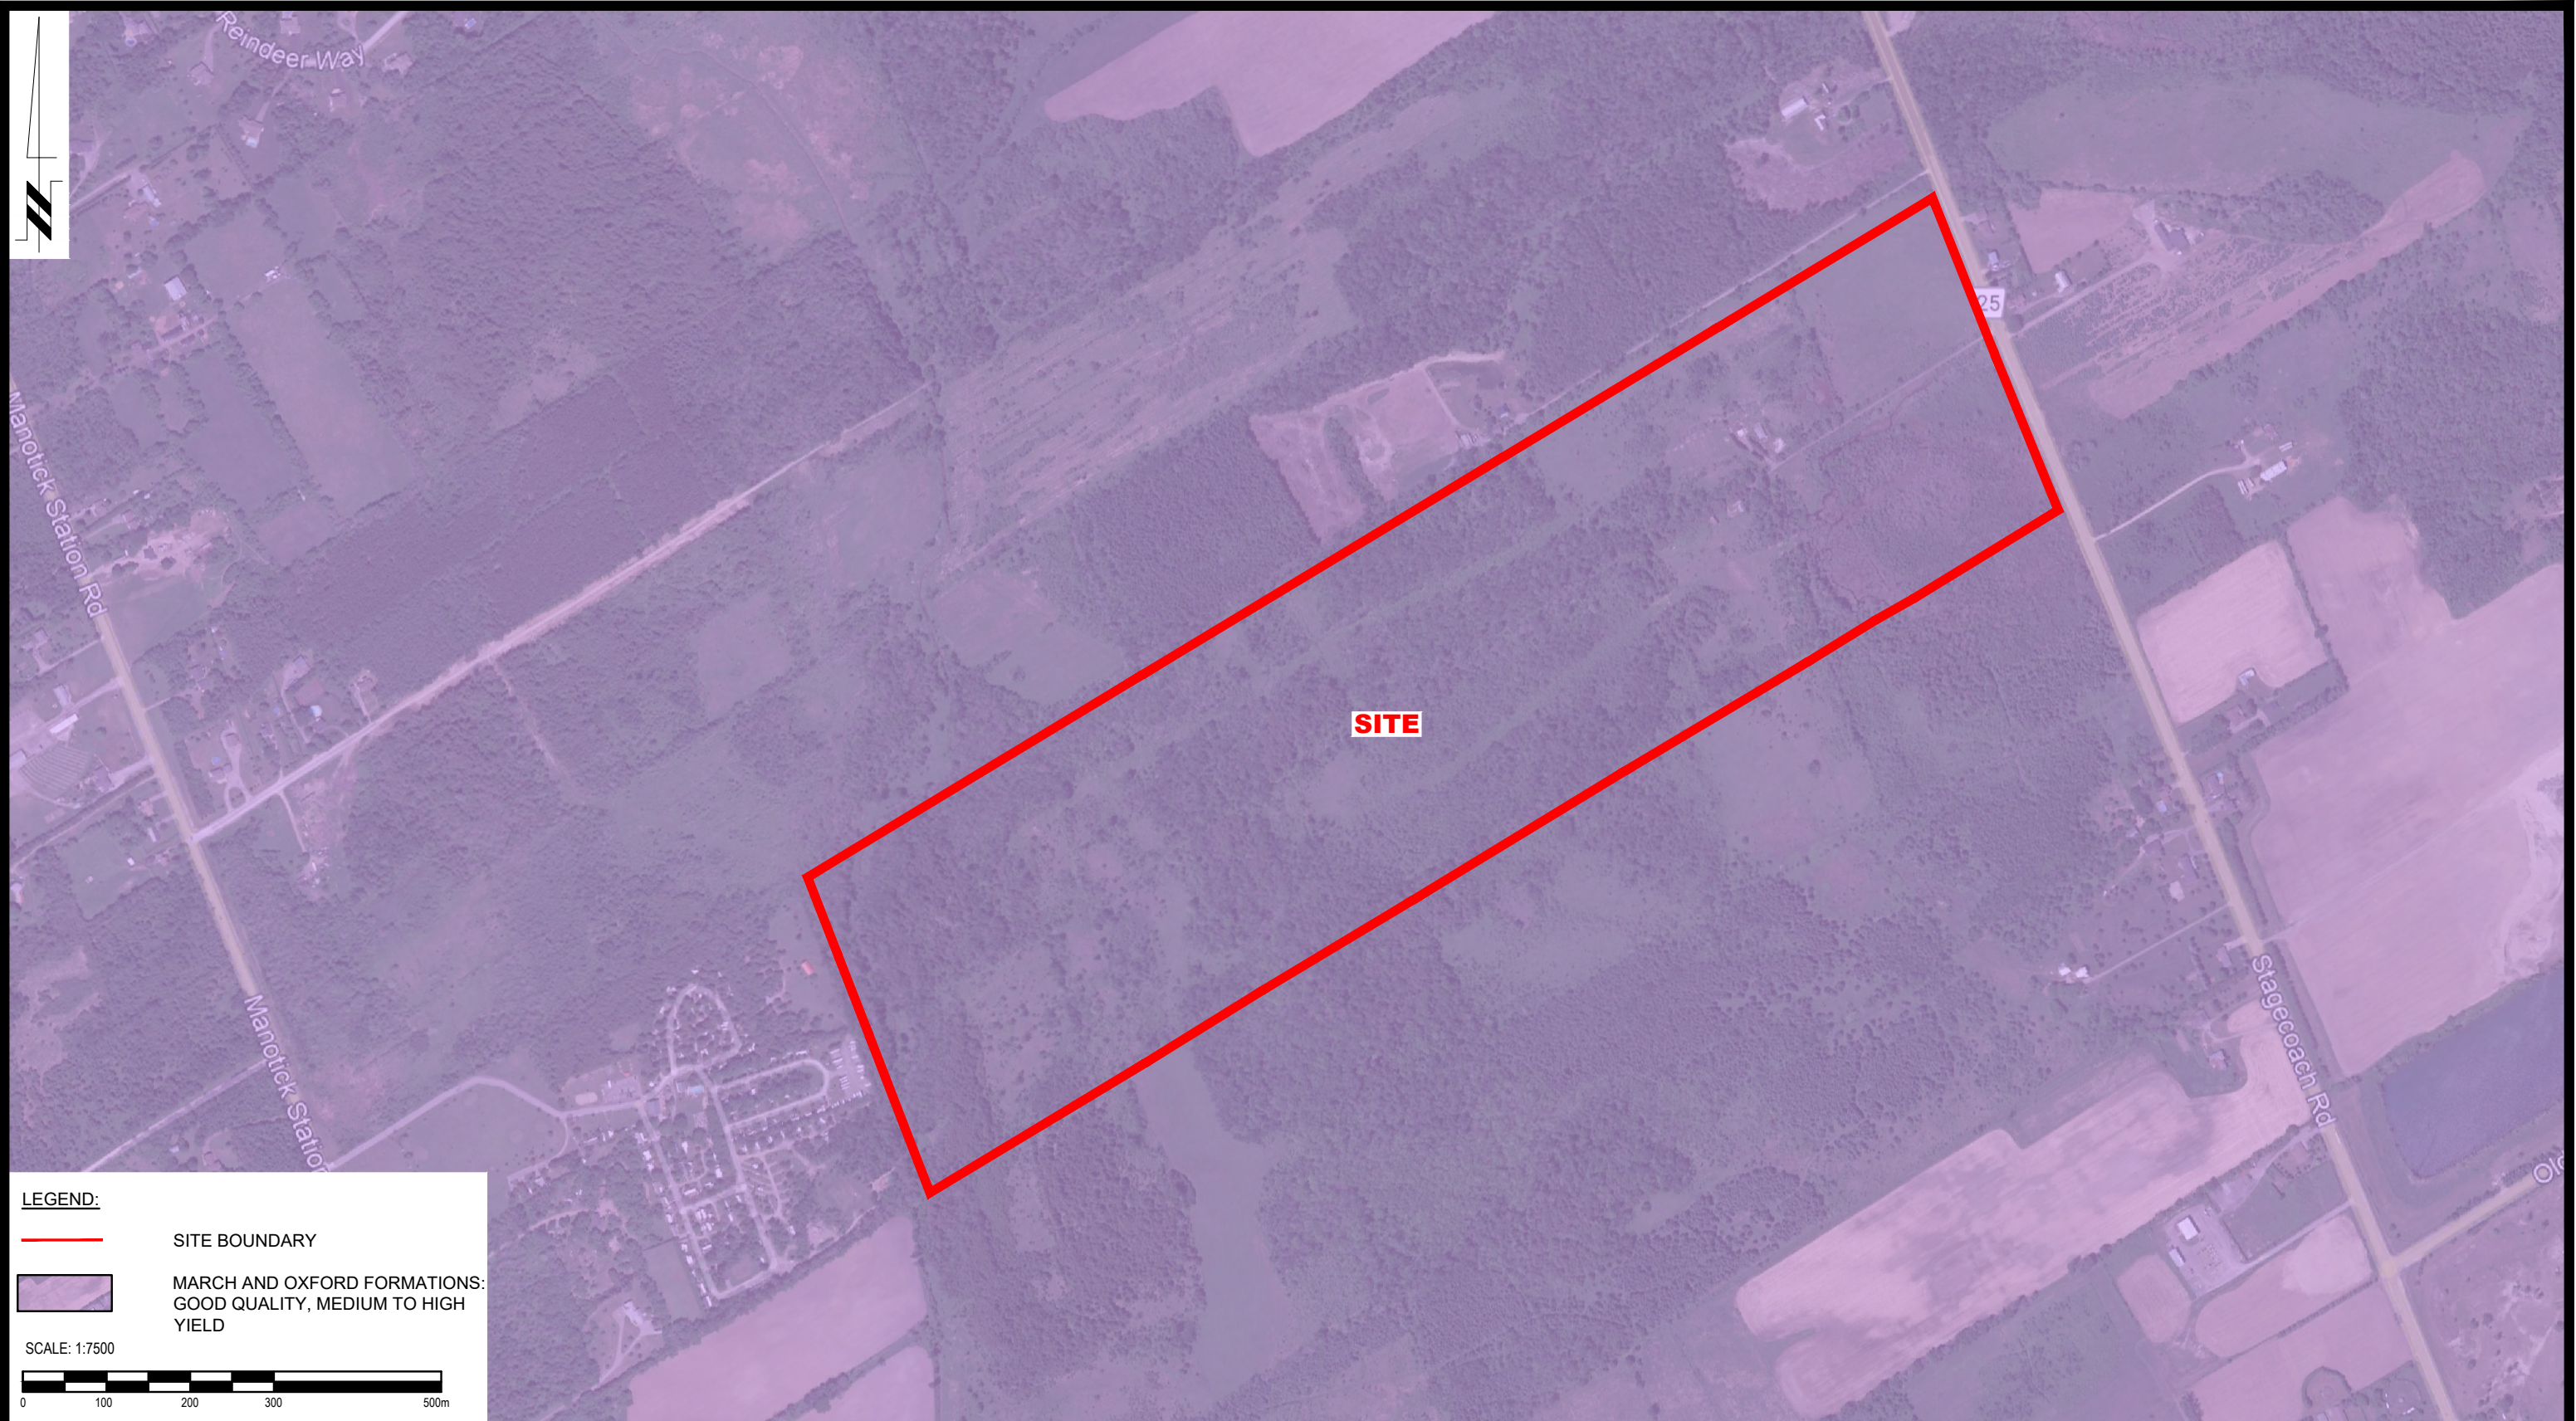
Title: **BEDROCK GEOLOGY PLAN**

- SITE BOUNDARY
- DOLOSTONE, MINOR SHALE AND SANDSTONE

- SITE BOUNDARY
- MARCH AND OXFORD FORMATIONS: GOOD QUALITY, MEDIUM TO HIGH YIELD
