Phase One Environmental Site Assessment
1770 Heatherington Road, Ottawa, Ontario
City of Ottawa

Project Name:
Phase One Environmental Site Assessment
1770 Heatherington Road, Ottawa, Ontario

Project Number:
OTT-00018293-J8

Prepared By:
EXP Services Inc.
100-2650 Queensview Drive
Ottawa, ON K2B 7H6
t: 1.613.688.1899
f: 1.613.255.7337

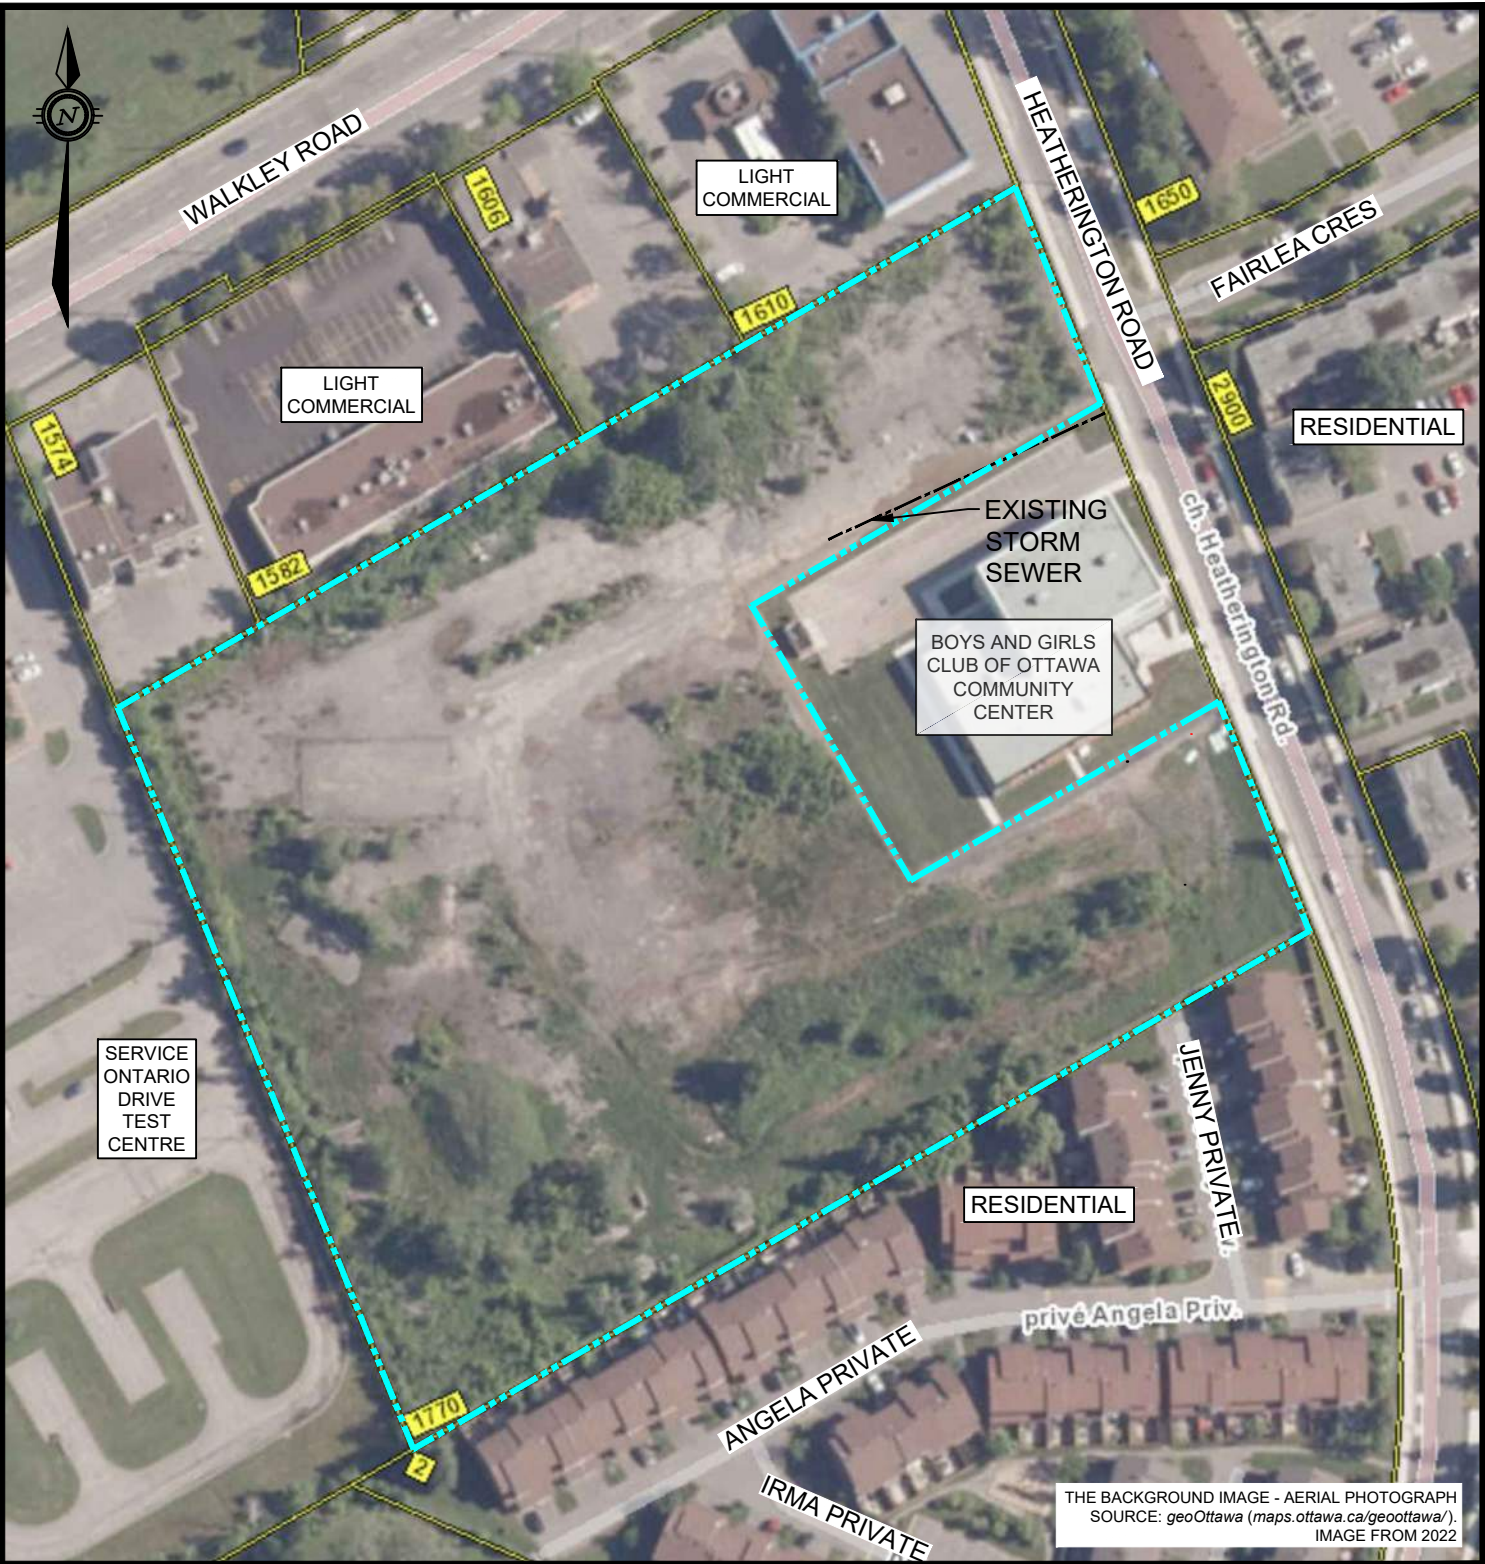
SCALE 1:1,500
 SKETCH NO
FIG 3A

Figure 3A – Site Plan, Current Conditions

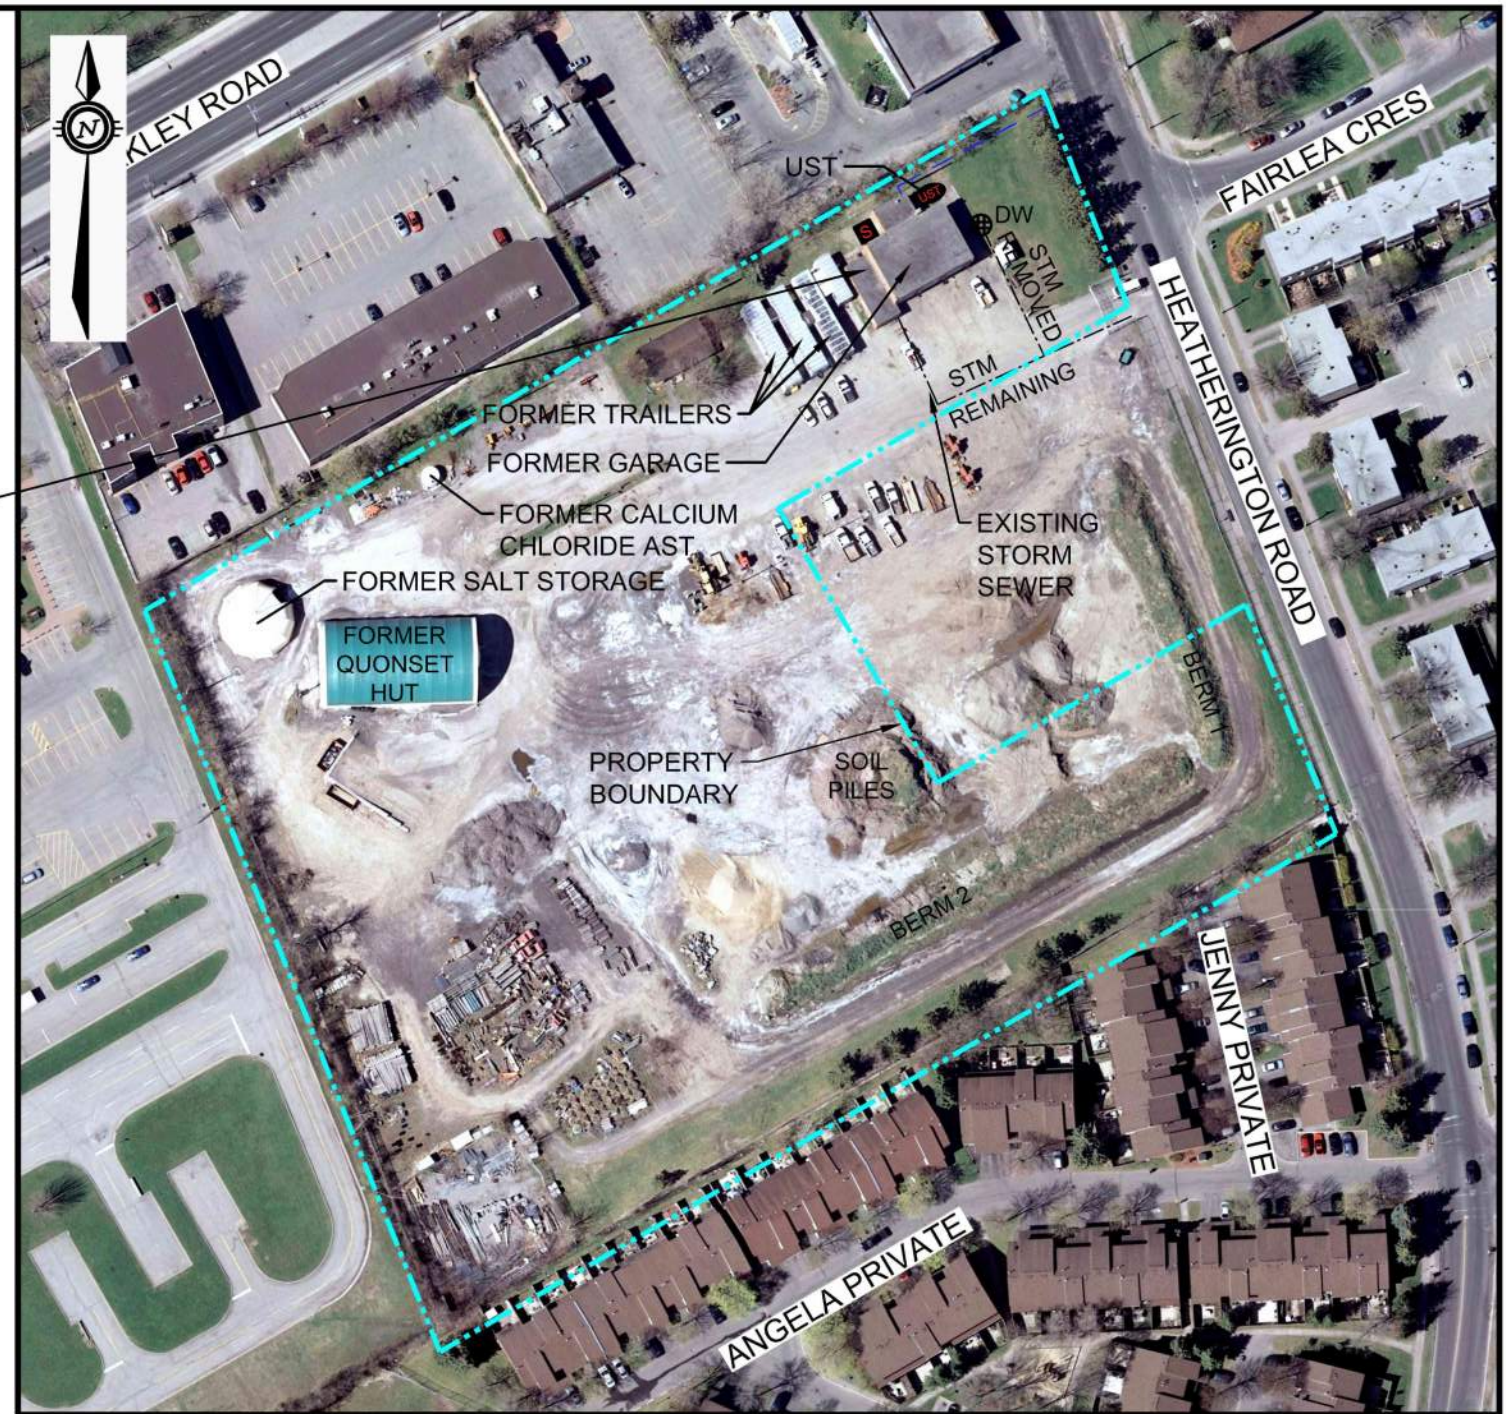
EXP Services Inc. 100-2650 Queensview Drive Ottawa, ON K2B 8H6 www.exp.com		DESIGN C.K. / S.P.	PHASE ONE ENVIRONMENTAL SITE ASSESSMENT 1770 Heatherington Road, Ottawa, Ontario	SCALE 1:1,500
		DRAWN T.M. / A.S.		SKETCH NO
		DATE APRIL 2024		FIG 3B
		FILE NO OTT-00018293-J5

Figure 3B – Site Plan, Former Conditions

Although no drains, pits or sumps were observed during the site visit, the former maintenance garage to the north had floor drains that were connected to a dry-well located east of the building. These features were removed along with surrounding soils during the 2012 site remediation activities.

FORMER GARAGE LAYOUT
 (APPROXIMATE SCALE: ~1:200)
