Muncaster
Environmental
Planning Inc.

September 16, 2024

**RE: Creekside Phase 2 Residential Development, Richmond
Environmental Impact Study and Tree Conservation Report- Updated**

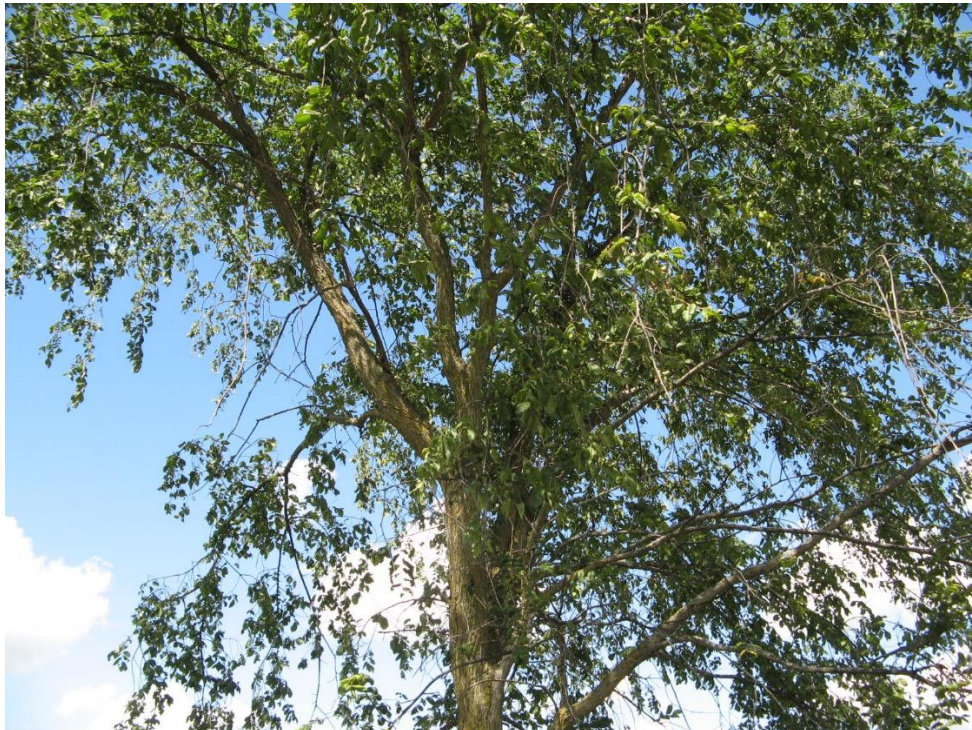
Coppice (multi-stem) Manitoba maples with individual stems up to 34cm dbh dominate the deciduous trees in the intermittent deciduous hedgerow immediately adjacent to the central portion of the east site edge, along the west edge of the Eagleson Road allowance. As mentioned above, the road allowance has been expanded slightly to the west and it is now believed the majority of these trees are City owned or co-owned, though the trunks are immediately adjacent to the page fencing parallel and to the west of Eagleson Road. There are a total of seventeen Manitoba maples that now appear to be City-owned. Once a survey of the tree locations is available, confirmation of the City-owned trees will be made and a detailed list of tree size and condition will be provided. All of the Manitoba maple are coppice or twin-stem, thirteen of the coppice Manitoba maples having four or more trunks. The Manitoba maples had generally good leaf-out and most had the typical Manitoba maple poor structure with no dominant leader (Photo 4). A 38cm dbh white elm to the north of the Manitoba maples had good leaf-out and a few dead branches (Photo 5). Hawthorn shrubs and regenerating Manitoba maple and elm stems are among the deciduous trees.

Photo 5 – White elm immediately adjacent to east site edge, west of Eagleson Road. View looking north

3. Many Manitoba maple are along the east edge of the site. These trees are now believed to be City-owned or co-owned with an expansion of the Eagleson Road allowance. It is not anticipated that these trees can be retained due to grading and other servicing requirements. A survey is required to determine which of these trees are co-owned or City-owned and discussions required with the City forester on compensation for the tree removal;

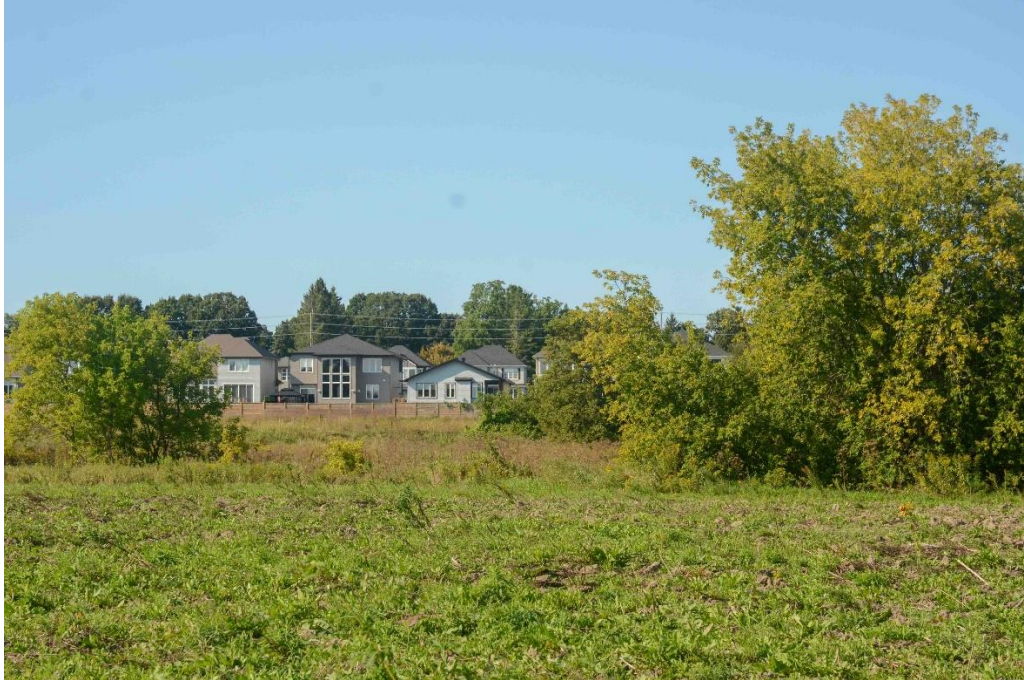
Photo 8 – View looking west towards the Flowing Creek Municipal Drain from the south service corridor block along the central-west edge of the residential development
