# **Phase I – Environmental Site Assessment**

Tunney's Pasture (Block 10)

Ottawa, Ontario

Report: PE6040-1

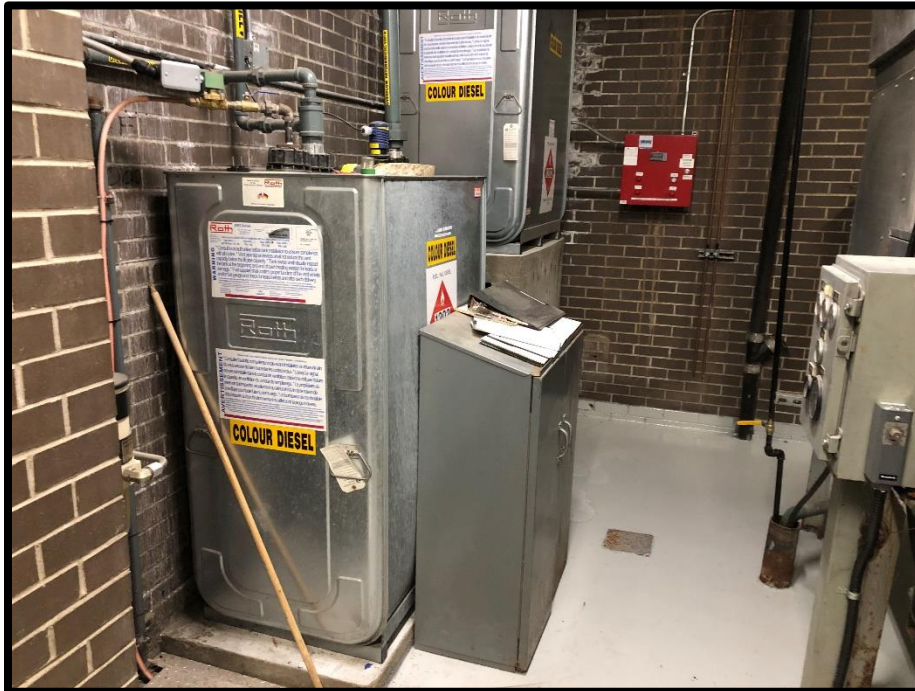
Two in-use, double walled, vacuum sealed, coloured diesel ASTs were observed within the southeast corner of the basement of the Brooke Claxton Building on the Phase I Property (associated with the vent and fill pipes identified on the south face of the Brooke Claxton building). The tanks were installed in 2008 and each have a capacity of 1,000 L. The ASTs are situated atop a concrete pad and a large concrete block and are used as day tanks. The ASTs were noted to be in good condition at the time of the site inspection, with no signs of spills or staining observed in the vicinity of the tank. The presence of these tanks are considered to represent an environmental concern to the Phase I Property (APEC 1).

**Photograph 5:** View of the two 1,000 L ASTs in the basement of the Brooke Claxton building.

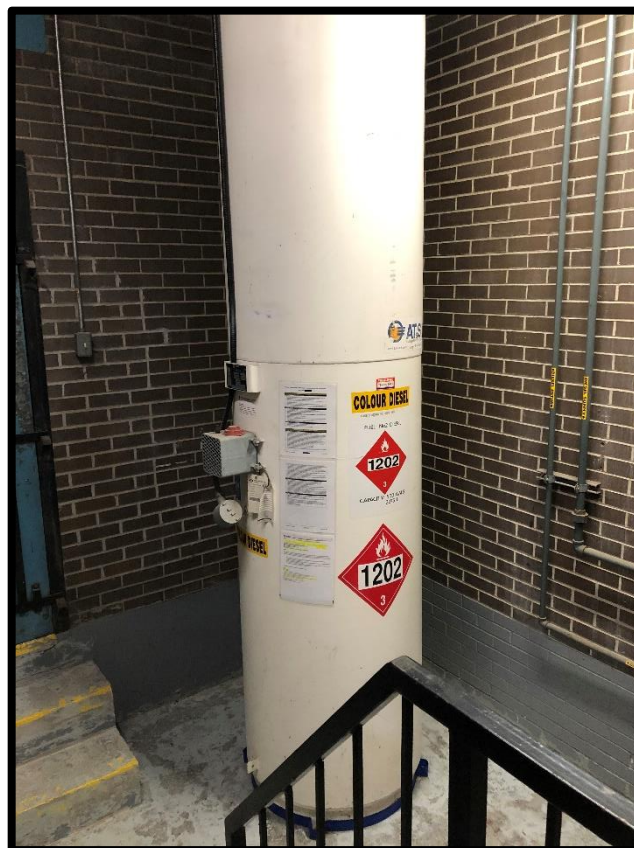
An in-use, double-walled, vacuum sealed, coloured diesel aboveground storage tank (AST) was observed within the southeast corner of the basement of the Brooke Claxton building on the Phase I Property. The tank was installed in 2008 and has a capacity of 2,275 L. The AST is situated on the concrete floor and is used to run an emergency generator. Approximately once a year the tank is refilled and approximately once a month the generator is turned on to ensure it is still in working order. The AST was noted to be in good condition at the time of the site inspection, with no signs of spills or staining observed in the vicinity of the tank. The presence of this tank is considered to represent an environmental concern to the Phase I Property (APEC 1).

**Photograph 6:** View of the 2,275 L AST in the basement of the Brooke Claxton building.
