### **PHASE II ENVIRONMENTAL SITE ASSESSMENT 3200 REIDS LANE CITY OF OTTAWA, ONTARIO**

Crestview Innovations Inc.  
12 Escade Drive  
Nepean, ON  
K2G 6R9

REVISION 1: June 21, 2024  
DATE: January 24, 2023

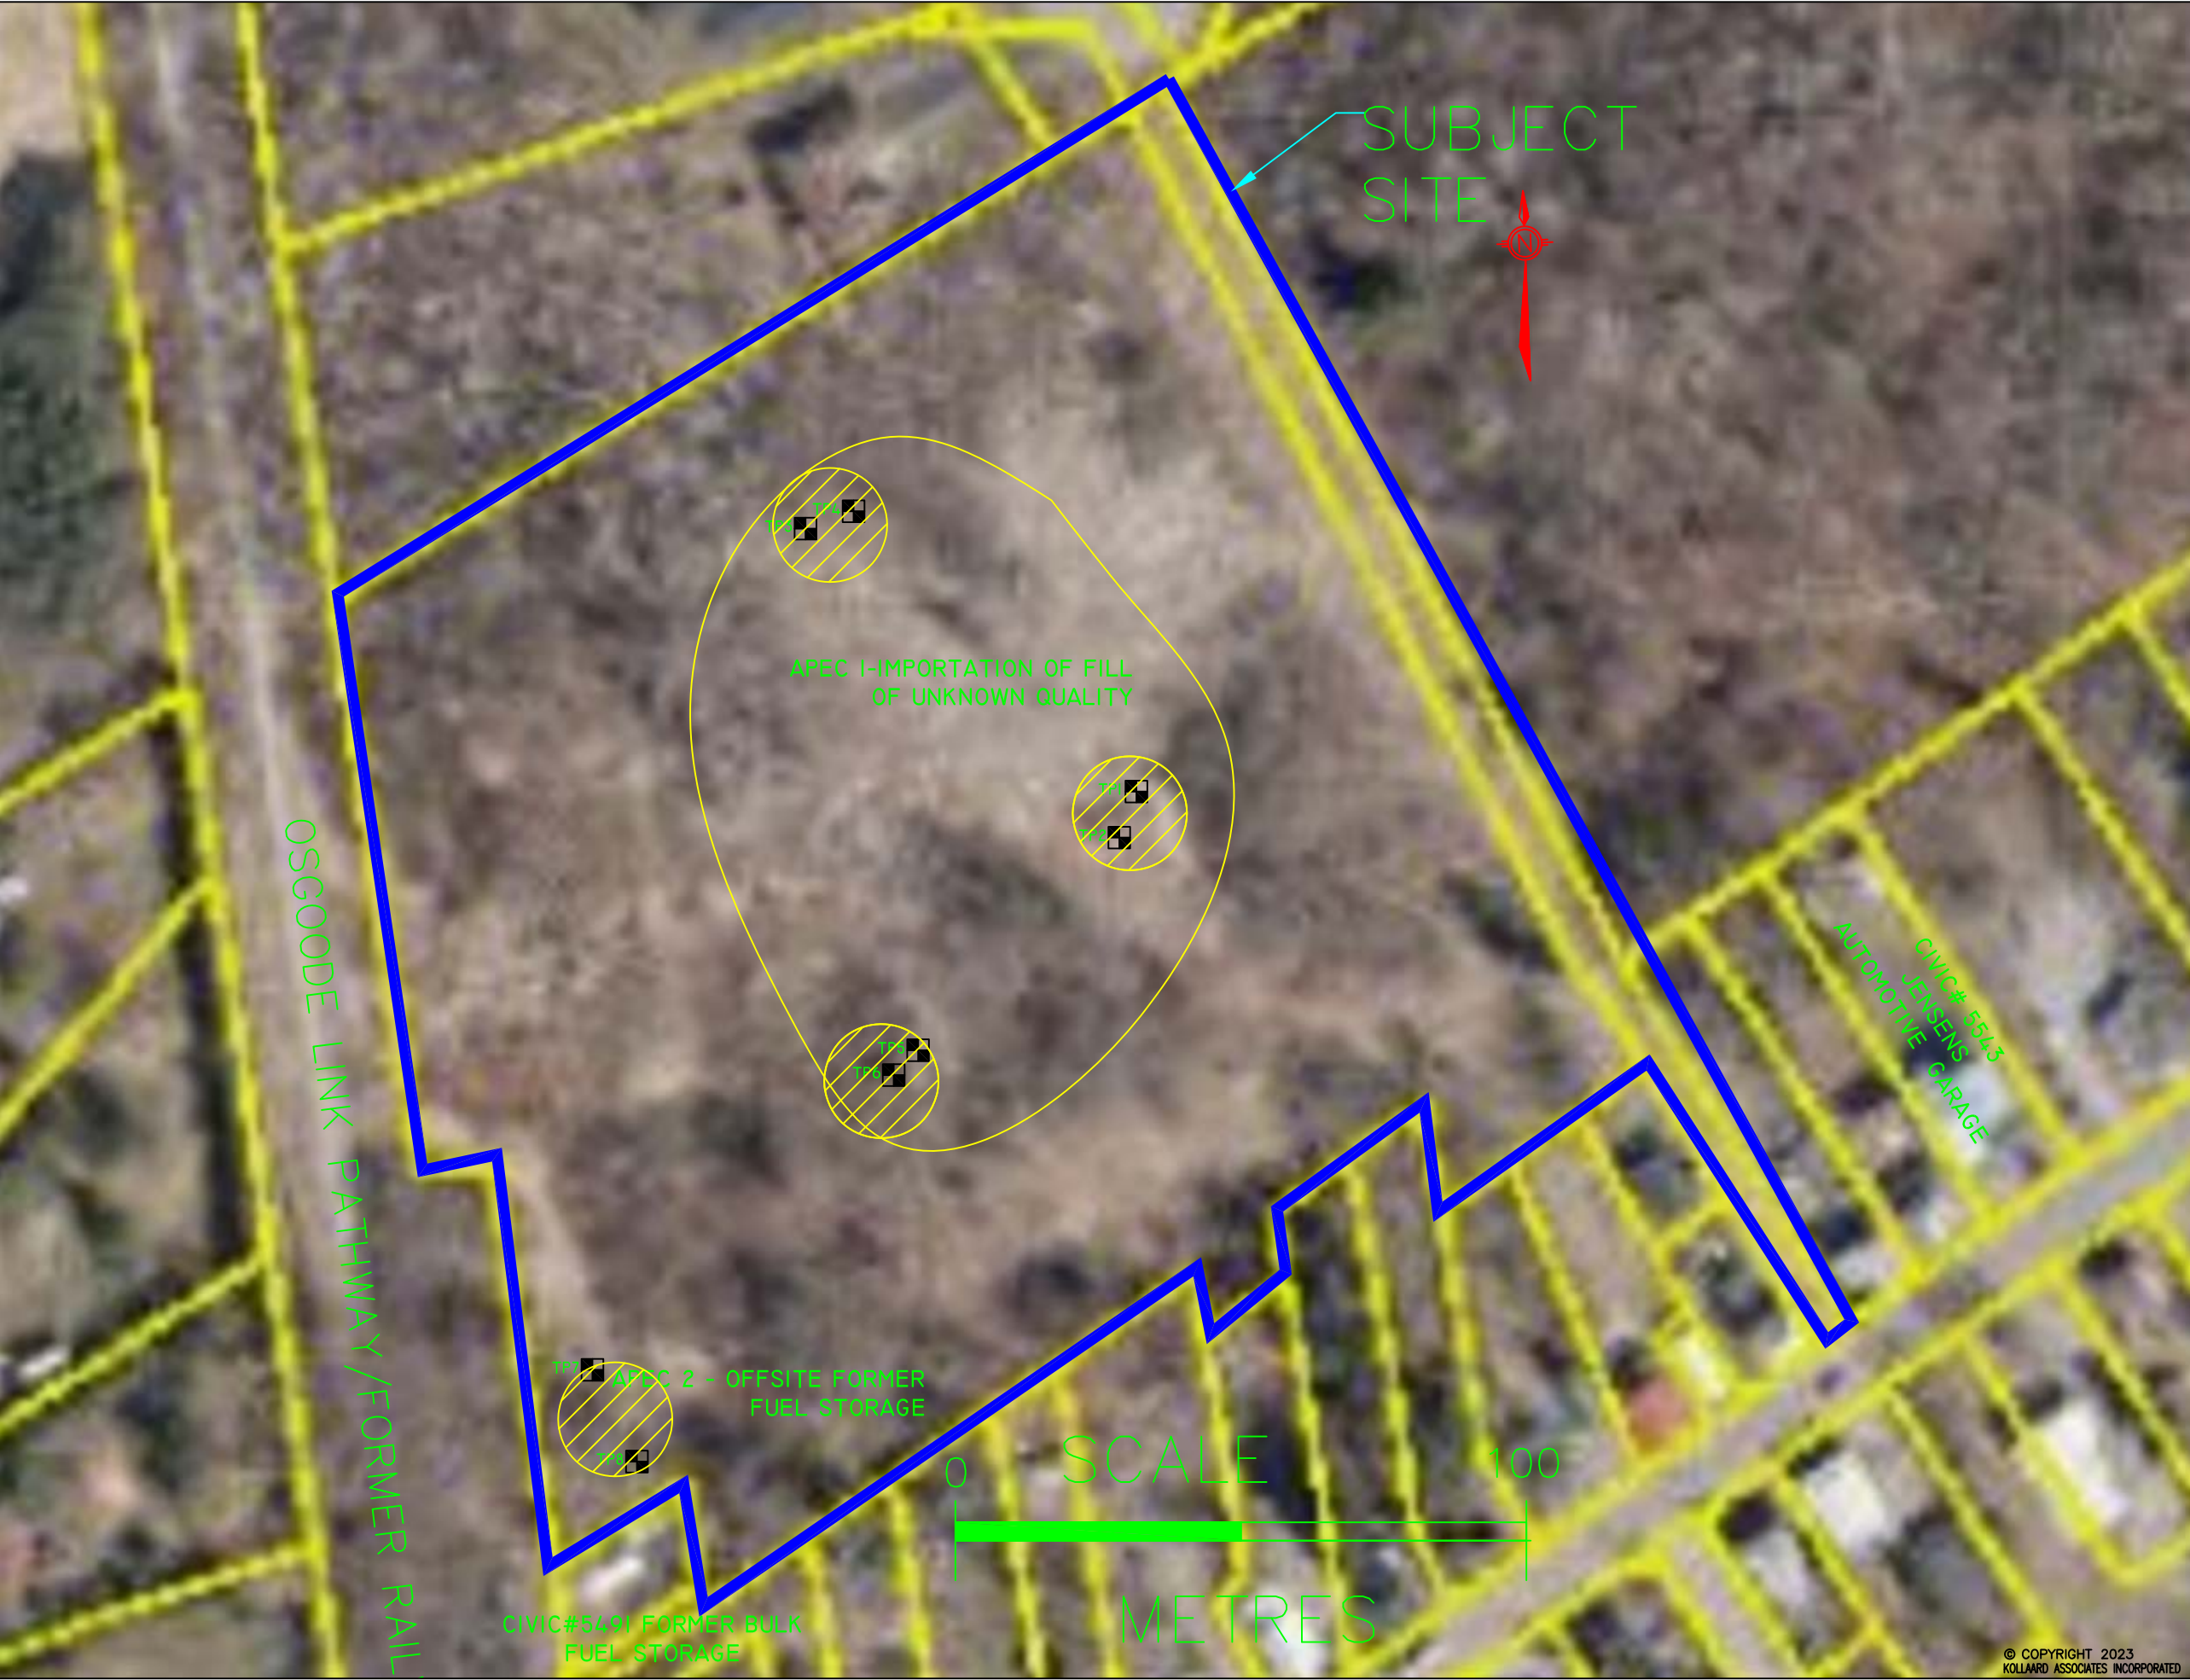
DRAWING NUMBER:  
FIGURE 2

The locations of the samples are provided on the attached Figure 2. The cross sections (Figures 3 and 4) show the fill areas and underlying native soil and bedrock conditions at the site.

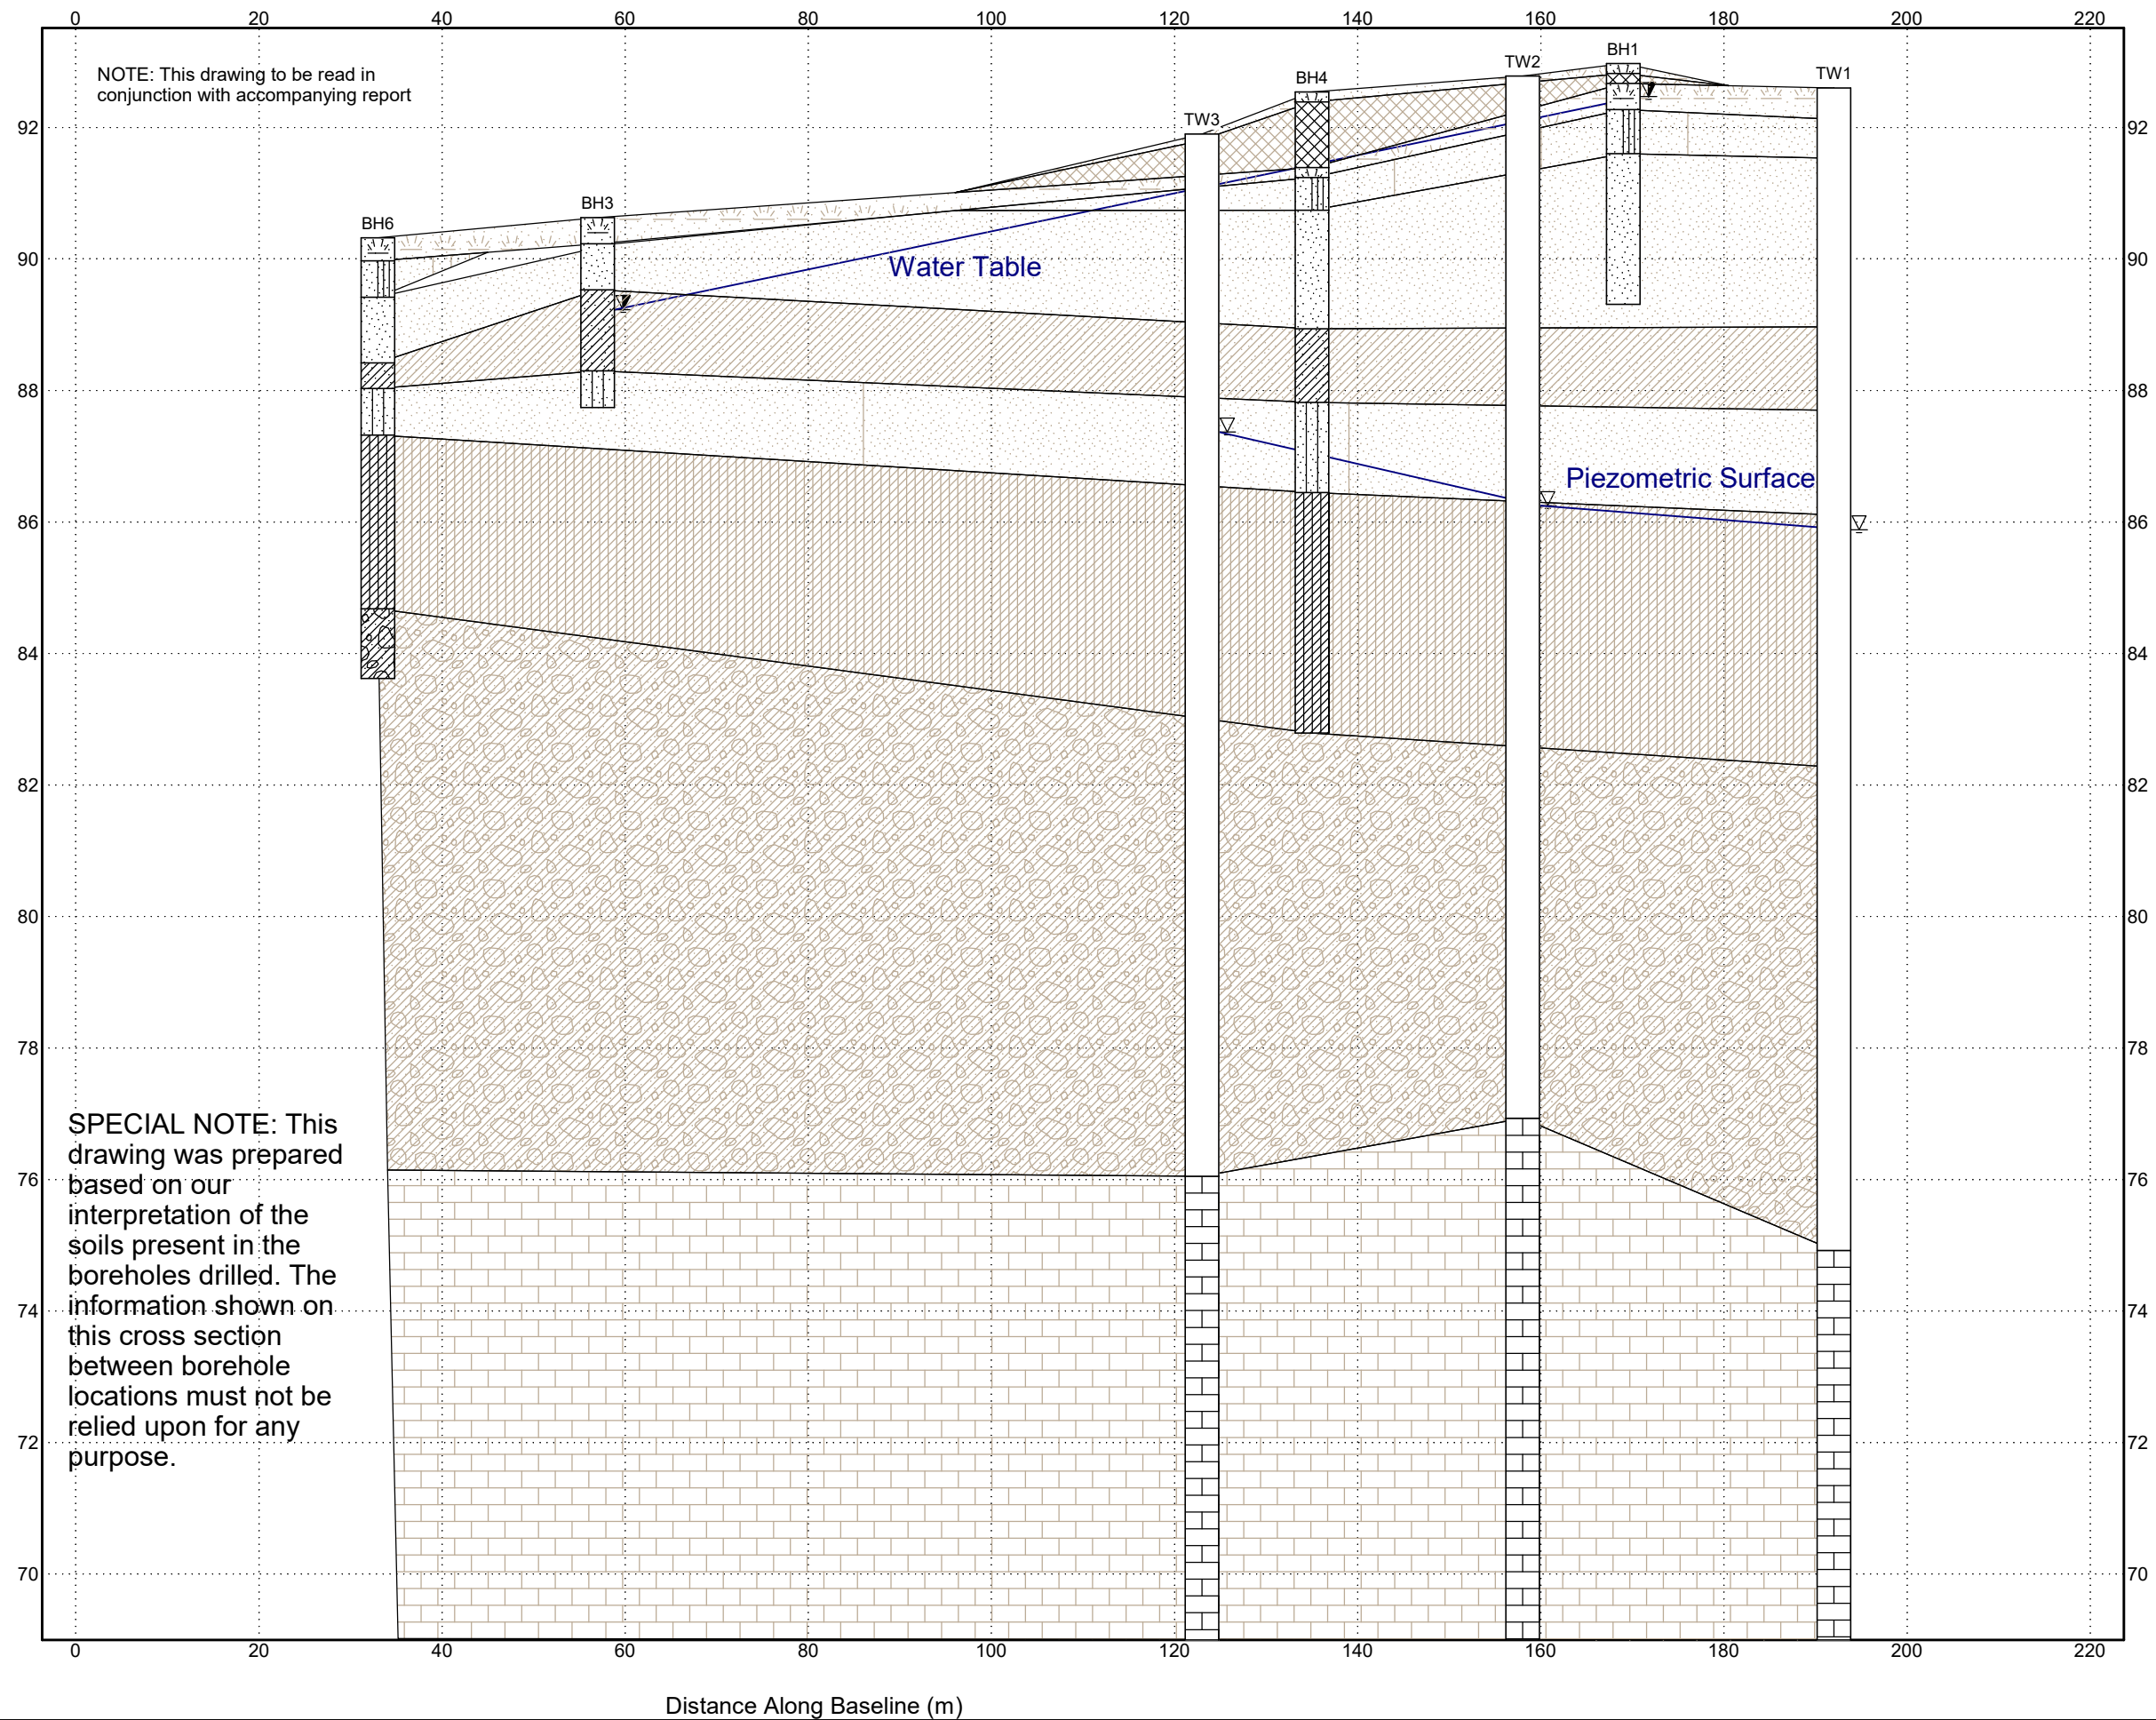
FIGURE 3

- TOPSOIL
- Yellow brown sand and gravel (FILL)
- Red brown fine to medium SAND, trace silt
- Grey fine to medium SAND
- Grey sandy CLAY, trace silt
- Grey SILTY SAND
- Grey SILTY CLAY
- Grey silty sand, trace to some gravel, cobbles and boulders, trace clay (GLACIAL TILL)
- LIMESTONE BEDROCK

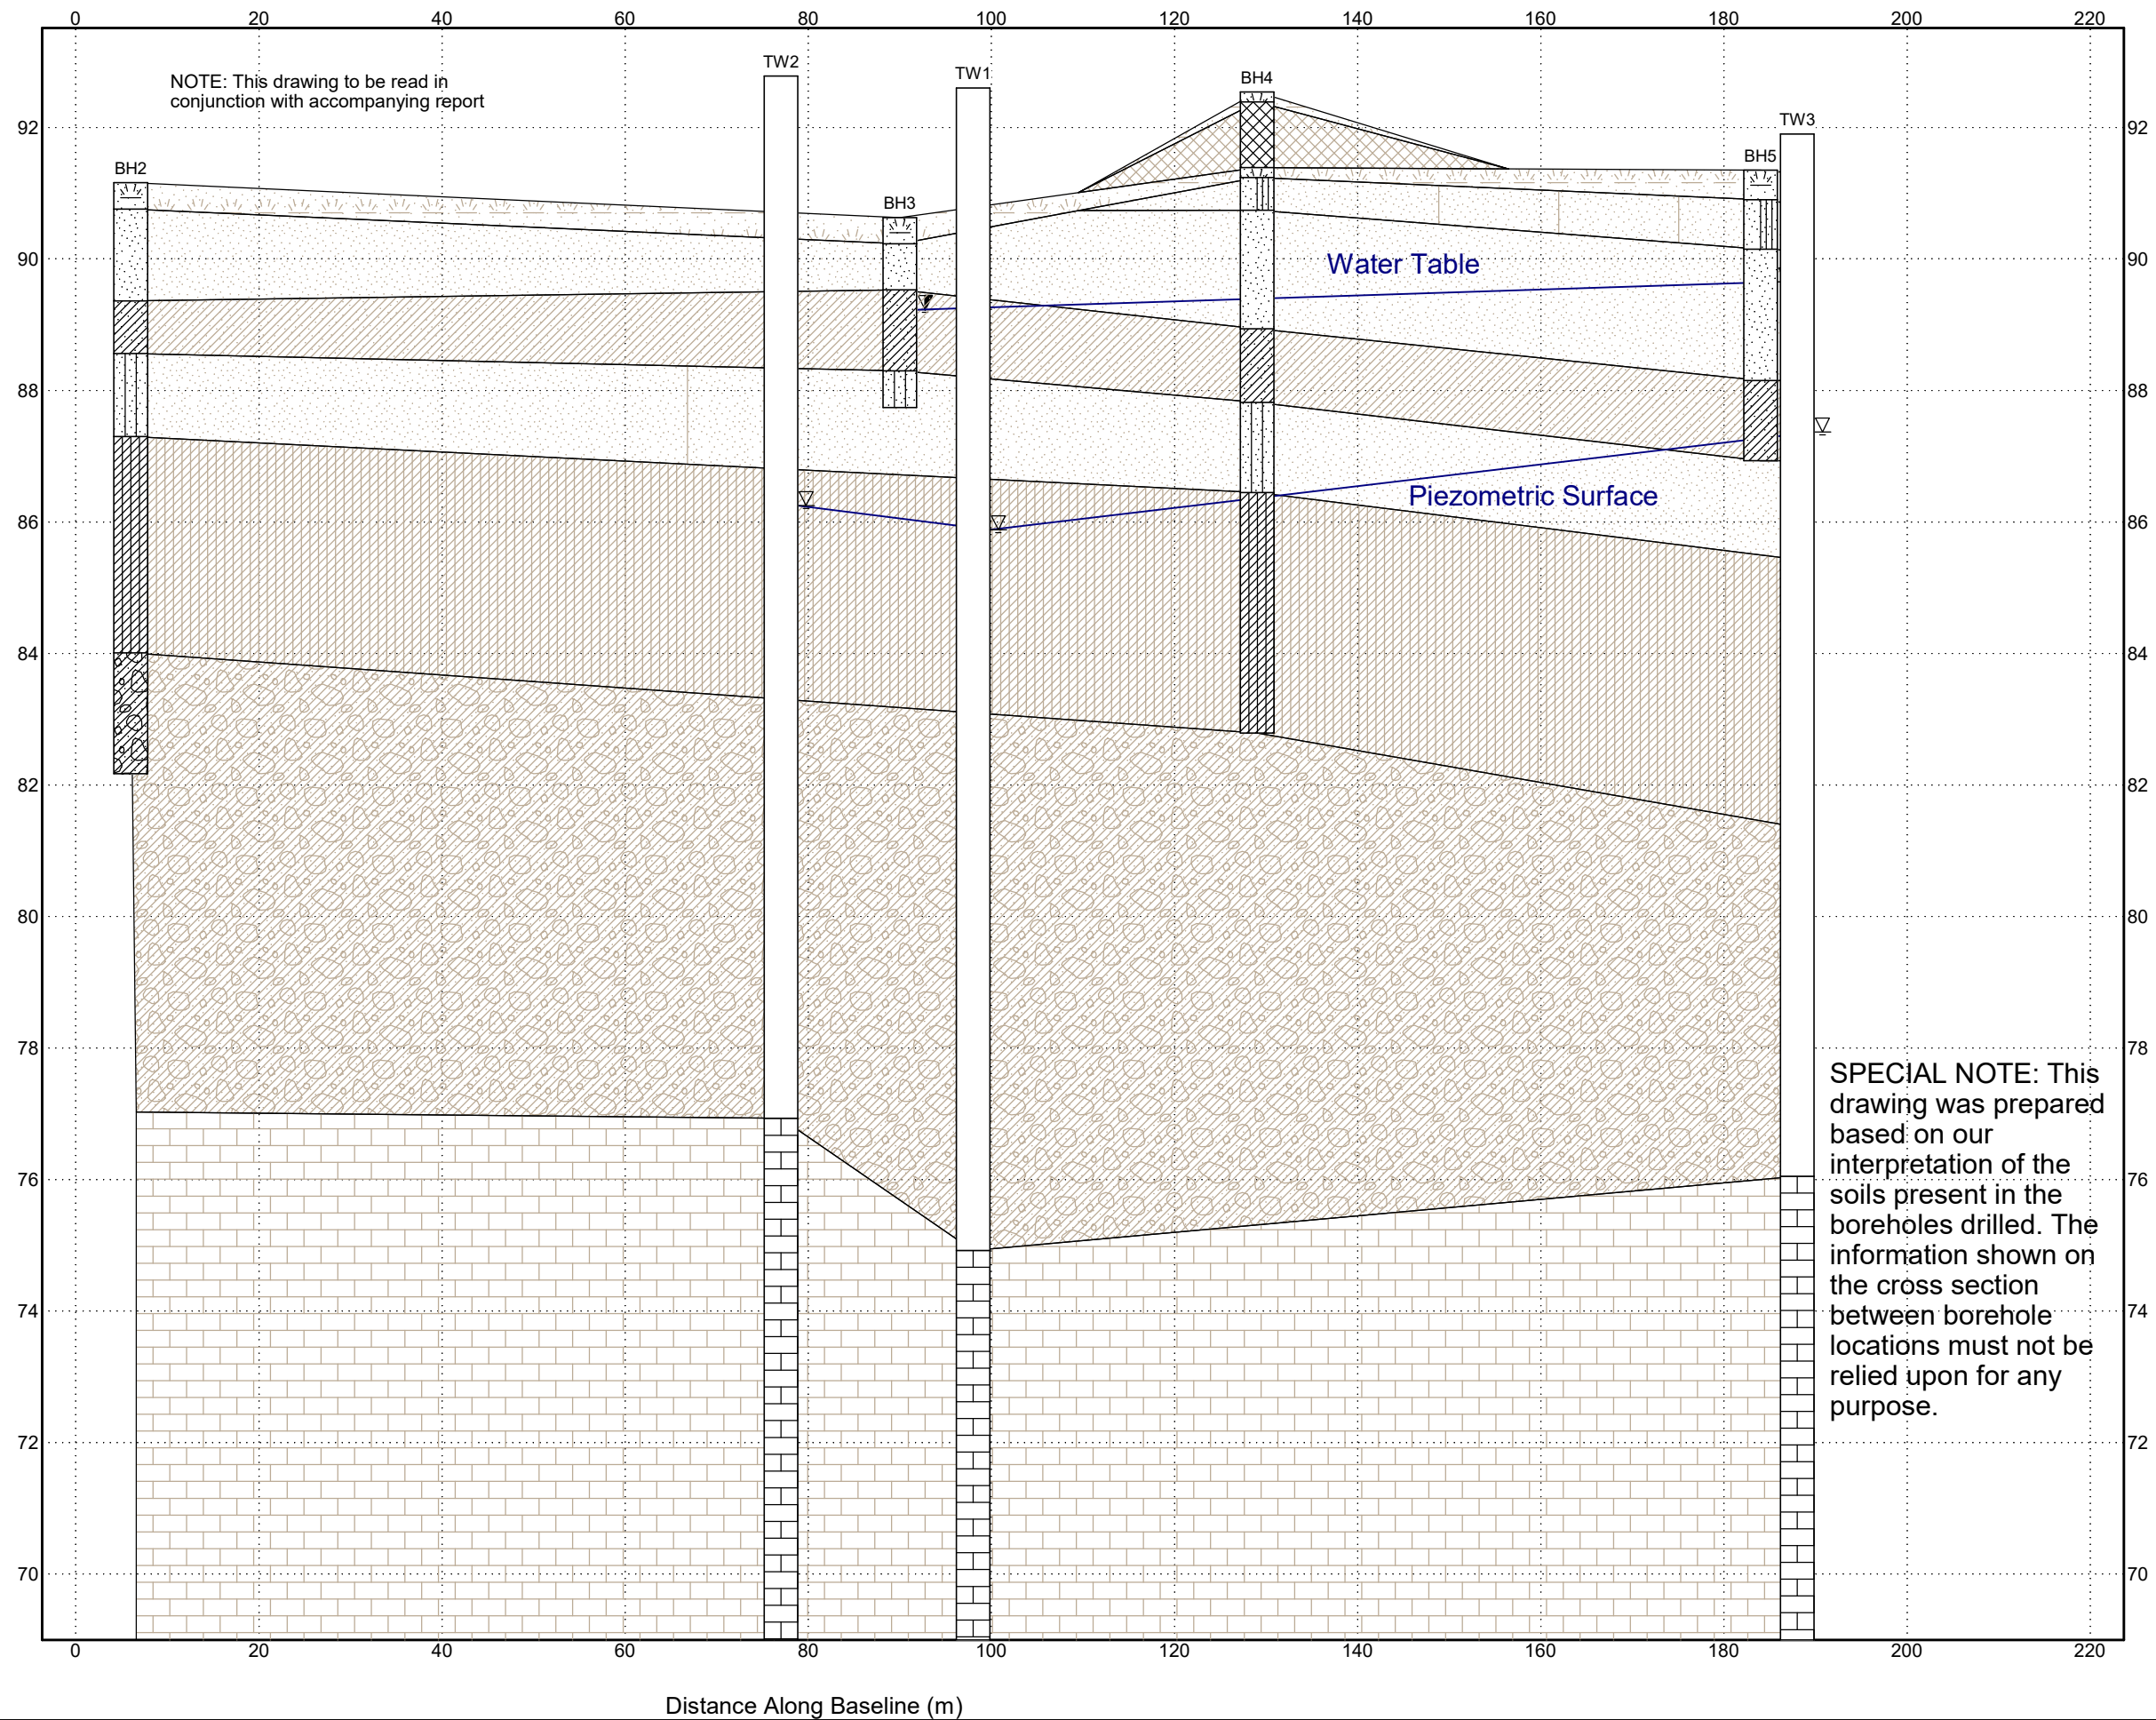
FIGURE 4

- TOPSOIL
- Yellow brown sand and gravel (FILL)
- Red brown fine to medium SAND, trace silt
- Grey fine to medium SAND
- Grey sandy CLAY, trace silt
- Grey SILTY SAND
- Grey SILTY CLAY
- Grey silty sand, trace to some gravel, cobbles and boulders, trace clay (GLACIAL TILL)
- LIMESTONE BEDROCK

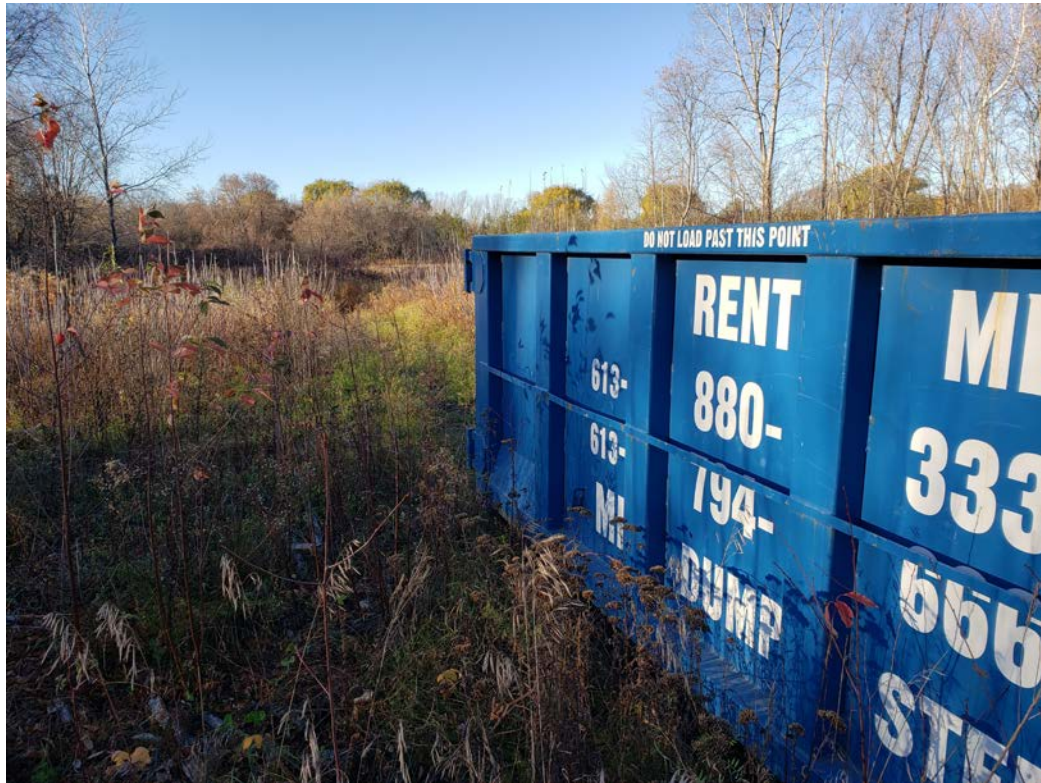
All materials that were excavated from Test pits 3 and 4 were placed in a dumpster that was observed by Kollaard Associates Inc. onsite on November 7 and 8, 2022. A subsequent site visit was carried out to determine whether the soil impacts were present in the native soils underlying the fill area at TP3. The underlying soil sample was obtained from the same test pit location from a depth of about 1.60 metres. That sample had non-detectable levels of all PAHs. The asphalt materials were removed from the site from the area of test pits 3 and 4 and no further soil assessment is necessary, based on the results of the additional testing on December 1, 2022.

Photograph of dumpster Nov. 7, 2022

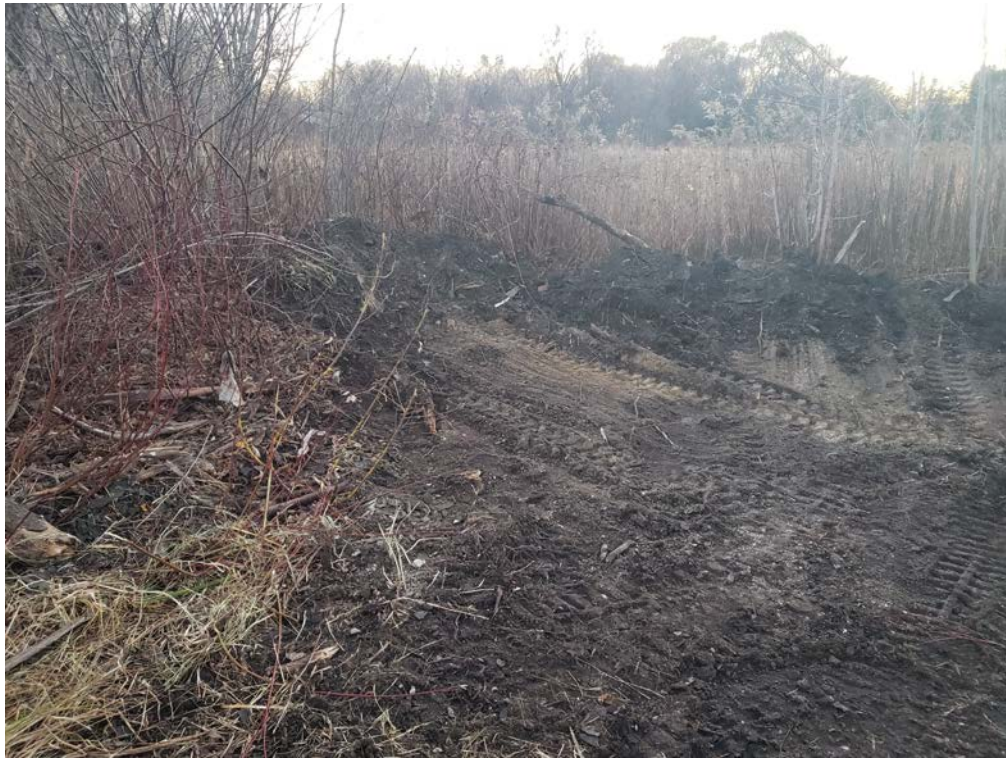
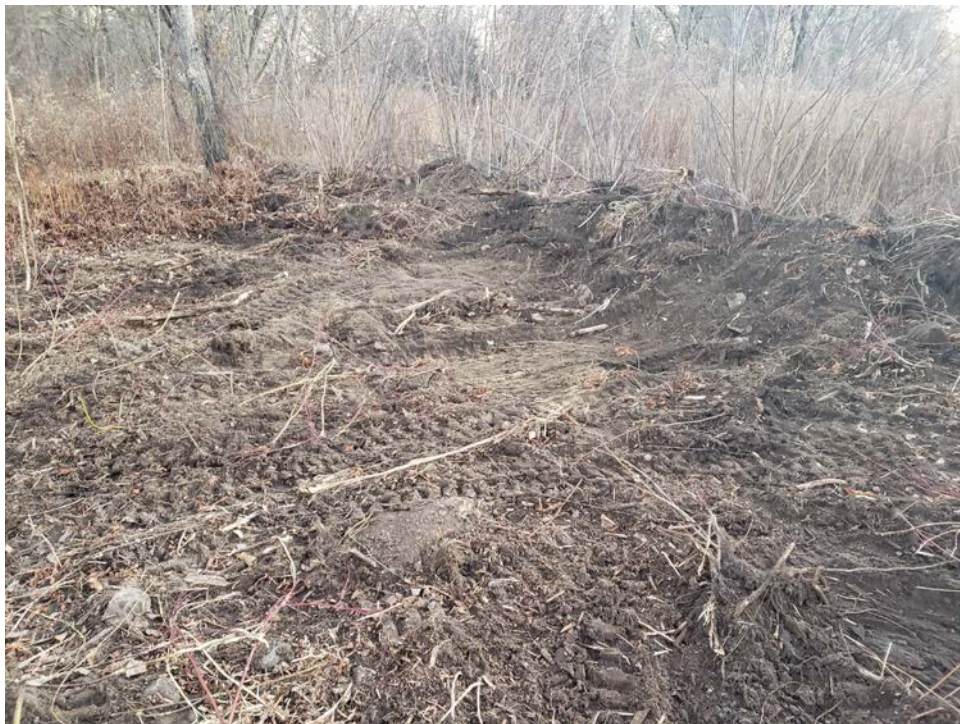
Based on the information from all the samples obtained, it is considered that the soil at the site does not impacted by PAHs. However, the presence of asphalt (especially at TP3) within the fill materials did cause one soil sample to exceed allowable limits for PAHs, due to the presence of asphalt within the soil matrix. That sample was noted to have contained asphalt pieces. During sample preparation, pieces of asphalt were crushed and formed part of the soil sample tested. It is considered that the asphalt within the soil sample caused the exceedance in this sample. There was non-detectable presence of PAHs in the underlying soil. There were no PAHs detected in any other soil sample. As such, it is considered that the source of the exceedance is from the buried asphalt pieces rather than the soil itself. The soil at TP3 was similar in colour and appearance to the soil in other test pits. The main difference was the presence and amount of asphalt that was observed within that location, compared to other test pits. Trace asphalt was observed at TP1 and TP4. Of the four soil samples obtained from those test pits, there were non-detectable levels of PAHs.

Photographs of surface of test pits 3 and 4, Nov. 8, 2022 after asphalt debris removed from test pits

On November 7 and 8, 2022, the owner hired a soil excavating company to remove soil and asphalt that were identified in the areas of TP3 and TP4. The owner also removed a debris pile containing wood and roofing shingles that was located in the same area. Kollaard Associates Inc. returned to the site on December 1, 2022 and obtained an additional soil sample from Test Pit 3. At that time, the asphalt had already been removed from the site from this area. The additional analytical results from this area indicate that there was no soil impact from any of the parameters that were tested. Based on the removal of buried asphalt, Kollaard Associates Inc. considers that there is no further soil excavating or testing needed.
