**Phase Two Environmental Site Assessment  
Proposed Plan of Subdivision  
3160 Carp Road  
Ottawa, Ontario**

GEMTEC Project: 102151.001

April 24, 2024  
GEMTEC Project: 102151.001

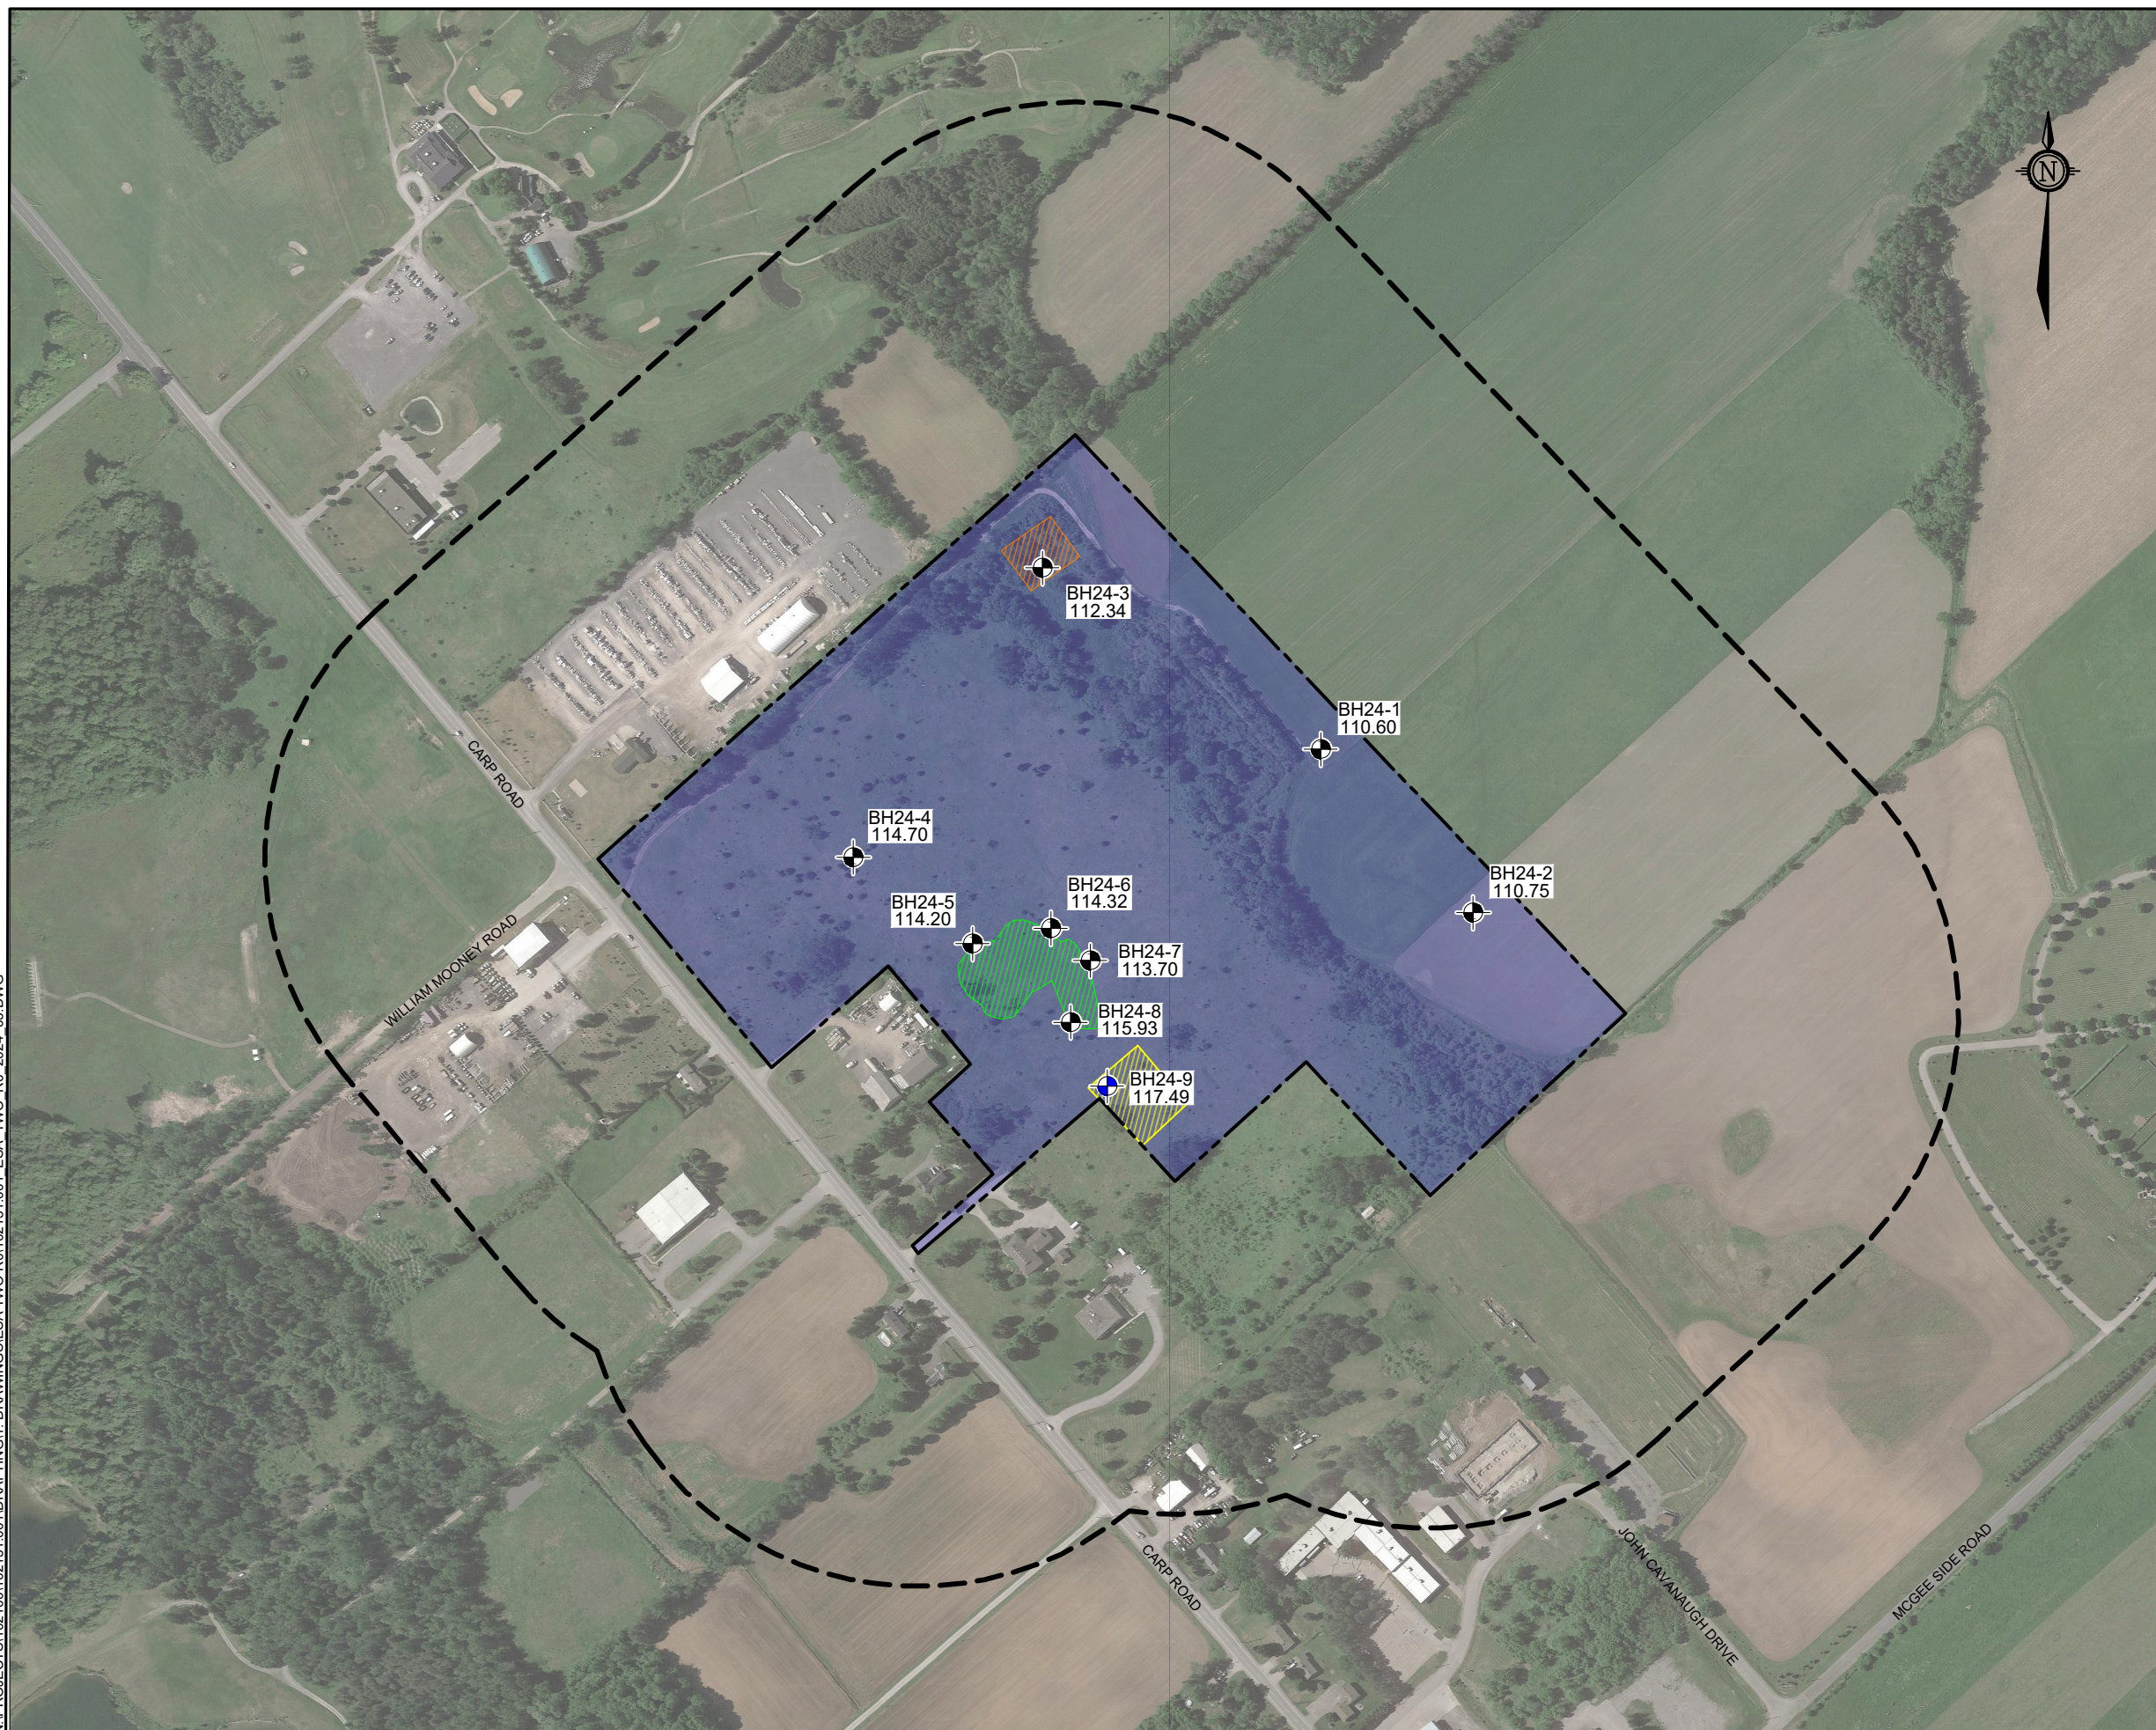
Utility locates were completed prior to the drilling program. On February 14, 2024, nine boreholes (BH24-1 to BH24-9) were advanced to depths ranging between 0.76 metres below ground surface (m bgs) and 3.35 m bgs. One borehole (BH/MW24-9) was completed as an overburden monitoring well to enable groundwater monitoring and sampling at the Site.

In general, the subsurface soil conditions encountered in the boreholes advanced as part of this Phase Two ESA (Boreholes BH24-1 through BH24-9) generally consisted of topsoil underlain by brown silty sand with trace clay and gravel. BH24-9 was advanced in a gravel graded parking lot and gravel was encountered up to 0.76 m bgs. The boreholes (BH24-1 to BH24-8) were advanced to depths ranging between 0.76 and 1.52 m bgs. BH/MW24-9 was advanced to the depth of 3.35 m bgs, refusal on inferred bedrock, and completed as a monitoring well.
