Stittsville South W4 Future Neighborhood Area: Environmental Impact Study for the Draft Plan of Subdivision

2025-04-25

Final Report

Project Number: CAIV 1300.4

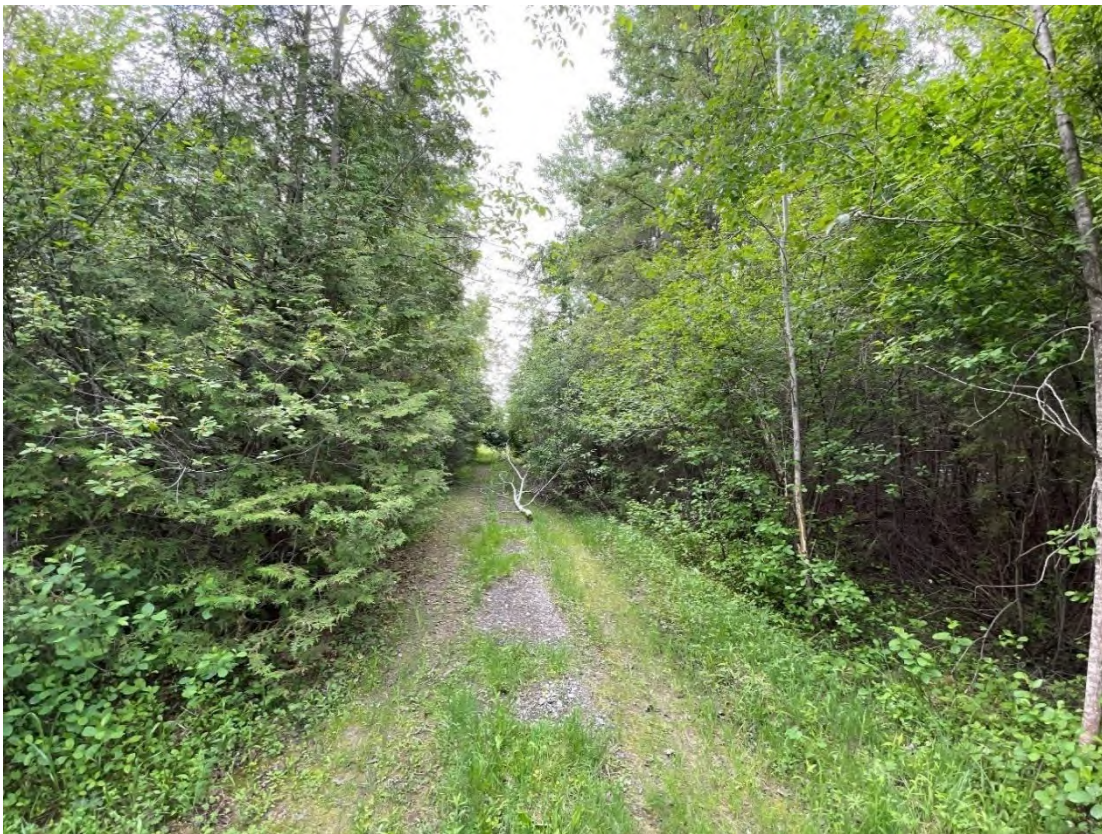
A broad swath of the western portion of the Site is characterized as a Dry - Fresh White Cedar – Hardwood Mixed Forest Type (FOMM4-3) community (Figure 4). It is dominated by Eastern White Cedar (*Thuja occidentalis*; 10-20 cm DBH), Trembling Aspen (*Populus tremuloides*; 10-20 cm DBH), Green Ash (*Fraxinus pennsylvanica*; 10-15 cm DBH), Large tooth Aspen (*Populus grandidentata*; ~15 cm DBH), White Spruce (*Picea glauca*; 30 cm DBH), White Pine (*Pinus strobus*; 25 cm DBH), Larch/Tamarack (*Larix laricina*; 15-20 cm DBH), American Beech (*Fagus grandifolia*; 10-15 cm DBH), and American Elm (*Ulmus americana*). Butternut* (*Juglans cinerea*; 20-50 cm DBH) were observed scattered throughout this community.

Figure 4. Dry - Fresh White Cedar – Hardwood Mixed Forest Type (FOMM4-3)

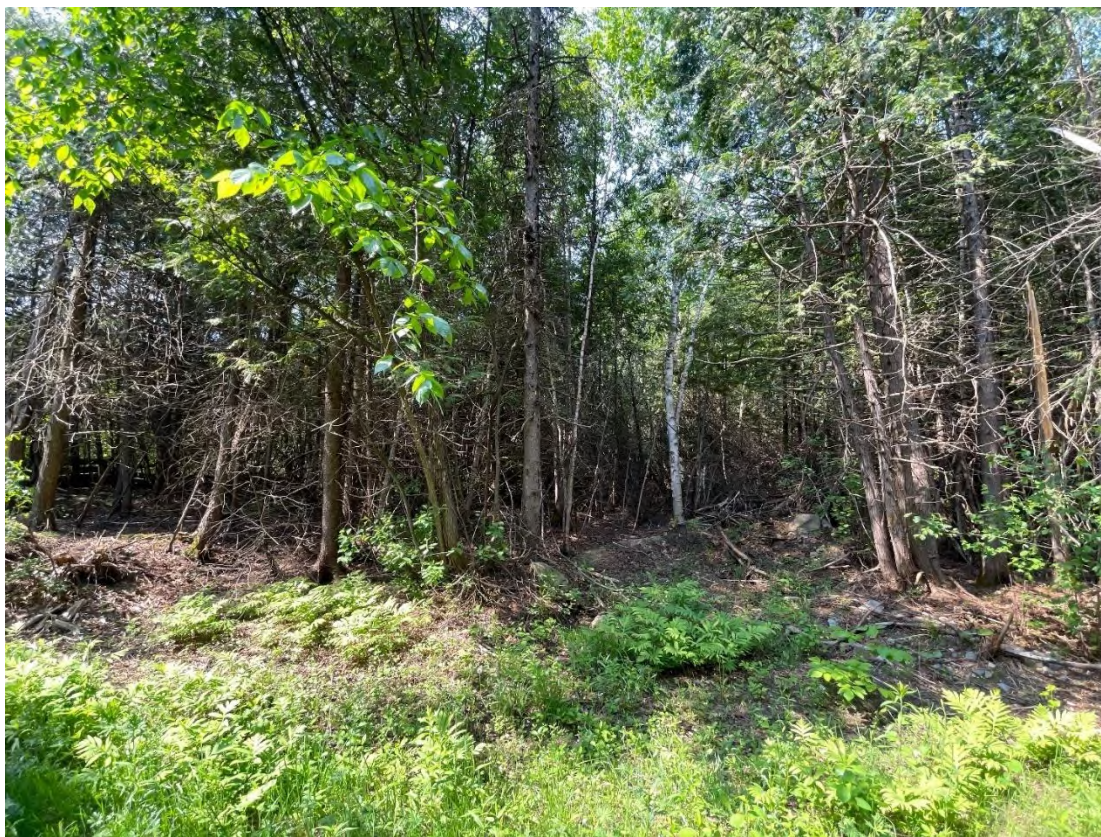
The western-most extent of the Site is characterized as a Fresh - Moist White Cedar - Hardwood Mixed Forest Type (FOMM7-2) community (Figure 5). It is dominated by Eastern White Cedar (*Thuja occidentalis*; 5-15 cm DBH), White Birch (*Betula papyrifera*; 10-20 cm DBH), Trembling Aspen (*Populus tremuloides*; 10-35 cm DBH), White Ash (*Fraxinus americana*; 5-8 cm DBH), White Spruce (*Picea glauca*; ~10 cm DBH), and Balsam Fir (*Abies Balsamea*) tree species.

Figure 5. Fresh - Moist White Cedar - Hardwood Mixed Forest Type (FOMM7-2)

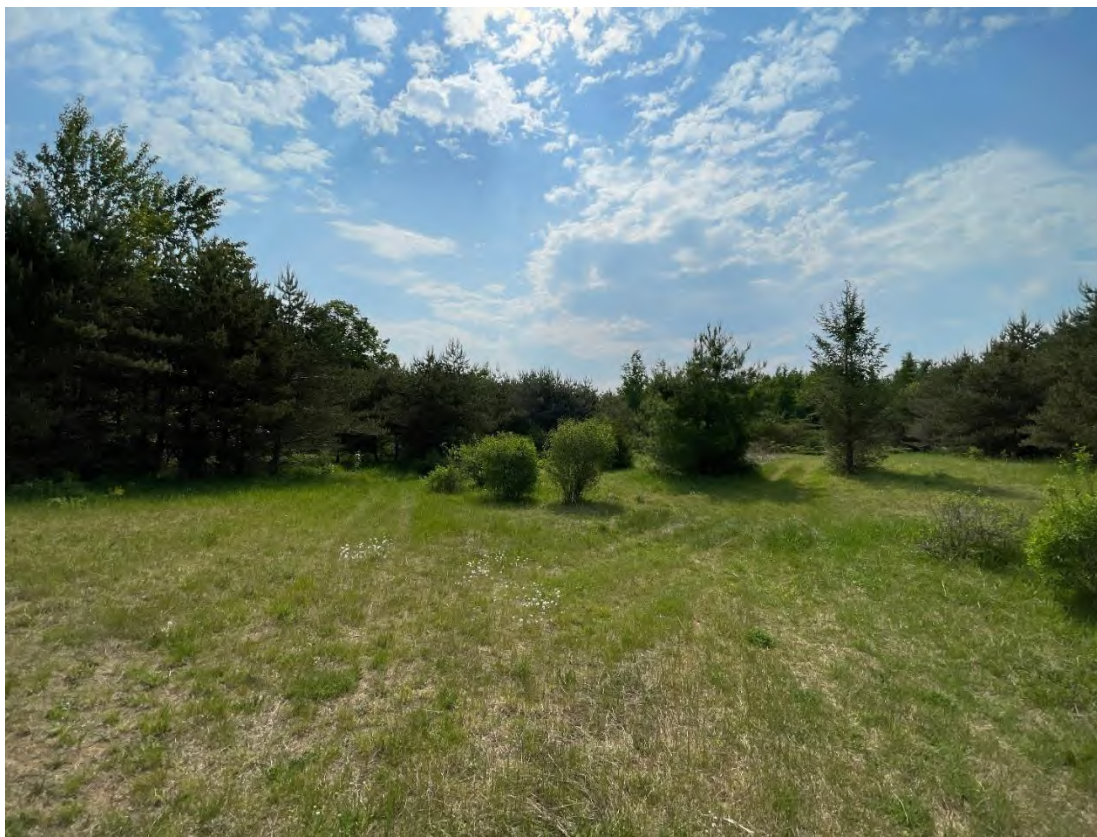
A Dry – Moist Old Field Meadow Type (CUM1-1; Figure 6) is located centrally on the Site. This area is characteristic of previous disturbance with scattered tree species including Large tooth Aspen (*Populus grandidentata*; ~5 cm DBH), Trembling Aspen (*Populus tremuloides*; 10-25 cm DBH), Eastern White Cedar (*Thuja occidentalis*; ~10 cm DBH), Scots Pine (*Pinus sylvestris*; 5-10 cm DBH), American Beech (*Fagus grandifolia*; ~10 cm DBH), Apple Spp. (*Malus*; 8-10 cm DBH), White Spruce (*Picea glauca*; 20-25 cm DBH), Larch/Tamarack (*Larix laricina*; ~5-10 cm DBH), Green Ash (*Fraxinus pennsylvanica*; <5 cm DBH). Dominant shrub and groundcover species included Common Juniper (*Juniperus communis*), Trembling Aspen (*Populus tremuloides*) saplings, Orchard Grass (*Dactylis glomerata*), Wild Strawberry (*Fragaria vesca*), Canada Goldenrod (*Solidago canadensis*), Poison Ivy (*Toxicodendron radicans*), Red Raspberry (*Rubus idaeus*), Alder Buckthorn (*Rhamnus frangula*), and Common Blackberry (*Rubus allegheniensis*).

Figure 6. Dry – Moist Old Field Meadow Type (CUM1-1)

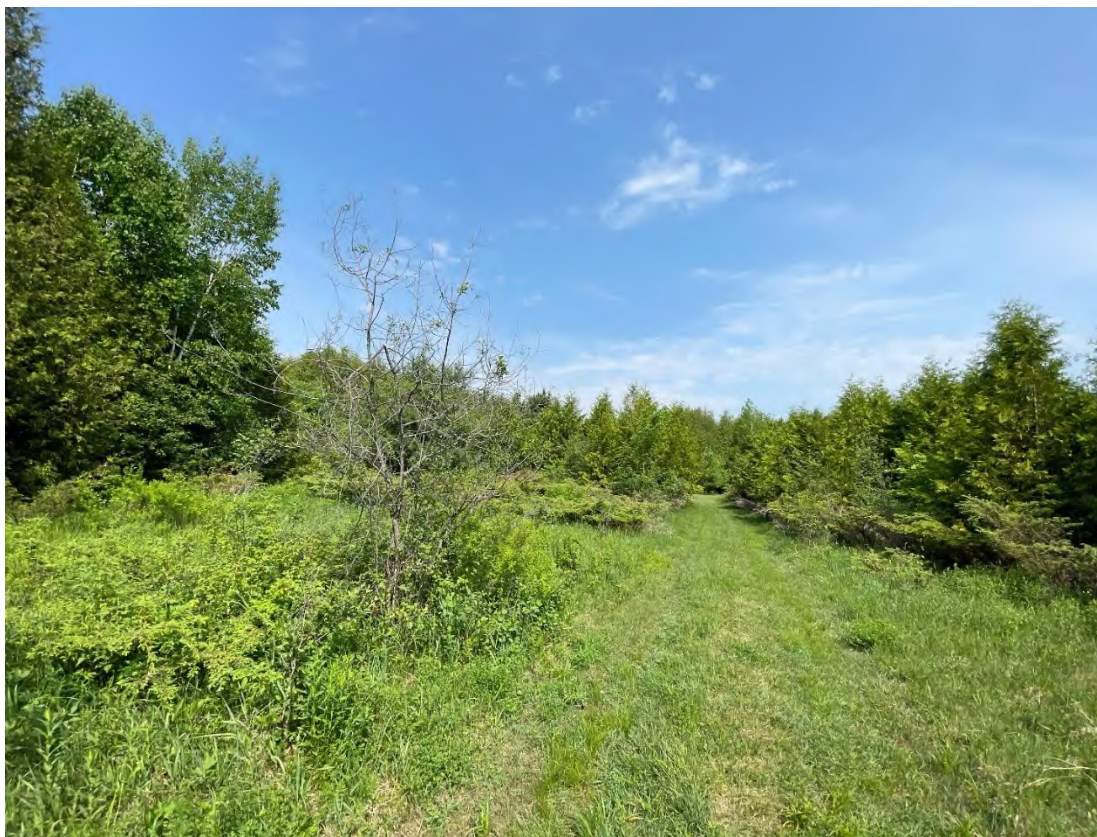
A Dry – Fresh Mixed Meadow Ecosite (MEMM3) is located in the northwest corner of the Site (Figure 7). This area is mainly characterized by Eastern White Cedar (*Thuja occidentalis*), Scots Pine (*Pinus sylvestris*; ~10-20 DBH), Larch/Tamarack (*Larix laricina*; ~10 DBH), and scattered Butternut* (*Juglans cinerea*; ~10-20 DBH) trees. Dominant shrub and groundcover species included Common Juniper (*Juniperus communis*), Orchard grass (*Dactylis glomerata*), Wild strawberry (*Fragaria vesca*), Canada Goldenrod (*Solidago canadensis*), Alder Buckthorn (*Rhamnus frangula*), and Common Blackberry (*Rubus allegheniensis*).

Figure 7. Dry – Fresh Mixed Meadow Ecosite (MEMM3)

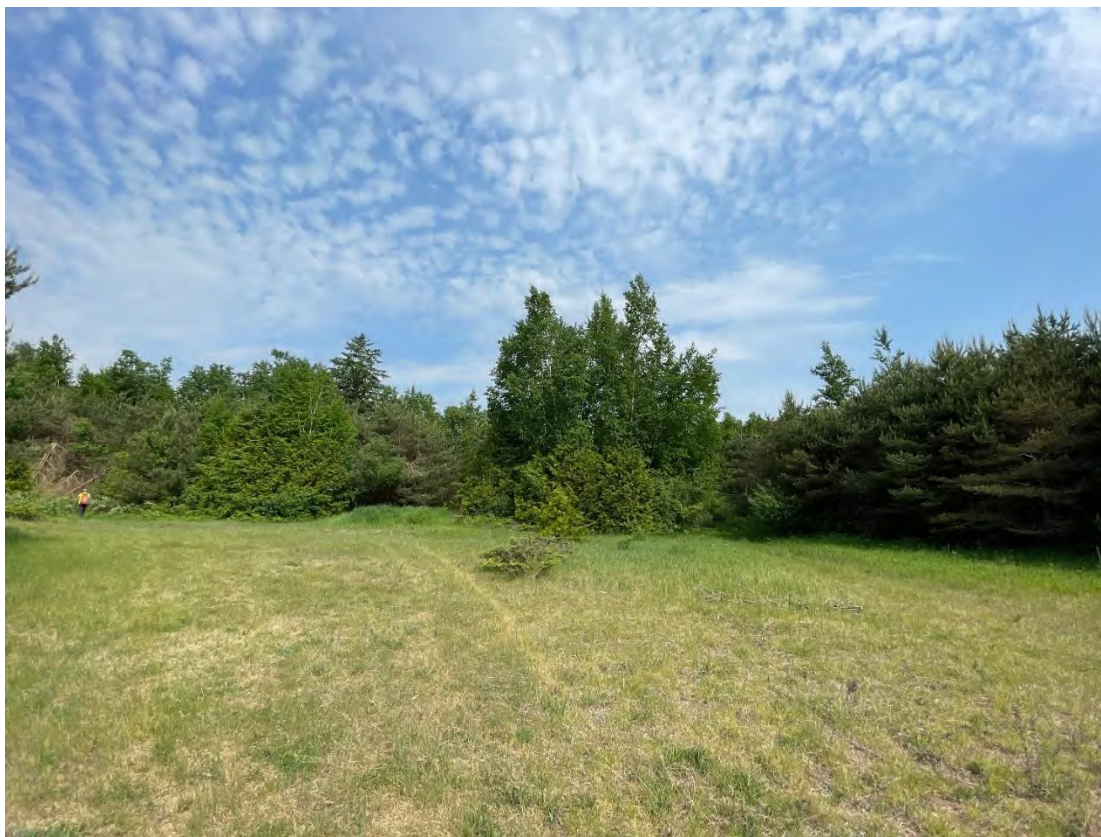
A Fresh Scots Pine Naturalized Coniferous Plantation Type (FOCM6-3) is located in the northwest corner of the Site (Figure 8). It is mainly dominated by Scots Pine (*Pinus sylvestris*; ~10-20 cm DBH), Jack Pine (*Pinus banksiana*; ~15 cm DBH), Eastern White Cedar (*Thuja occidentalis*), White Pine (*Pinus strobus*; ~20 cm DBH), White Birch (*Betula papyrifera*; 10-20 cm DBH), Butternut* (*Juglans cinerea*), American Beech (*Fagus grandifolia*), and Green Ash (*Fraxinus pennsylvanica*; 10-15 cm DBH).

Figure 8. Dry – Fresh Scots Pine Naturalized Coniferous Plantation Type (FOCM6-3)

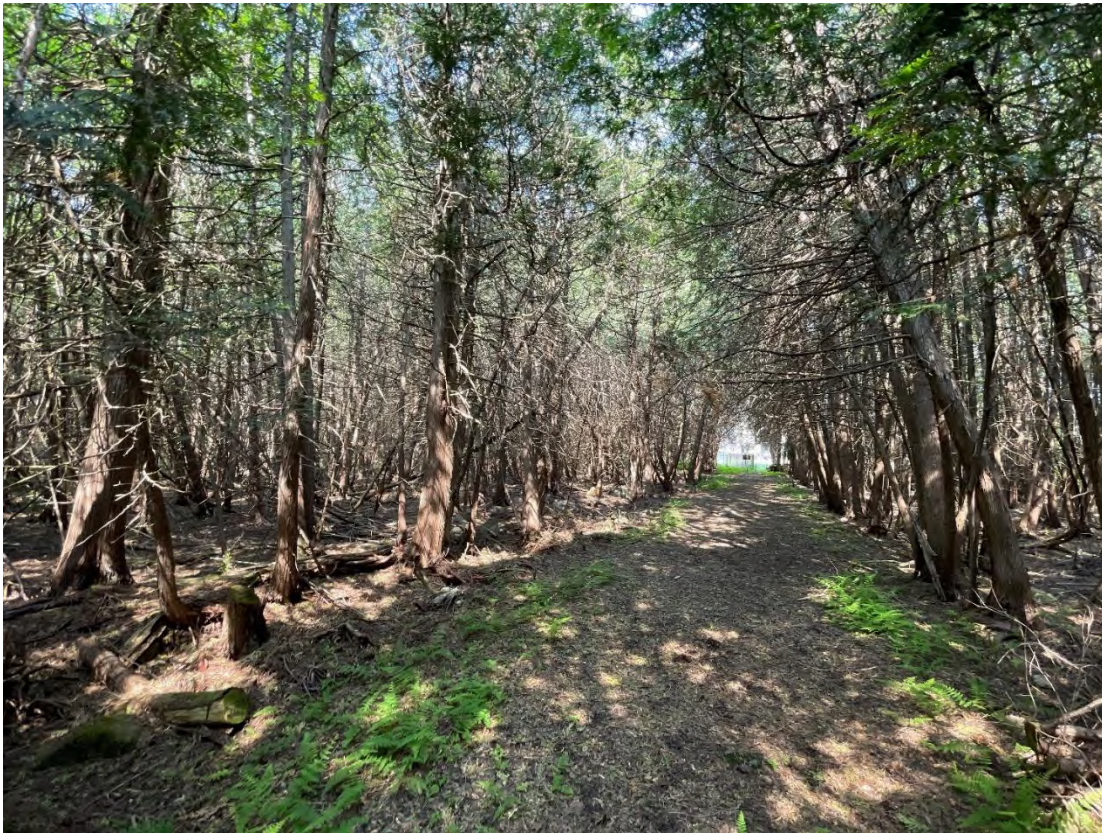
A White Cedar Mineral Coniferous Swamp (SWCM1-1) is located on Site (Figure 9). It is dominated by Eastern White Cedar (*Thuja occidentalis*) and has ground cover consisting of Bulblet Bladder Fern (*Cystopteris bulbifera*), Alder Buckthorn (*Rhamnus frangula*), Interrupted Fern (*Osmunda claytoniana*), Sensitive Fern (*Onoclea sensibilis*), and Poison Ivy (*Toxicodendron radicans*).

Figure 9. White Cedar Mineral Coniferous Swamp (SWCM1-1)

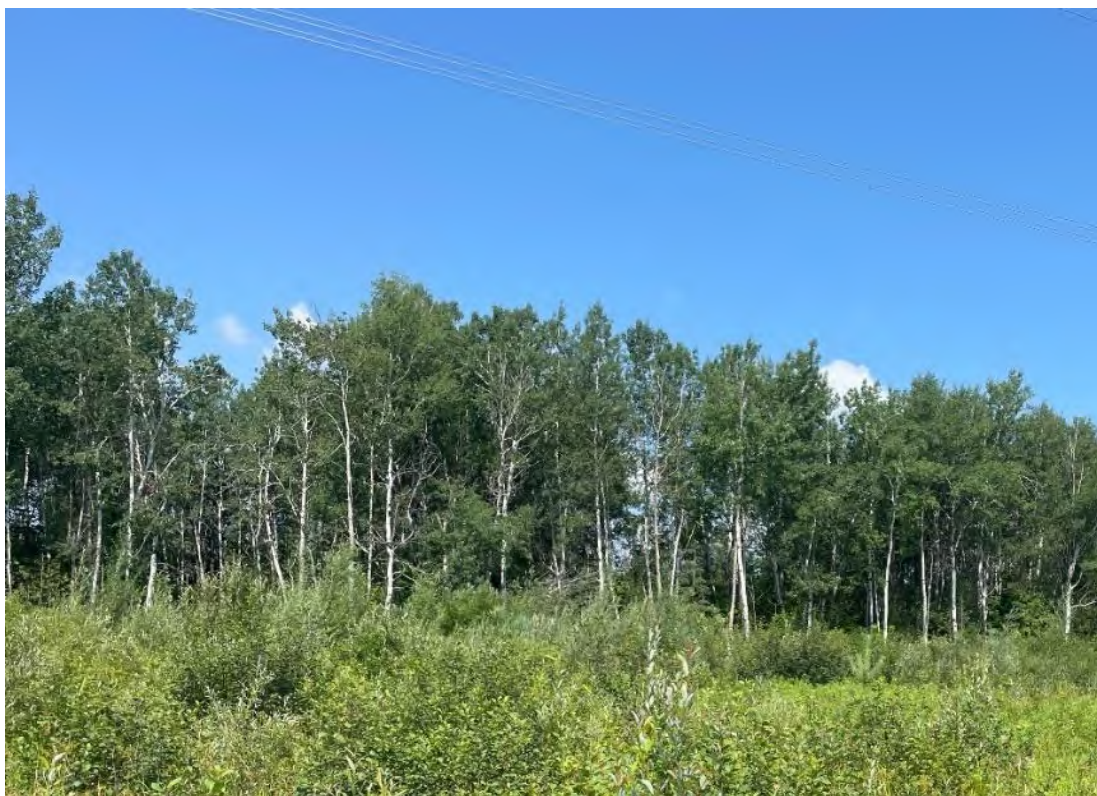
A Fresh-Moist Lowland Deciduous Forest Ecosite (FODM7) is located in the center of the Site (Figure 10). It is dominated by Trembling Aspen (*Populus tremuloides*) Eastern White Cedar (*Thuja occidentalis*), Butternut* (*Juglans cinerea*), Black Ash* (*Fraxinus nigra*), and Balsam Poplar (*Populus balsamifera*). Its ground cover consists of Common Buckthorn (*Rhamnus cathartica*), Poison Ivy (*Toxicodendron radicans*), White Panicle Aster (*Symphotrichum lanceolatum*), Riverbank Grape (*Vitis riparia*), Common Ragweed (*Ambrosia artemisiifolia*), and Yellow Sweet Clover (*Melilotus officinalis*).

Figure 10. Fresh – Moist Lowland Deciduous Forest Ecosite (FODM7)

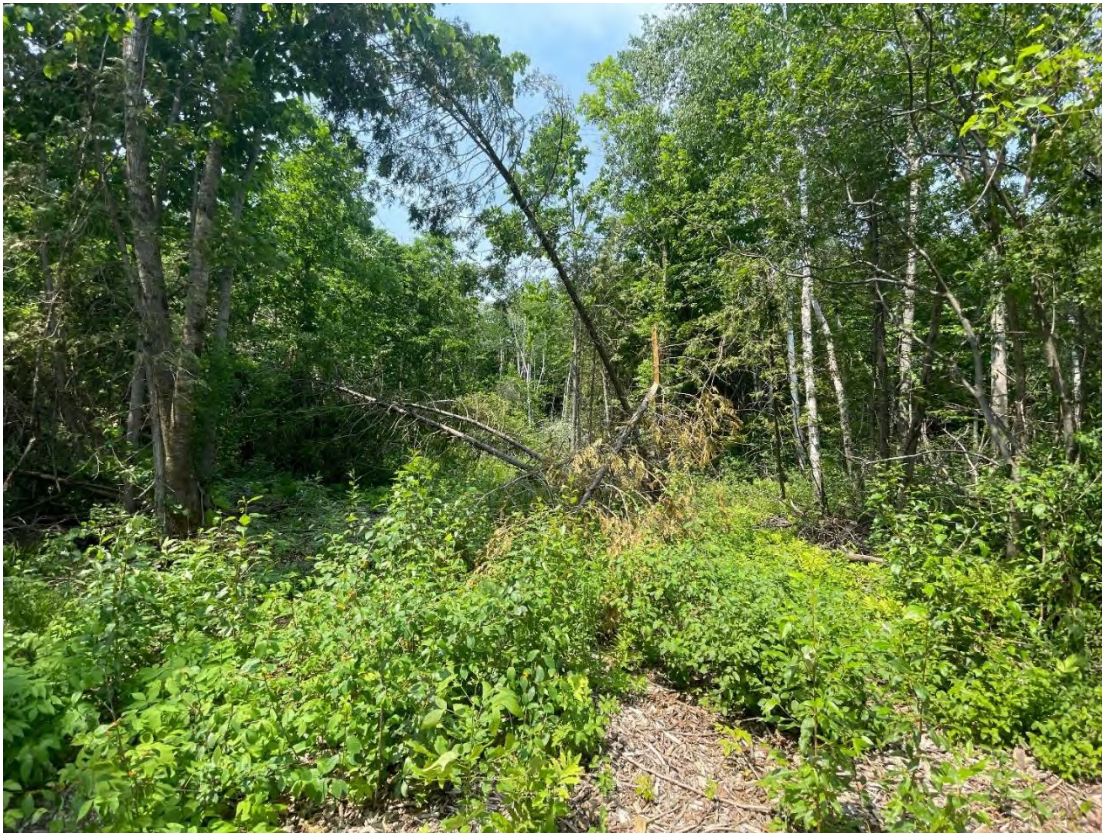
A Fresh – Moist Poplar Deciduous Forest Type (FODM8-1; Figure 11) is located on Site and is dominated by Trembling Aspen (*Populus tremuloides*; 10-20 cm DBH), White Birch (*Betula papyrifera*; 10-20 cm DBH), Balsam Poplar (*Populus balsamifera*; 10-25 cm DBH), Butternut* (*Juglans cinerea*; 10-20 cm DBH), Eastern White Cedar (*Thuja occidentalis*; 10-20 cm DBH), Basswood (*Tilia americana*; ~30 cm DBH), Red Maple (*Acer rubrum*; ~27 cm DBH), American Elm (*Ulmus americana*; 10-20 cm DBH), and Black Ash* (*Fraxinus nigra*). Its dominant ground cover consists of Common Juniper (*Juniperus communis*), Trembling Aspen saplings (*Populus tremuloides*), Sensitive Fern (*Onoclea sensibilis*), Ostrich Fern (*Matteuccia struthiopteris*), Interrupted Fern (*Osmunda claytoniana*), Canada Goldenrod (*Solidago canadensis*), Poison Ivy (*Toxicodendron radicans*), Alder Buckthorn (*Rhamnus frangula*), Bloodroot (*Sanguinaria*), and Meadow Horsetail (*Equisetum pratense*).

Figure 11. Fresh – Moist Poplar Deciduous Forest Type (FODM8-1)
