PATERSON GROUP

Attention: **Ms. Stefanie Kaminski**

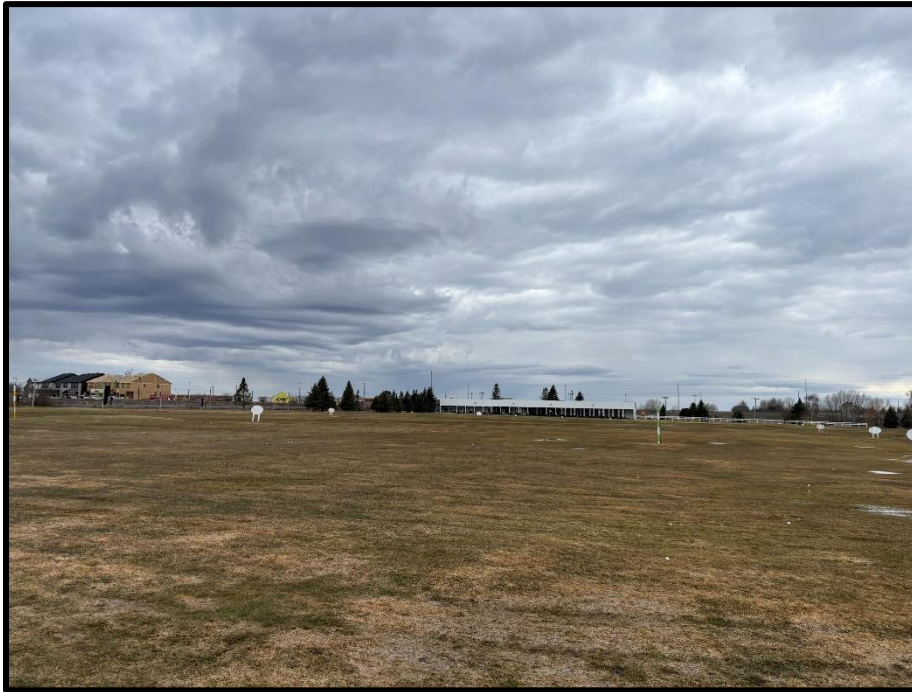
Photograph 1: View of the southeastern portion of the Phase I Property, facing northwest.

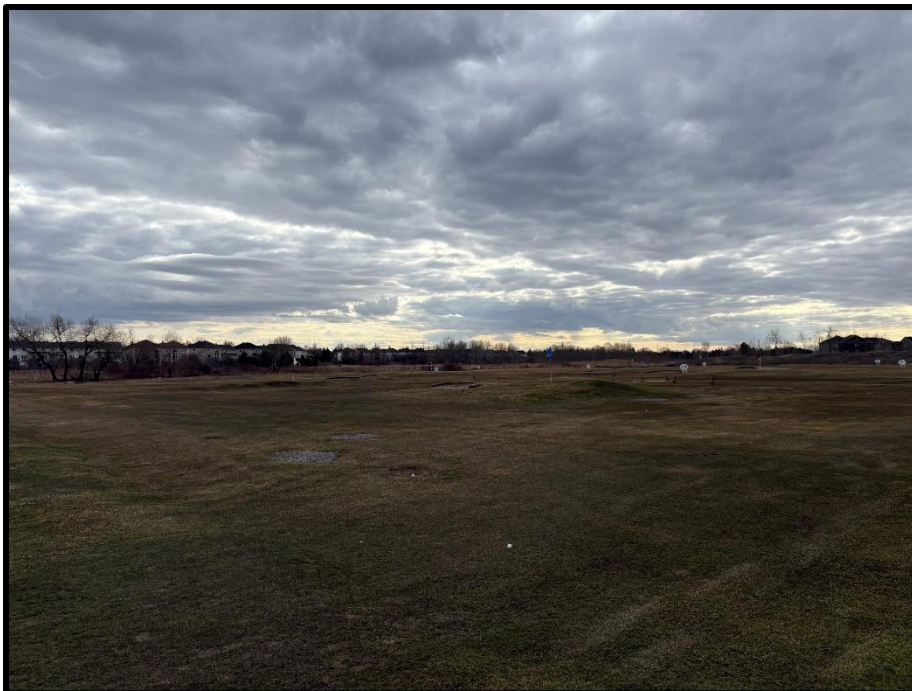
Photograph 2: View of the central portion of the Phase I Property, facing east.

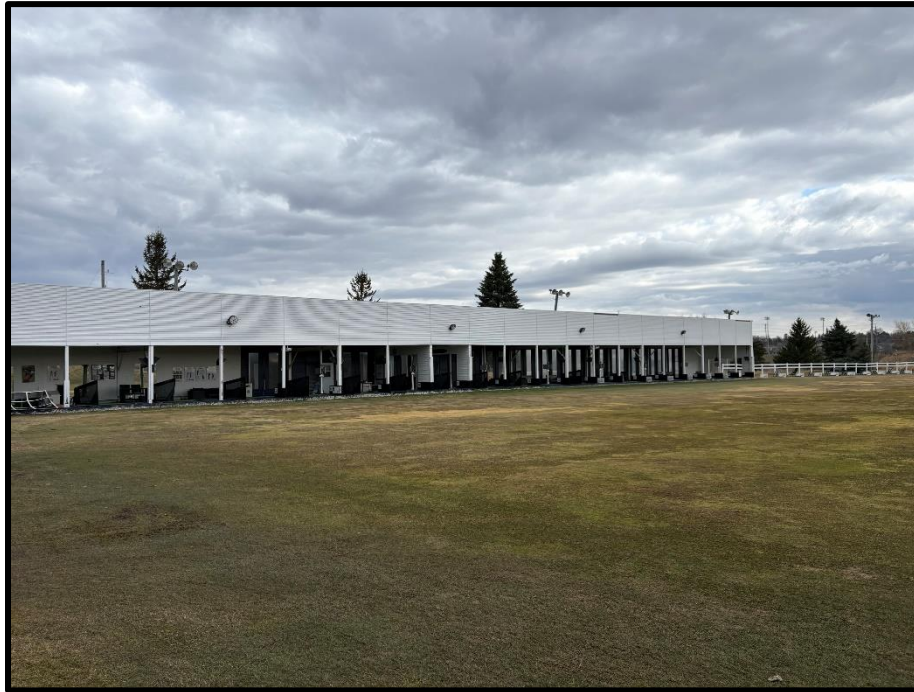
Photograph 3: View of the gold driving range pro shop building, facing north.

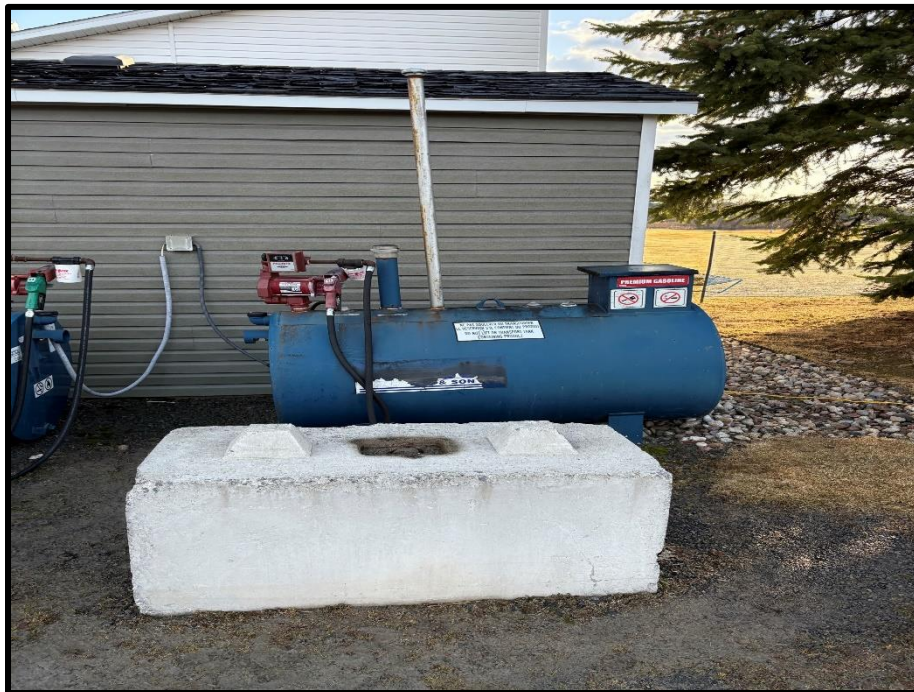
At the time of the site inspection, two aboveground fuel storage tanks were identified adjacent to the south side of the subject building. The tanks were each noted to be constructed and vacuum sealed with double-steel walls and contain a capacity for 1,360 litres of gasoline and coloured diesel fuel. The tanks were observed to be in good condition, with no signs of fuel leakage or corrosion visible on the exterior shell or underlying ground surface. In addition, the pressure gauges on the tanks were noted to display negative pressures, indicating that the interior vacuum seals were intact. Due to the potential for soil and/or groundwater impacts resulting from fuel leaks and/or spillages, these fuel tanks are considered to represent an APEC on the Phase I Property.

Photograph 4: View of the aboveground fuel storage tanks, located within the southwestern portion of the Phase I Property, adjacent to the south side of the golf driving range pro shop building.
