## **Phase II – Environmental Site Assessment**

560 Hazeldean Road  
Ottawa, Ontario

Prepared for Double Deck Regional Inc.  
c/o Regional Group

Report: PE5304-2  
July 15, 2025

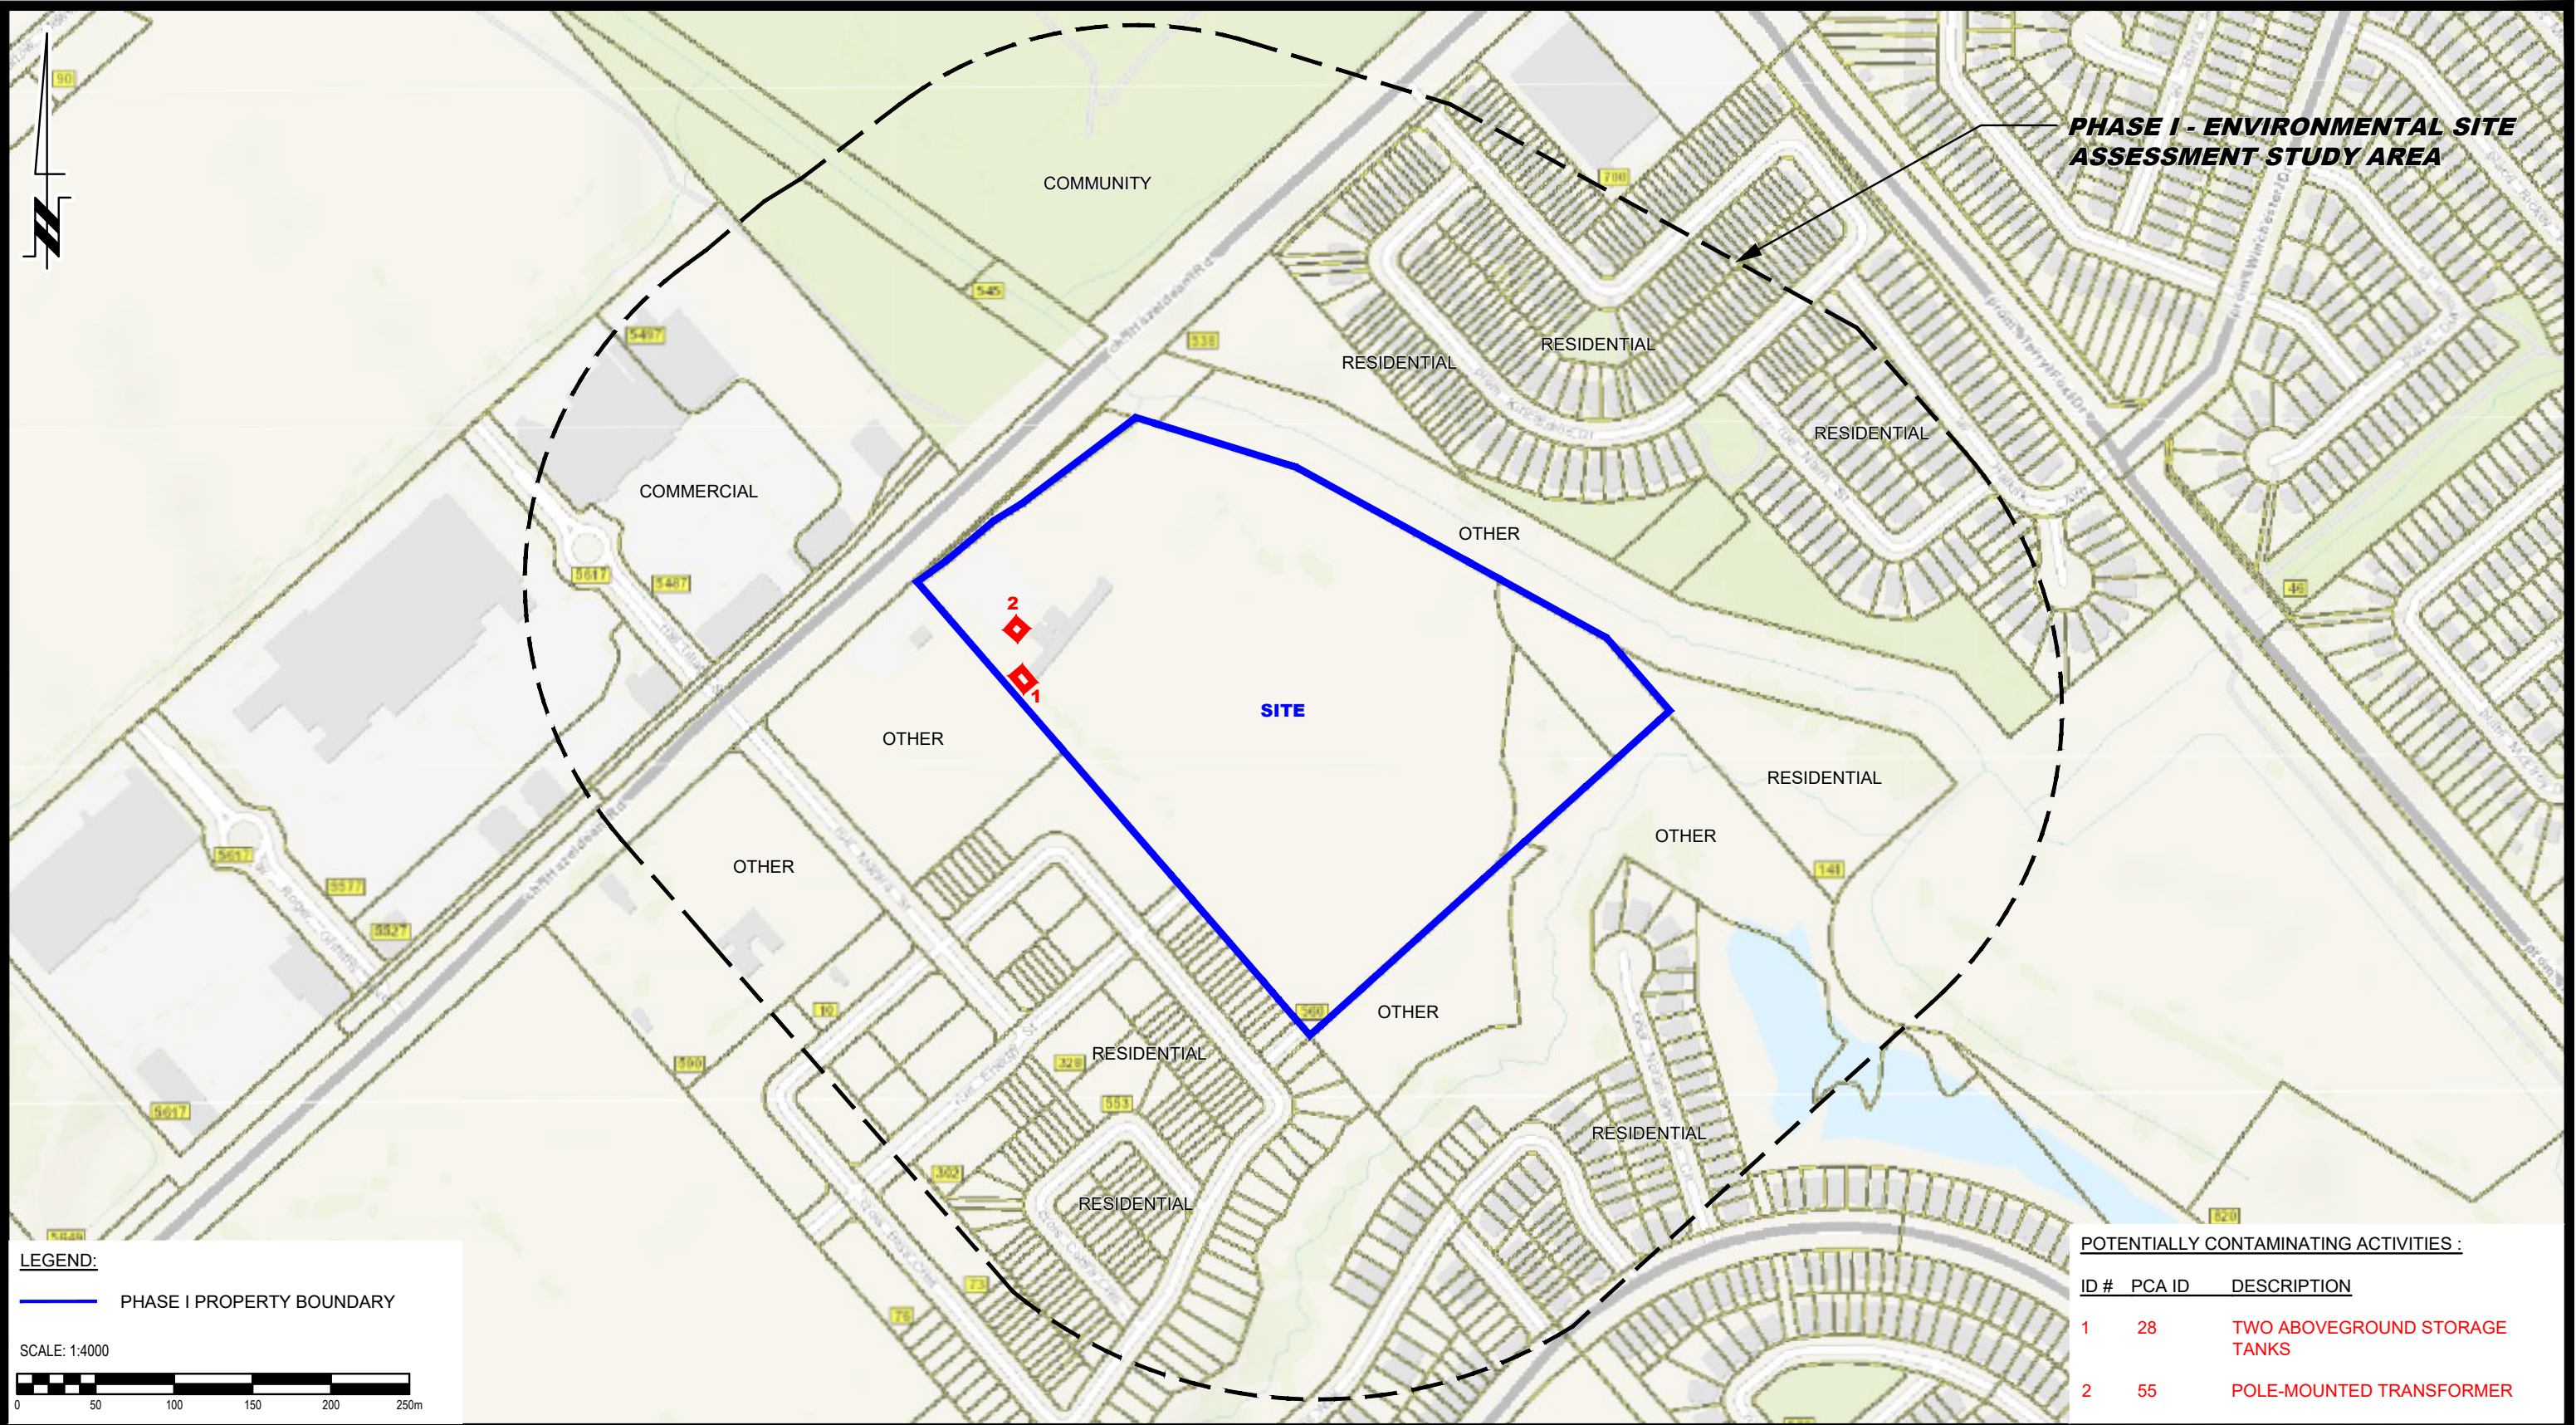
The surrounding lands within the Phase I Study Area consist largely of residential and commercial properties. Current land use is depicted on Drawing PE5304-2R – Surrounding Land Use Plan, in the Figures section of this report.

POTENTIALLY CONTAMINATING ACTIVITIES :		
ID #	PCA ID	DESCRIPTION
1	28	TWO ABOVEGROUND STORAGE TANKS
2	55	POLE-MOUNTED TRANSFORMER

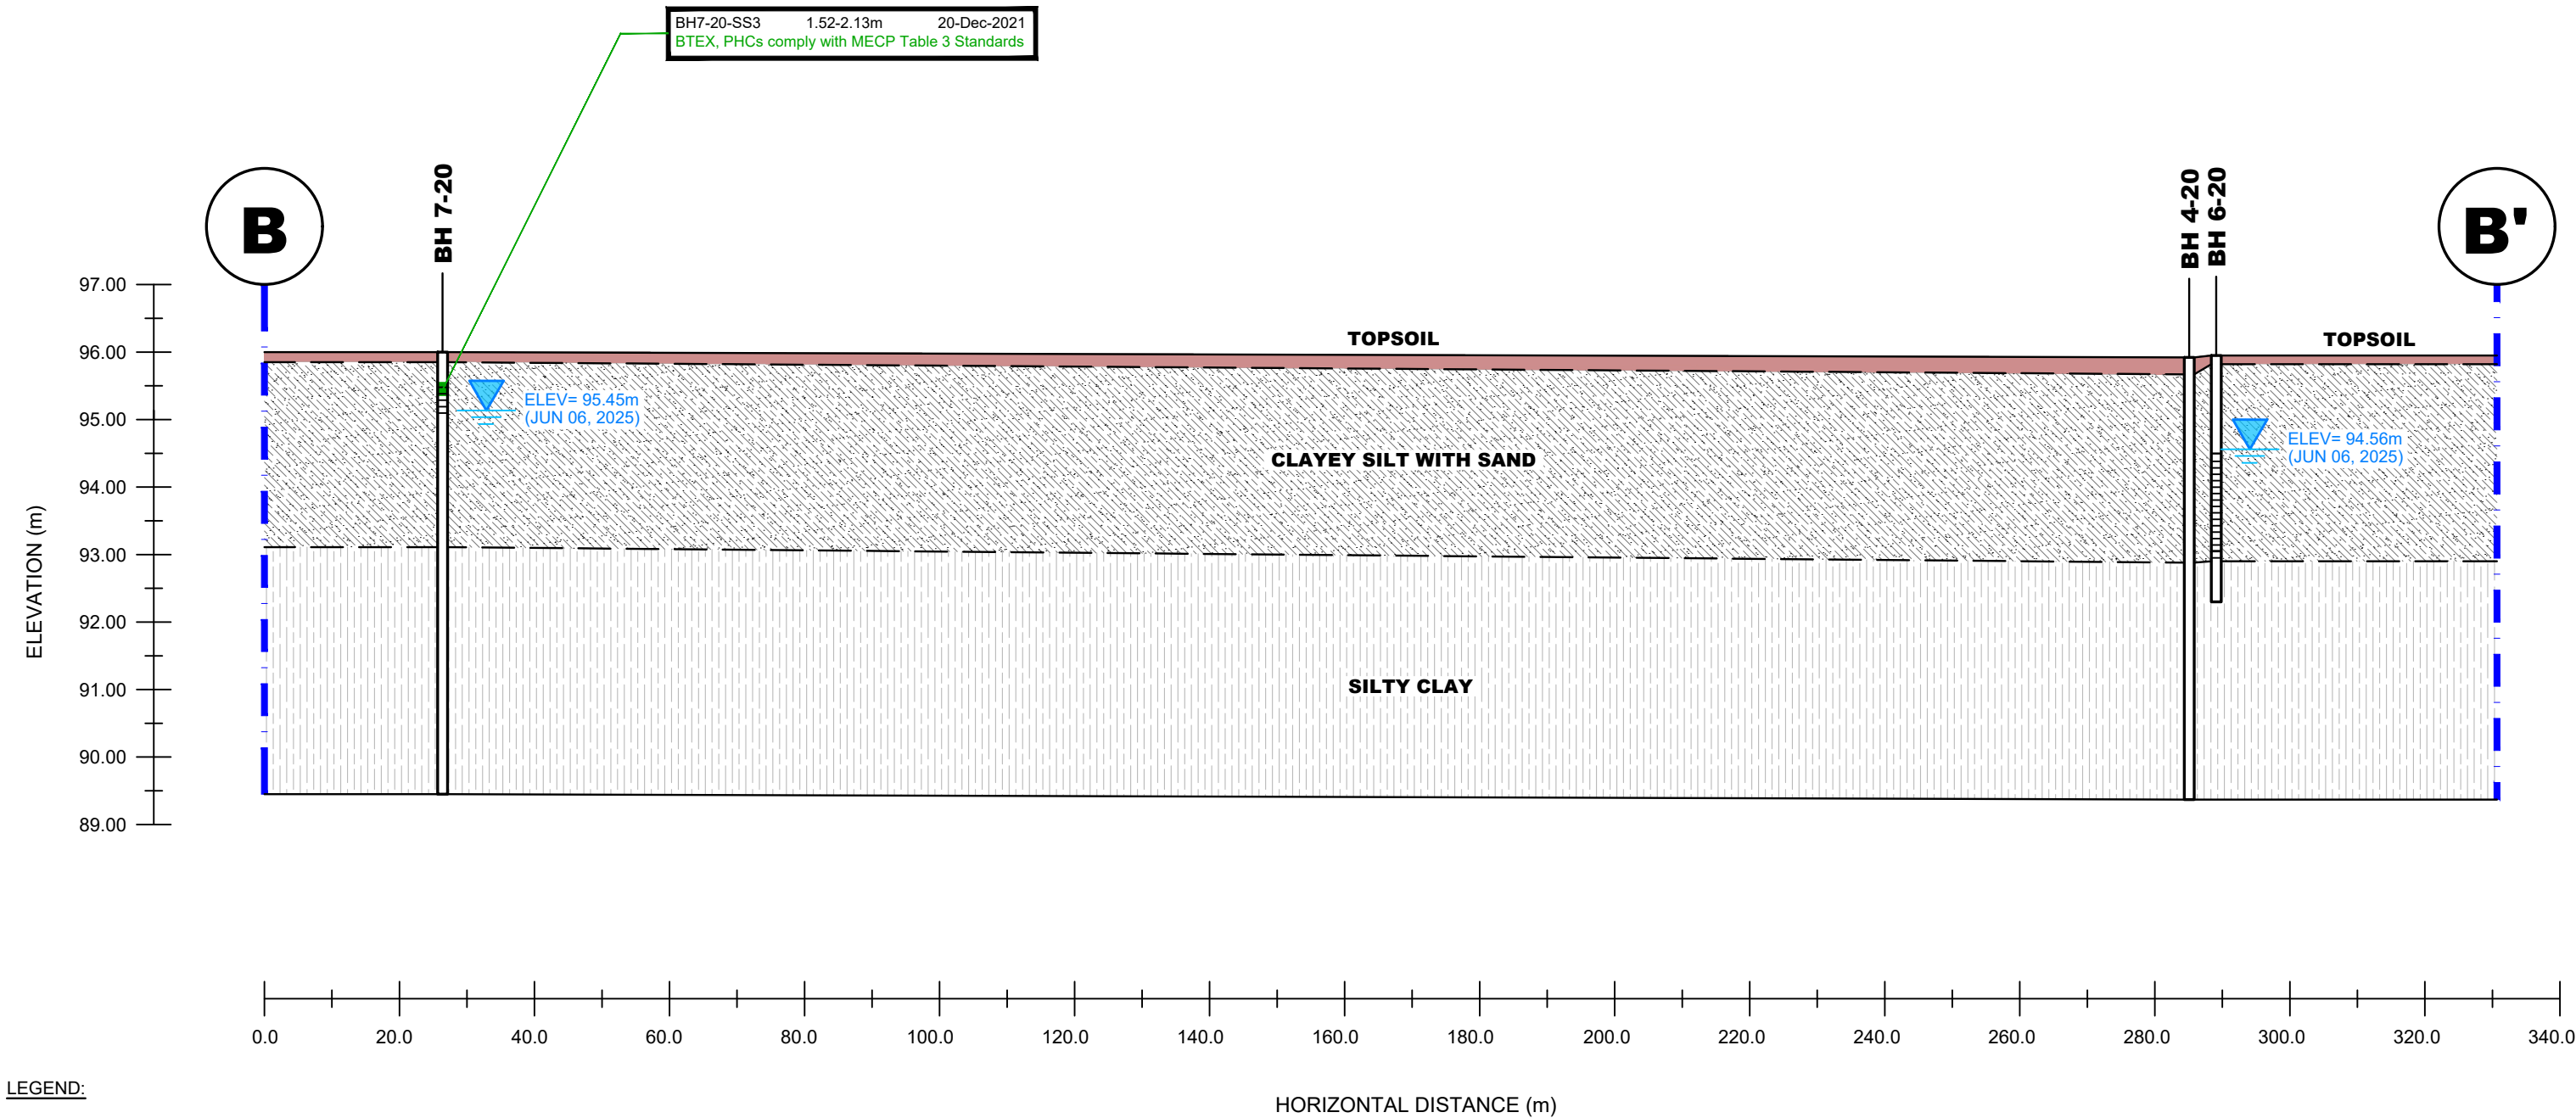
**SOIL RESULT COMPLIES WITH THE MECP TABLE 3 STANDARDS**

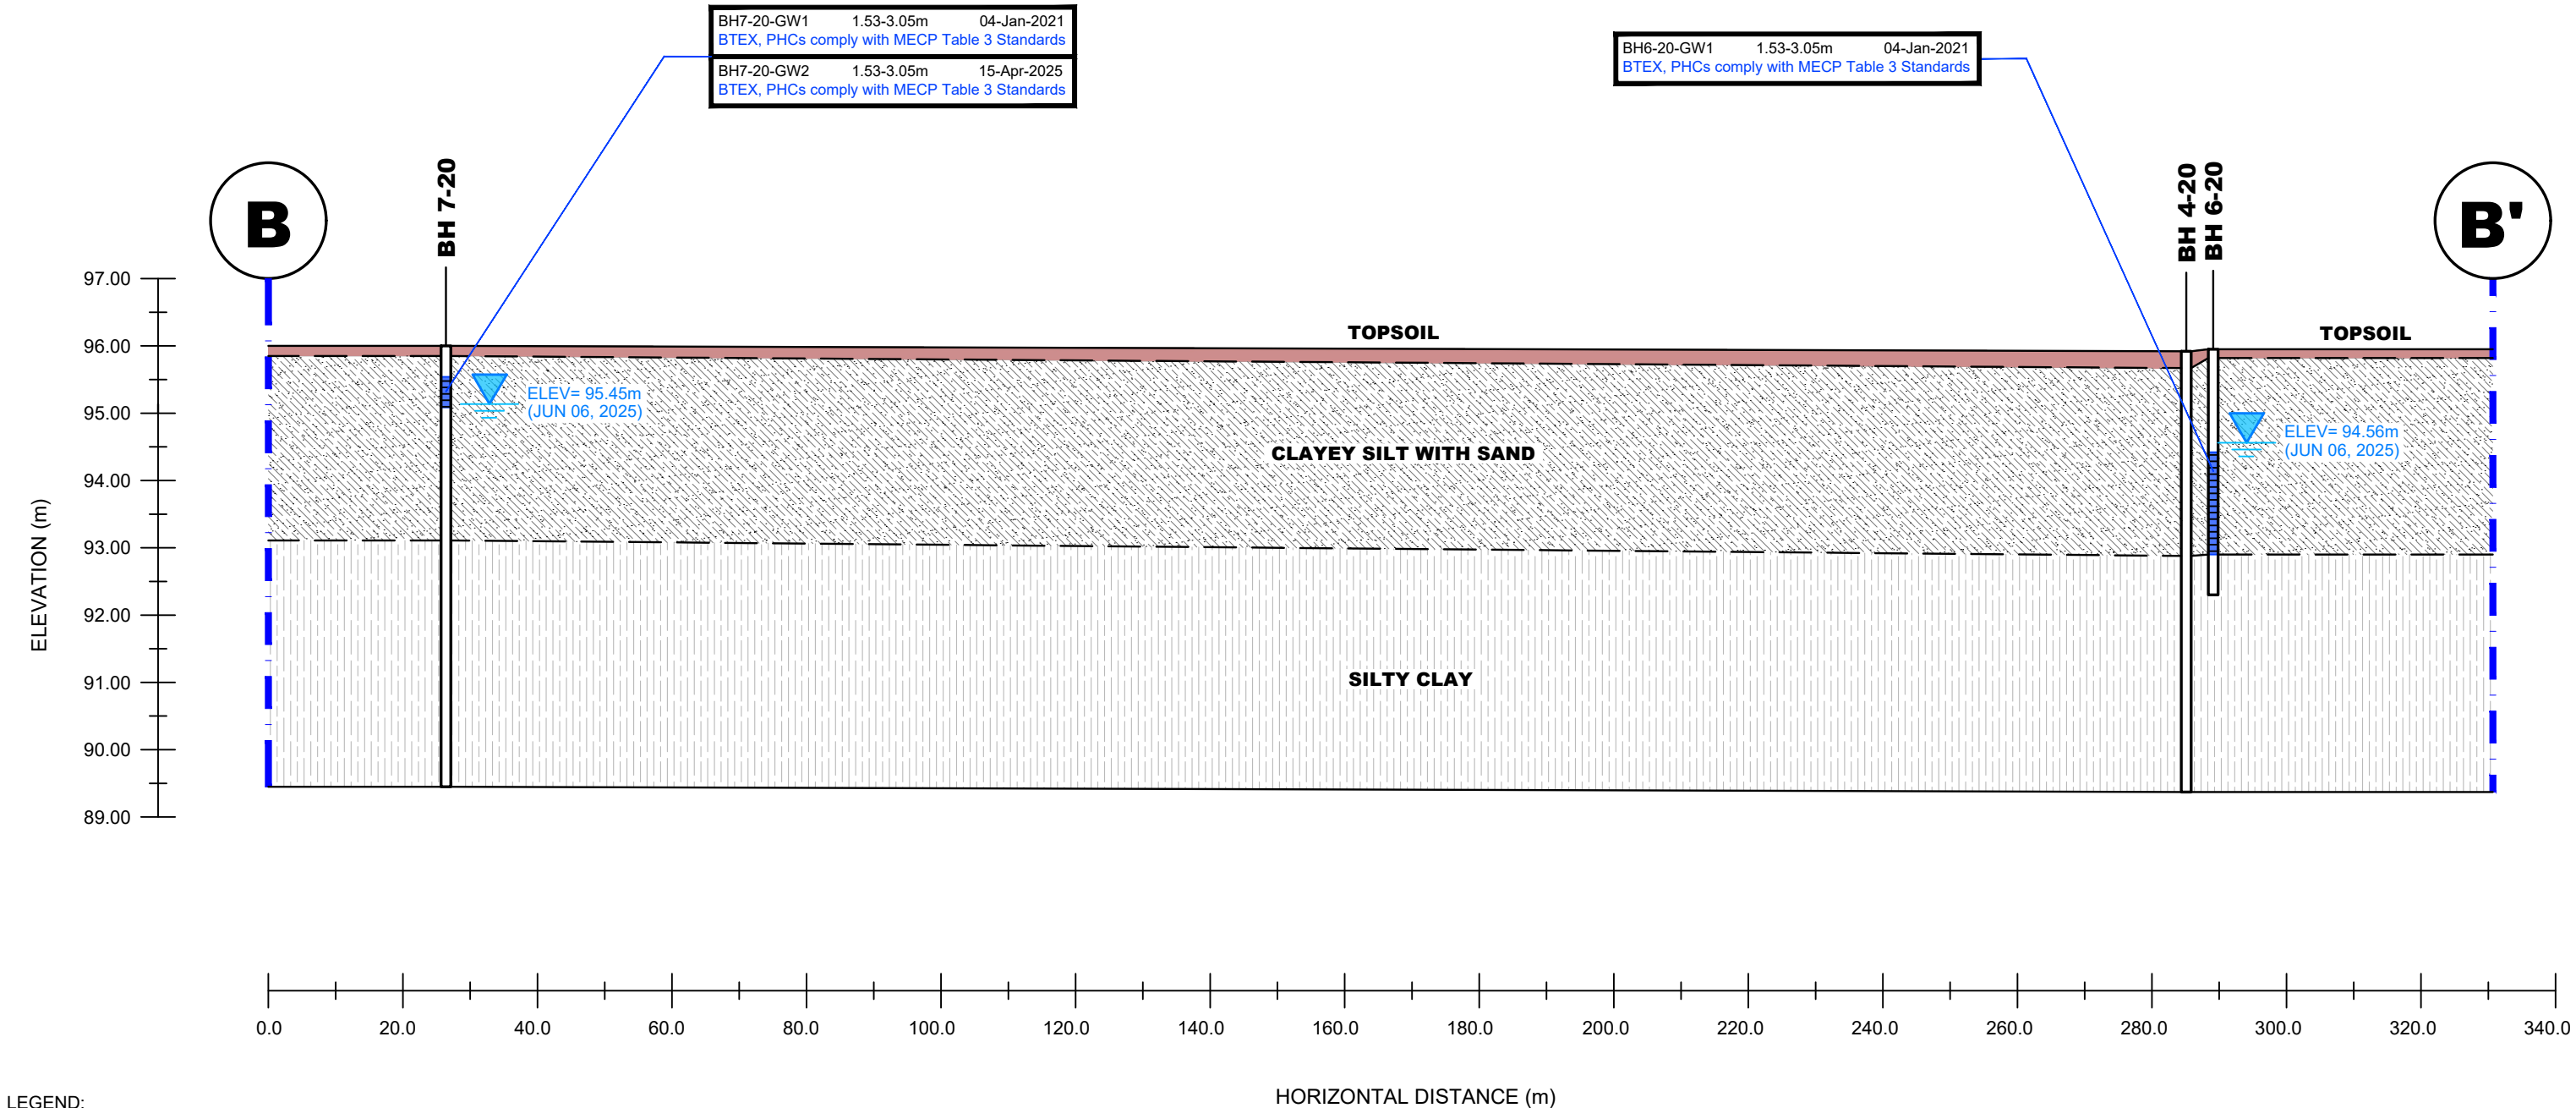
**DRAWING PE5304-5B – CROSS SECTION B-B' – GROUNDWATER**

GROUNDWATER RESULT COMPLIES WITH THE MECP TABLE 3 STANDARDS
