# S-4 Leitrim Urban Expansion Area

## Serviceability Report

2025-08-08

Arcadis Professional Services (Canada) Inc.  
333 Preston Street, Suite 500  
Ottawa, Ontario  
K1S 5N4

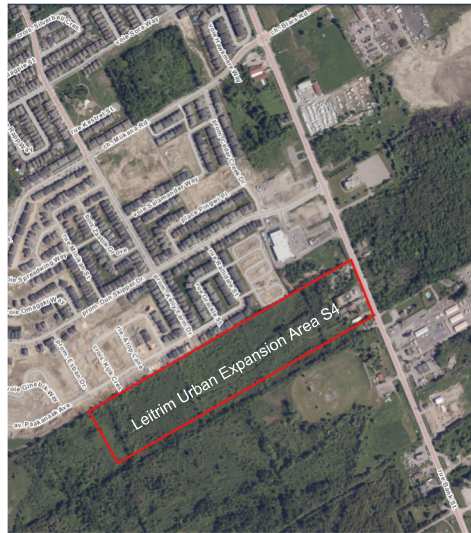
*Figure 1-1 – Site Location*

The development area consists primarily of undeveloped lands under single ownership by the Edge at Pathways Regional Inc., a city-owned water pump station, and three existing rural lots with frontage along Bank Street.

Please refer to **Figure 1-1** below for more information on the site location.

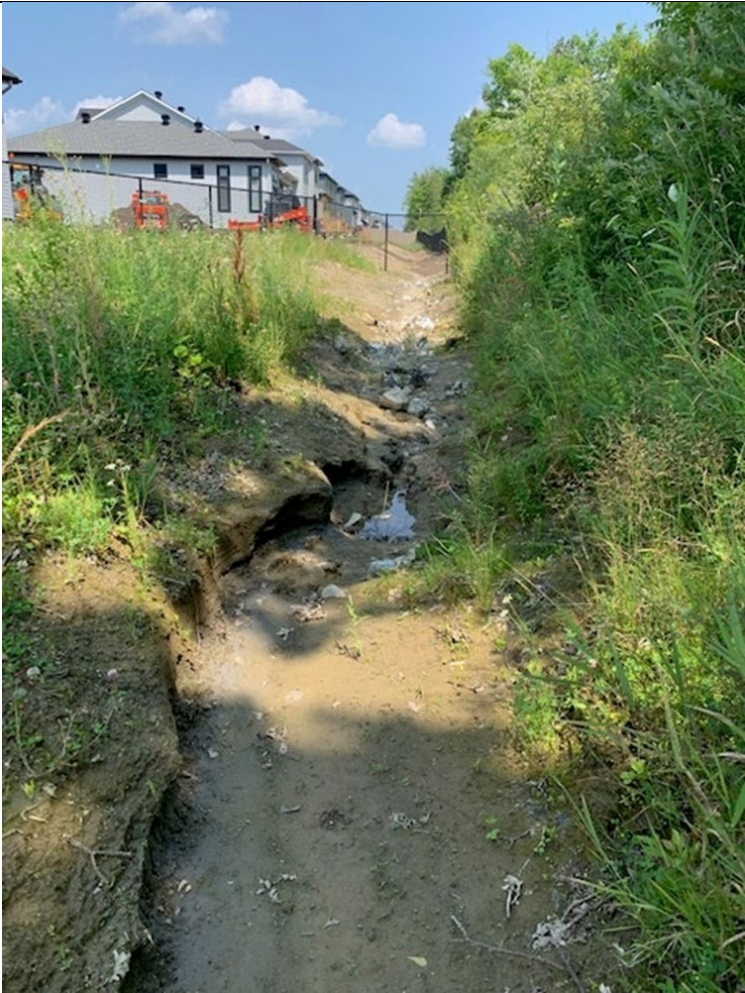
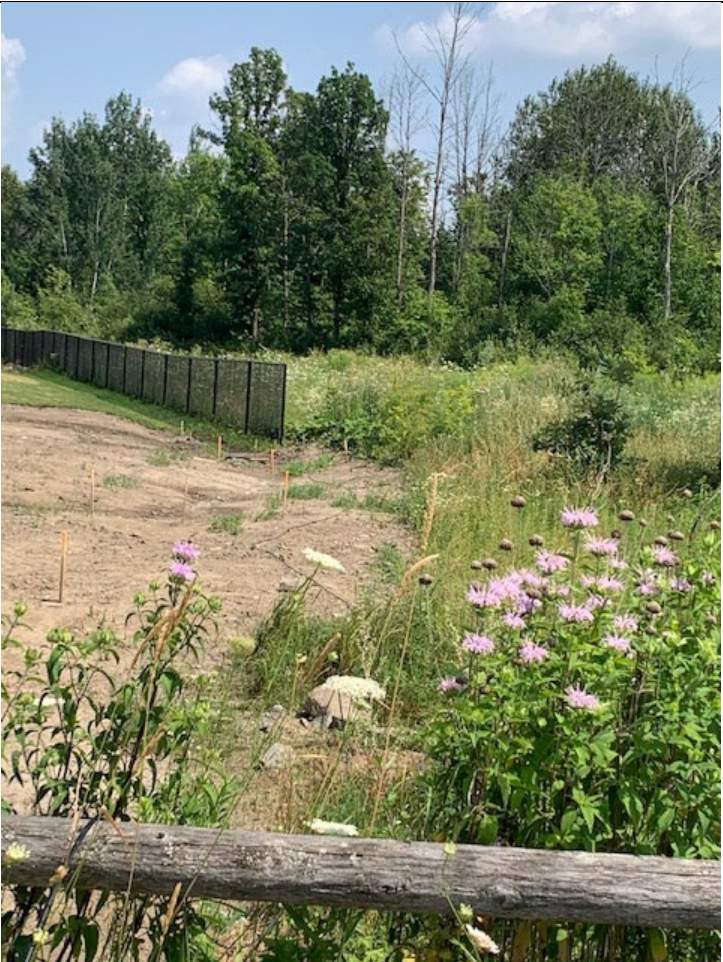
| Constructed Channel Plan Fig. 6-2 EMP Reference Location | Notes/Observations | Aerial Photo Location | Corresponding Site Photos | |
|---|---|---|---|---|
| LOCATION A<br><br>INT-3<br>Watercourse and<br><br>Watercourse outlet and start of Conveyance Channel and end of Scratch Ditch/rear yard swale on adjacent development | <p><b>Observations</b></p> <ul style="list-style-type: none"><li>- not apparent where the INT-3 HDFA watercourse enters into the channel, outlet now obstructed with rock weir and not functioning – needs maintenance/removal</li><li>- Rear Yard double swale/ Scratch Ditch entirely on private properties – As Built location of Scratch Ditch different than Remer Site Serviceability Plan</li><li>- double swale design to service subdivision and catch overland flows</li><li>- erosion where scratch ditch enters constructed channel</li><li>-conveyance area was moist after rain but essentially with no vegetation in this area</li><li>- Tire tracks of a vehicle in dry mud</li></ul> <p><b>INT-3</b><br/>Intermittent watercourse 3 (INT-3) enters the southwest part of the Site from the southeast. INT-3</p> | | | |

| | <p>appears to convey surface flow from the upstream rural lands to the south of the Site into WC-B. INT-3 conveys major flows during spring freshet and high water events, however north of the Idone property boundary the channel is more defined.</p> <p><b>Action:</b><br/>S4 Servicability Update for the Leitrim Development Area, corresponding to the As-Built for the Scratch Ditch/rear yard swale contained within the adjacent development in property owner’s backyards.</p> <p>Discuss if this feature will be redundant and if a permanent swale will be placed to the south of the S4 lands to intercept surface sheet flow south to northwest.</p> | | | |

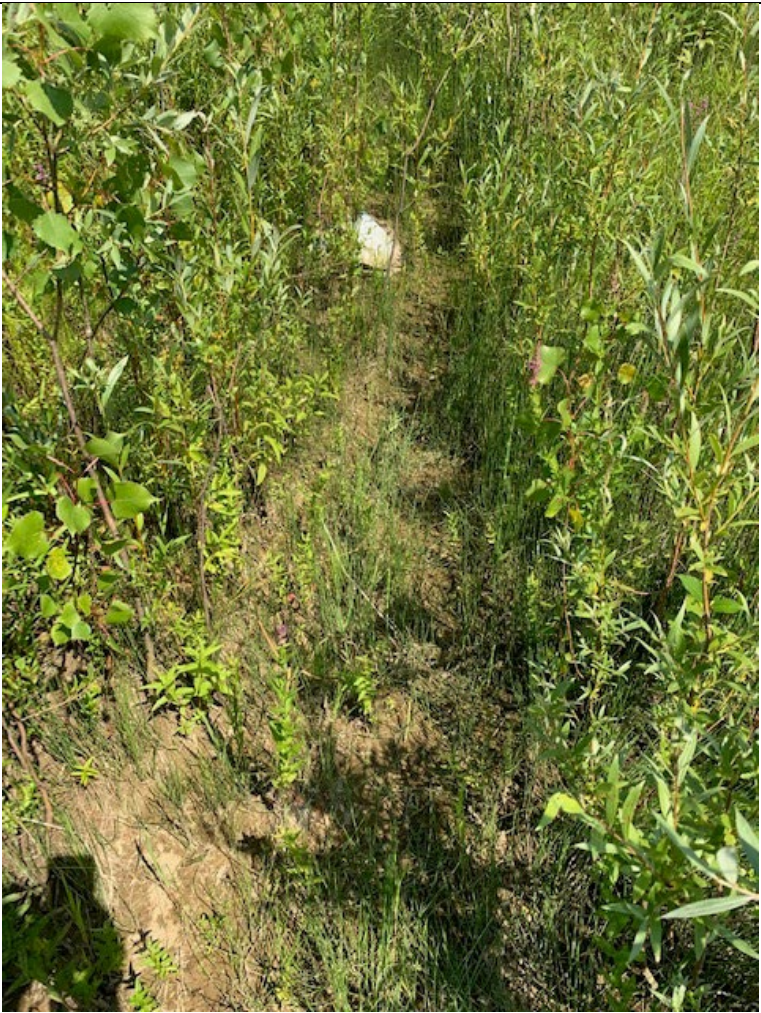
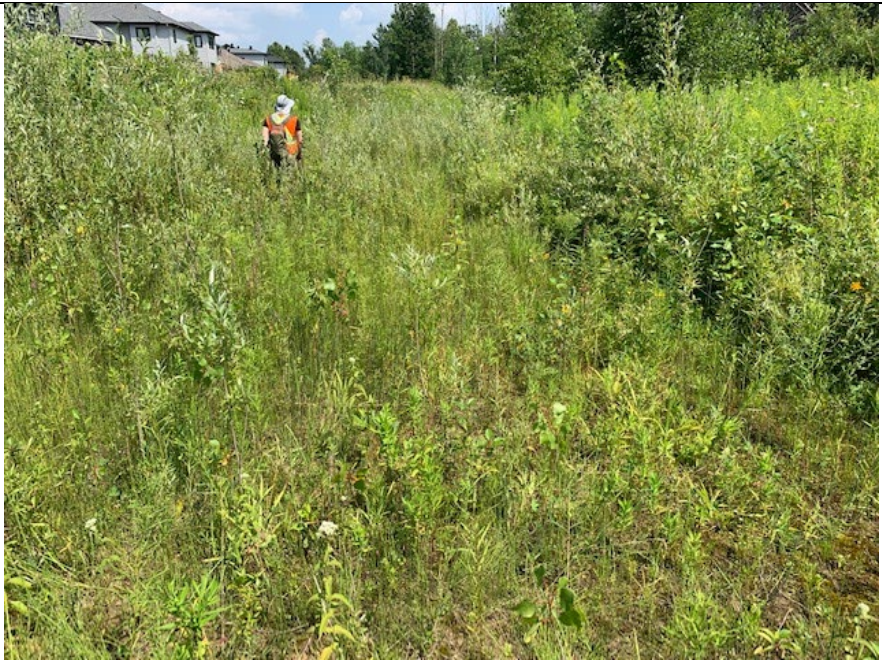
**LOCATION C**  
**Mid-section**  
**conveyance**  
**channel**

Observed wetland vegetation with some small pools of standing surface water. Well established buffer zones with mature plantings. Area functioning as per design.

The constructed conveyance channel requires that a linkage be maintained between the Casino Wetland and the Leitrim Core Wetland through maintenance of a natural area within the proposed development area.

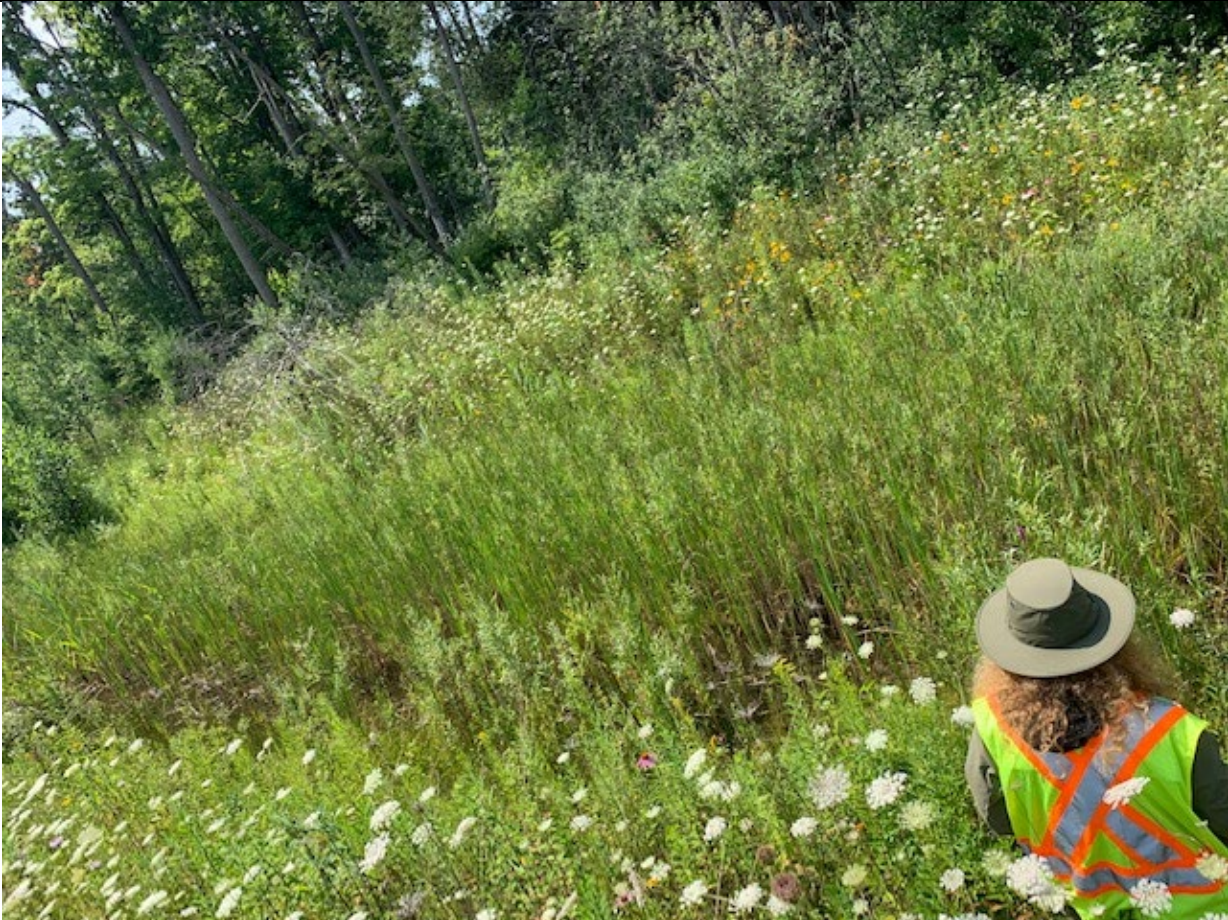
LOCATION D  
UPPER  
REACH  
CHANNEL

**Conveyance Channel – upper reach**

Water in channel from channel mid point to outlet into wetland, two species of frog observed (green, leopard).

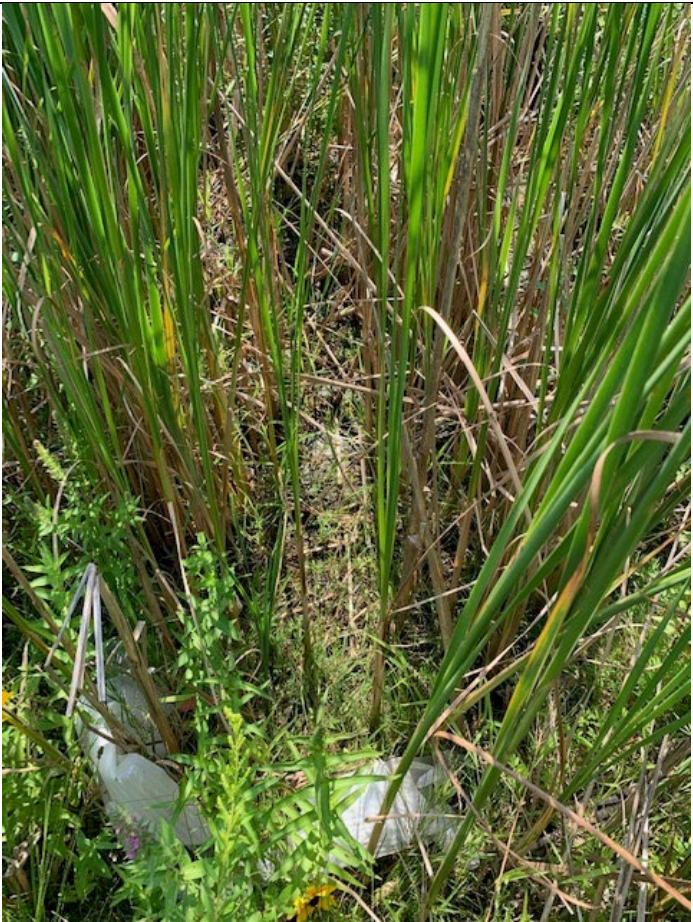
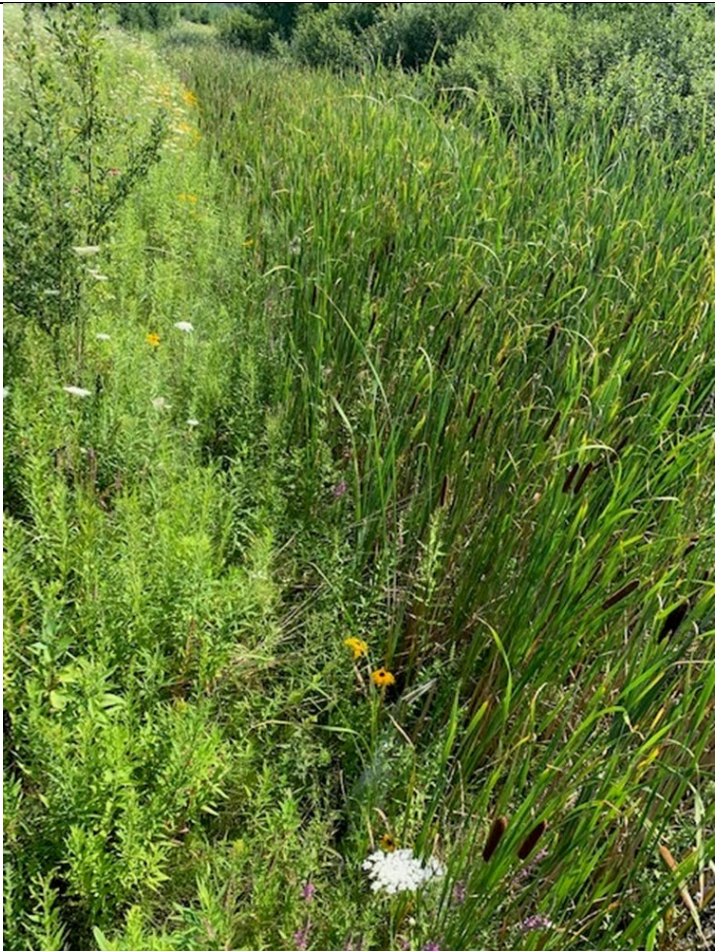
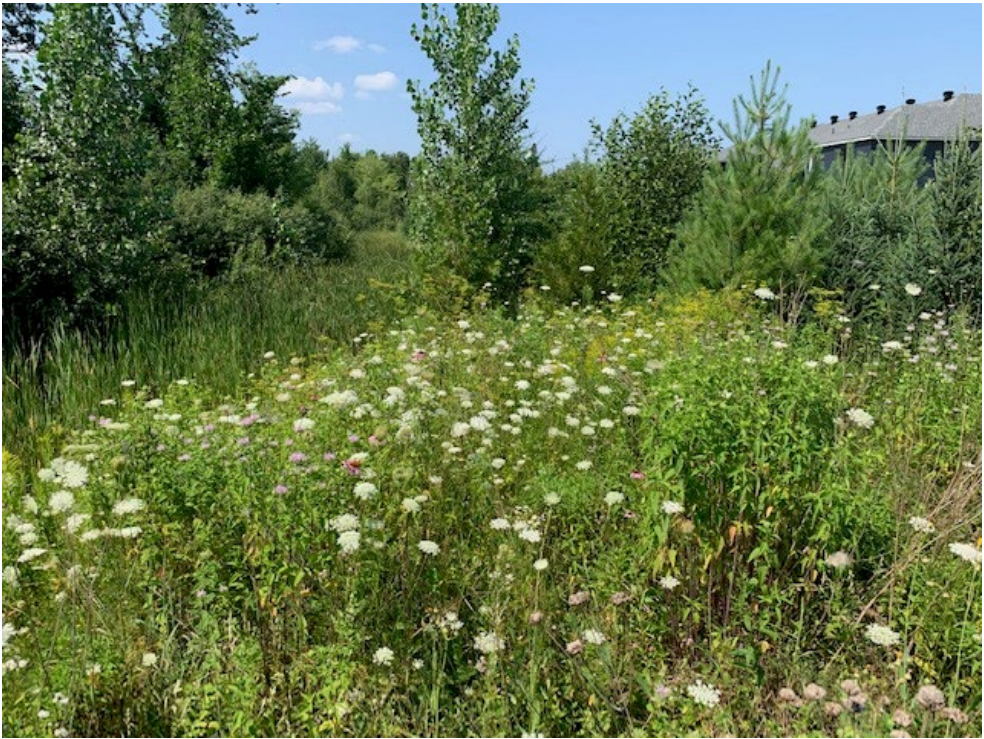
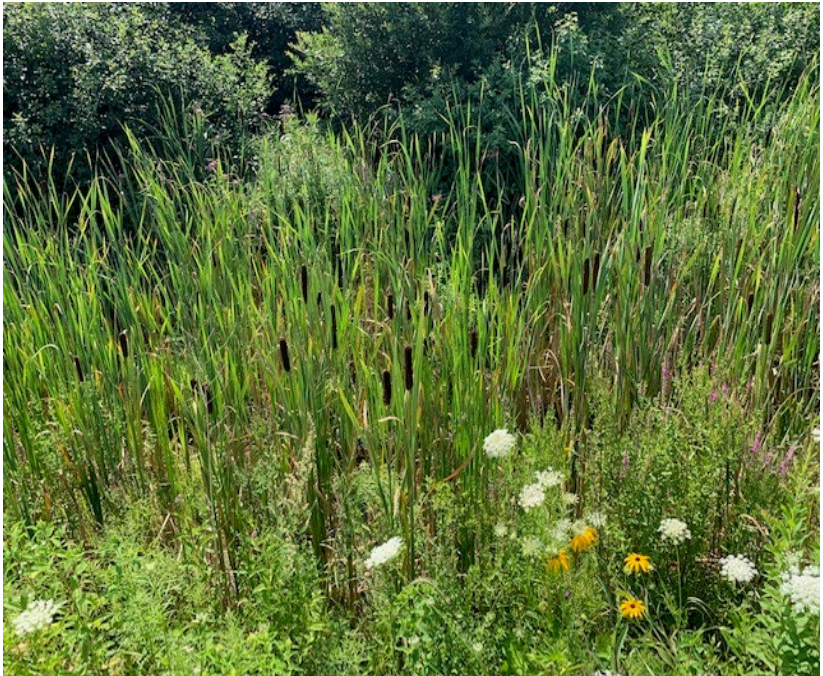
Mature species of field meadow flowers, wetland vegetation and planted trees well established.
