# **Phase I – Environmental Site Assessment**

Tunney's Pasture (Block 10)

Ottawa, Ontario

Report: PE6040-1

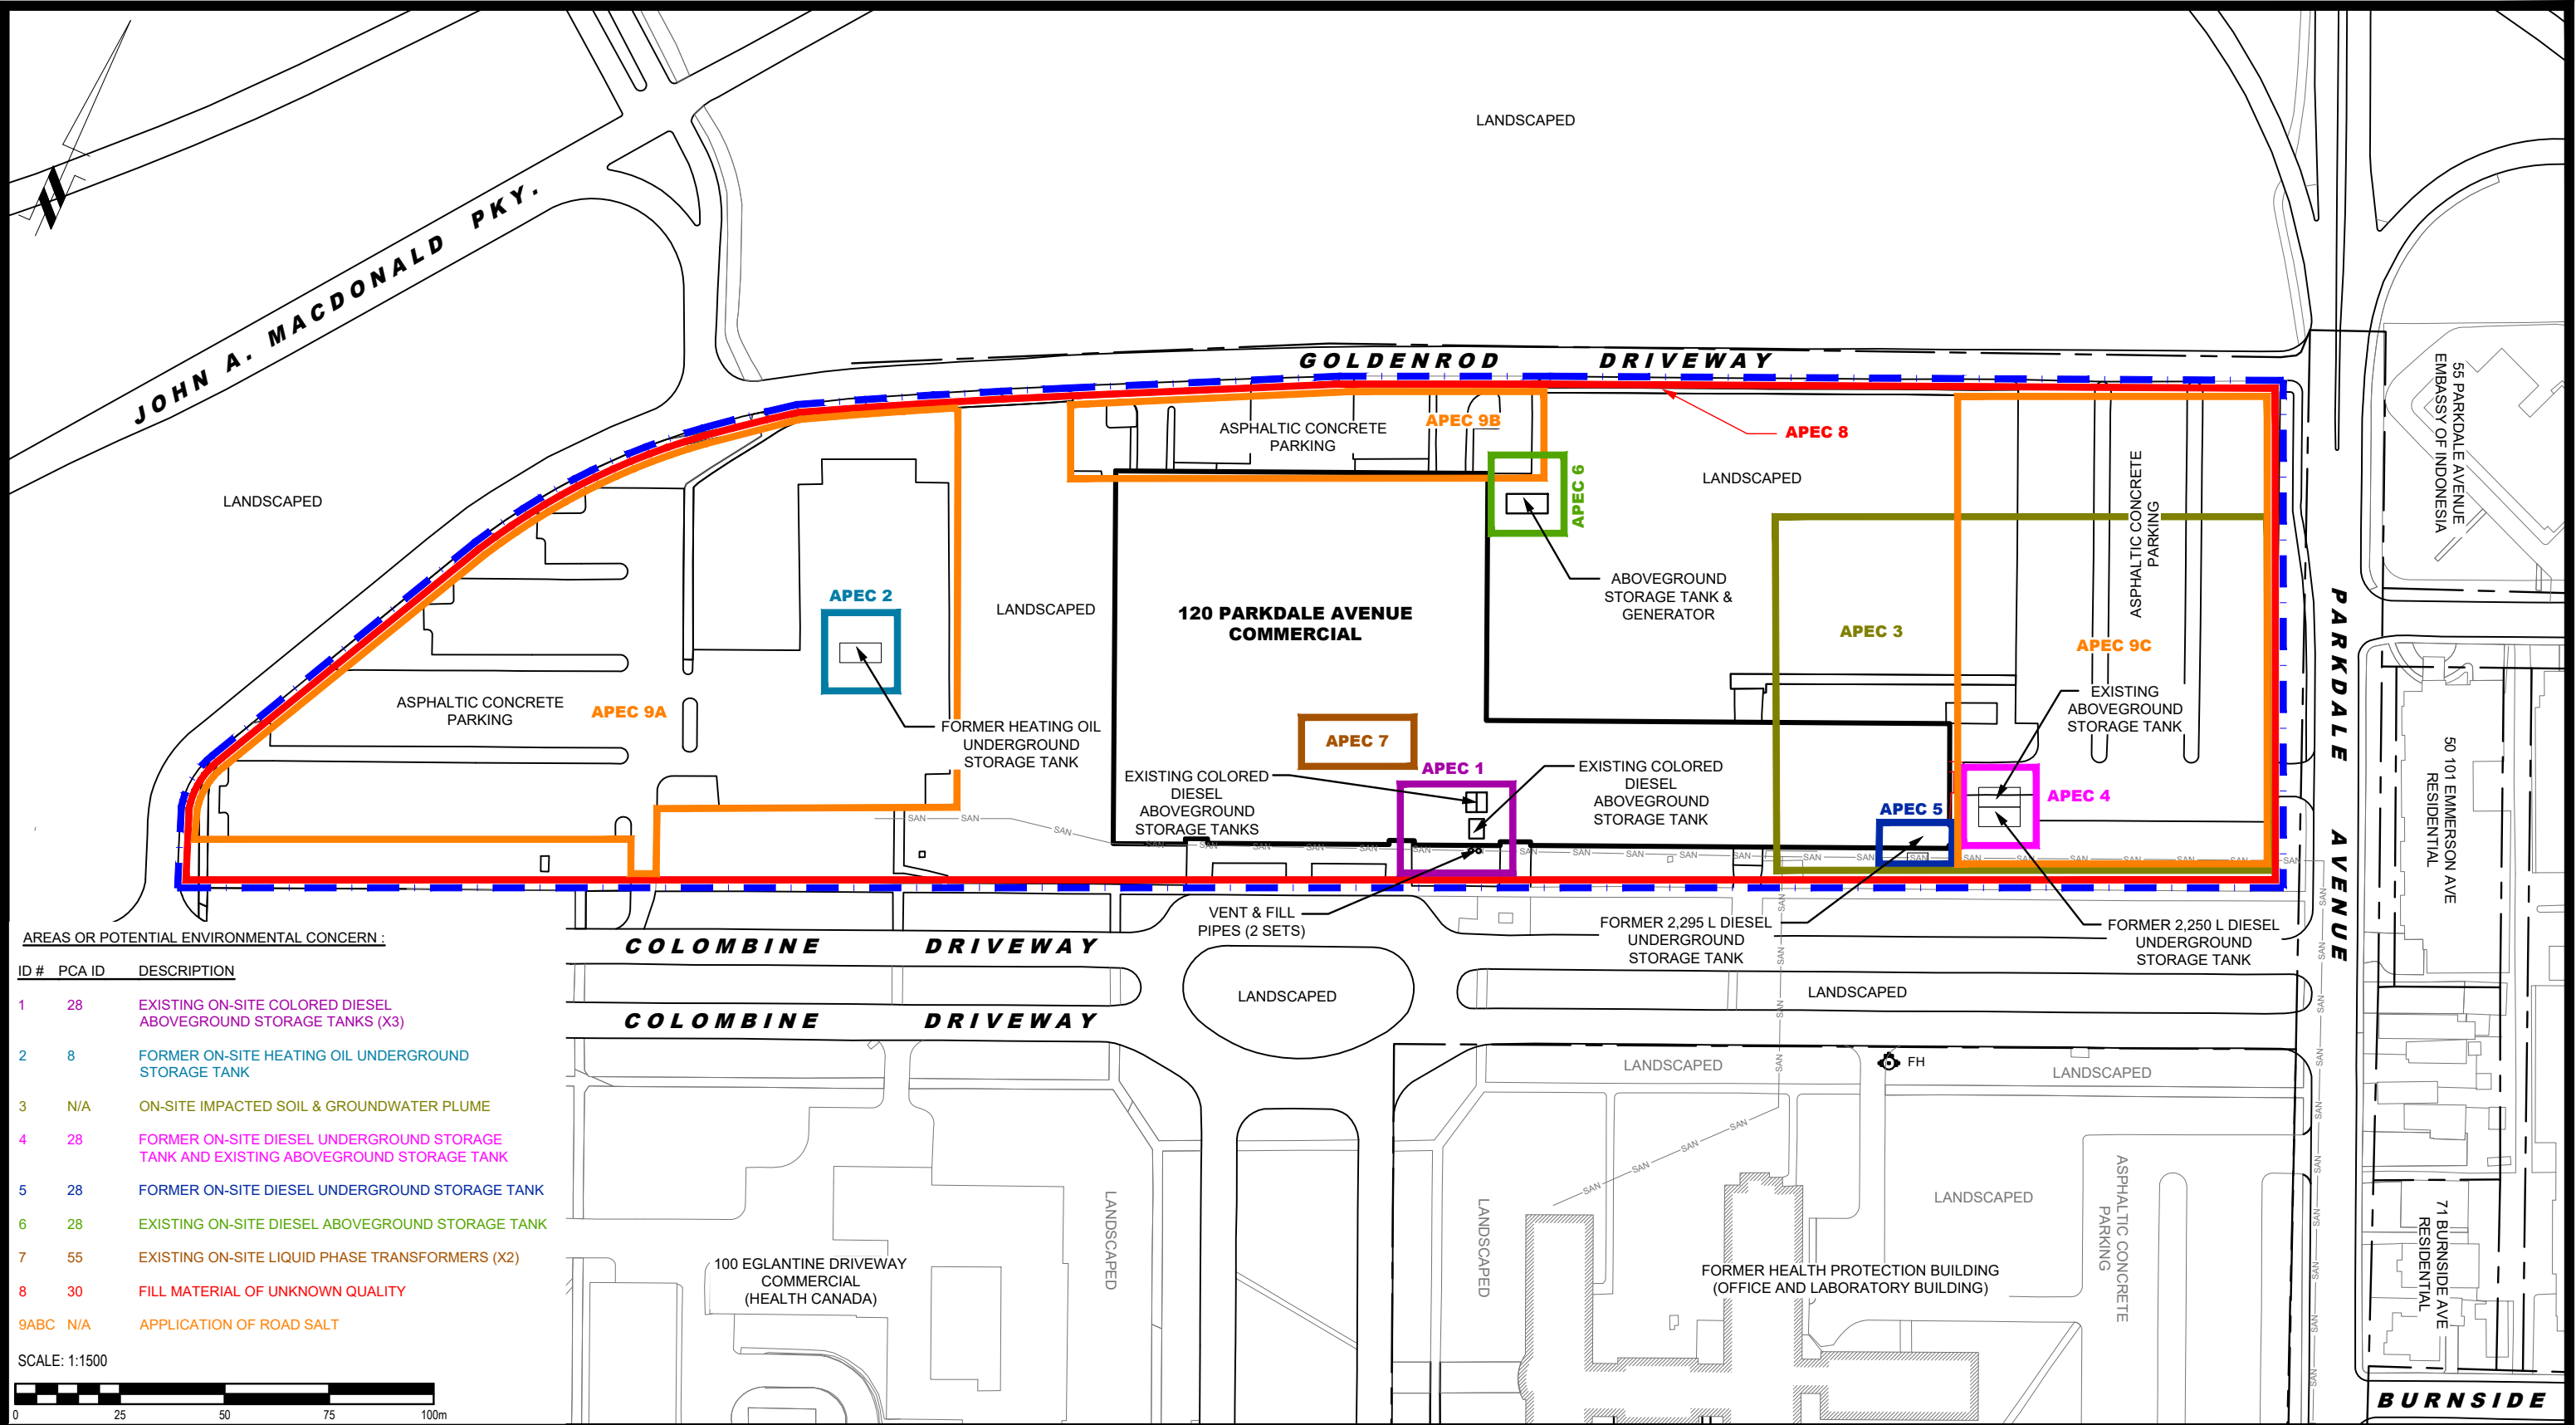
**DRAWING PE6040-1 – SITE PLAN**

AREAS OR POTENTIAL ENVIRONMENTAL CONCERN :

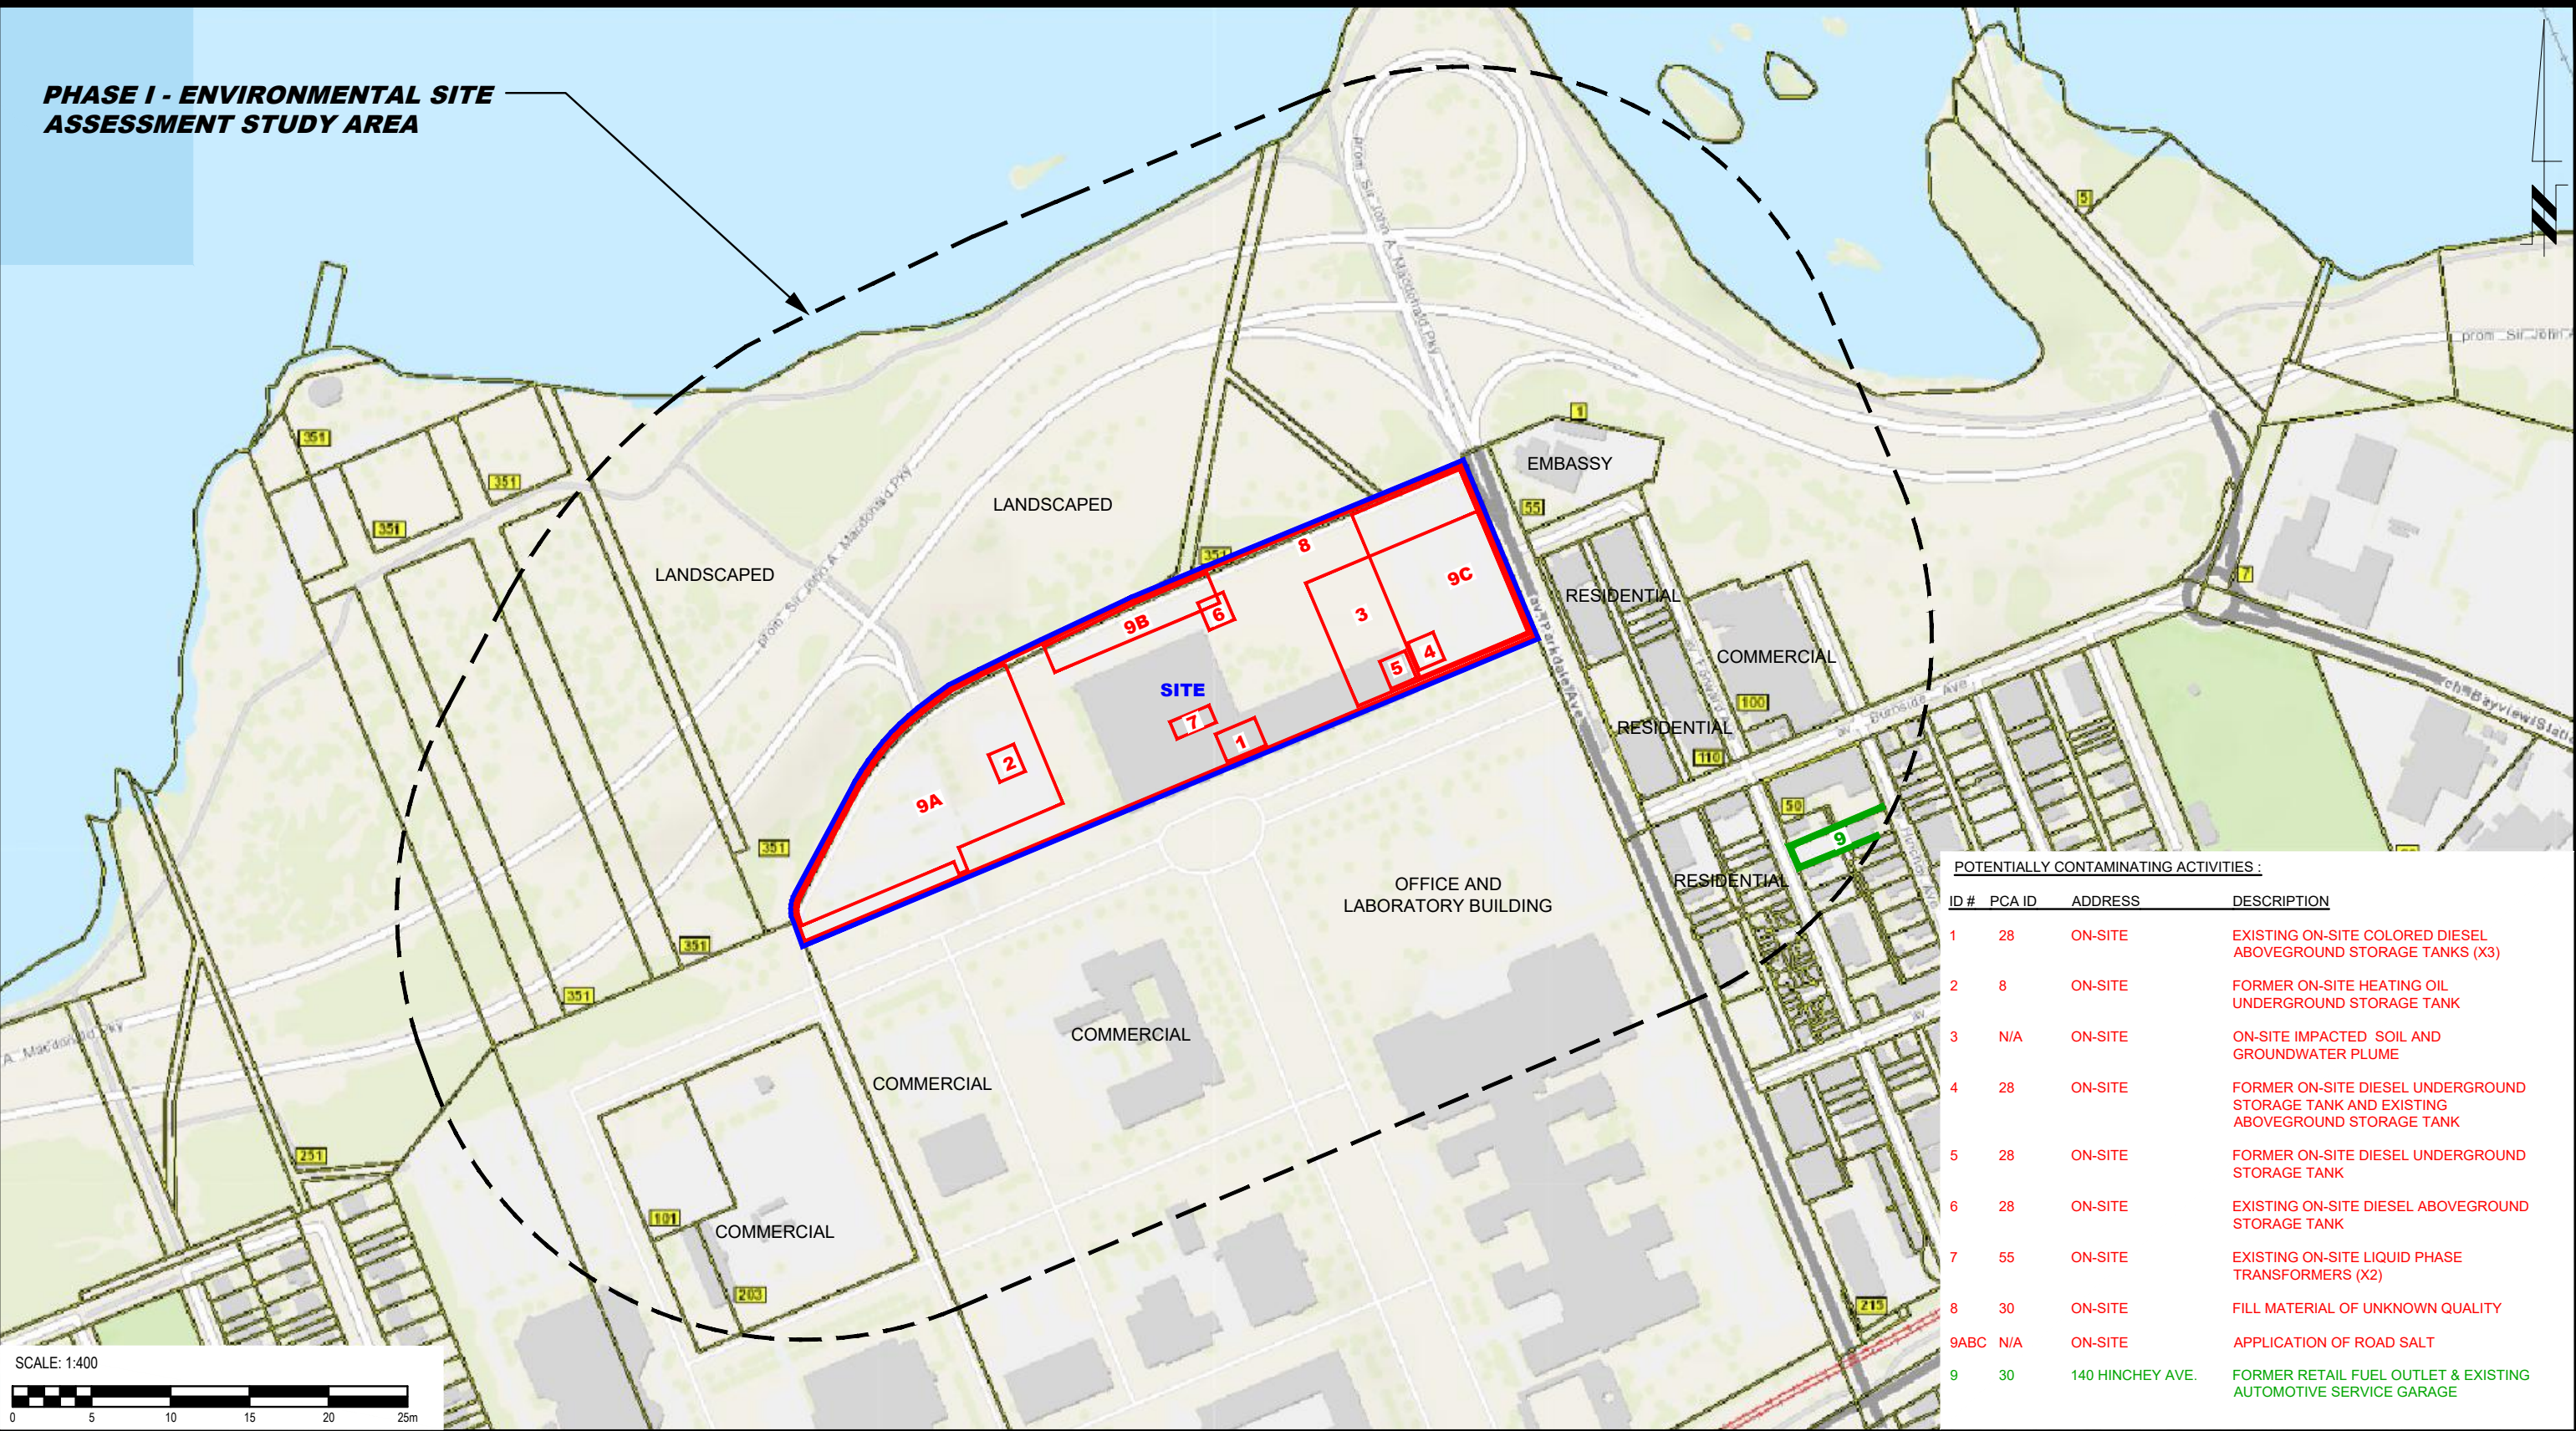
**DRAWING PE6040-2 – SURROUNDING LAND USE PLAN**

| POTENTIALLY CONTAMINATING ACTIVITIES : | | | |

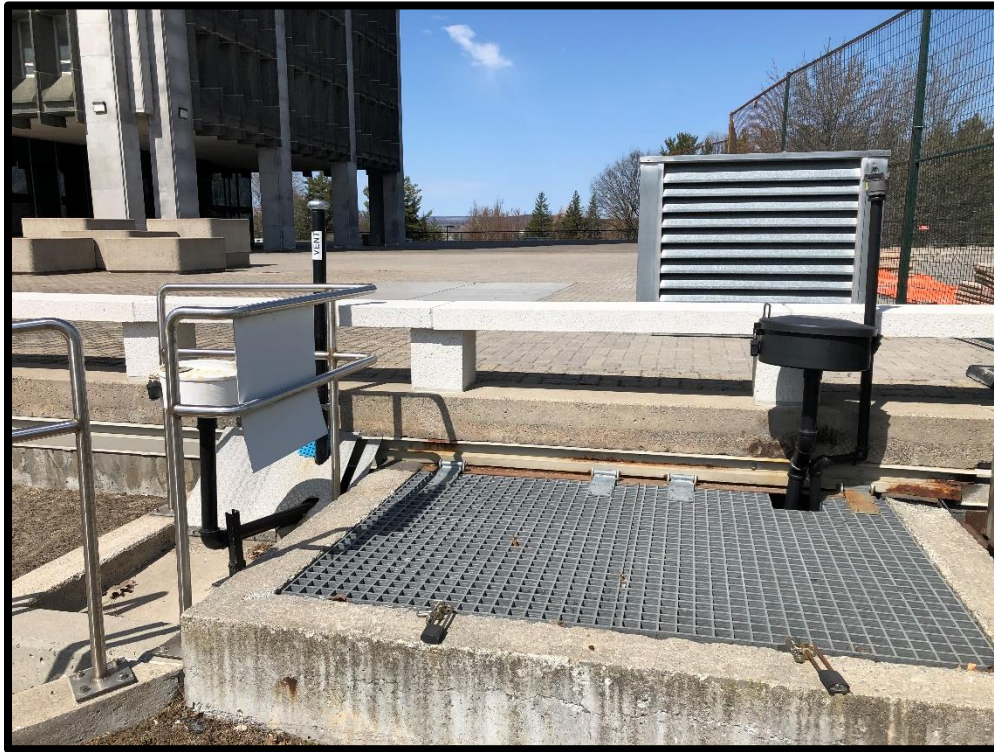
Vent and fill pipes were observed protruding from the south face of the Brooke Claxton building. The vent and fill pipes and ground beneath them were noted to be in good condition at the time of the site inspection, with no visual or olfactory signs of contamination noted. The vent and fill pipes are considered to attribute to the APEC on the Phase I Property from the associated aboveground storage tanks.

**Photograph 3:** View of the vent and fill pipes on the south face of the Brooke Claxton building, facing north.

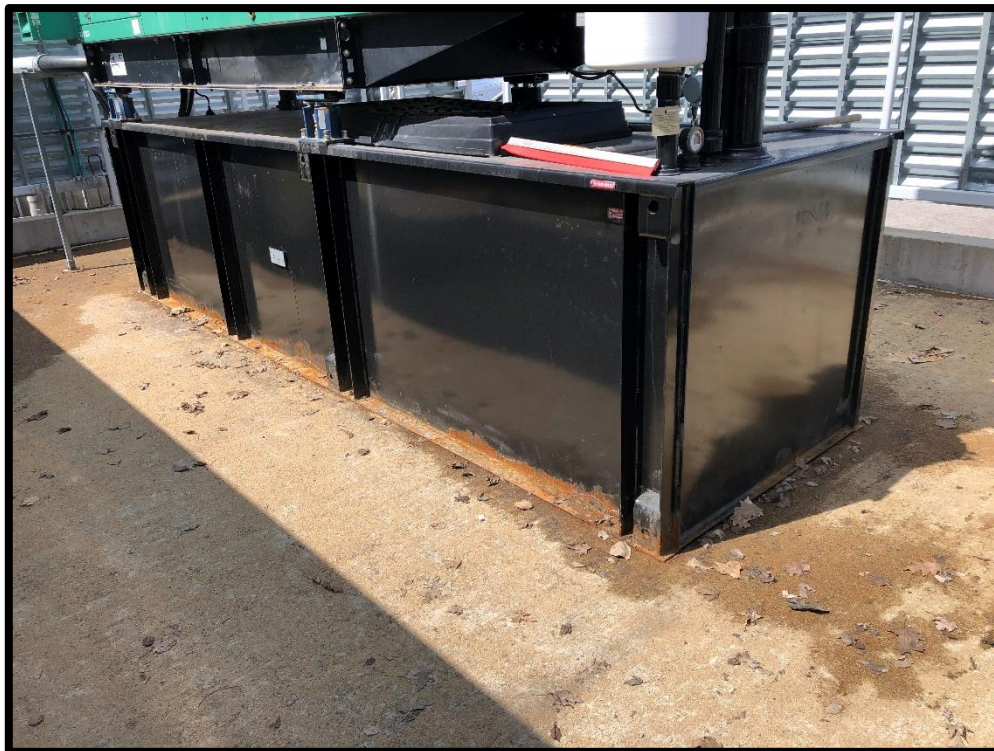
An in-use, single-walled, diesel aboveground storage tank (AST) was observed adjacent to the northeast of the Brook Claxton building on the Phase I Property. The tank was installed in 2013 and has a capacity of 5,700 L. The AST is situated atop a concrete containment basin and is used to run an emergency generator. Approximately once a month the generator is turned on to ensure it is still in working order. The AST was noted to be in good condition at the time of the site inspection, with no signs of spills or staining observed in the vicinity of the tank. The presence of this tank is considered to represent an APEC on the Phase I Property (APEC 6).

**Photograph 4:** View of the AST on the northeast corner of the Brooke Claxton building, facing south.

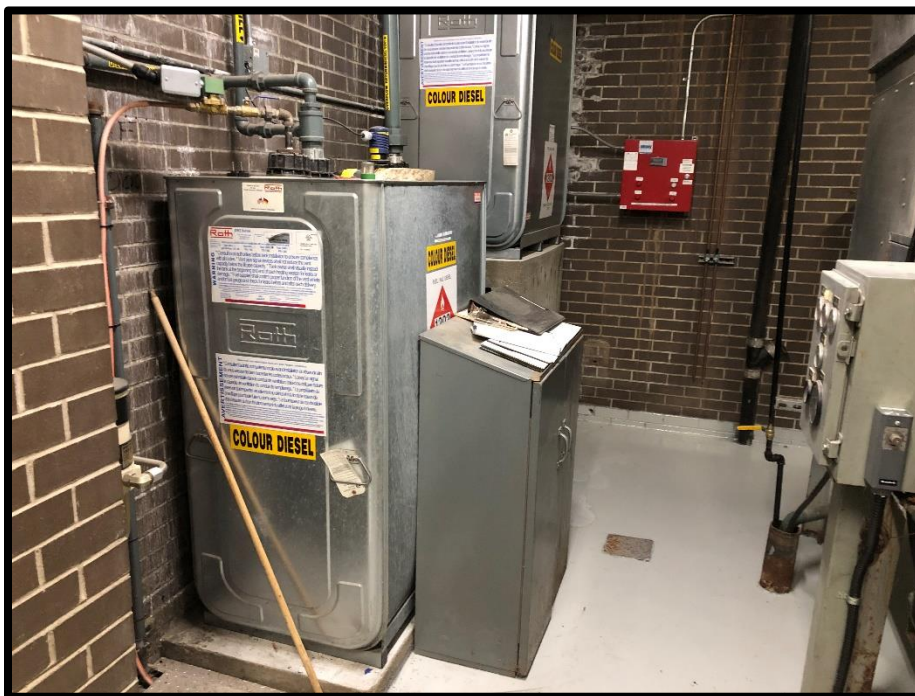
Two in-use, double walled, vacuum sealed, coloured diesel ASTs were observed within the southeast corner of the basement of the Brooke Claxton Building on the Phase I Property (associated with the vent and fill pipes identified on the south face of the Brooke Claxton building). The tanks were installed in 2008 and each have a capacity of 1,000 L. The ASTs are situated atop a concrete pad and a large concrete block and are used as day tanks. The ASTs were noted to be in good condition at the time of the site inspection, with no signs of spills or staining observed in the vicinity of the tank. The presence of these tanks are considered to represent an environmental concern to the Phase I Property (APEC 1).

**Photograph 5:** View of the two 1,000 L ASTs in the basement of the Brooke Claxton building.

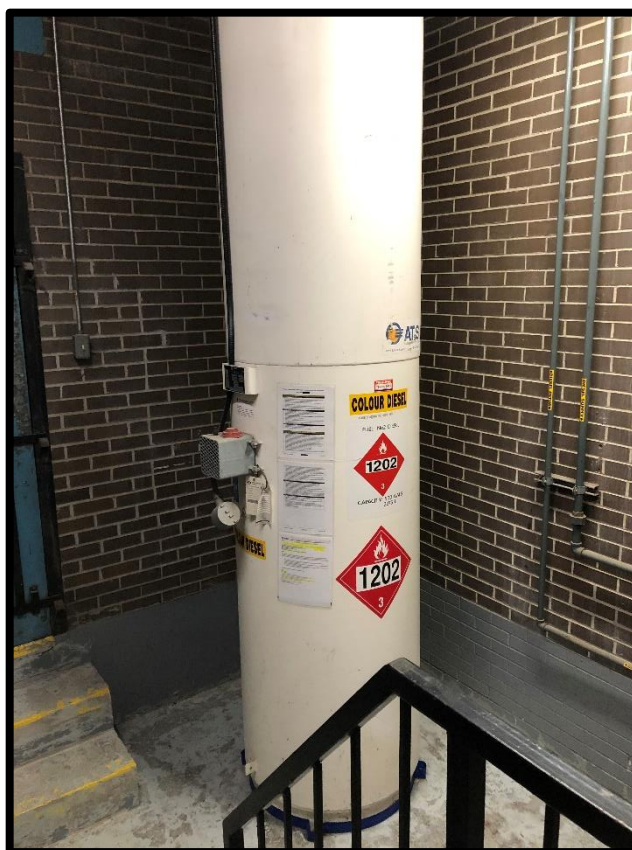
An in-use, double-walled, vacuum sealed, coloured diesel aboveground storage tank (AST) was observed within the southeast corner of the basement of the Brooke Claxton building on the Phase I Property. The tank was installed in 2008 and has a capacity of 2,275 L. The AST is situated on the concrete floor and is used to run an emergency generator. Approximately once a year the tank is refilled and approximately once a month the generator is turned on to ensure it is still in working order. The AST was noted to be in good condition at the time of the site inspection, with no signs of spills or staining observed in the vicinity of the tank. The presence of this tank is considered to represent an environmental concern to the Phase I Property (APEC 1).

**Photograph 6:** View of the 2,275 L AST in the basement of the Brooke Claxton building.

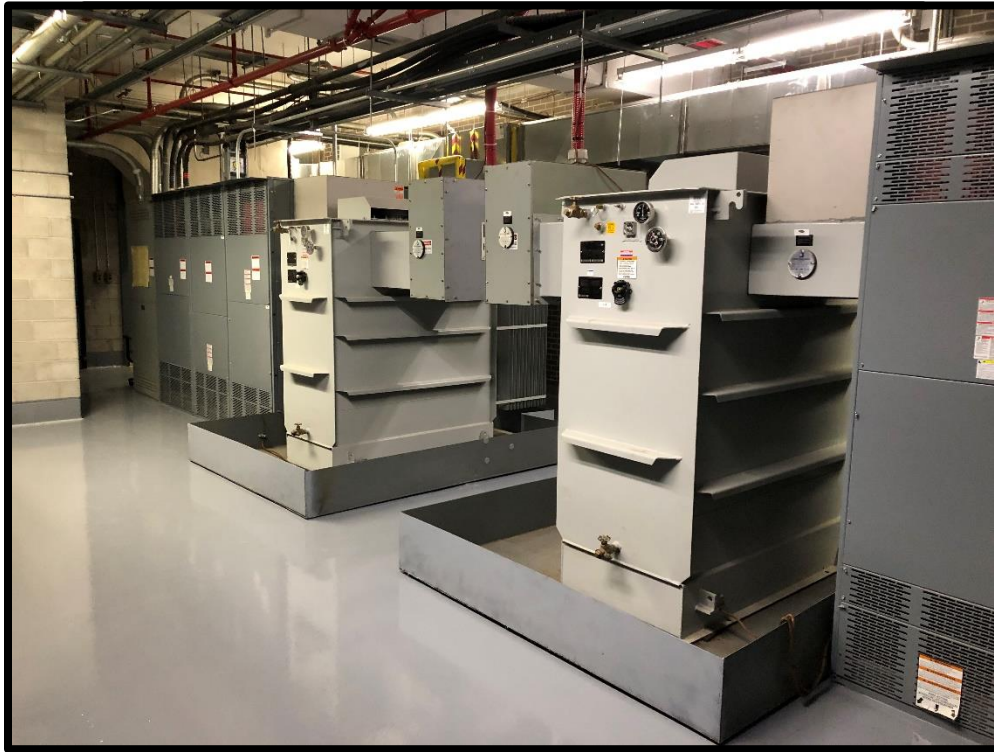
Two liquid, three phase transformers were identified in the basement of the Brooke Claxton building. Each transformer was noted to have an approximate capacity of 1,499 L and were situated atop respective concrete containment basins. The transformers were noted to be in good condition at the time of the site inspection, with no signs of spills or staining observed in the vicinity of the transformers. The presence of these transformers is considered to represent an environmental concern to the Phase I Property (APEC 7).

**Photograph 7:** View of the two liquid phase transformers in the basement of the Brooke Claxton building.
