June 25, 2026  
File: PE6465-LET.03

Subject: **Phase I - Environmental Site Assessment Update  
S-1 Lands (Quinn's Pointe Phase 6-8) -  
Part of 3882 Barnsdale Road and  
3933 Borrisokane Road  
Ottawa, Ontario**

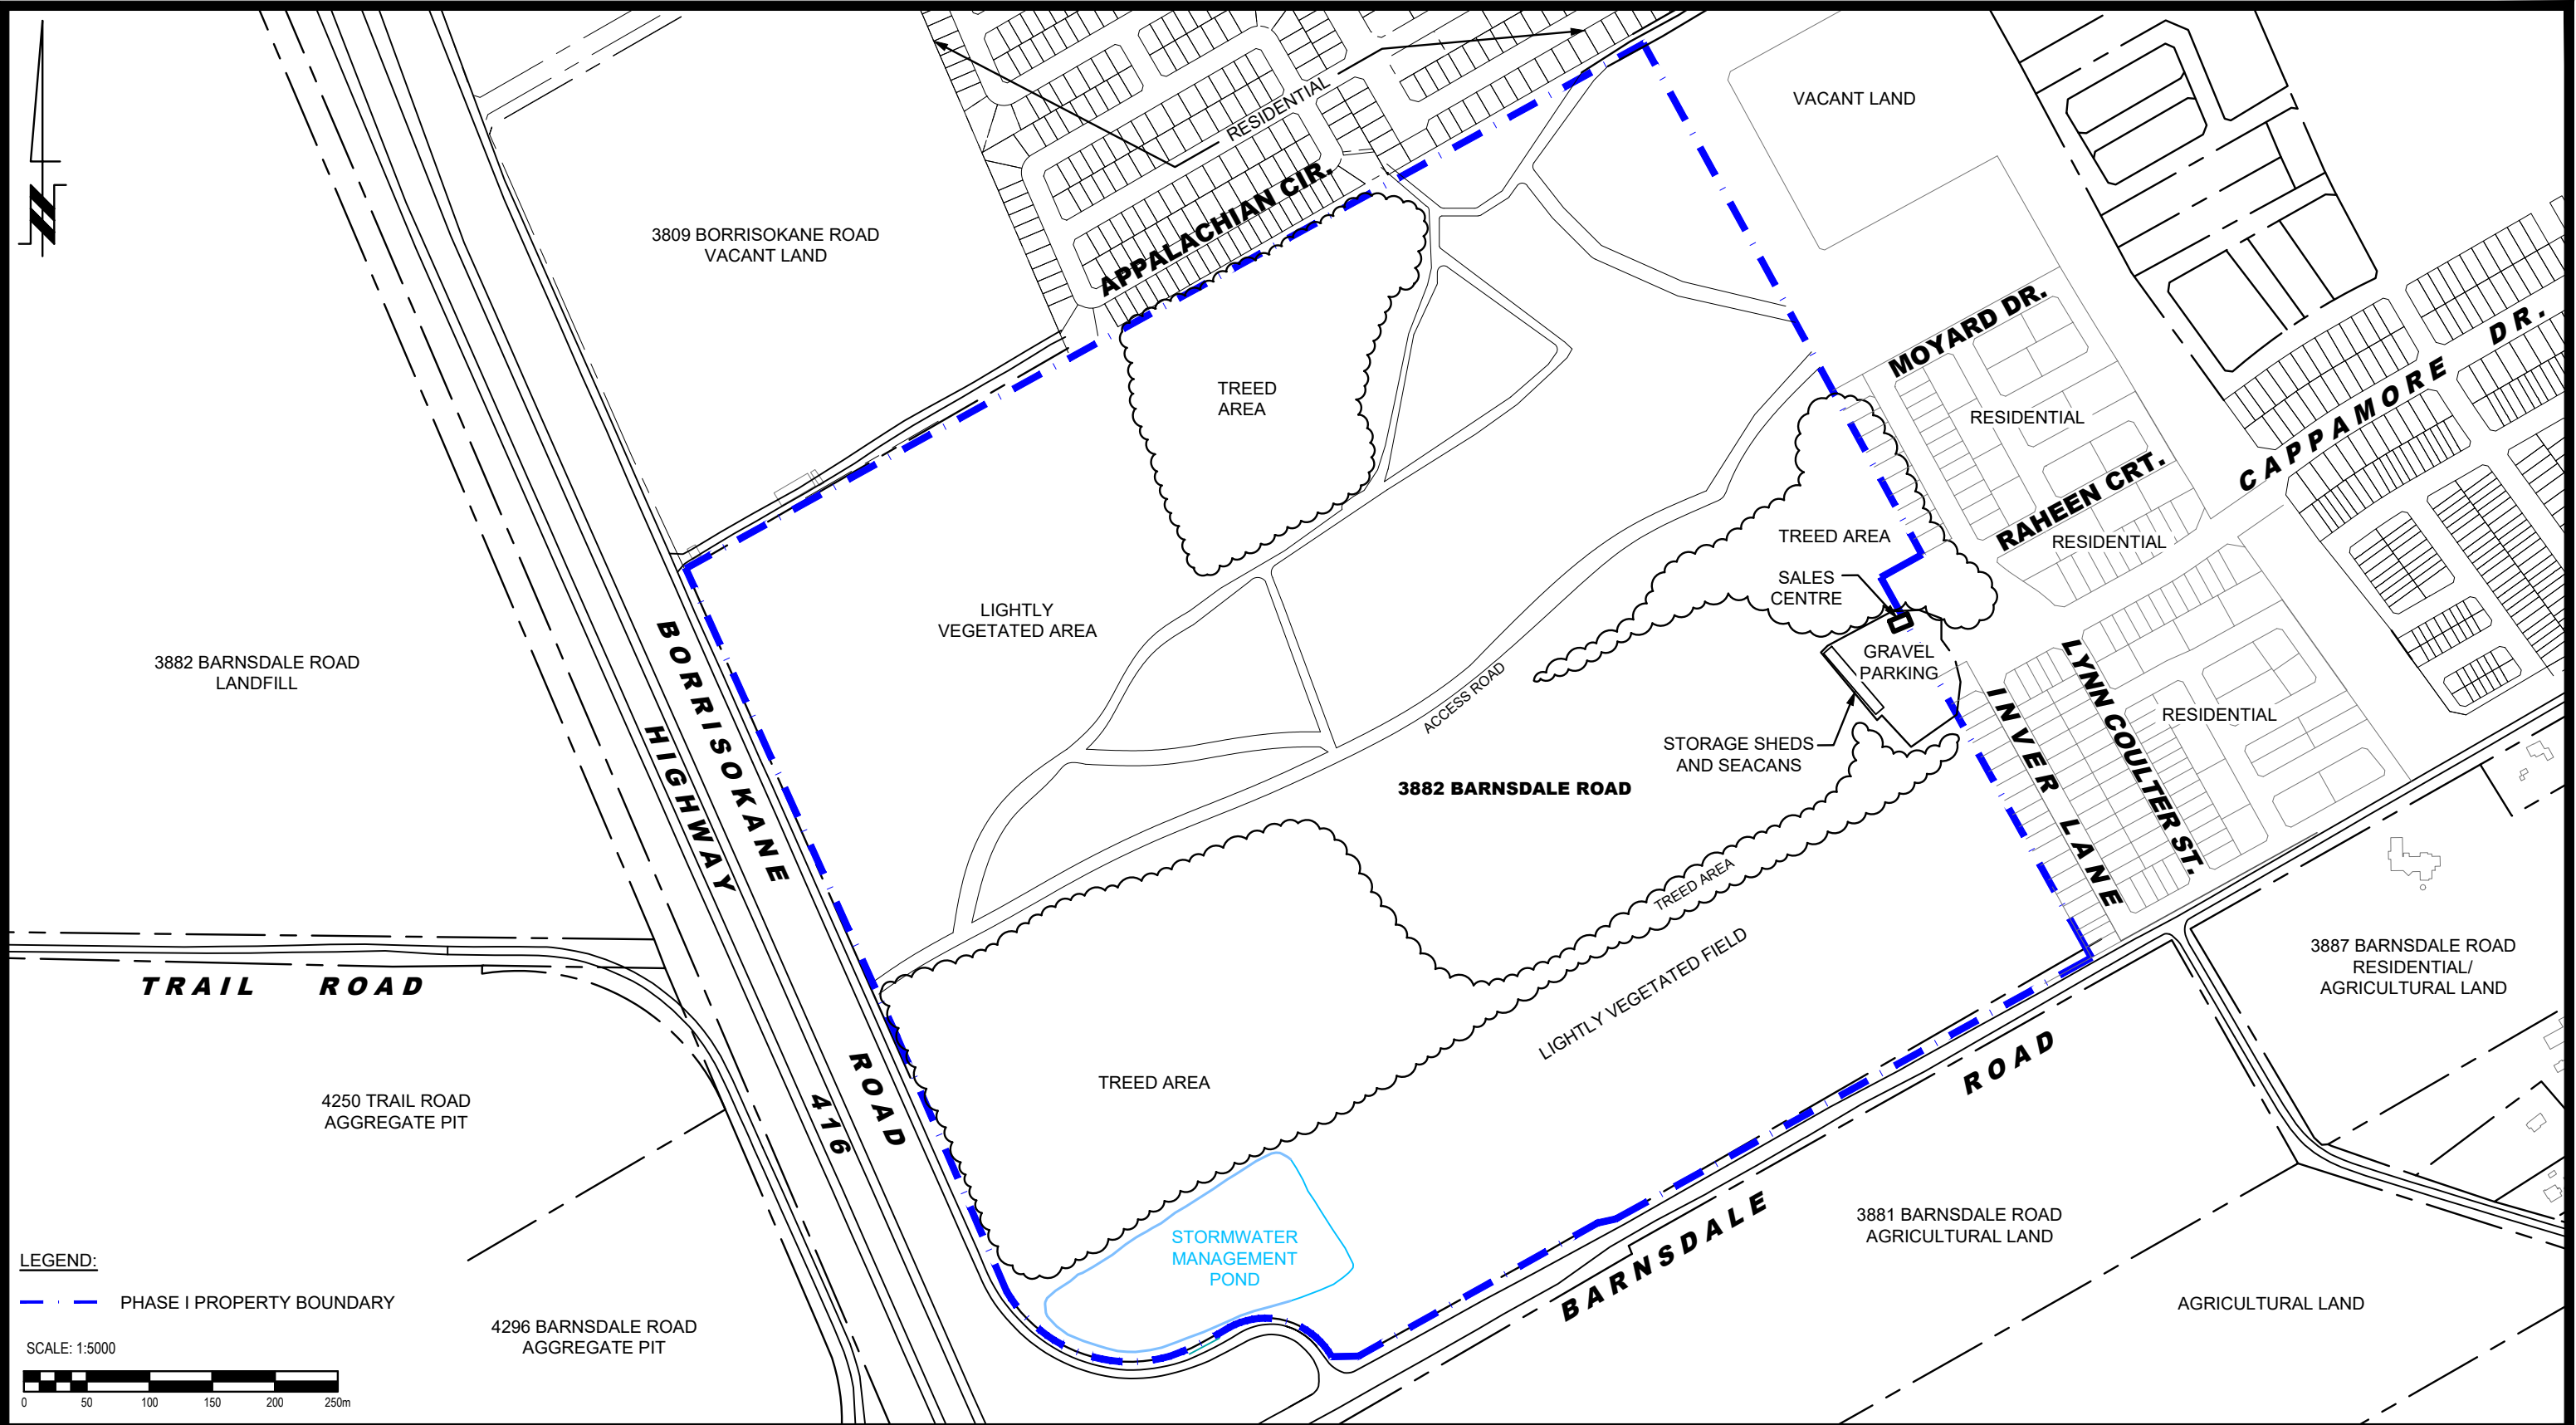
No permanent buildings or structures were observed on the Phase I Property however, a temporary sales centre was observed on the east-central portion of the Phase I Property. Additionally, several seacans and storage sheds were identified on the east-central portion of the Phase I Property.

Several monitoring wells were observed across the Phase I Property during the site visit. The monitoring wells were confirmed to have been recently installed as part of hydrogeological and geotechnical investigations on the Phase I Property. No potable wells or private sewage systems were observed on site, nor are any expected to be present, as the site has never been formally developed.

Stockpiles of native sand were observed in the eastern portion of the Phase I Property. The stockpiled material is not considered to represent an environmental concern on the Phase I Property.

The above-noted site features are shown on Drawing PE6465-1R - Site Plan.
