# PATERSON GROUP

July 16, 2026  
File: PE5957-LET.05

Subject: **Phase I Environmental Site Assessment Update**  
**1900 & 2000 City Park Drive**  
**Ottawa, Ontario**

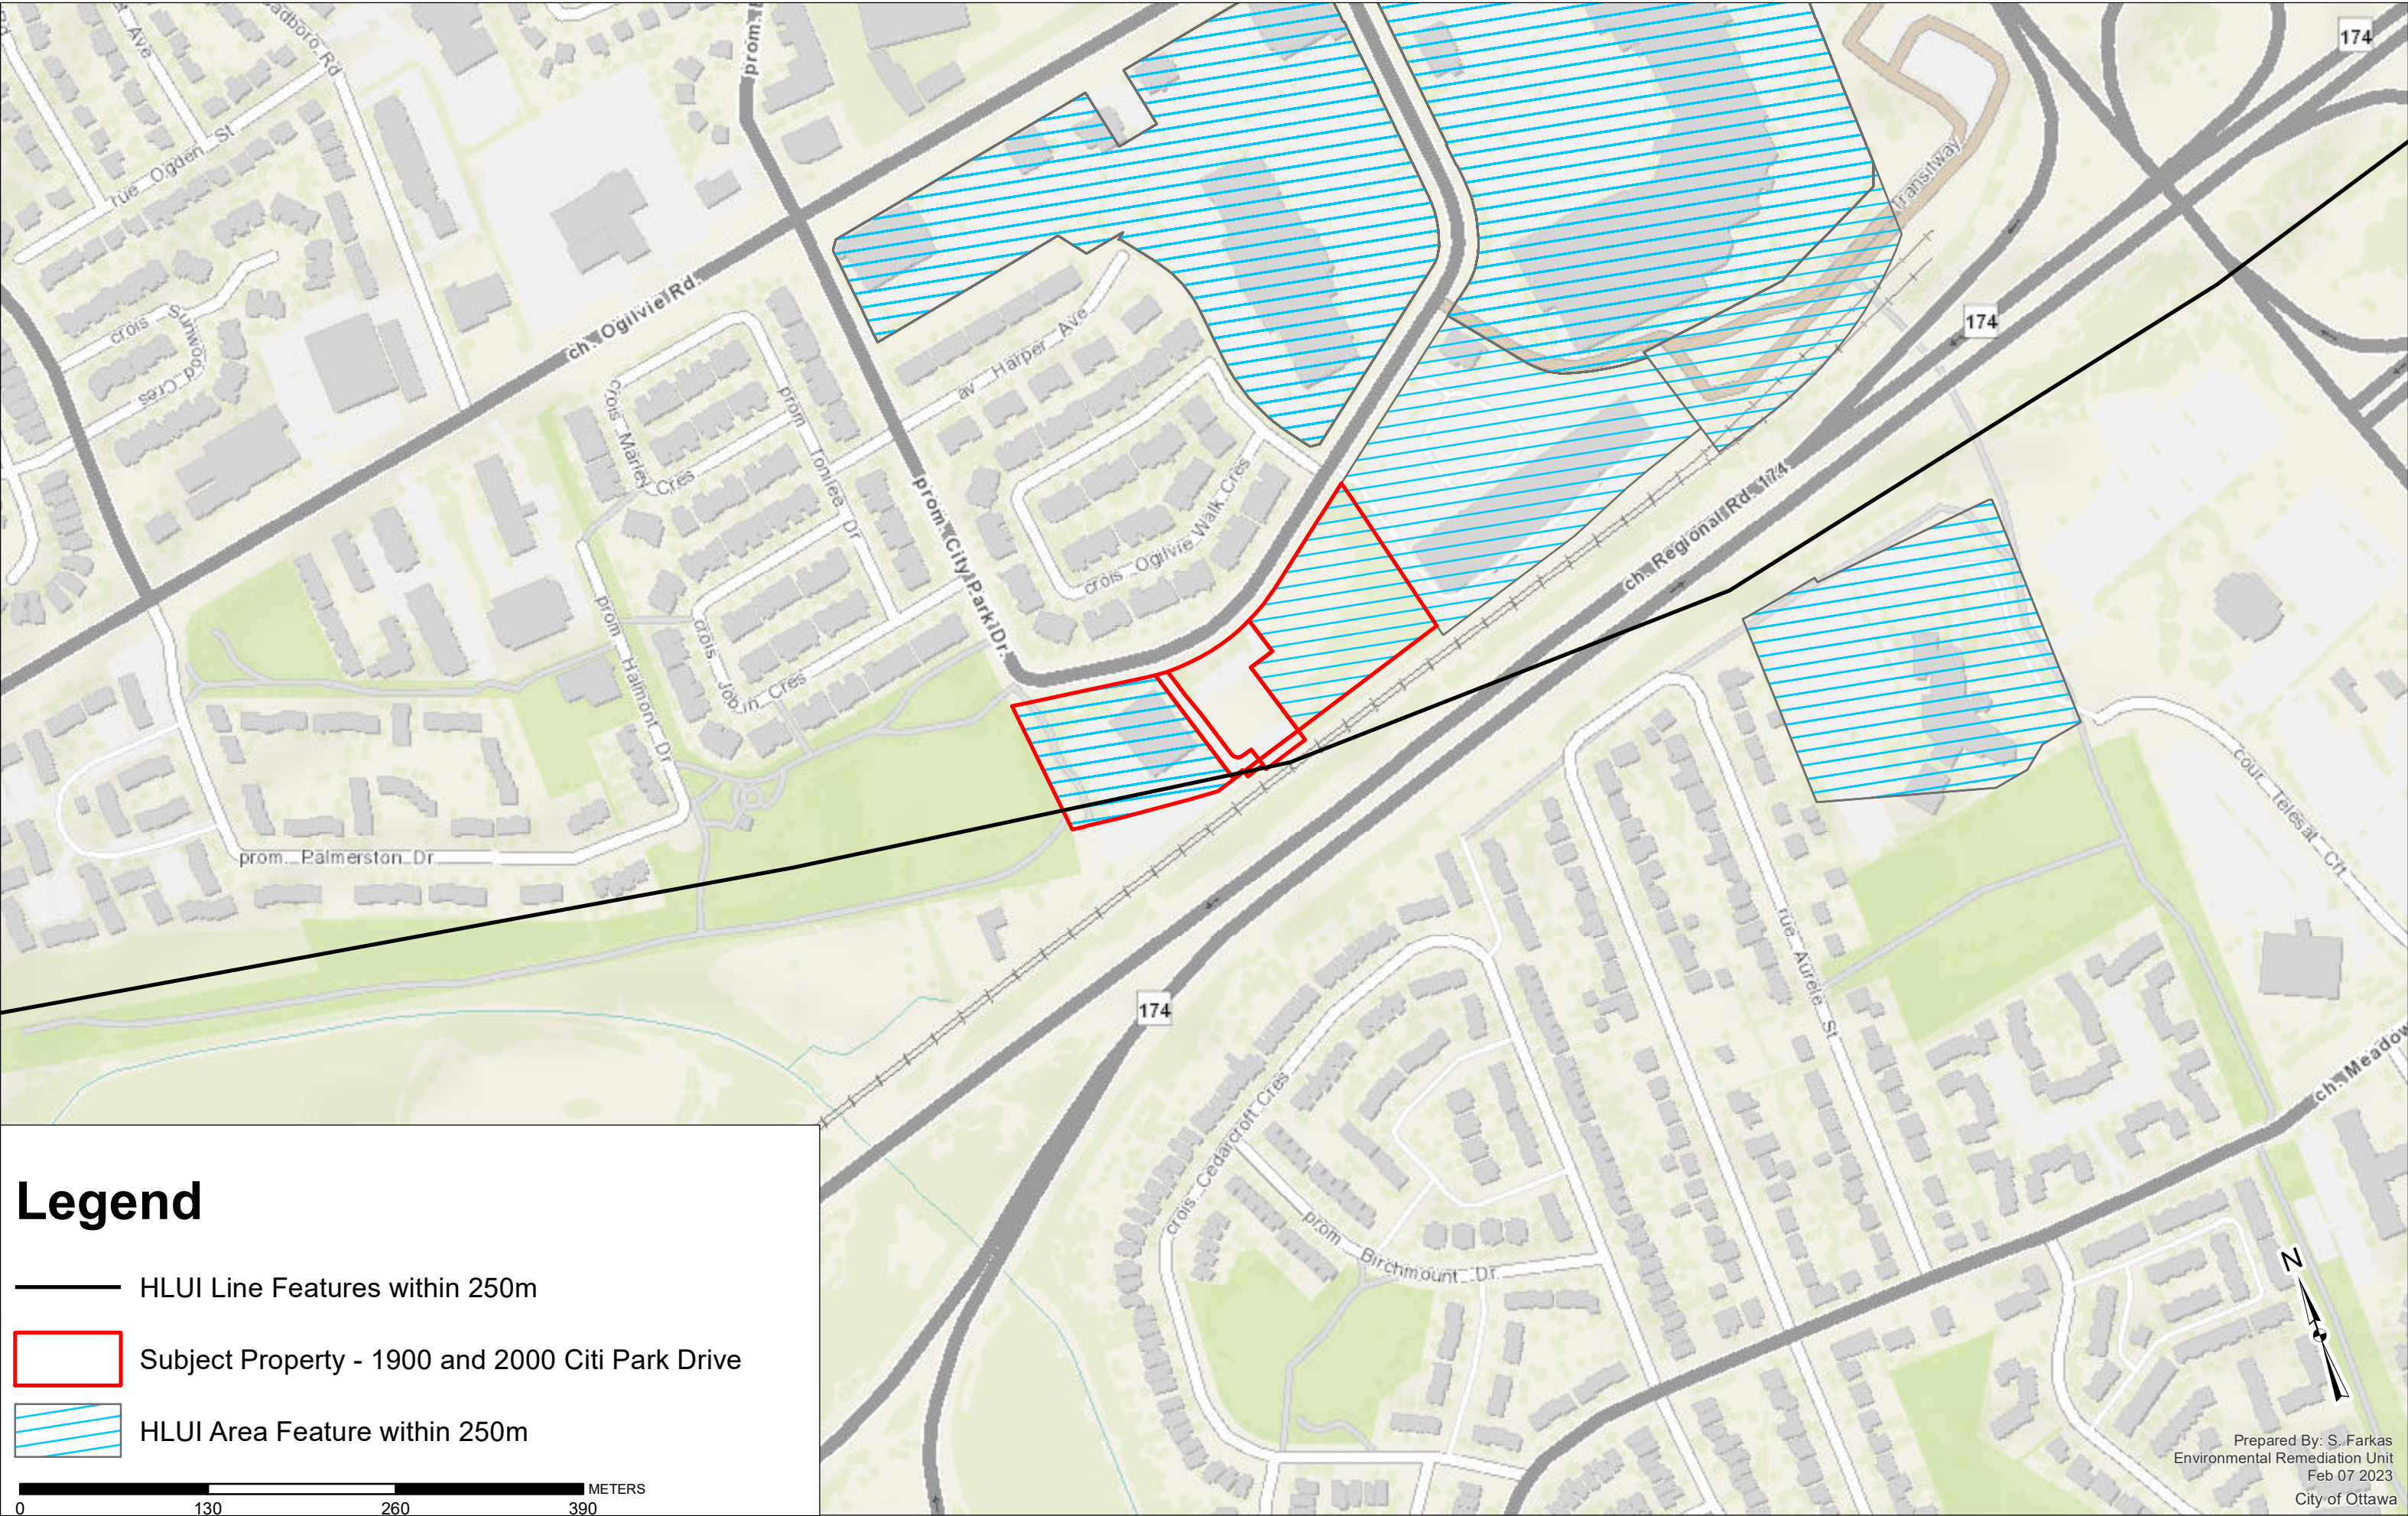
HISTORIC LAND USE INVENTORY (HLUI) - REPORT REFERENCE MAP

The response received did not identify any records with respect to the Phase I Study Area which were considered to pose a potential environmental concern.

The HLUI Summary Report Excel spreadsheet identifies HLUI area, point and line features within 250 metres of the Subject Property, as shown on the provided HLUI Map PDF. Within 500 metres of the Subject Property, landfills and Environmental Risk Management Area (ERMA) are also identified if applicable.
