# **Fish Habitat Inventory, Mattamy Richmond Lands, Spring 2009**

**February 2010**

**KILGOUR & ASSOCIATES LTD.**

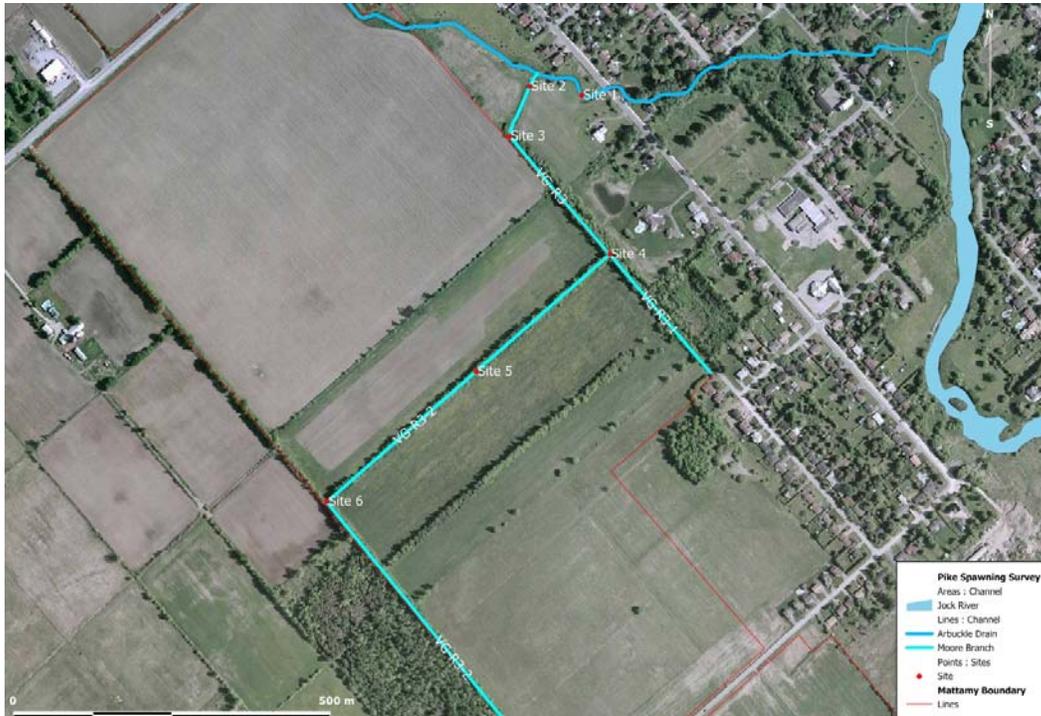
**Figure 1. Map of the study area on Mattamy's Richmond property.**

Weekly site visits to the Arbuckle Drain and Moore Branch began March 19, 2009 and continued until April 26, 2009, with one final site visit on May 28. During each visit, Anthony Francis dip netted extensively along the overhanging grass of the main channel of the Arbuckle Drain and lower Moore Branch, searching for the presence of pike eggs. Additionally, five sites were marked with six-foot long rebar stakes driven into the stream bed to serve as location markers for consistent depth measurements (Figure 1). Site 1 included a second stake on the grassy bank, the only flooded grassy step of the sort to provide likely potential spawning habitat. However, even at the highest flood level year, the water level here was likely too shallow to be of use to pike (maximum 10 cm and cut off from the main channel by a ridge of grass). A sixth site (on the west side of the property) was also regularly monitored for temperature and photographed to observe how water levels varied. However, no consistent location was established here to monitor depth as the water flowed randomly across a dirt road over a collapsed culvert. Water temperatures were taken at these sites on each visit. Additionally, Hobo continuous-temperature monitoring sensors were installed at Sites 1 and 4.

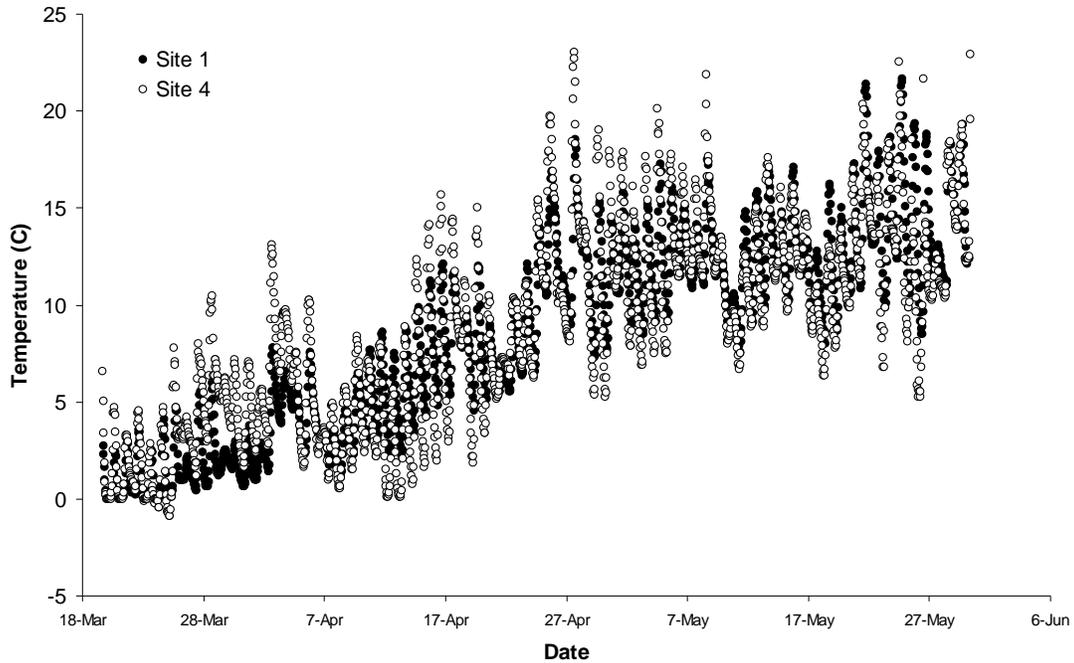
**Figure 2. Water temperature profile for Site 1 (Arbuckle) and Site 4 (Upper Moore) as recorded using Hobo automatic temperature sensors.**

Pike spawning generally occurs in the early spring at ice-off once water temperatures reach 4-7°C (Scott and Crossman, 1973). While these conditions usually occur around mid April in the Ottawa area, this year's warm dry spring led to the early start date for our survey. By March 19 many of the surrounding fields were nearly snow free and the Arbuckle and lower sections of the Moore were already ice free (see photographs in Appendix A). By about April 5th, water temperatures in the both of these reaches were generally above 4°C (Figure 2). By April 26, temperatures were consistently above 10°C thus marking the likely end of pike spawning.

Figure Note: An additional Hobo was set at Site 3 (Lower Moore), but disappeared at some point during the field study.
