# MATTAMY RICHMOND LANDS

## *Natural Environment & Impact Assessment Study*

FEBRUARY 2010

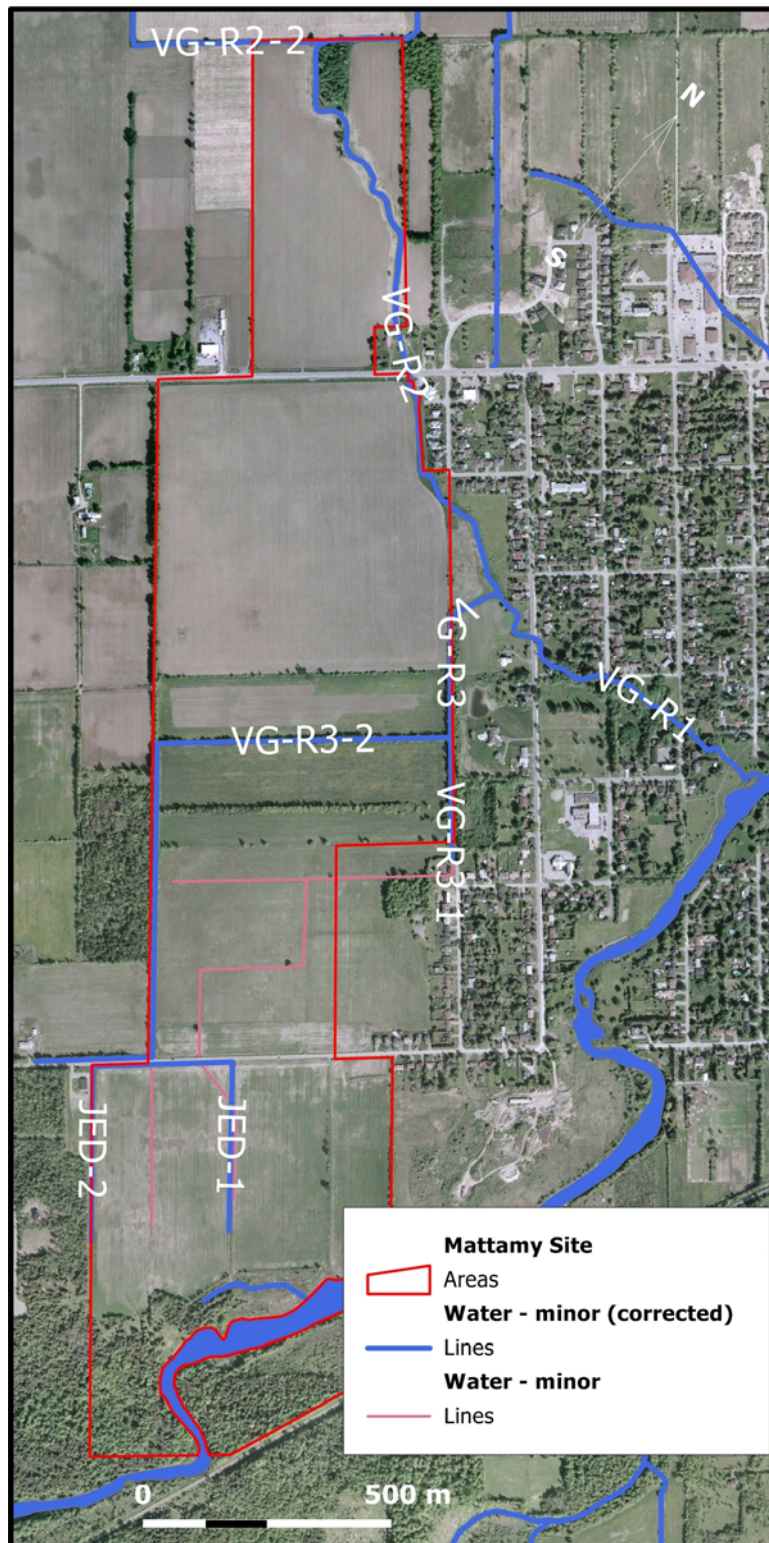
**Figure 9. Map of the Mattamy Richmond Land showing watercourses.**

Figure Note: Lines in heavy blue denote confirmed drainage. Narrow pink lines denote drainage

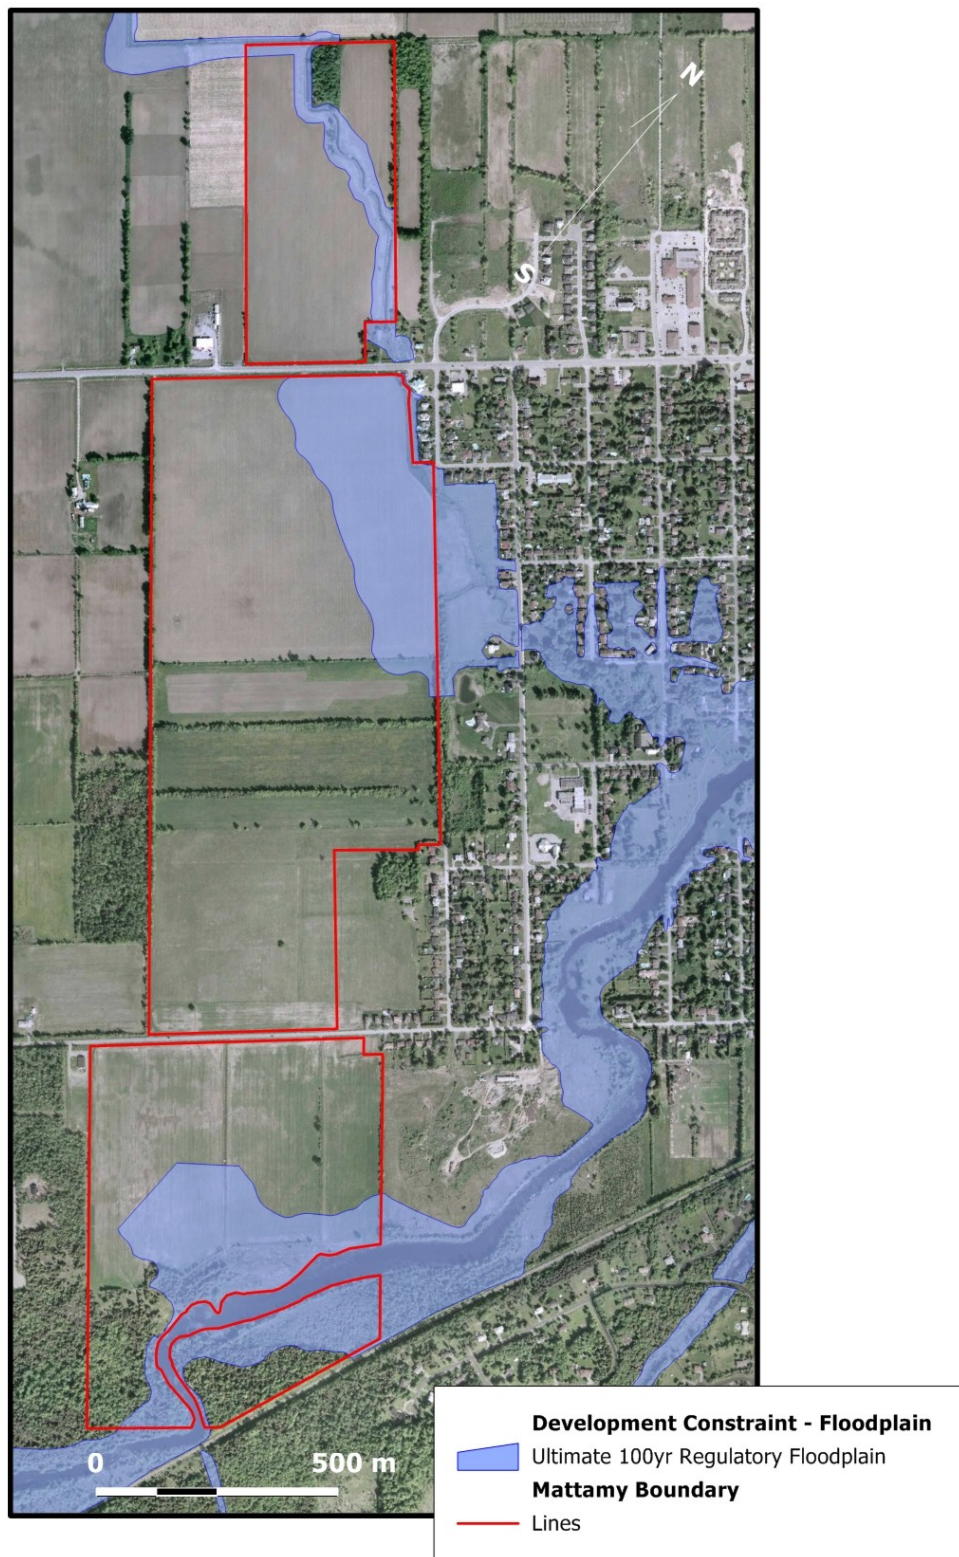
**Figure 25. Map of the Mattamy Richmond land holding showing the ultimate 100-year floodplain.**

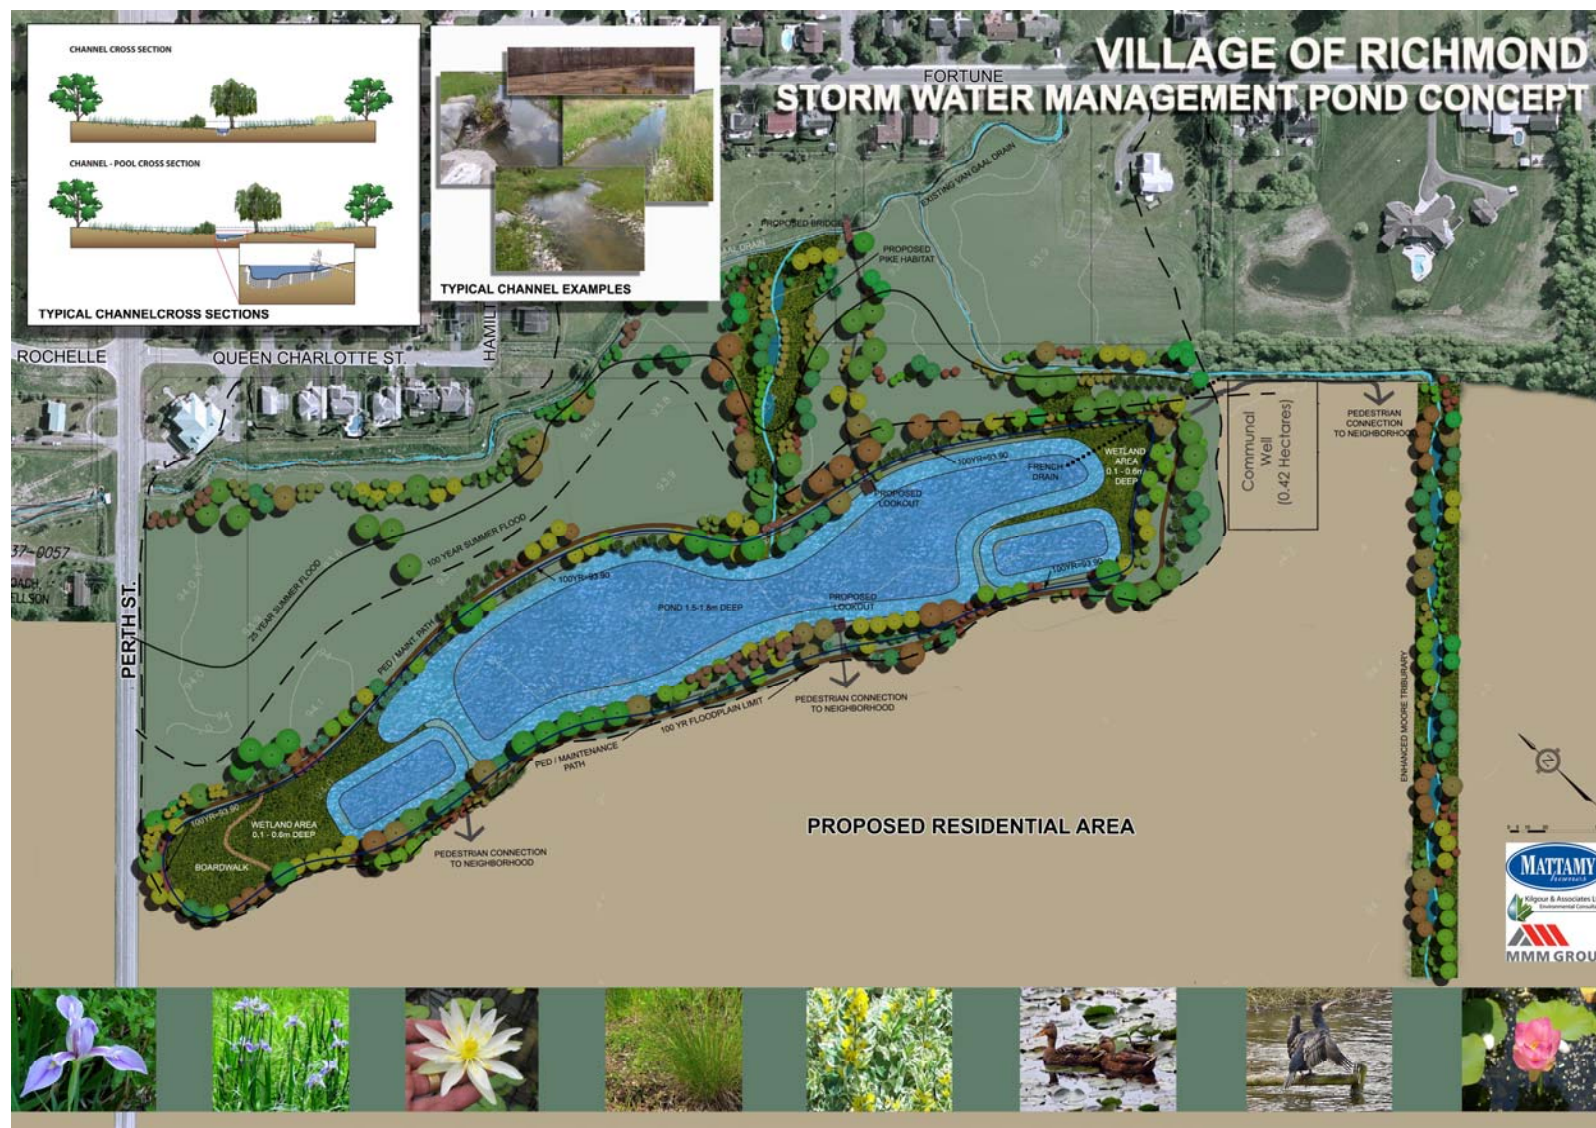
Figure 29. Concept drawing for SWM Pond 1.

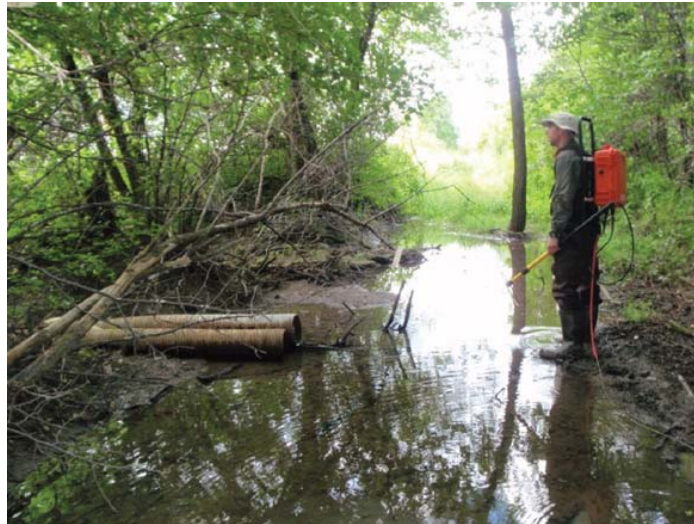
**Figure 30. Photo of the Moore Branch at the top of Section 3 showing the tile drain that provides cool baseflow.**

Figure Note: photo taken August 19, 2008, facing downstream. The creek was dry upstream of this point at the time of the photo.

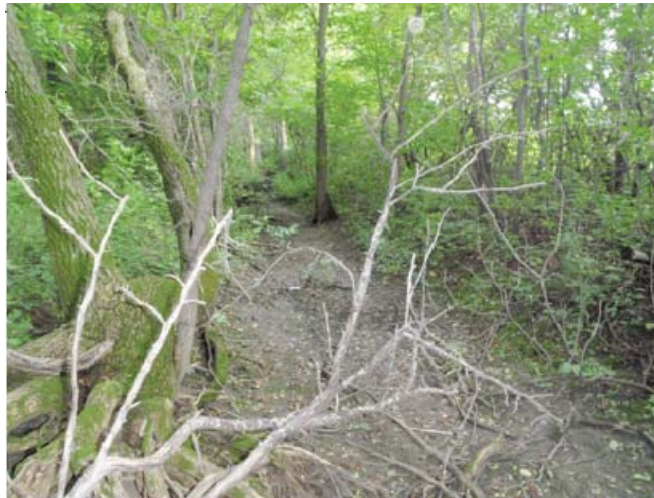
**Figure 39. Photo of Section 5 of the Moore Tributary, facing upstream.**
