REPORT ON

PHASE I  
ENVIRONMENTAL SITE ASSESSMENT  
PART OF LOT 20, CONCESSION 4,  
RIDEAU FRONT, NEPEAN WARD  
CITY OF OTTAWA, ONTARIO

DCR/Phoenix Development Corporation  
18 Bentley Avenue  
Nepean, Ontario  
K2E 6T8

October 2006

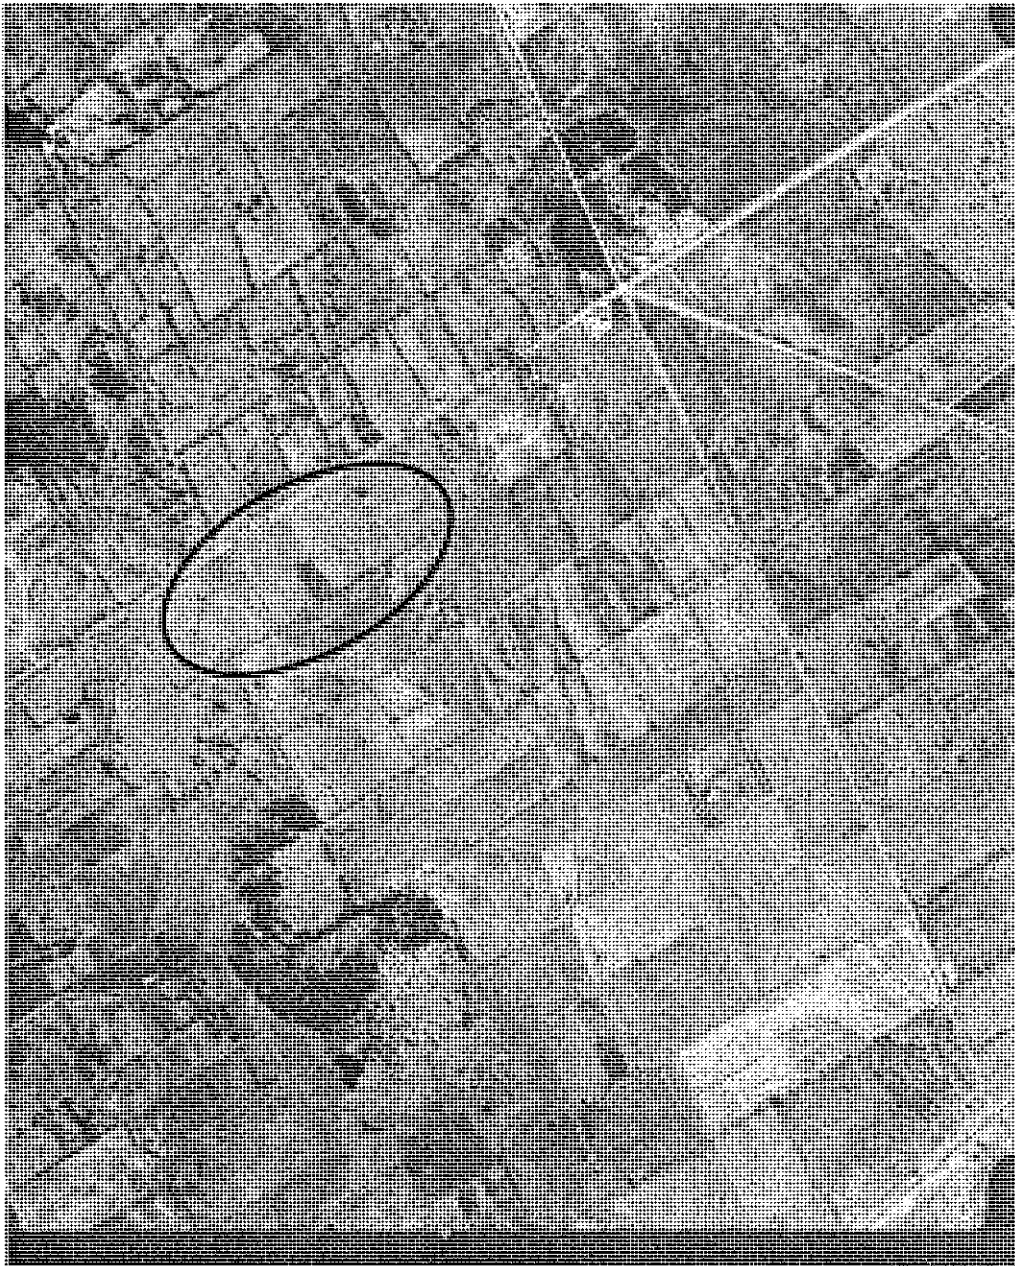
1963

A review of air photographs of the site for the years 1963, 1971, 1983, 1994 and 2002 was carried out as part of this Phase I ESA. All of the air photographs indicate the subject site to be vacant or previously used as farmland. All of the air photographs indicate development out beyond the site has progressively occurred to the north and east over time. The 1994 air photograph indicates some possible recreation type trails have developed around a treed portion of the site near the center of the property. This photograph also indicates some disturbed areas on the north side of the treed area, probably associated with some filling of the site.
