REPORT ON

**PHASE I
ENVIRONMENTAL SITE ASSESSMENT
1626 OLD PRESCOTT ROAD
OSGOODE WARD, GREELY
CITY OF OTTAWA, ONTARIO**

March 2012

120080

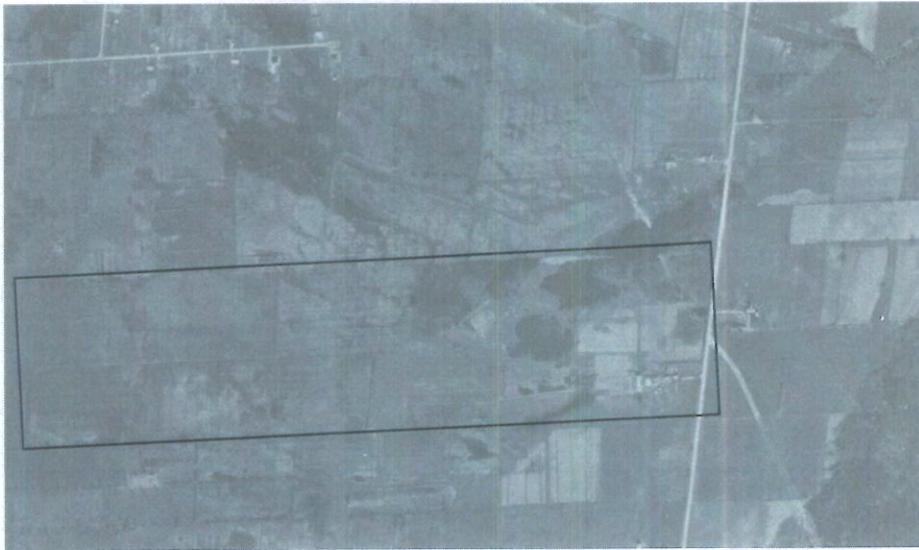
AIR PHOTOGRAPH

A review of air photographs of the site for the years 1969, 1975, 1989, 2002, 2005 and 2011 was carried out as part of this Phase I ESA (see Attachment B). The 1969 air photograph indicates four buildings in a cluster near Old Prescott Road at the site and a cleared trail crossing through the northeast corner of the property. The air photo also indicates a pathway leading to a clearing near the north central portion of the site. The 1975 air photograph indicates only two buildings in that cluster remain along with a disturbed area and a larger disturbed area and possible buildings have been added southwest of the original cluster of buildings noted above. The air photograph also indicates a lake has been created west of the site. The 1989 air photograph indicates one building in the original cluster and two buildings and a silo in the area southwest of the original cluster exist at the site. The air photograph also indicates a disturbance to the ground surface near the center of a series of treed areas near the north center portion of the site. The air photograph indicates another lake has been created adjacent to the southwest corner of the site. The air photograph indicates that development has steadily increased in the vicinity of the site. The 2002 air photograph indicates five buildings and a silo exist at the site. The air photograph indicates a large granular surface area near the silo and buildings. The air photograph indicates two fill piles located northwest of the buildings at the site. Some scattered debris was observed throughout the areas of

1969

1969 - Enlarged

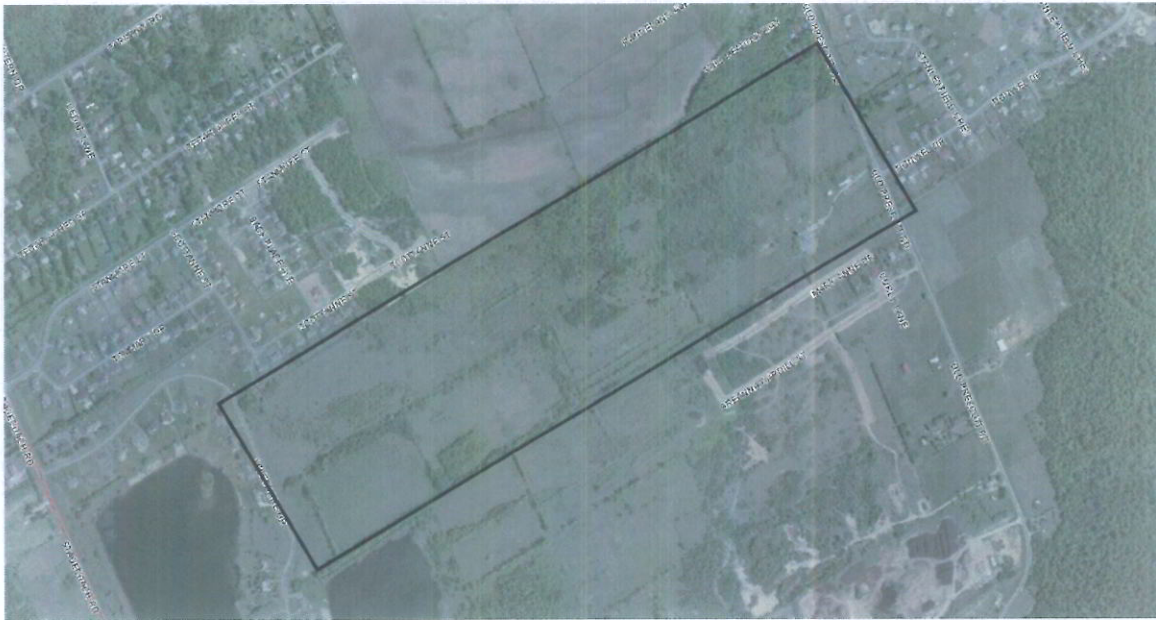
AIR PHOTOGRAPH

these existing buildings. The air photograph also indicates a roadway has been developed immediately west of the subject site. The 2005 air photograph indicates more debris has been added on the ground surface in the vicinity of the silo and nearby building. The 2011 air photograph indicates a building near the silo has been removed or demolished and more debris is present in the vicinity of the silo. The air photograph also indicates a large and a small building have been removed near the building closest to Old Prescott Road. The air photograph indicates a few vehicles parked near the silo. No other significant changes at the site were identified from the review of the air photographs.

2005

2005 - Enlarged

- Possible presence of subsurface contamination associated with former parked vehicles, as observed in the air photograph review, which may have leaked at the site.

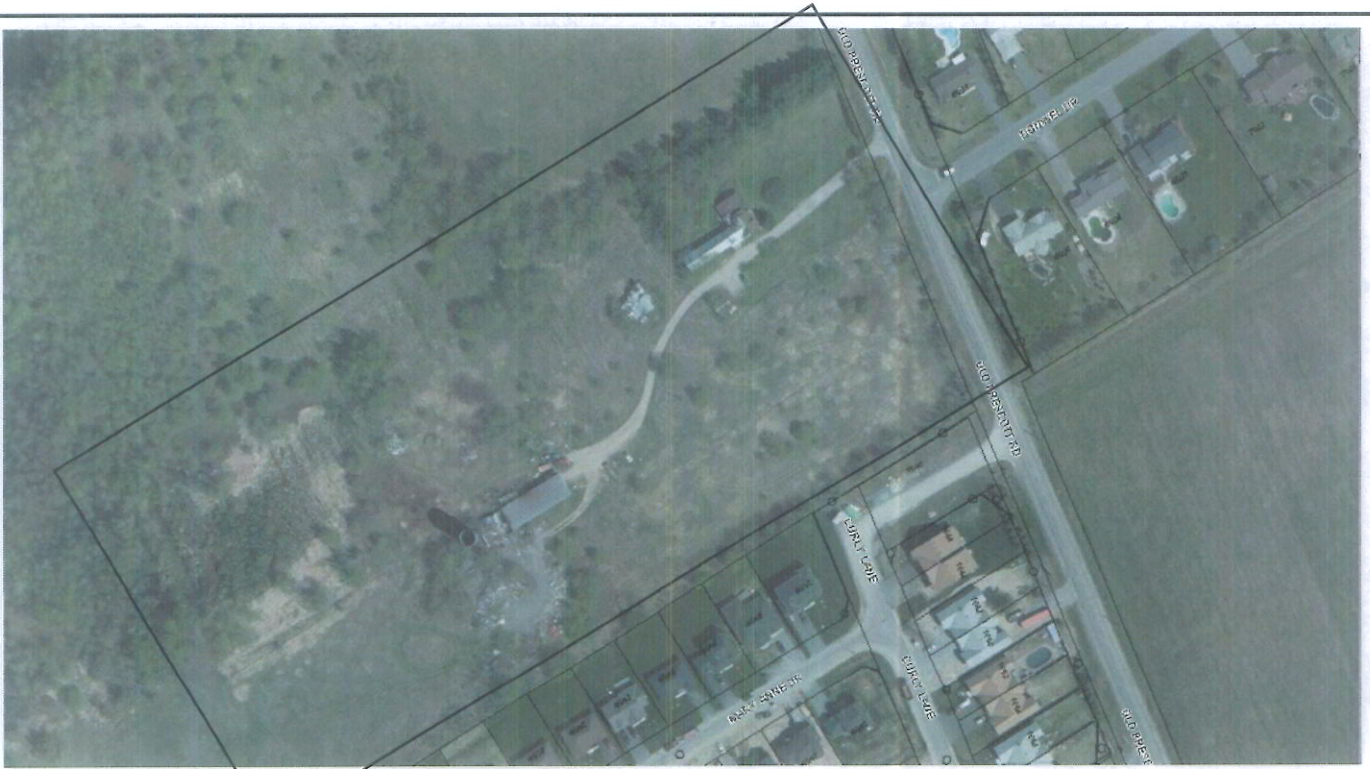
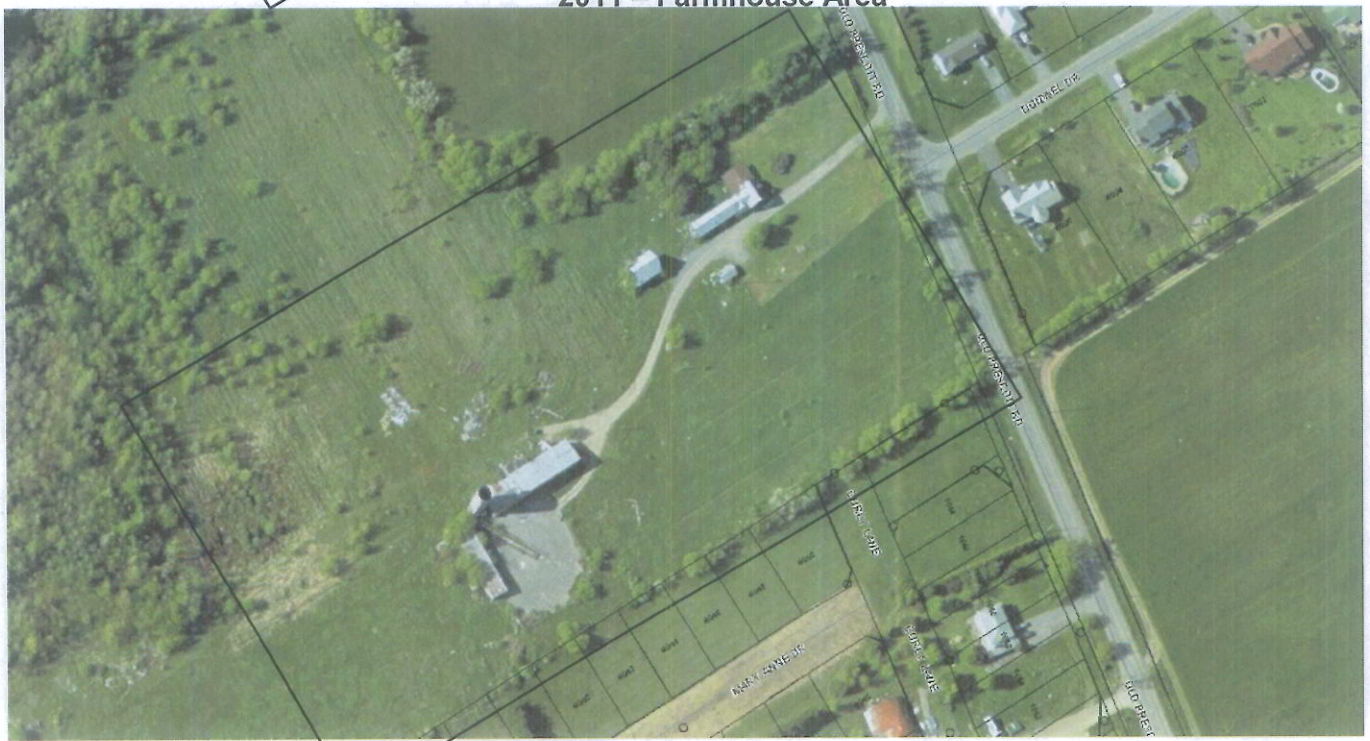
AIR PHOTOGRAPH

2011 – Farmhouse Area

2002 – Farmhouse Area

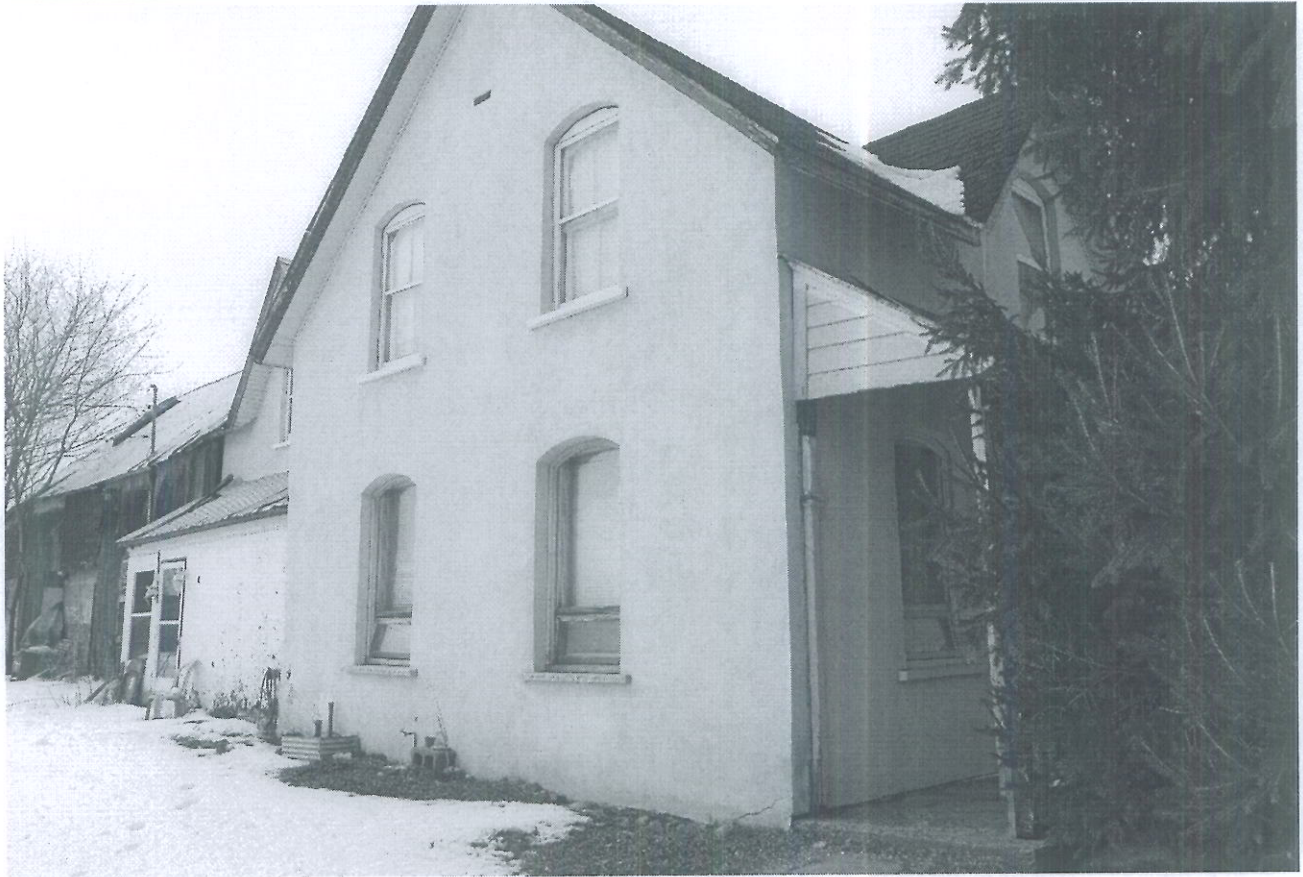
The single family dwelling is a two storey structure divided into two apartments with a basement. The interior of the main floor of the dwelling consists of three bedrooms, a living room, a dining room, a kitchen, a laundry room and a bathroom. A covered second storey contains two bedroom apartments with its own separate entrance, a kitchen and a bathroom. The basement is unfinished and divided into two spaces. The basement floor was observed to be covered with sand, however evidence of a deteriorated concrete slab beneath the sand was observed. One oil burning furnace and an above ground fuel oil storage tank were observed within the basement. An abandoned oil burning furnace was also observed within the basement adjacent to the replacement furnace. The fuel oil tank was observed to be relatively new with no evidence of rusting. No staining was observed at the top, bottom or sides of the fuel oil storage tank. Two newly installed fill pipes were observed to have replaced two former fill pipes for the above ground fuel storage tank. The abandoned fill pipes were observed to have been cut and left in the wall of the foundation at the site. Ice was observed to have formed inside the fill pipes. Other items within the basement included a water pump, a hot water tank and a pressure tank. Some miscellaneous items including rubber hoses, copper piping, concrete debris, fibre insulation and metal pieces were observed within the basement space.

Single Family Dwelling facing South

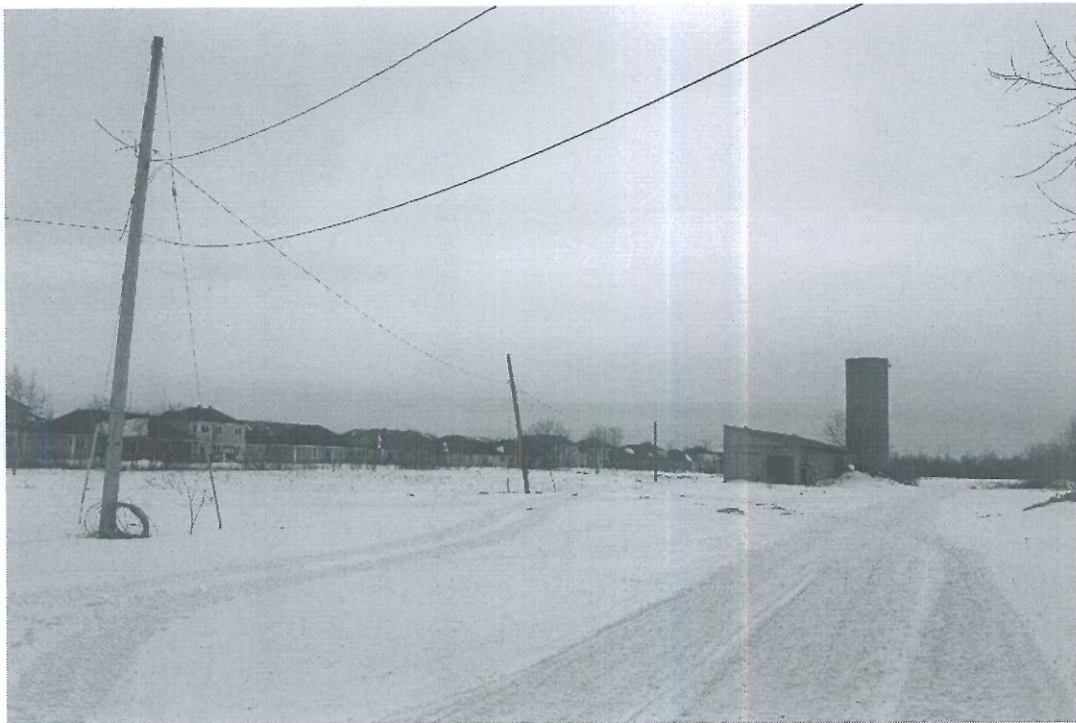
A storage building and a silo were also observed at the site. Access to the storage building was unavailable at the time of the site visit. An above ground fuel storage tank was observed on the north side of the building, near the northeast corner. A large debris pile possibly from a collapsed

Storage Building and Silo

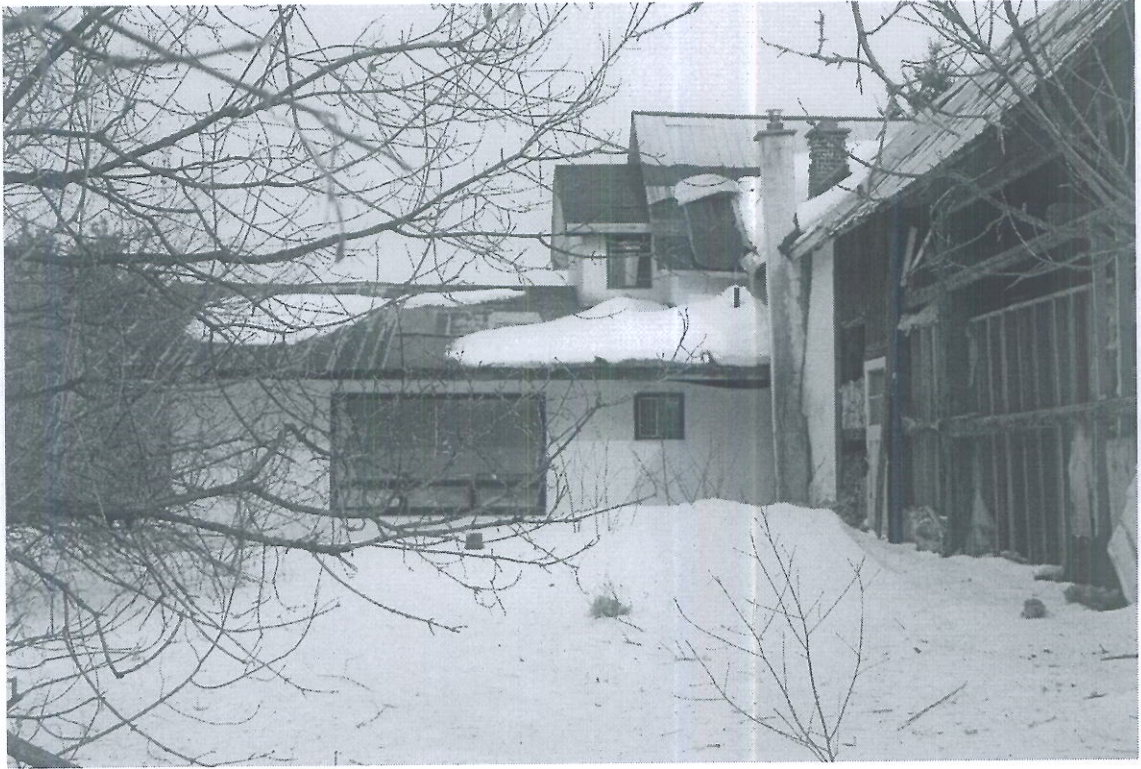
A attached barn used for storage exists immediately west of the dwelling at the site. The barn was observed to be in poor condition. A stockpile of miscellaneous items such as wood, a mattress, rope, a microwave (see Attachment F) were observed in the west entranceway to the barn.

South Side of Barn Building

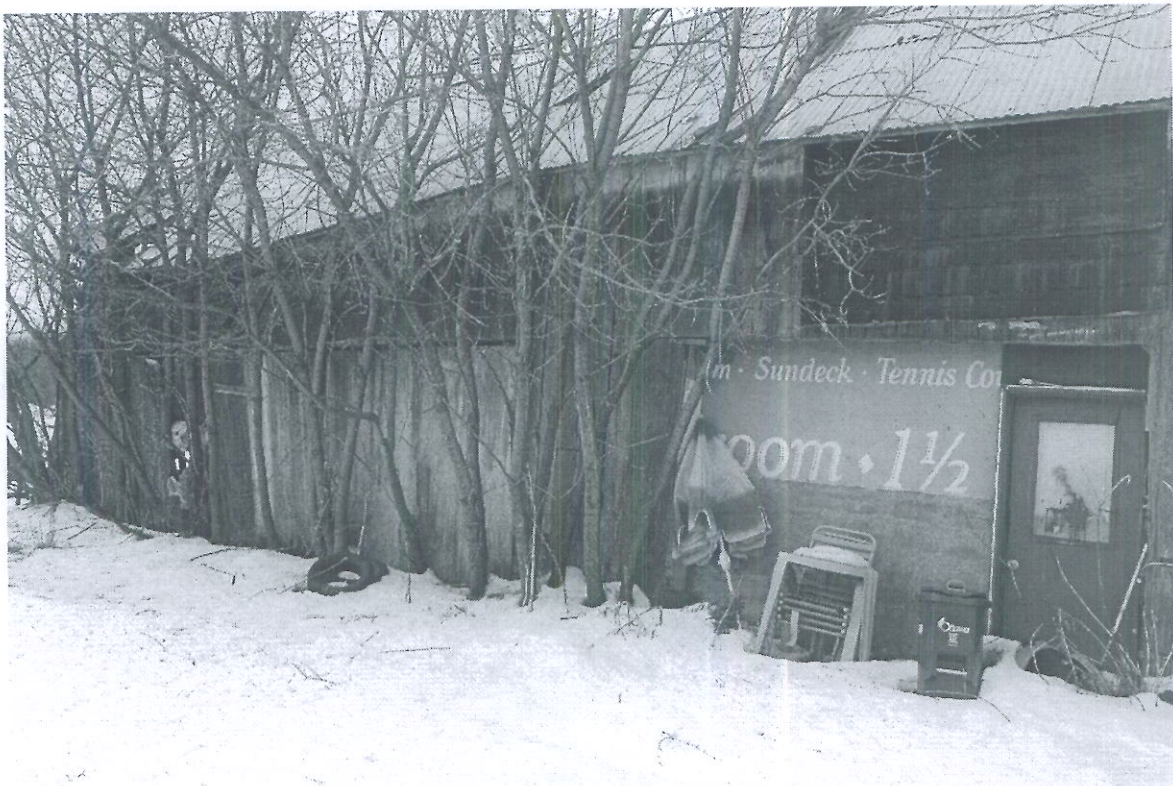
South Side of Storage Barn

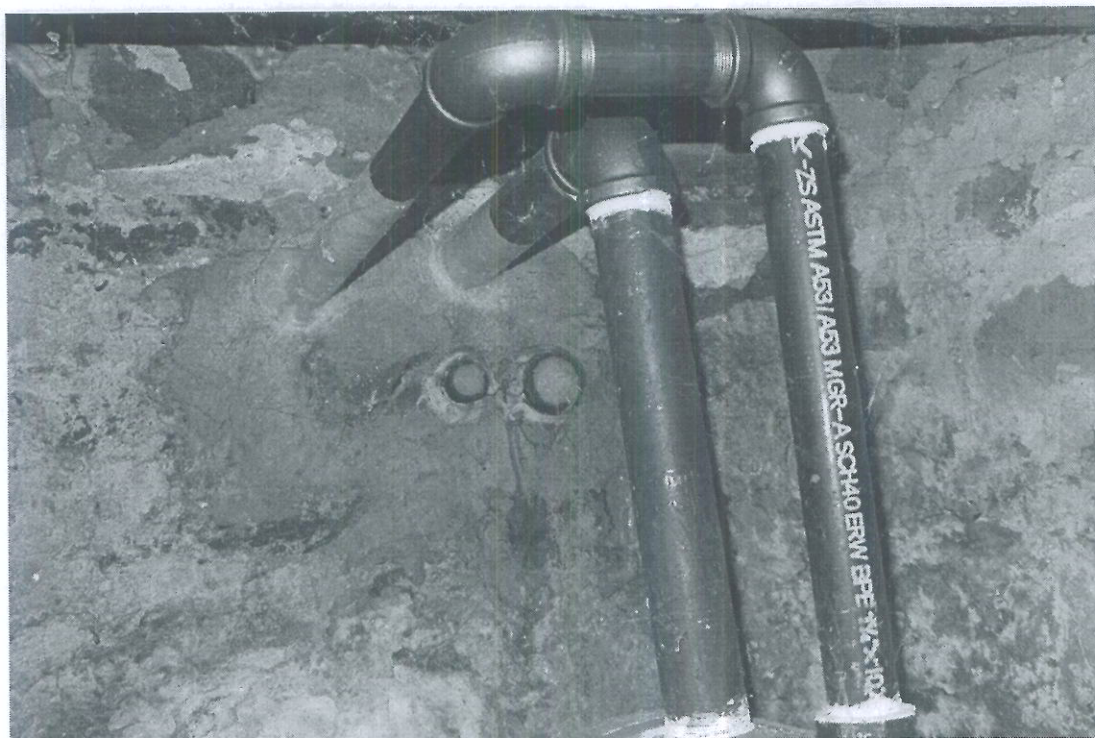
One above ground fuel storage tank was observed within the basement of the existing dwelling at the site. The fuel oil tank was observed to be relatively new with no evidence of rusting. No staining was observed at the top, bottom or sides of the fuel oil storage tank. Two newly installed fill pipes were observed to have replaced two former fill pipes for the above ground fuel storage tank. The abandoned fill pipes were observed to have been cut and left in the wall of the foundation at the site. Ice was observed to have formed inside the fill pipes.

Infill pipe to Basement Fuel Oil Storage Tank

Former and Newly Installed Fill Pipes for Fuel Oil Storage Tank in Basement

- investigation of possible subsurface hydrocarbon contamination associated with the former above ground fuel oil storage tank located in the basement, prior to being replaced with the new fuel oil storage tank.
- investigation of possible subsurface hydrocarbon contamination associated with possible leaking vehicles parked at the site in the area of the storage building and silo observed during the air photograph review.
- Investigation of possible subsurface contamination related to former buildings identified during the air photograph review which are no longer present at the site.
- Investigation of possible surface stains not visible due to snow and ice cover during the time of the site reconnaissance.
- Investigation of possible fill piles not visible due to snow and ice cover during the time of the site reconnaissance.

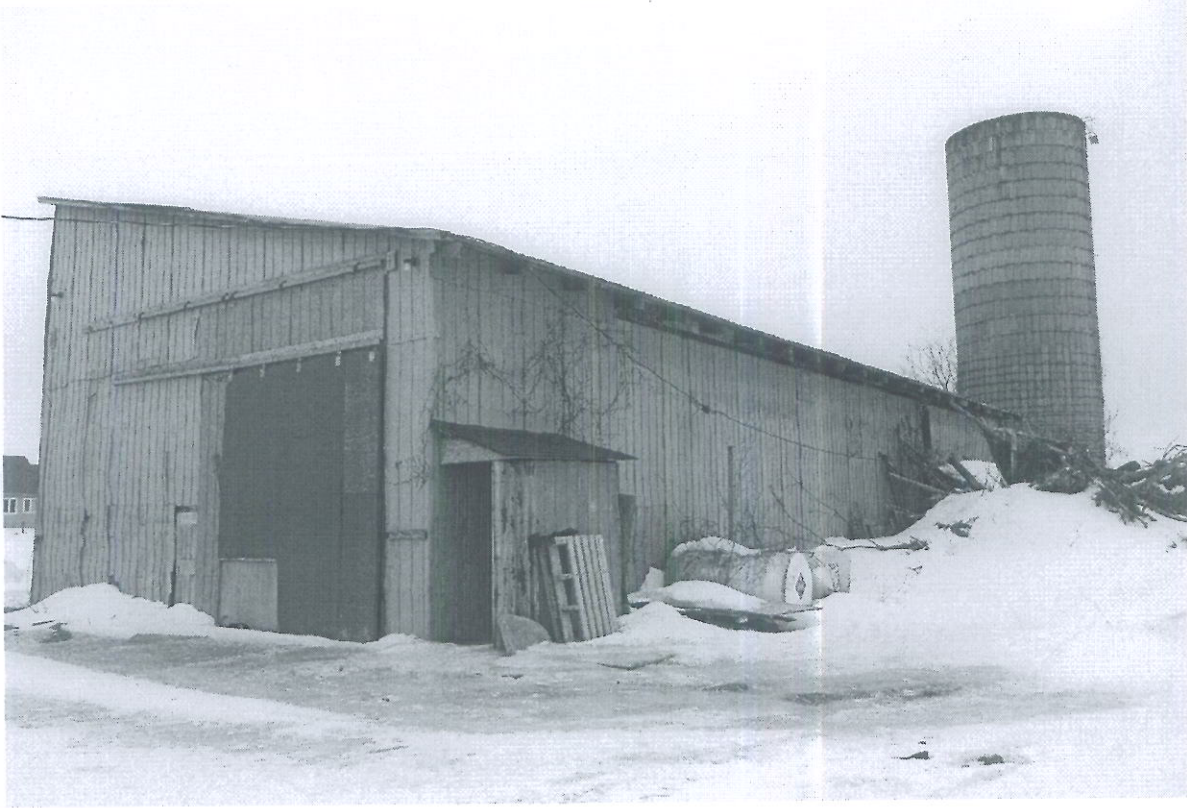
North Side of Existing Storage Building and Silo

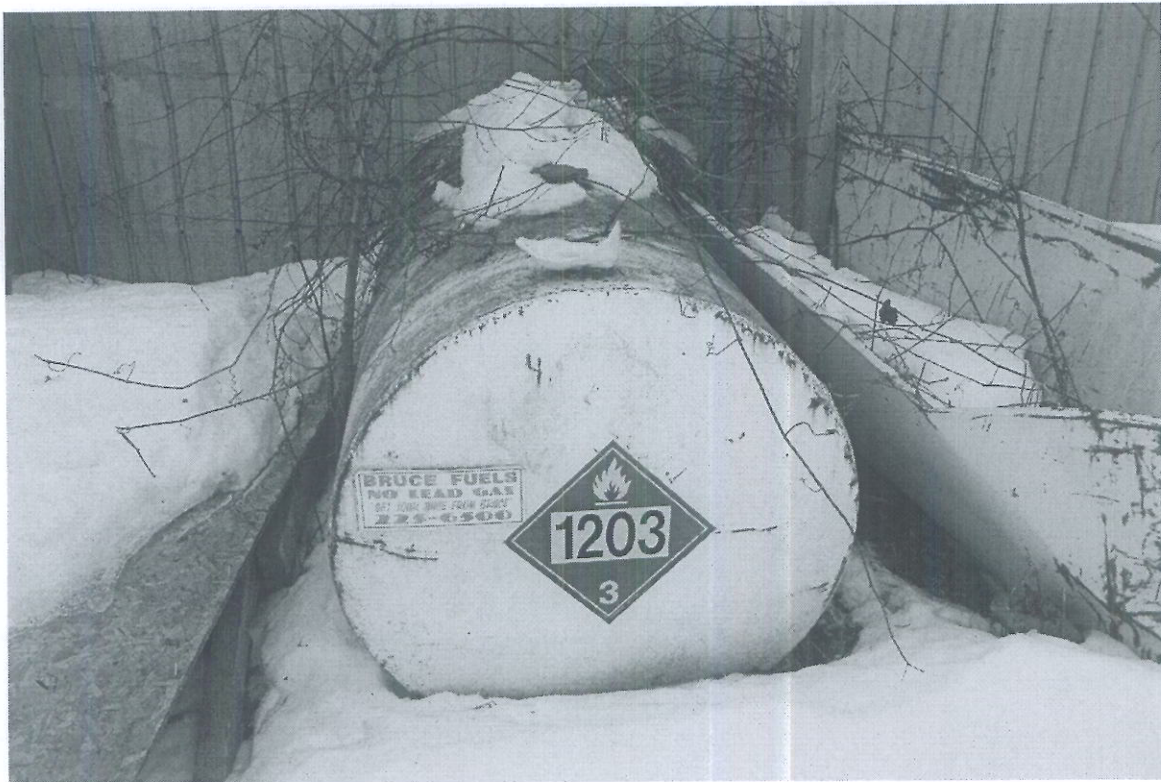
An above ground fuel storage tank was observed on the north side of the storage building. The fuel storage tank was located near the northeast corner of the storage building. The storage tank was observed to be partially snow covered with some rusted areas along the ends and the top of the fuel tank. No odours were evident in the vicinity of the fuel storage tank. Due to the presence of ice and snow around the base of the tank, no observations of the base, the soil conditions or vegetation near or beneath the tank were observed.

Above Ground Fuel Storage Tank located on North Side of Storage Building

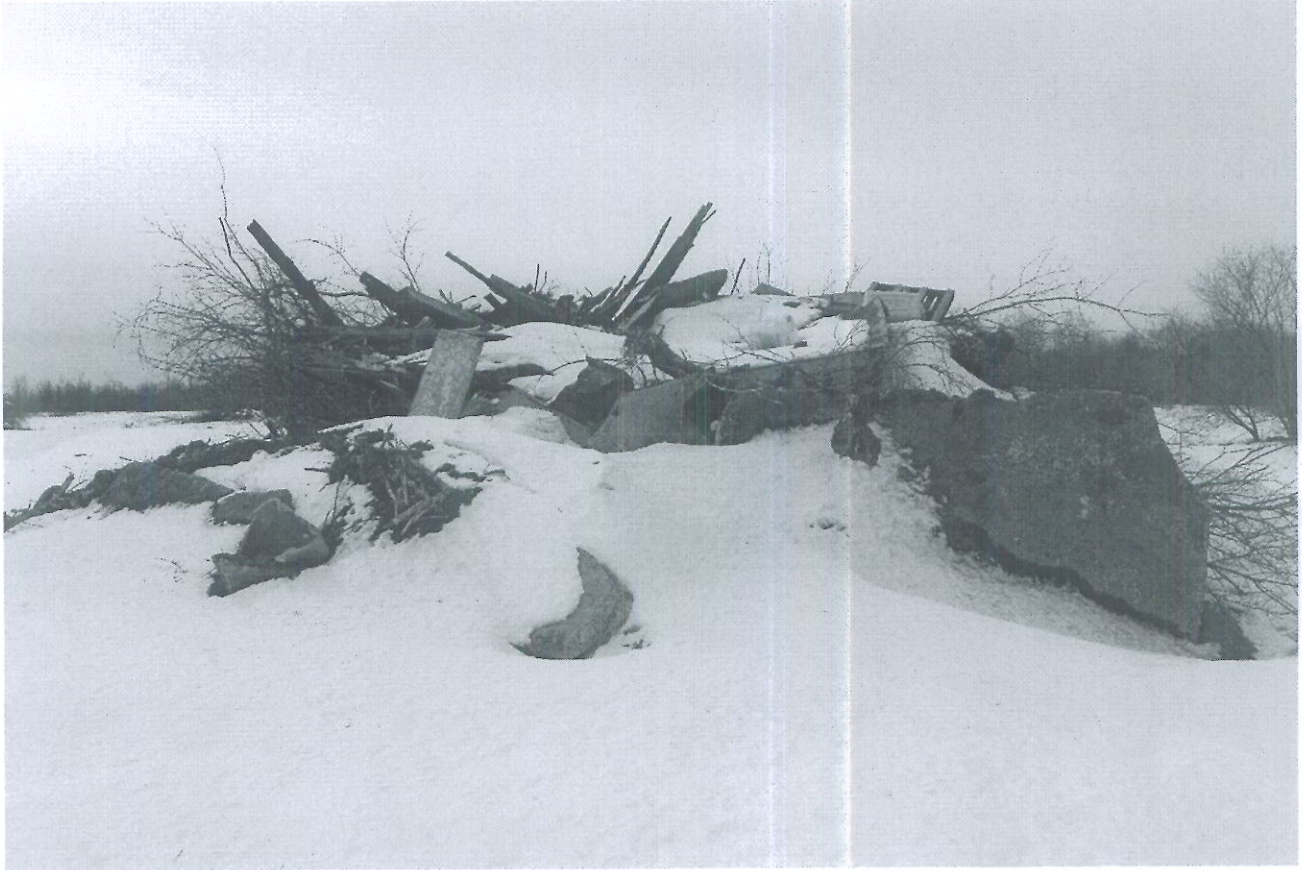
The site was covered in ice and snow at the time of the site visit. Accordingly, no observations could be made of ground staining or distressed vegetation or fill materials throughout the site. Several piles of debris material identified earlier, likely from collapsed building structures, were observed at

the site. Those debris piles possibly relate to former building structures observed during the review of the air photographs for the site.

Miscellaneous Fill Debris in East Portion of Site

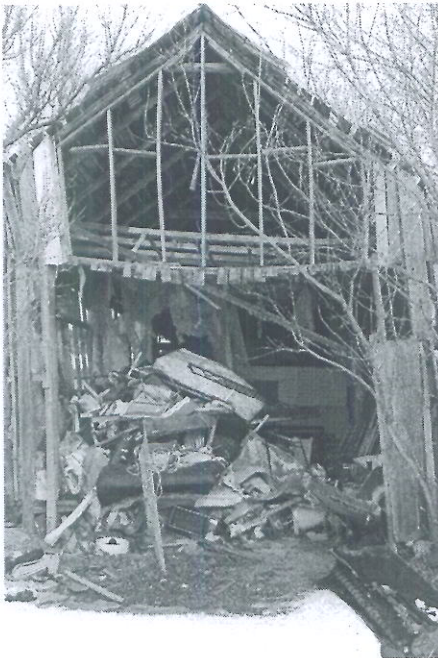
West Entry to Barn

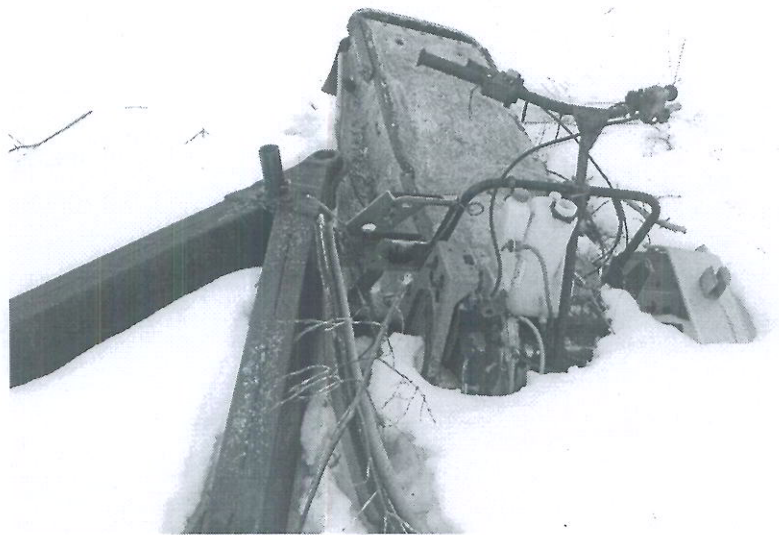
Miscellaneous items including abandoned farm machinery, an abandoned snowmobile, a boat trailer, a stockpile of asphaltic shingles, wood debris, a plastic container (possibly containing motor oil), a propane tank and two barbecues were observed throughout the property at the time of the site visit.

Miscellaneous Items

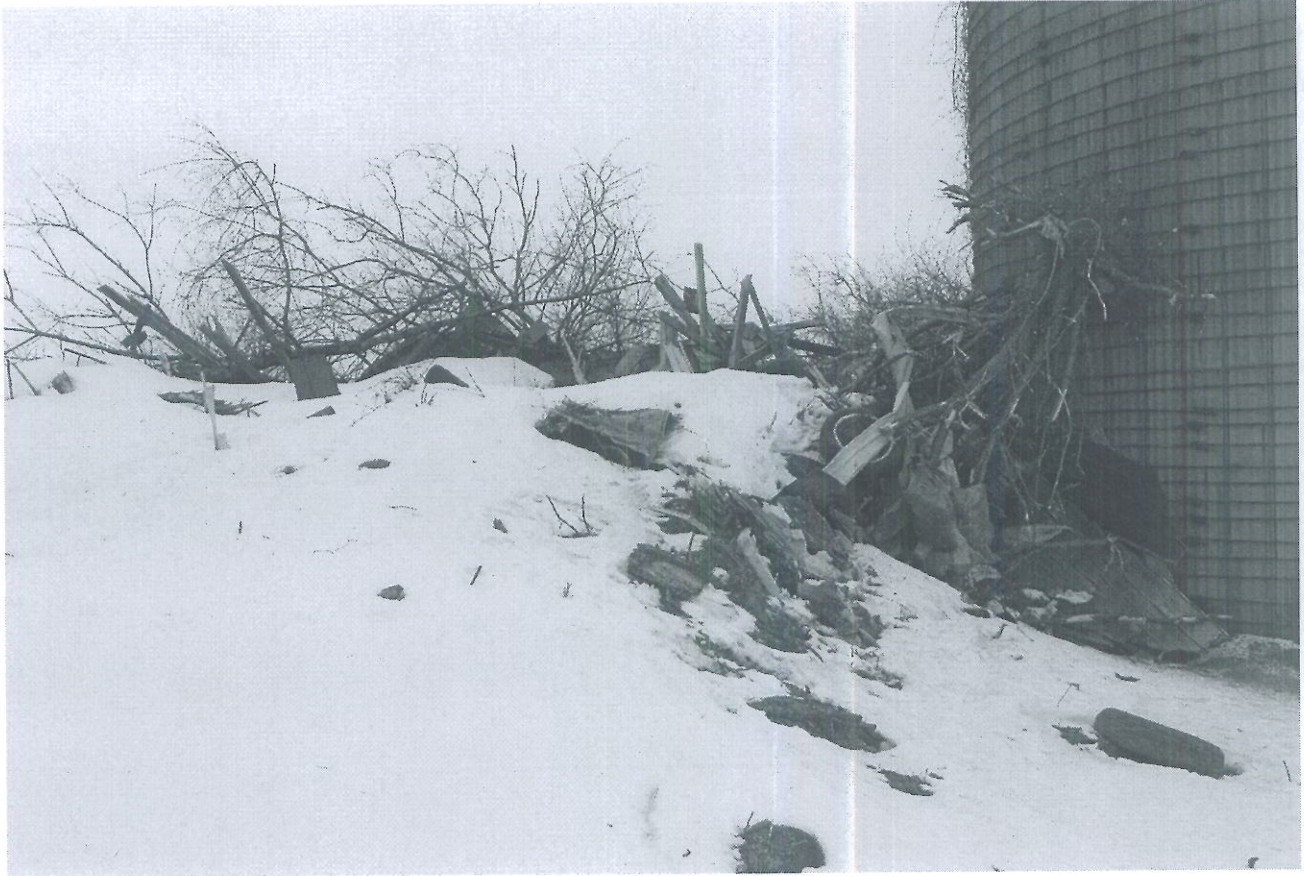
building was observed on the west side of the building, between the silo and the existing building. A concrete slab was also observed south of the silo, likely from another former building at the site. Part of an asphaltic concrete surfaced area was observed south of the existing building and silo. Other large debris piles were observed in the vicinity of the existing buildings, possibly from former buildings as evident in the review of the air photographs for the site.

Debris Pile Adjacent Silo

- Possible pesticide and herbicide residue from past agricultural use of the site.
- Possible presence of subsurface contamination within the debris piles observed within the areas of former buildings at the site.

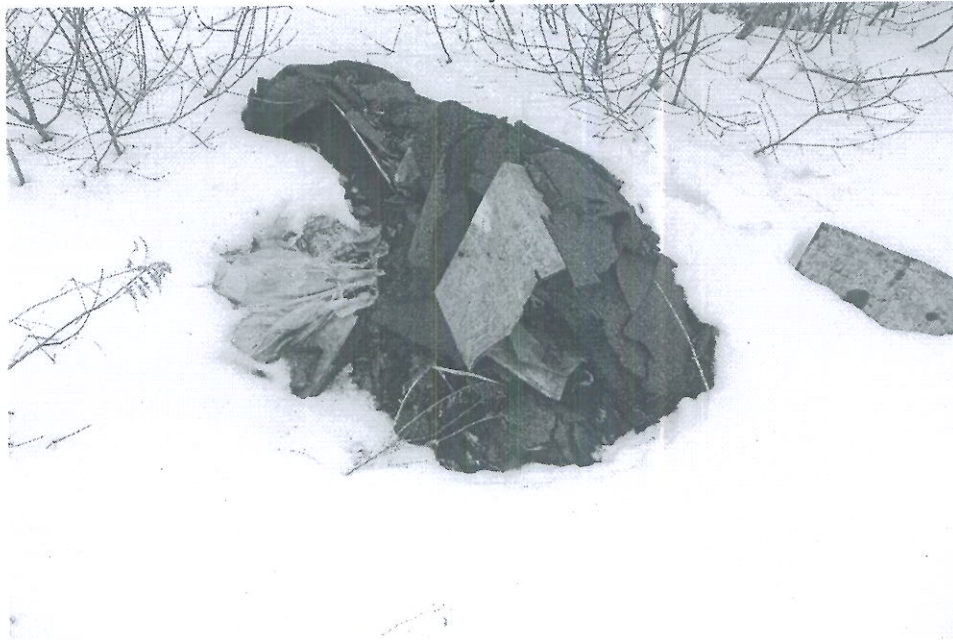
Asphaltic Shingle Pile
