Muncaster  
Environmental  
Planning Inc.

October 11, 2016

**RE: 5618 Hazeldean Road**  
**Tree Conservation Report and Environmental Impact Statement**

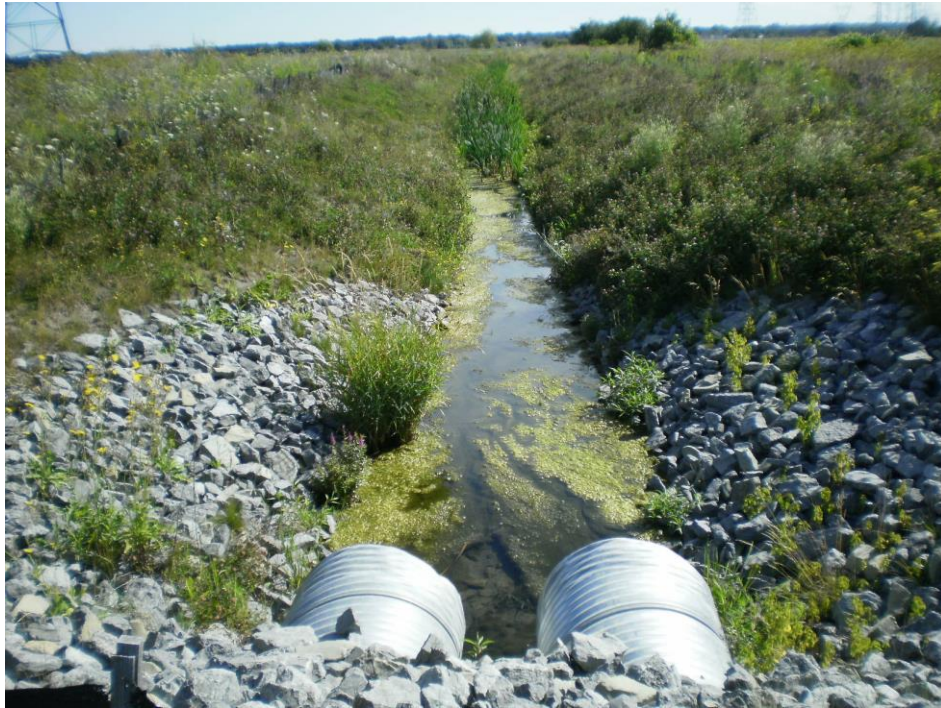
*Photo 1 – Realigned portion of the West Tributary downstream of the new high school.  
View looking east*

As part of the construction of the Paul-Desmarais High School the West Tributary was piped for the first 190 metres from the west site boundary and a temporary channel created along the east edge of the school to collect drainage from the Abbott Street extension and surrounding lands (Photo 1). On May 9<sup>th</sup>, 2007 23 fish, representing three fish species - northern redbelly dace, creek chub and brook stickleback, were netted by Muncaster (2007) along the portion of the West Tributary that is now piped. The fish community included a good representation of young creek chub.

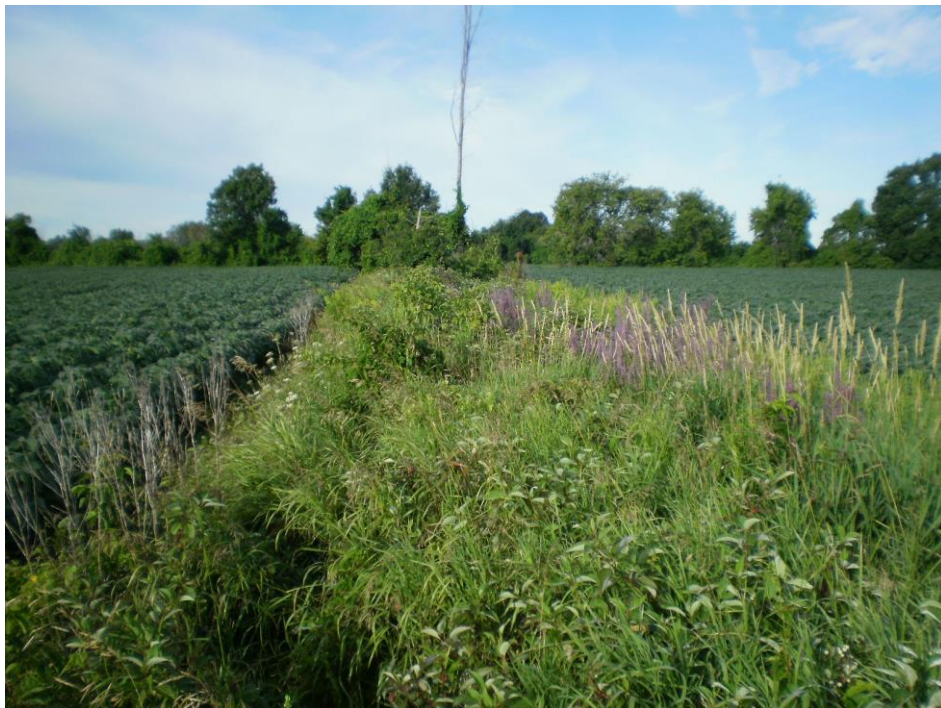
*Photo 2 – Former west to east channel in the central portion of the site*

There are two remaining tributaries to the Carp River on and adjacent to the site. The Hazeldean Tributary crosses Hazeldean Road adjacent to the northwest corner of the site while the West Tributary, as named in the Fernbank Community Design Plan (Muncaster, 2007), flows from the Granite Ridge Stormwater Management facility to the east under Iber Road and enters the site in the vicinity of the new Paul-Desmarais High School (Map 1). A third west to east channel is shown on background mapping in the middle of the site. This channel enters the West Tributary at the east edge of the site, approximately 550 metres south of Hazeldean Road. The confluence with the West Tributary was historically altered by deepening the reach of the West Tributary oriented to the south along the east site boundary. Fish access into the middle channel did not appear possible under typical flows and no fish were captured in this channel by Muncaster (2007). It is likely that the flows in the middle channel were decreased substantially as a result of development along Iber Road and to the west. The channel is now choked with vegetation and has no apparent aquatic characteristics (Photo 2). In 2006 Muncaster (2007) reported maximum water depths less than 10cm and in 2016 there was no evidence of flow in the middle channel.

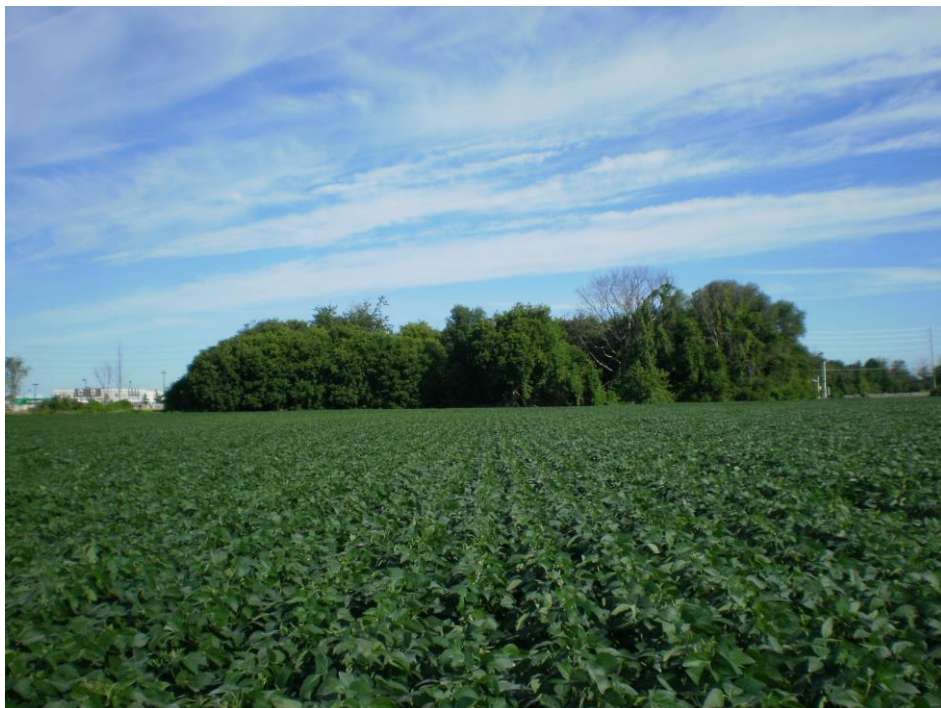
*Photo 4 – Cultivated field of soybeans south of Hazeldean Road, with view looking north to the west cultural woodland representation south of Hazeldean Road*

The site is dominated by cultivated fields, planted in soybeans in 2016 and previously planted in corn (Map 1, Photos 3, 4 and 5).

Areas of cultural woodland are south of Hazeldean Road (Photos 4 and 8) and in the west portion of the site. White elm, Manitoba maple, bur oak and crack willow between 60 and 105cm dbh were the largest trees in the cultural woodlands with smaller green ash, white ash and trembling aspen also present. The larger white elm and Manitoba maple had many broken limbs, with vine growth common and fungus on the larger elm. Trembling aspen was dominant in the west cultural woodland representation, with white elm common. Manitoba maple was dominant in the central-east cultural woodland and the woodland south of Hazeldean Road. Many of the aspen and elm were in poor condition with reduced leaf-out.

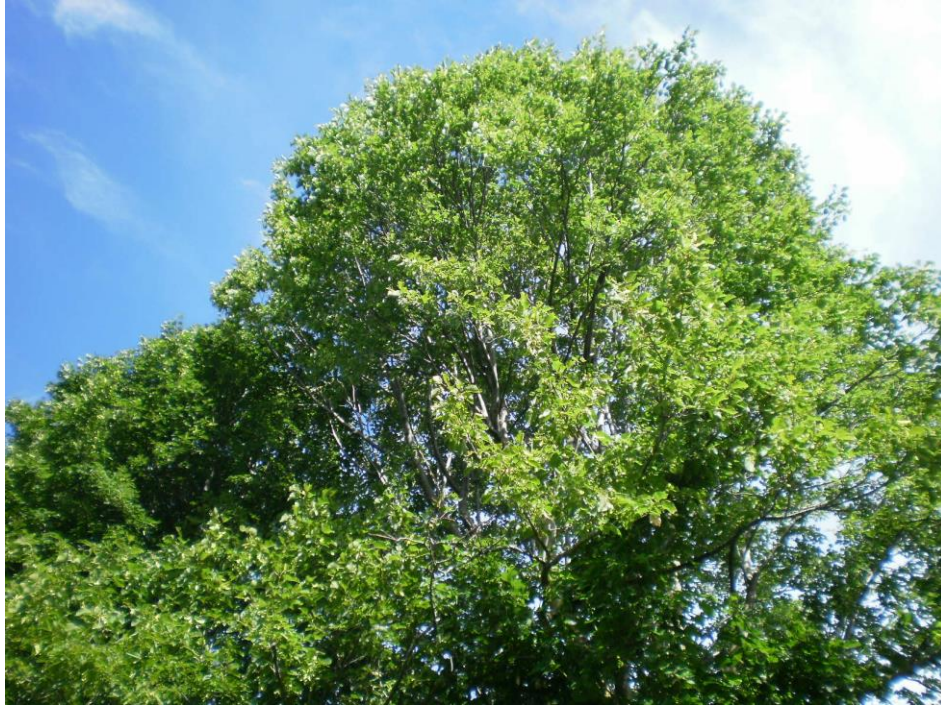
*Photo 9 - Mature basswood in an east-west deciduous hedgerow in the northwest portion of the site with good leaf-out*

The larger trees in the deciduous hedgerows are principally Manitoba maple, bur oak, basswood, crack willow, white elm and white ash, with the largest stems in good condition in the range of 50 to 80cm dbh. An 80cm dbh white elm in the north portion of the hedgerow along the west property line appeared dead with no leaf-out (Photo 10). White elms in the deciduous hedgerows in the middle-south portion of the site appeared to be in better condition with a fair amount of leaf-out and in the central portion of the west site boundary (Photo 11). A 120cm dbh bur oak in the north east-west hedgerow appeared to be in relatively good condition with good leaf-out noted (Photo 12), as were mature basswoods in the central-west portion of the site (Photo 9).

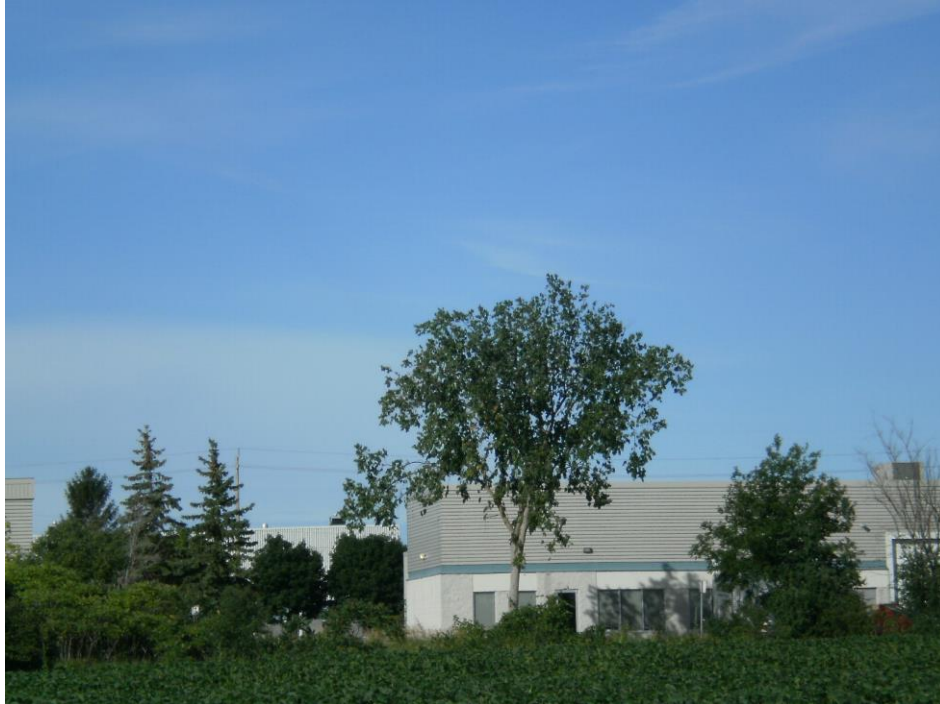
*Photo 11 – White elm with good leaf out in the intermittent deciduous hedgerow along the west edge of the site approximately 450 metres south of Hazeldean Road. View looking west to the rear of the commercial buildings off the east side of Iber Road*

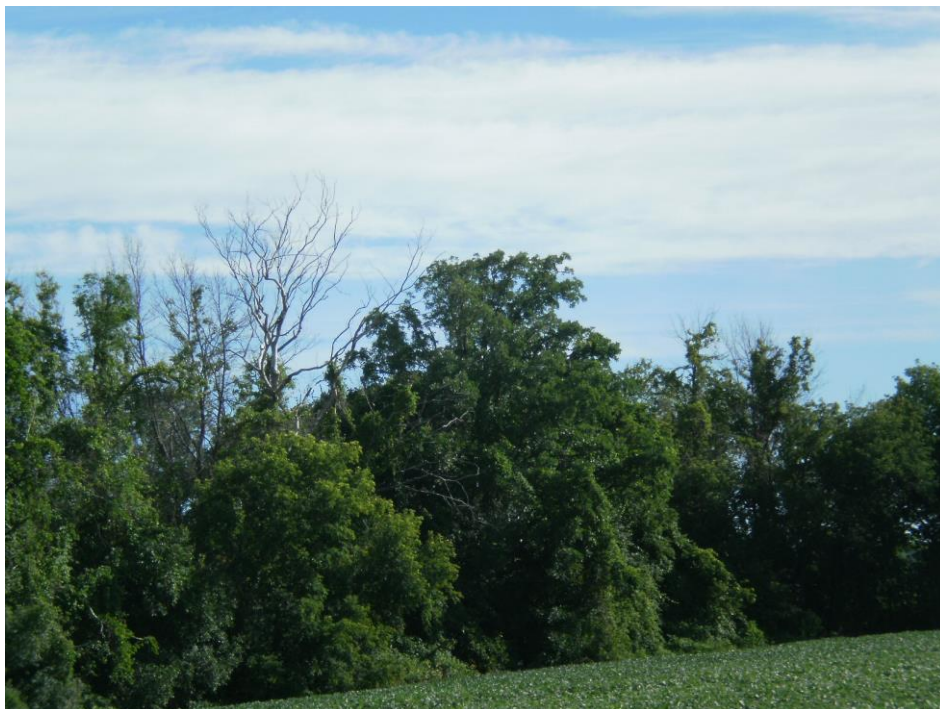
*Photo 12 – Bur oak with good leaf-out among ash and elm trees in poorer condition in the north east-west hedgerow*

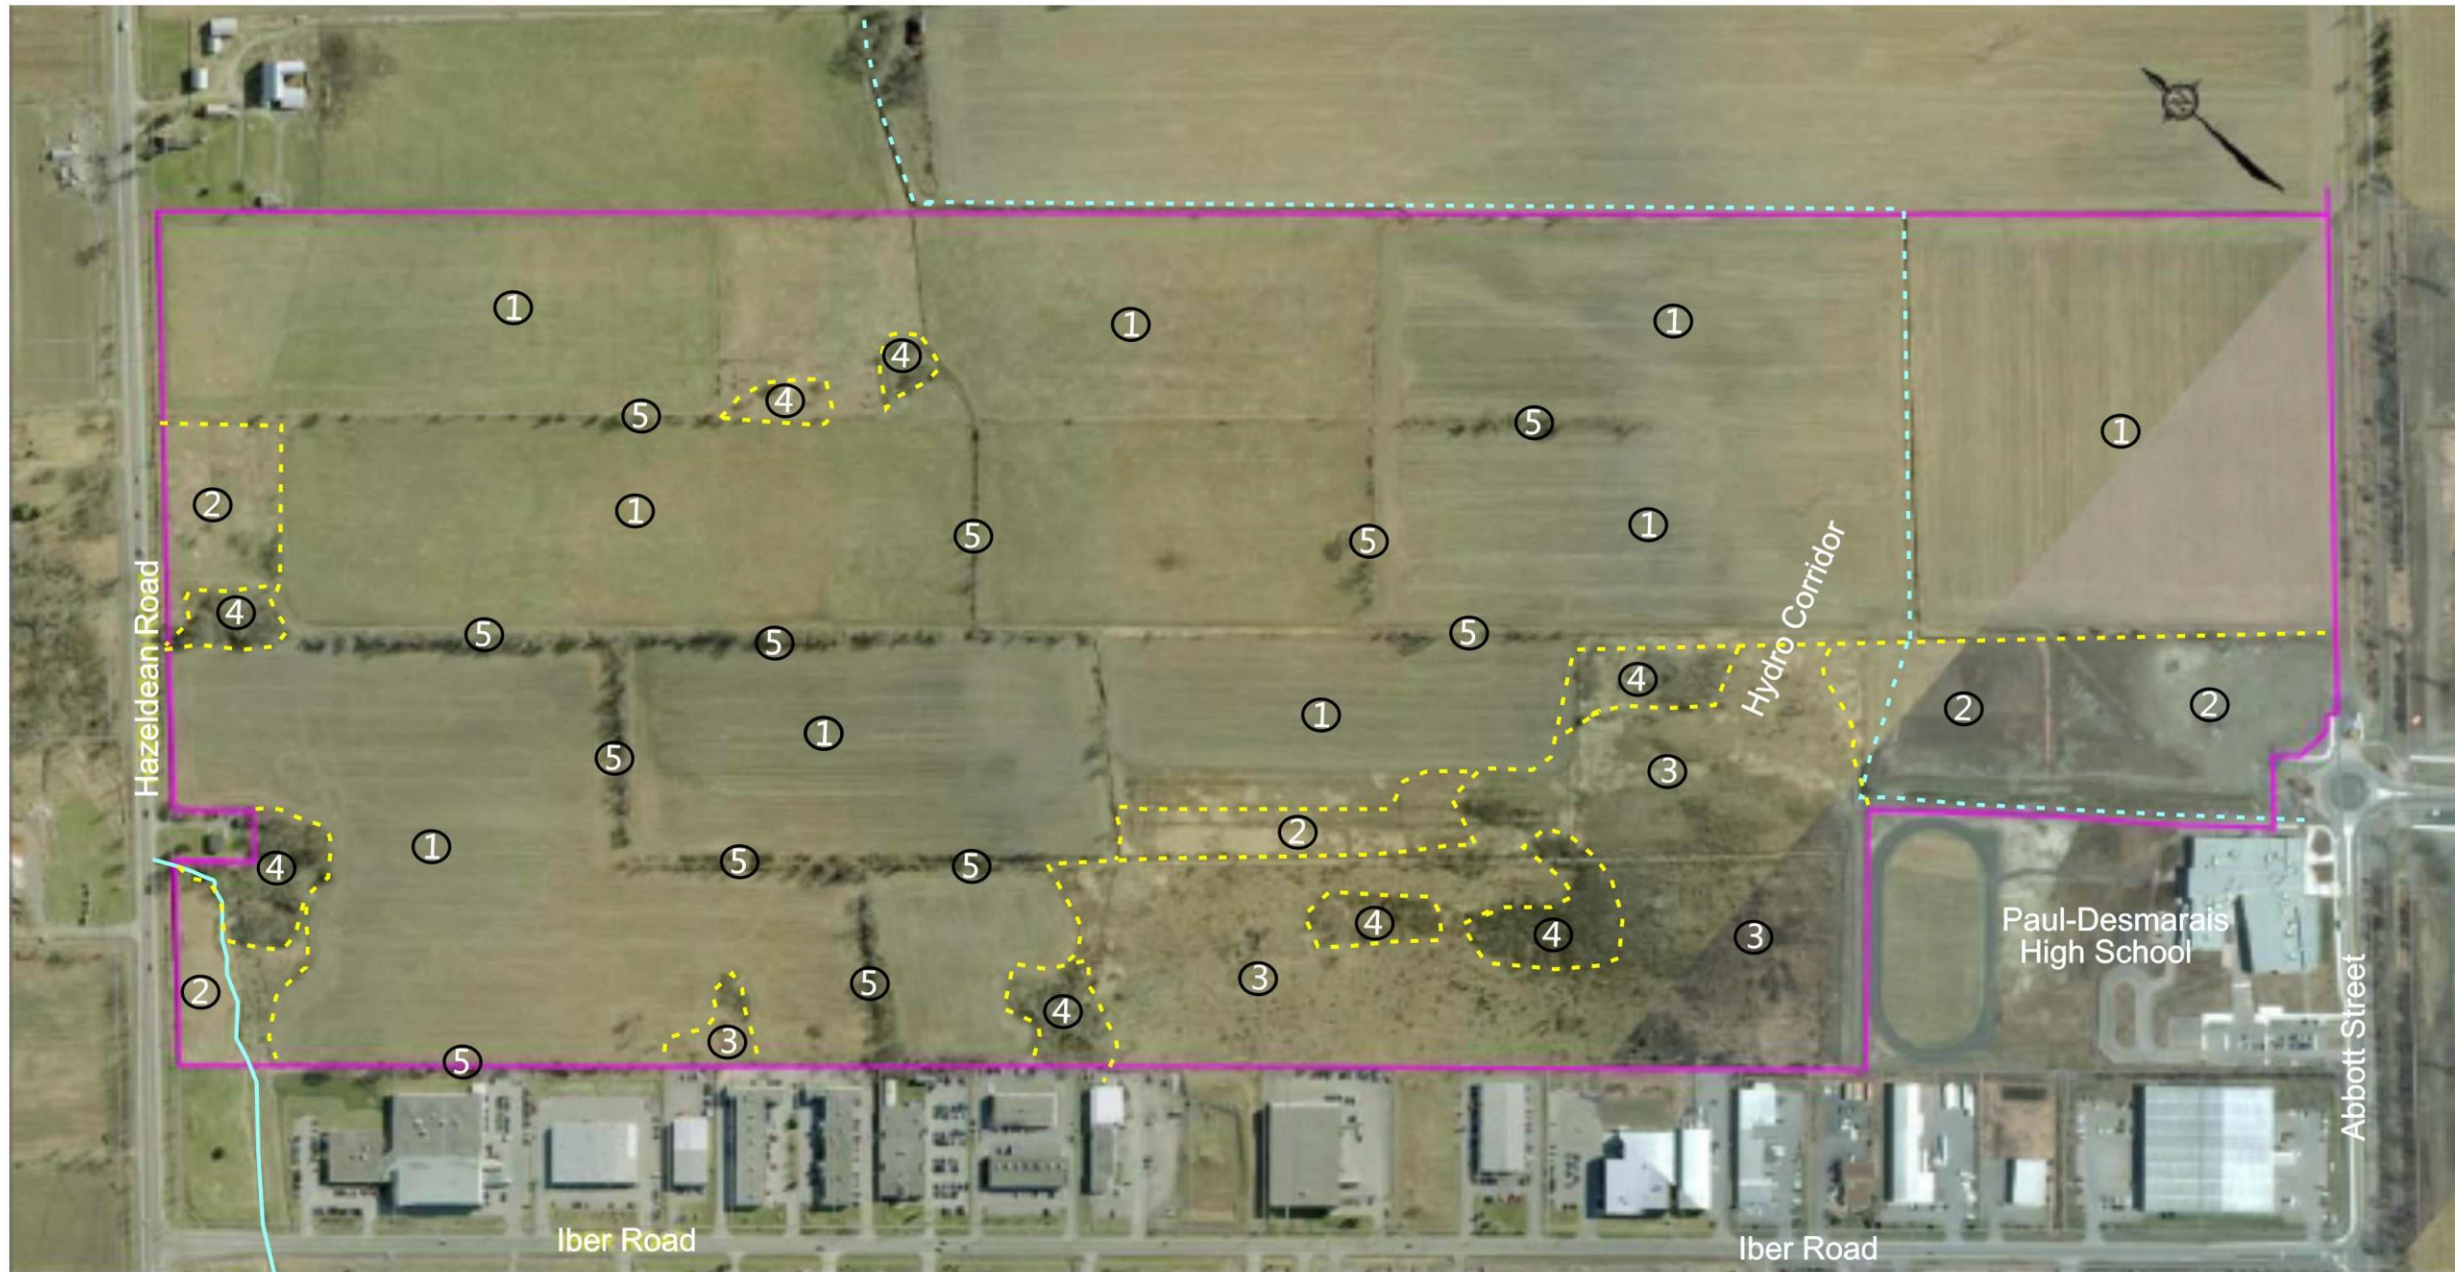
## Map 1

- ① Agricultural lands
- ② Cultural meadow
- ③ Cultural thicket
- ④ Cultural woodland
- ⑤ Deciduous hedgerow

### CURRENT VEGETATION

Cultivated fields, a steel dual-tower hydro line, deciduous hedgerows and cultural habitats are present on the site (Map 1). Aerial photography indicates the site has been in agricultural activity since at least 1976. There is regenerating woody vegetation in the southwest portion of the site where the lands do not appear to have been in agricultural use since the early 1990s and areas of cultural woodlands south of Hazeldean Road.
