**Environmental Impact Statement
3809 Borrisokane Rd.**

Initial Report

December 21, 2018

KILGOUR & ASSOCIATES LTD.
www.kilgourassociates.com
Project Number: CAIV836

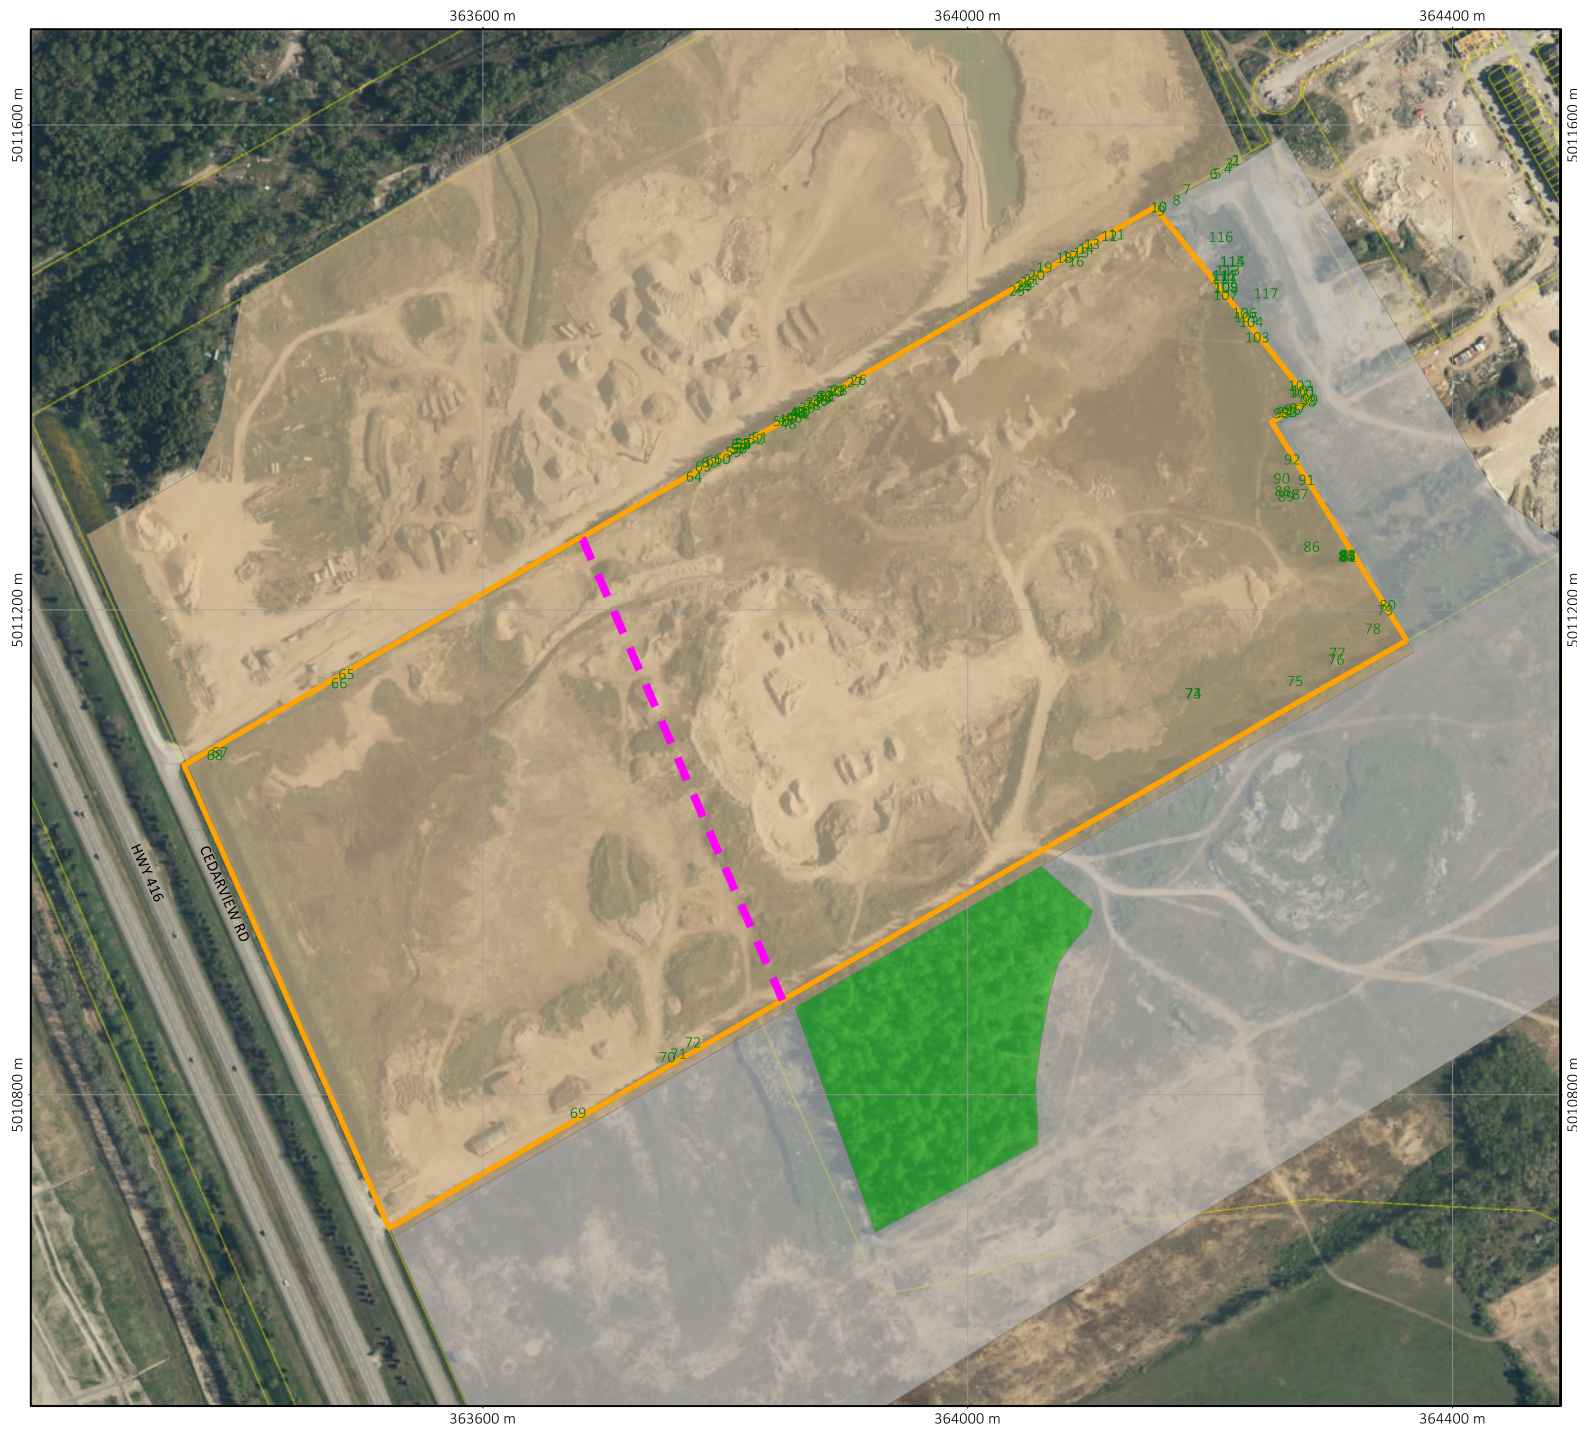
Figure 2 Existing site conditions

Site land cover is mapped in Figure 2. The entire site has been excavated, leaving only narrow bands of trees along the site periphery. These hedgerows were generally left perched on tall ridges of leftover material. The site originally consisted of sand and gravel soils - Uplands and Mille-Isles formations in the west (strongly acid fine to coarse sand with limited fine gravel), to a Kars formation in the east (slightly acid to neutral, gravelly and cobbly coarse to moderately coarse textures glaciofluvial materials with a surface generally worked into beach deposits) (Marshall et al. 1979). Remnant piles of this material are scattered about the site. The site was active until recently. As such these piles are considered very unlikely to have had time to have become useful as habitat features.

Highway 416 is located adjacent to the western end of the site. The land to the north, south and east has a similar usage history and land cover as the site, though the parcel to the east is currently being redeveloped as a residential community. The parcel to the south does have a small woodlot on near to, but set back 5 to 10 m from, the south side of the proposed development area.

The deciduous woodlot to the south of the site a 3.8 ha Dry – Fresh Sugar Maple Forest (FOD5). Large Sugar Maples with diameters of 45cm or larger dominate the upper canopy cover although they are fairly spaced out within the lot. The understory is almost entirely sugar maples smaller than 10cm DBH though some small basswoods occur near the edges of the feature. It appears as if this woodlot was previously managed as a maple sugar bush with trees being removed to facilitate the growth of the larger sugar maples. The larger maples show some signs of crown and branch dieback and many of them have significant cavities as a result.

Trees located along the north and south side of the property are perched somewhat precariously along the raised edges of the site. Many tree previously occurring there have already toppled over into the former pit area. While remaining individual trees provide some shading and possible nesting space for local fauna, this functionality is likely very limited. As a row, they do not lead to any other natural features cannot provide service as a corridor. All trees on site will be removed as the area is rehabilitated

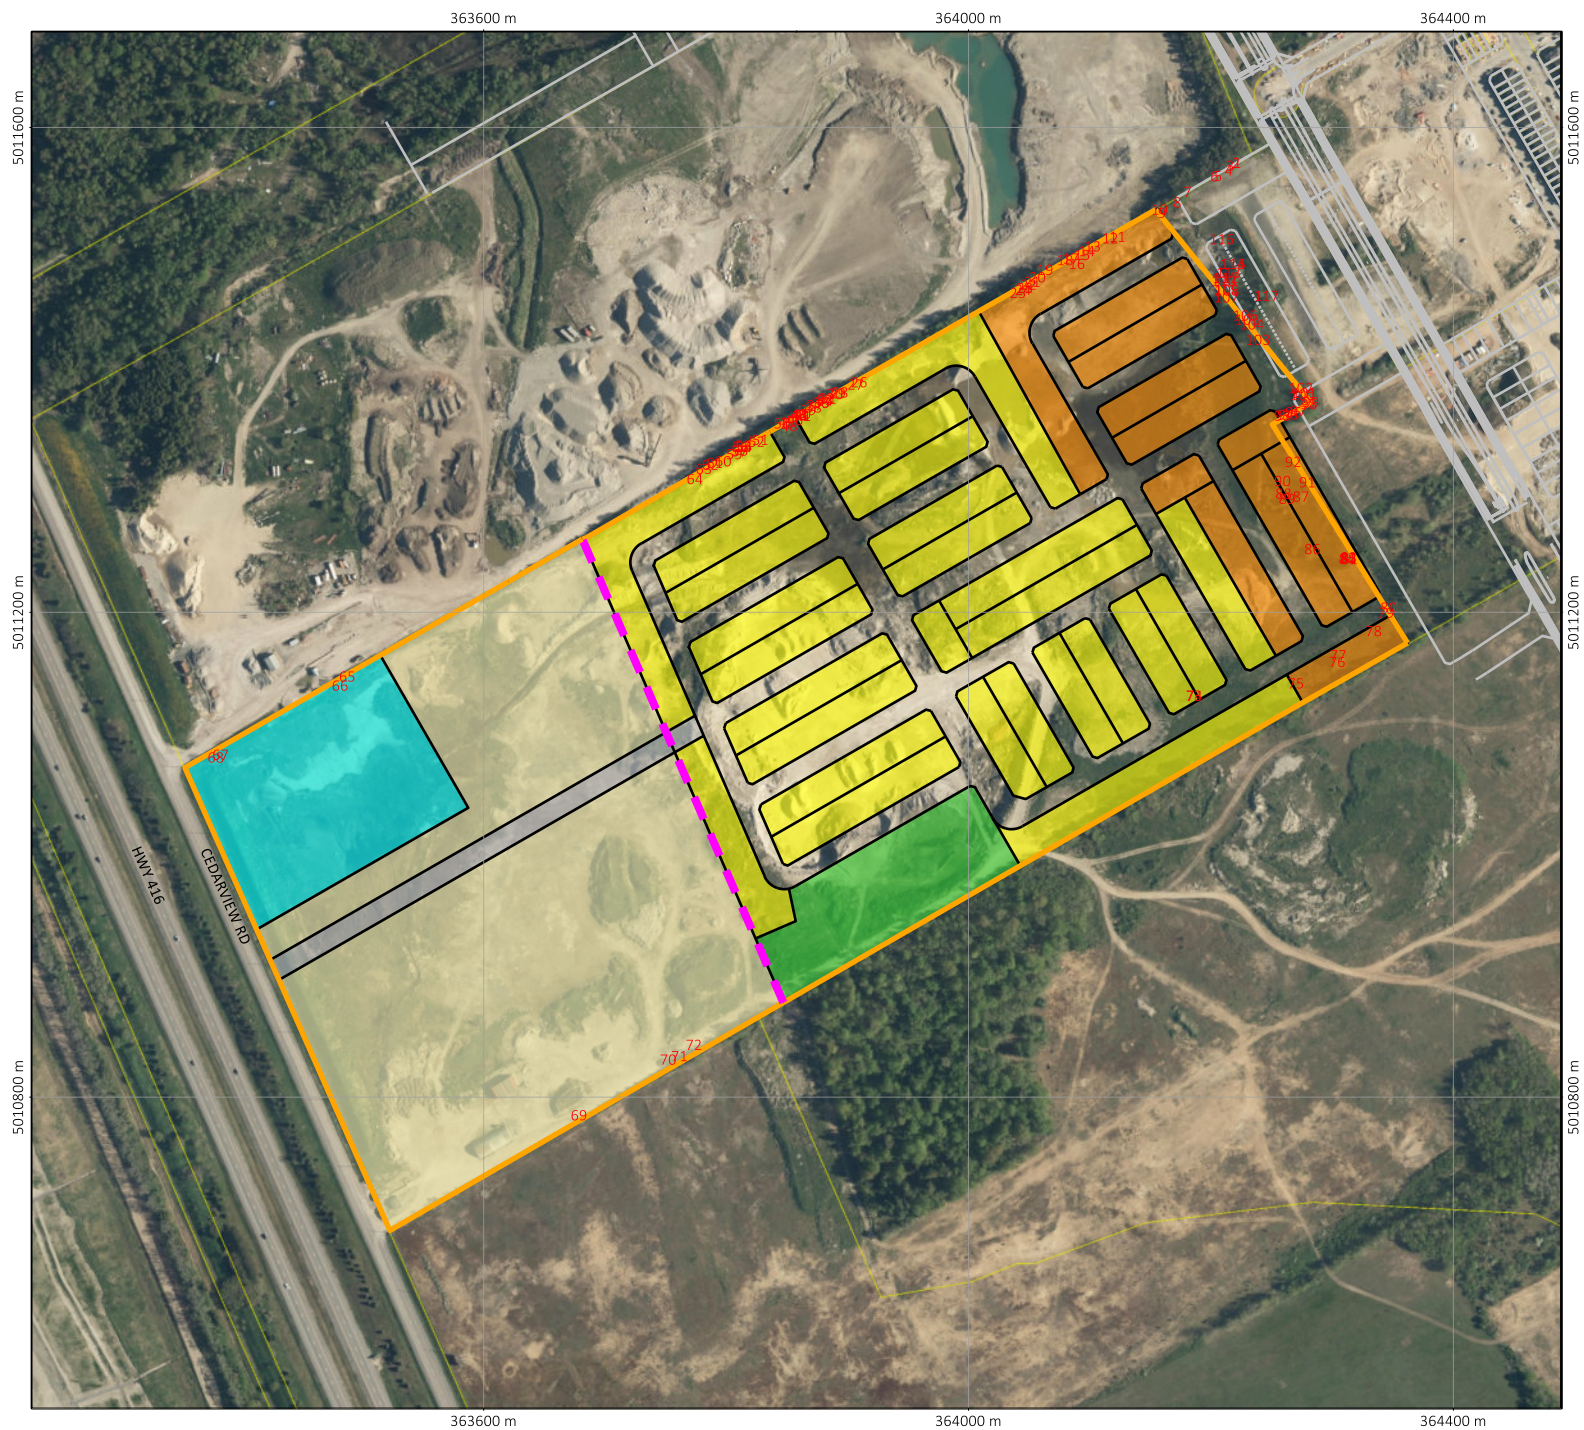
Figure 3 Proposed development

The project addressed by this EIS is a proposed residential community on the site consisting of a mix of single and town homes with a 1.6 ha community park in the south west corner. Extraction activities are ceasing on the entire site, with all areas to be rehabilitated to support current and future residential development. Main access to the proposed community will be from Borrisokane Road to the west. The community will be designed to allow for street access to the future residential to the east. Servicing will be in accordance with the Functional Servicing Report prepared by DSEL. The stormwater management area for the development will be located within the northwest corner of the property. The pond will outlet to a pipe which goes down Borrisokane to Cambrian where it outlets into the roadside ditch, and eventually into the Jock River.

The entire site will require significant fill and grade raising. Trees on site are either located in areas to be filled, or are precariously balanced along the high site edges and would unlikely to survive adjacent ground works regardless. All trees within the development area will be removed to accommodate grading and site prep, and the proposed roadway and residential development. Trees beyond the eastern end of the development area may yet be removed as part of the site works there by neighbouring builders, but such removals are outside of the scope of this project. Details of trees to be planted on site will be provided within the landscape plan for the development.
