Phase I Environmental Site Assessment

Residential Property
21 Withrow Avenue - Ottawa

Theberge Developments

Report: PE4068-1

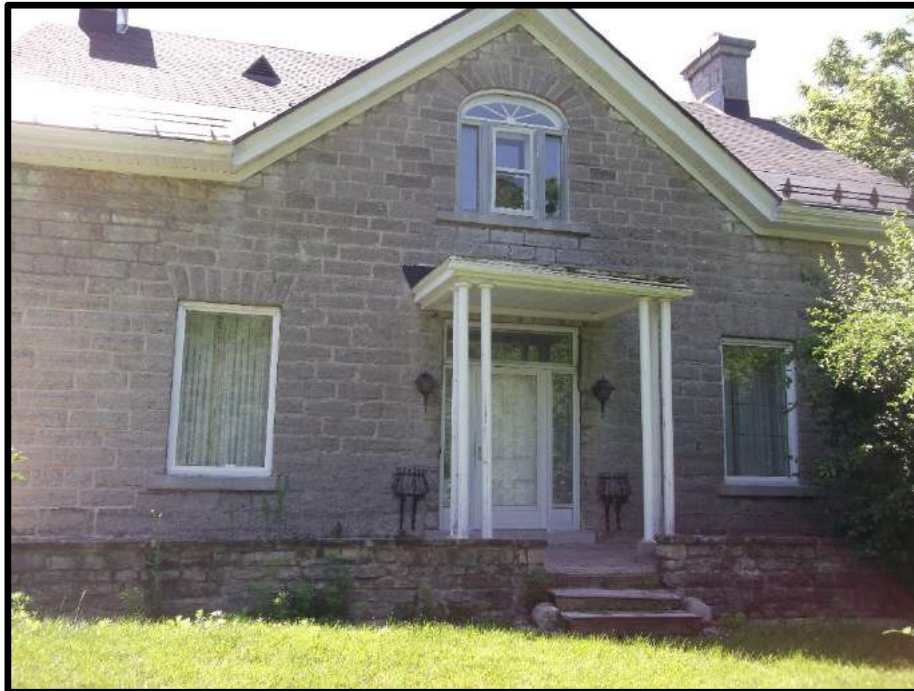
The property at 21 Withrow Avenue is occupied by a residential dwelling and a stand-alone private garage. The dwelling is one and a half stories with a full basement and is constructed with a stone and mortar foundation. The dwelling is finished on the exterior with stone and mortar and has a peaked roof covered with asphaltic shingles. An addition along the south side of the dwelling is constructed with a concrete foundation and finished with vinyl siding and a metal roof. The porch, through which the basement is accessed along the south side of the dwelling, west of the aforementioned addition, appears to have been added or possibly refinished when the private garage was constructed. The private garage, a wood frame structure constructed with a concrete slab-on-grade foundation, and the porch are both finished on the exterior with modern, decorative stone and mortar and a metal roof.

Photograph 1: East face of the subject residential dwelling, facing west.

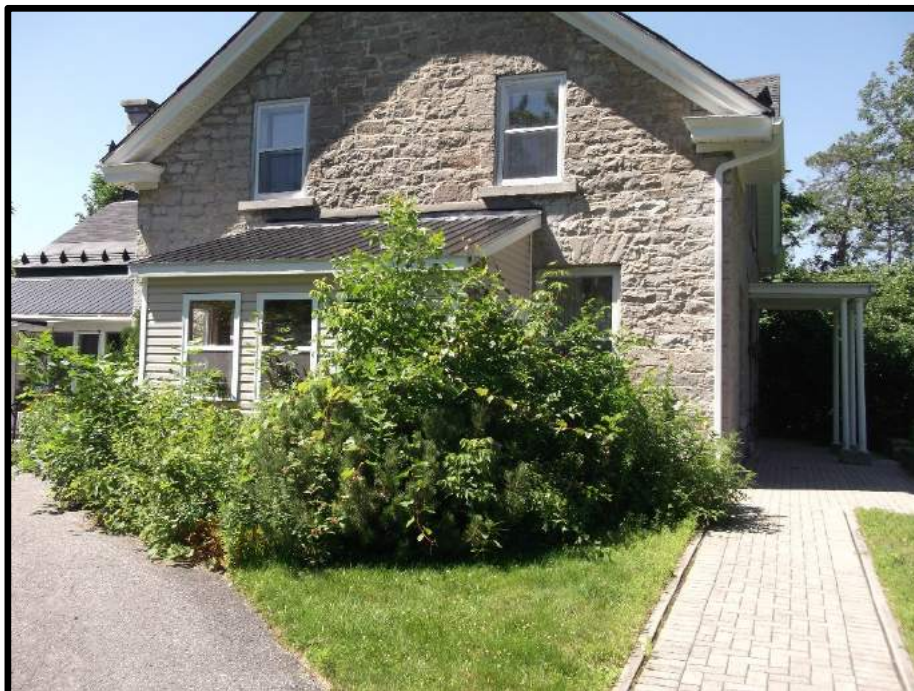
Photograph 2: View of south face of dwelling, facing northwest.

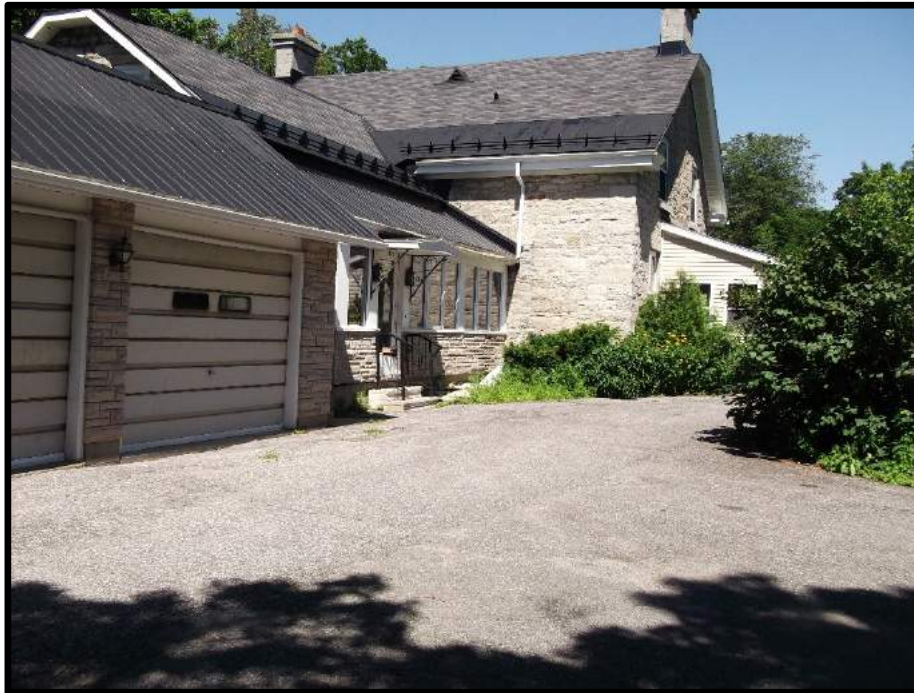
As noted previously, the dwelling was constructed at some time in the 1830's or 1840's and is currently heated with an electric furnace. Based on aerial photographs, the private garage was likely constructed at some time in the 1980's and is not heated.

Photograph 3: View of western portion of residential dwelling and the private garage, facing northeast.
