**Phase One Environmental
Site Assessment
6102 Renaud Road, Ottawa, Ontario**

OTT-00242146-A0

Final

September 18, 2017

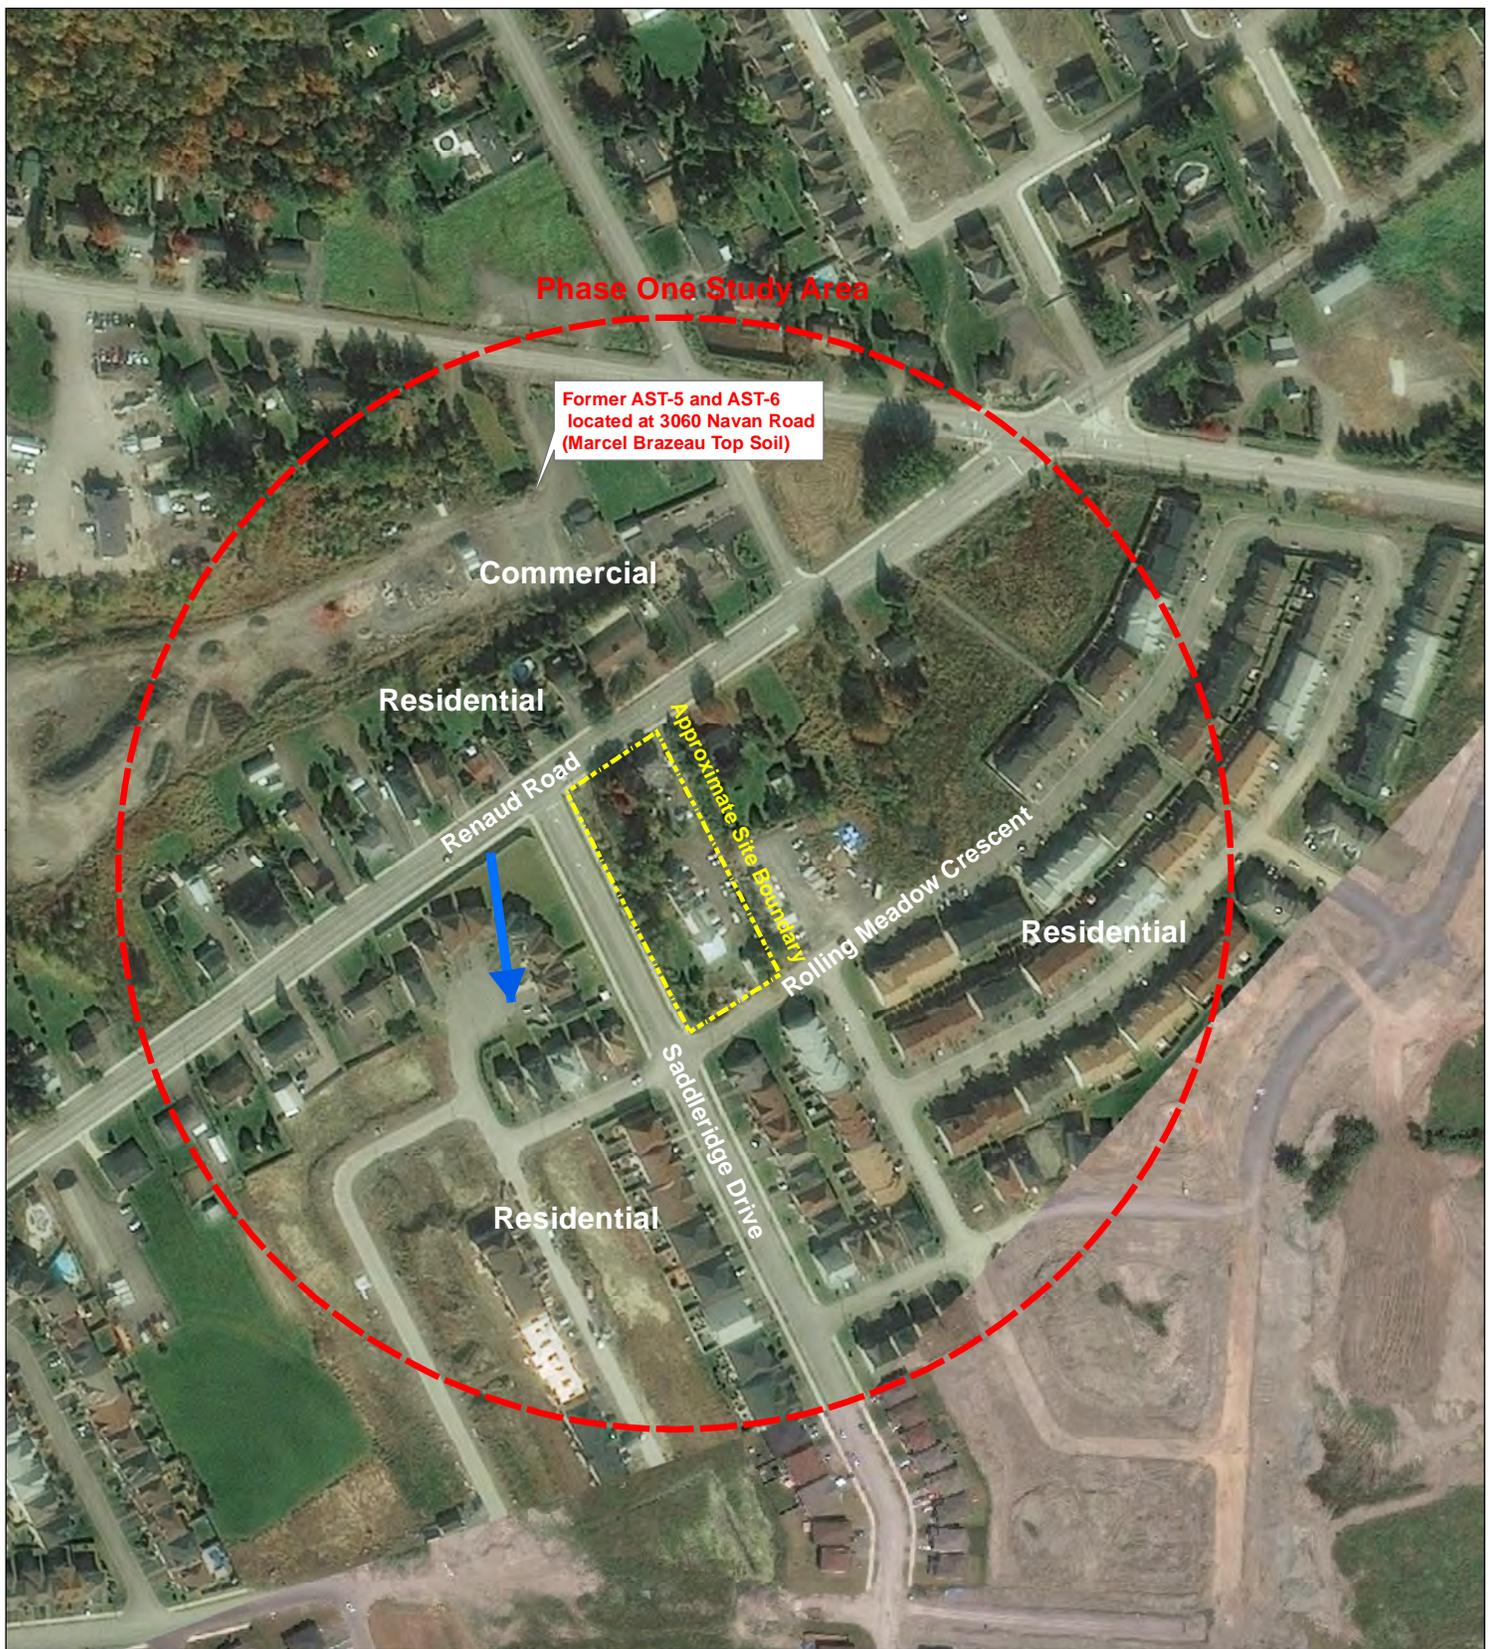
DRAWING TITLE:
 PHASE ONE STUDY AREA

Phase One Study Area

**Former AST-5 and AST-6
located at 3060 Navan Road
(Marcel Brazeau Top Soil)**

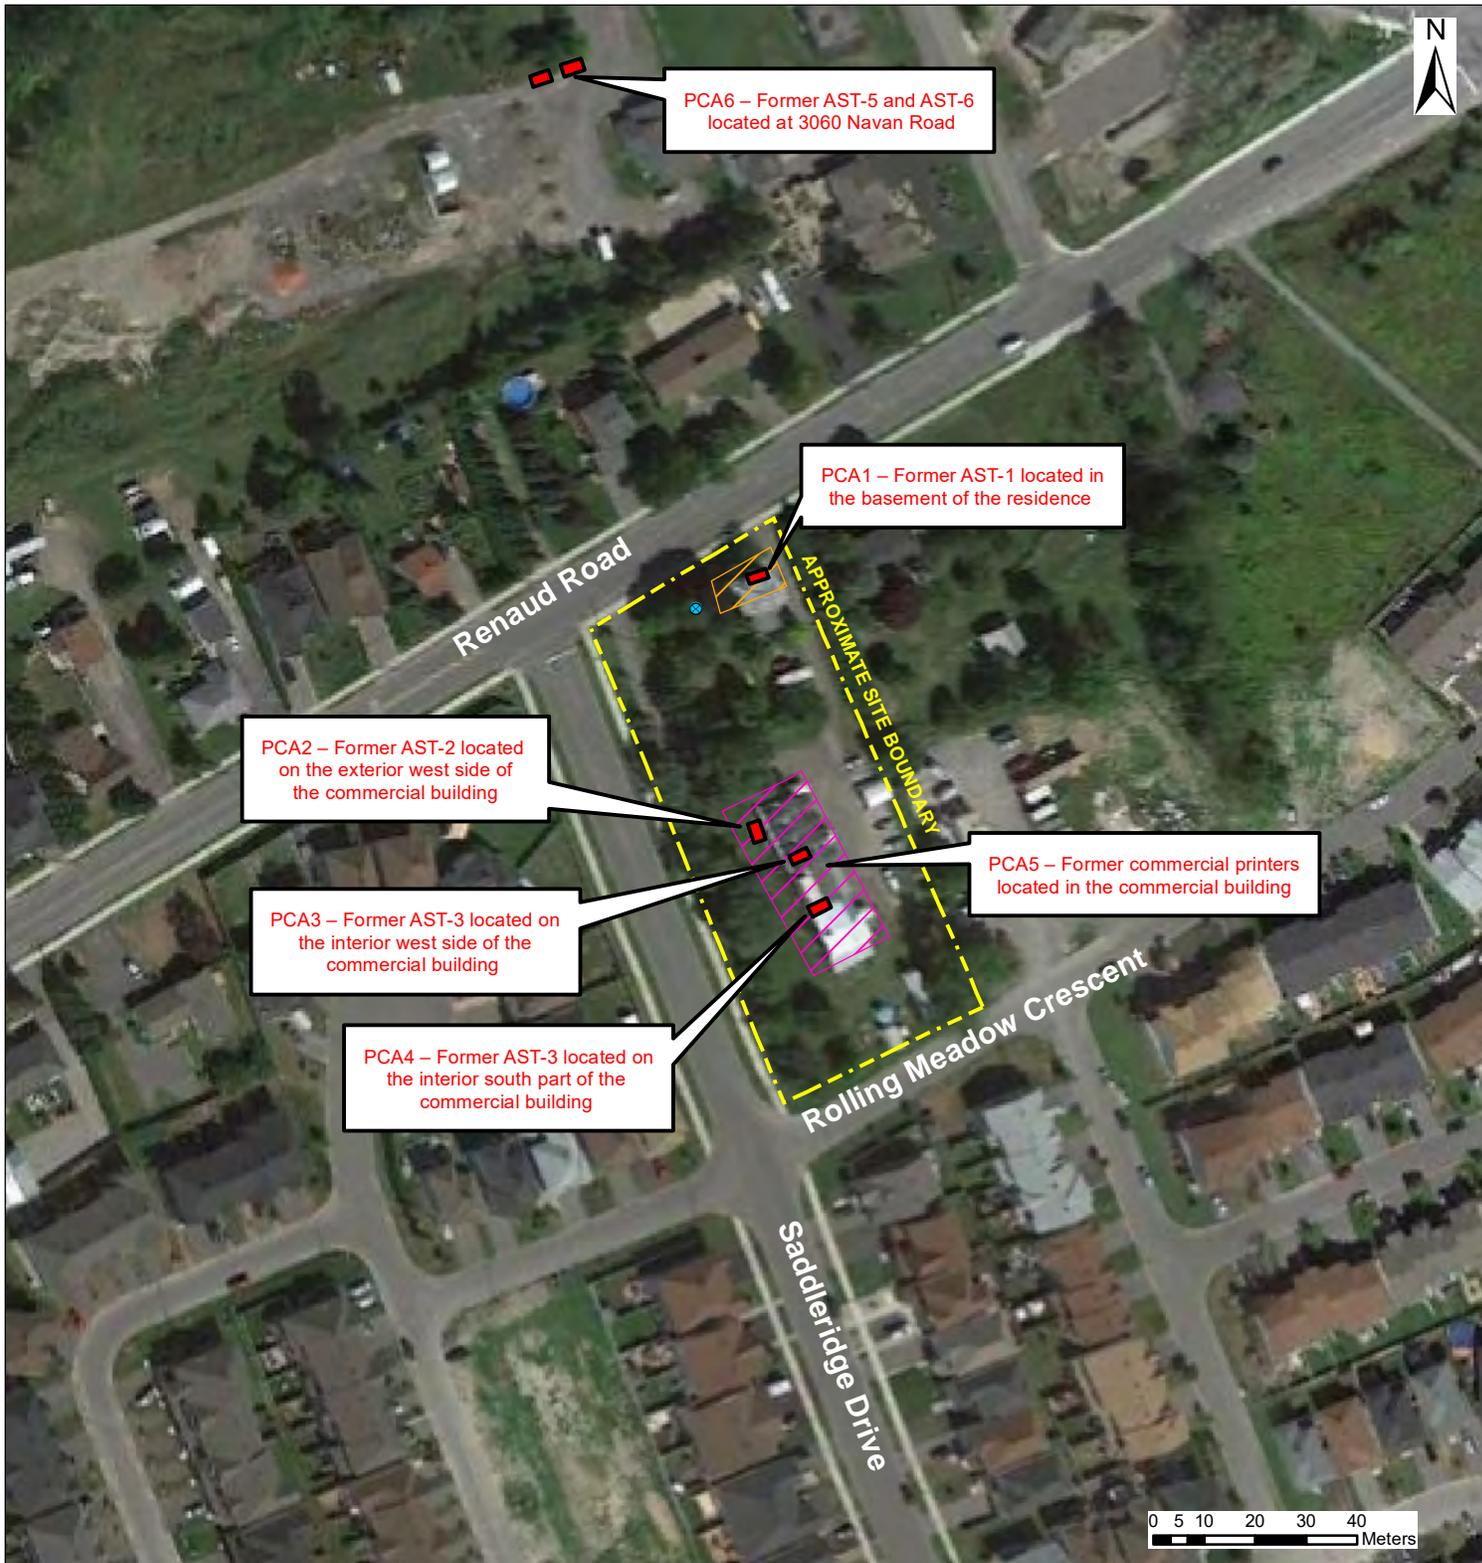
PCA6 – Former AST-5 and AST-6 located at 3060 Navan Road

PCA1 – Former AST-1 located in the basement of the residence

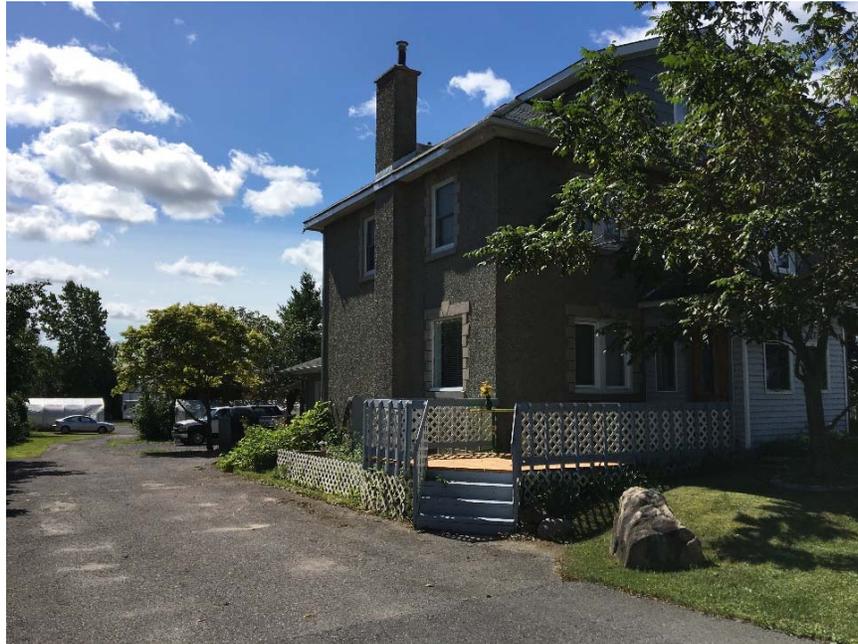
Photograph No. 1

View of the Residence on the northern part of the Site

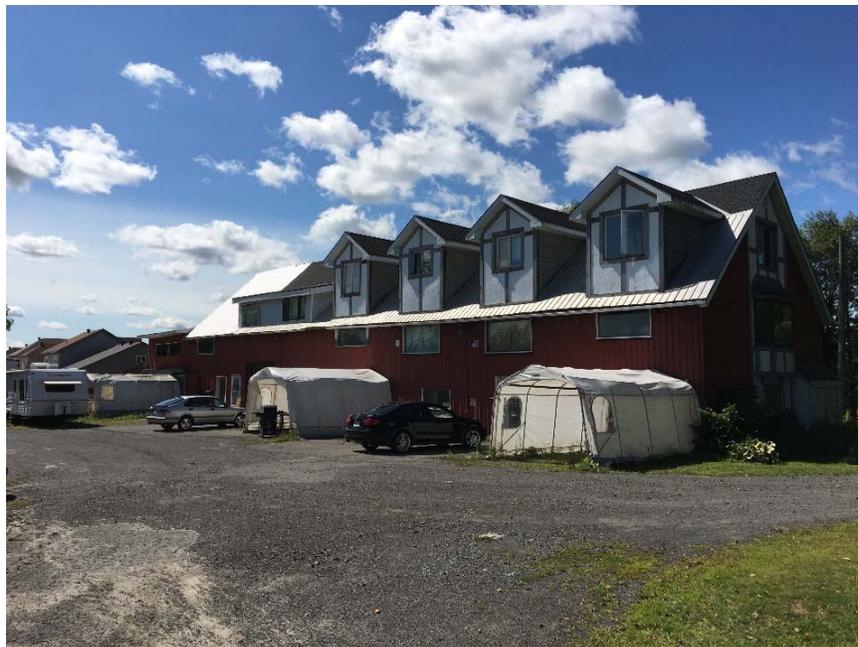
Photograph No. 2

View of the Commercial Building on the southern part of the Site

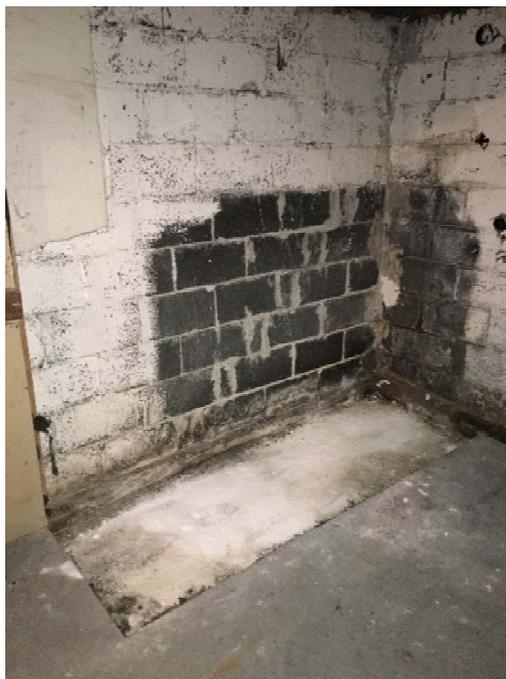
Photograph No. 3

AST-1 was formerly located in the residences basement in the northeast corner, located on a concrete floor in fair condition (APEC 1). The AST-1 was a steel tank and was removed in 2016 as indicated by Mr. Perrault (Photograph 3, Appendix E).

View of the former AST-1 location, located in the Residence basement

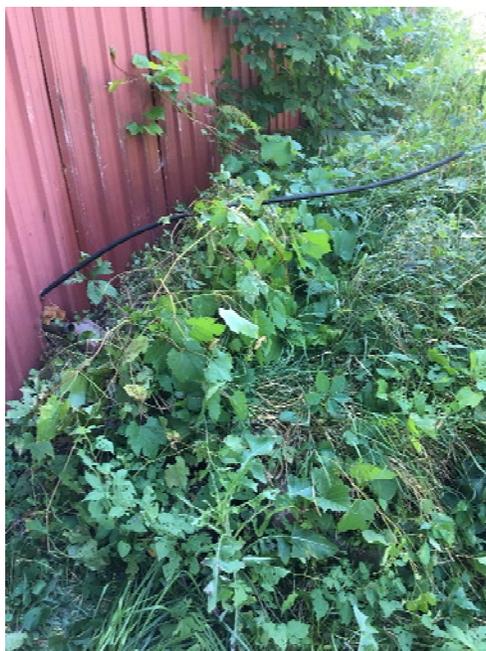
Photograph No. 4

View of the former AST-2 location, located on the exterior west side of the commercial building

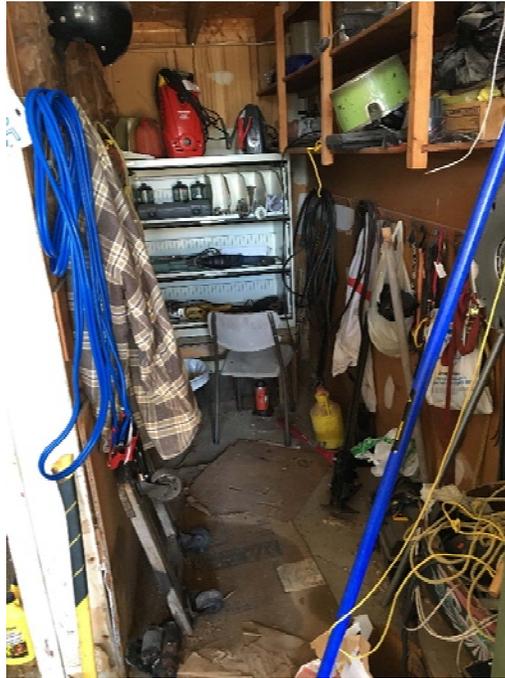
Photograph No. 5

AST-3 was formerly located interior of the commercial building located along the west wall on a concrete floor in fair condition (APEC 2). The AST-2 was steel and removed in 2009 (Photograph 5, Appendix E) as indicated by Mr. Perrault.

View of the former AST-3 location, located on the interior west side of the commercial building

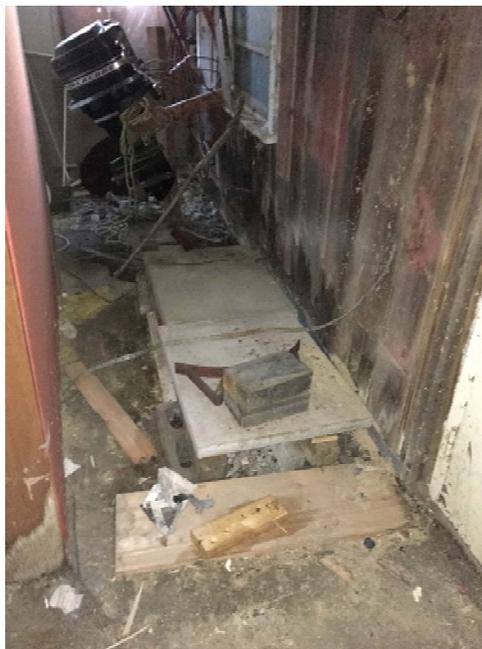
Photograph No. 6

AST-4 was formerly located interior of the commercial building located in the southern part of the building on a patio stones in poor condition with some staining (APEC 2). The AST-2 was steel and removed in 2016 (Photograph 6 and 7, Appendix E) as indicated by Mr. Perrault.

View of the former AST-4 location, located on the interior south part of the commercial building

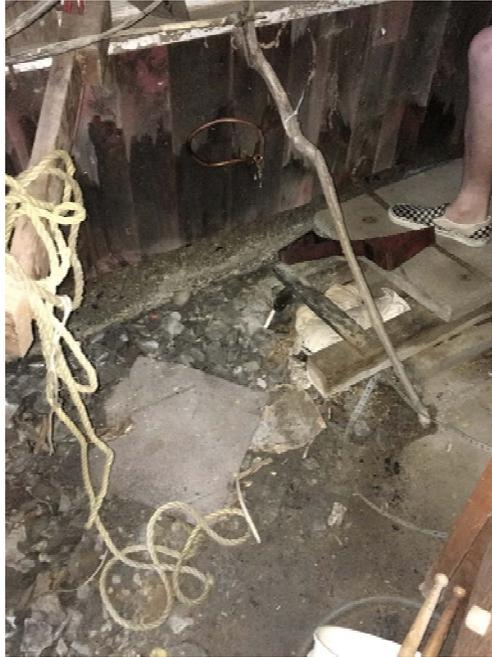
Photograph No. 7

The floor conditions varied throughout the commercial building, some areas were in good conditions others were in poor condition. The worst floor condition was at the former location of AST-4 (Photograph 7, Appendix E).

There was some minor staining around the former AST-4 location on a soil surface (Photograph 7, Appendix E). This represent an APEC.

View of the poor floor condition at the former AST-4 location

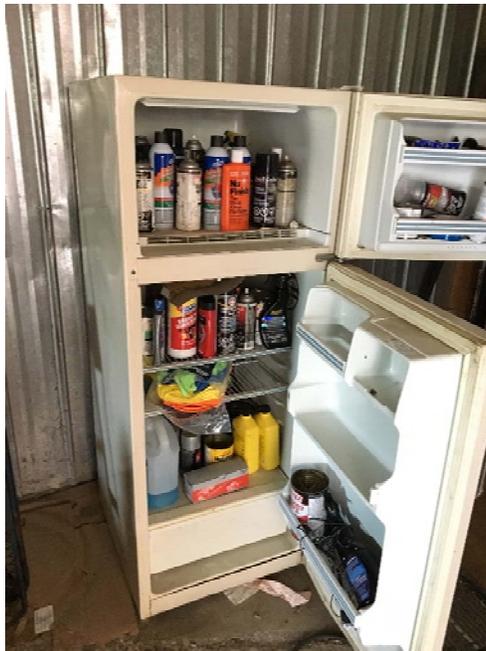
Photograph No. 8

View of the chemical storage at the commercial building

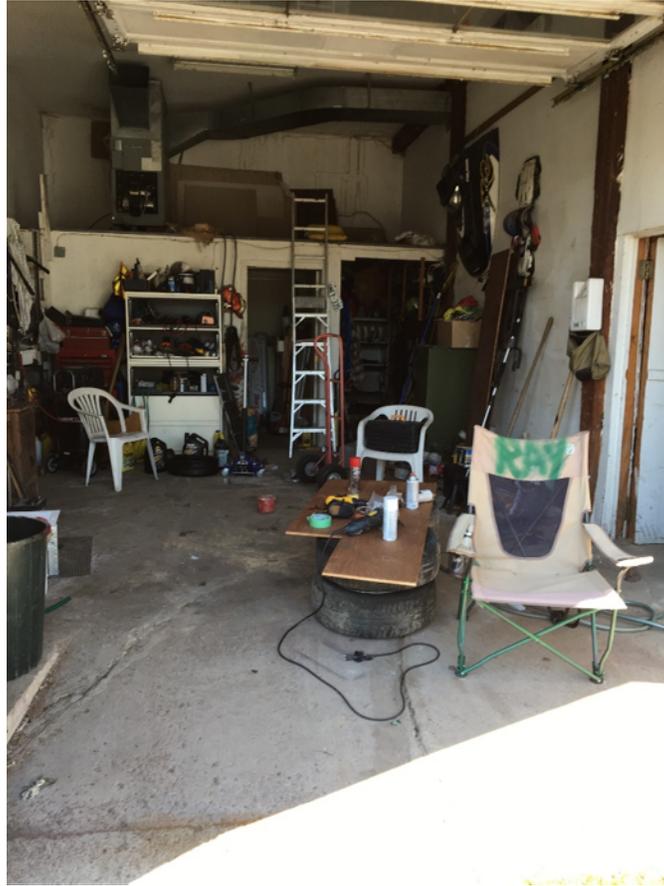
Photograph No. 9

There was a garage that appears to be used for personal vehicle and equipment maintenance, the garage had a concrete floor in good conditions with no drains (Photograph 9, Appendix E). The site representative mentioned no commercial maintenance has taken place at that Site. This is not considered to be an APEC.

View of the garage used for personal use
