Phase I - Environmental Site Assessment

Kanata Highlands, Huntmar Drive
Ottawa, Ontario

January 31, 2013

Report: PE0846-2

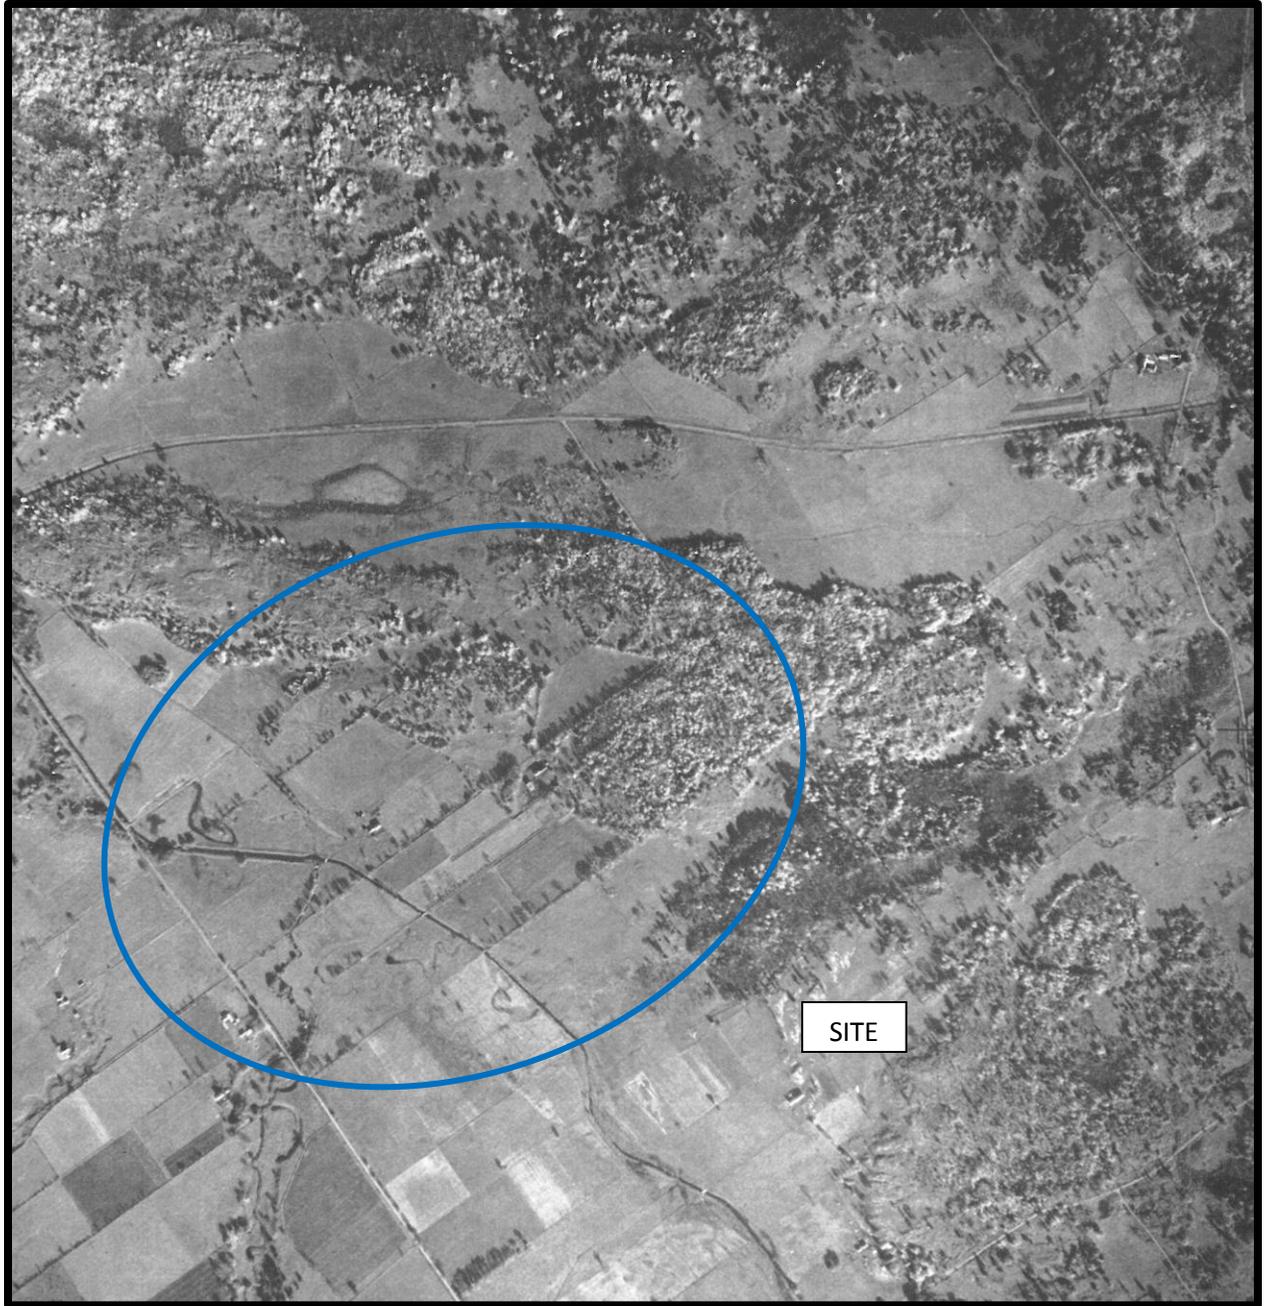
AERIAL PHOTOGRAPH
1945

| 1945 | The subject site is predominantly agricultural land with some treed areas. There appears to be a few farmsteads located throughout the subject site. Neighbouring properties either are vacant and treed or agricultural land with occasional farmsteads. |

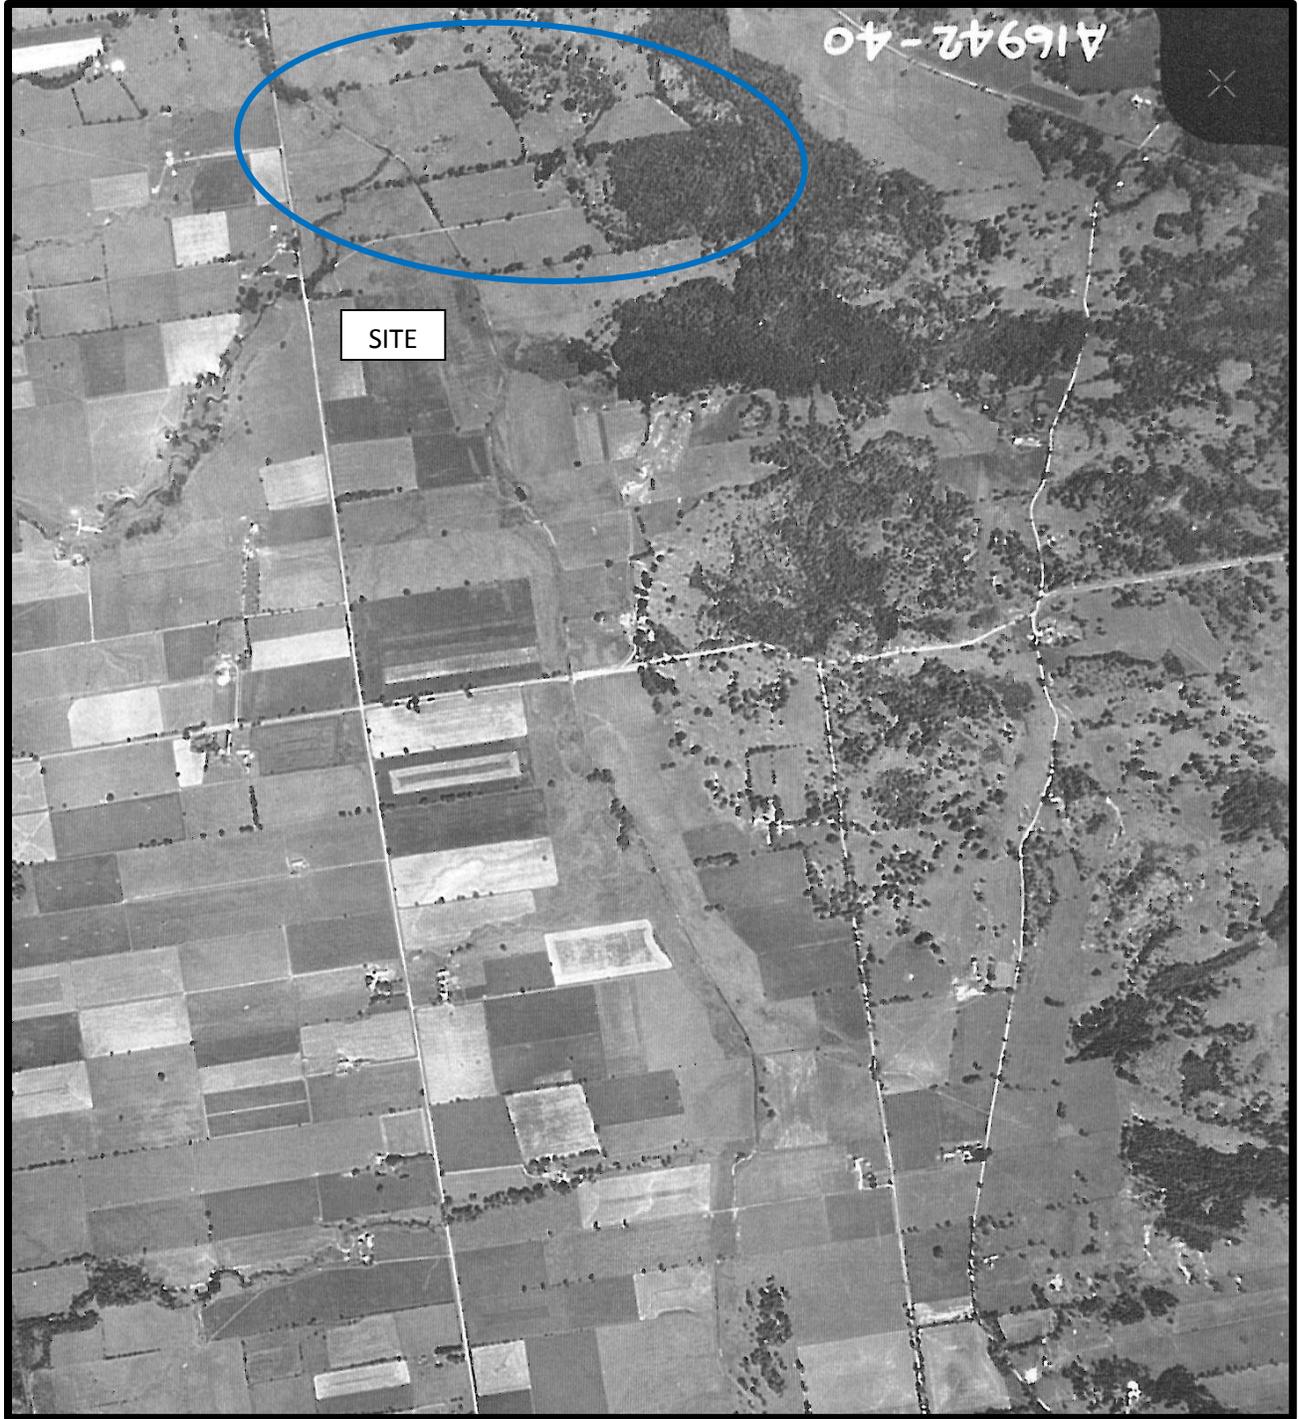
AERIAL PHOTOGRAPH
1959

| 1959 | No significant changes appear to have been made to the subject site or neighbouring properties. |

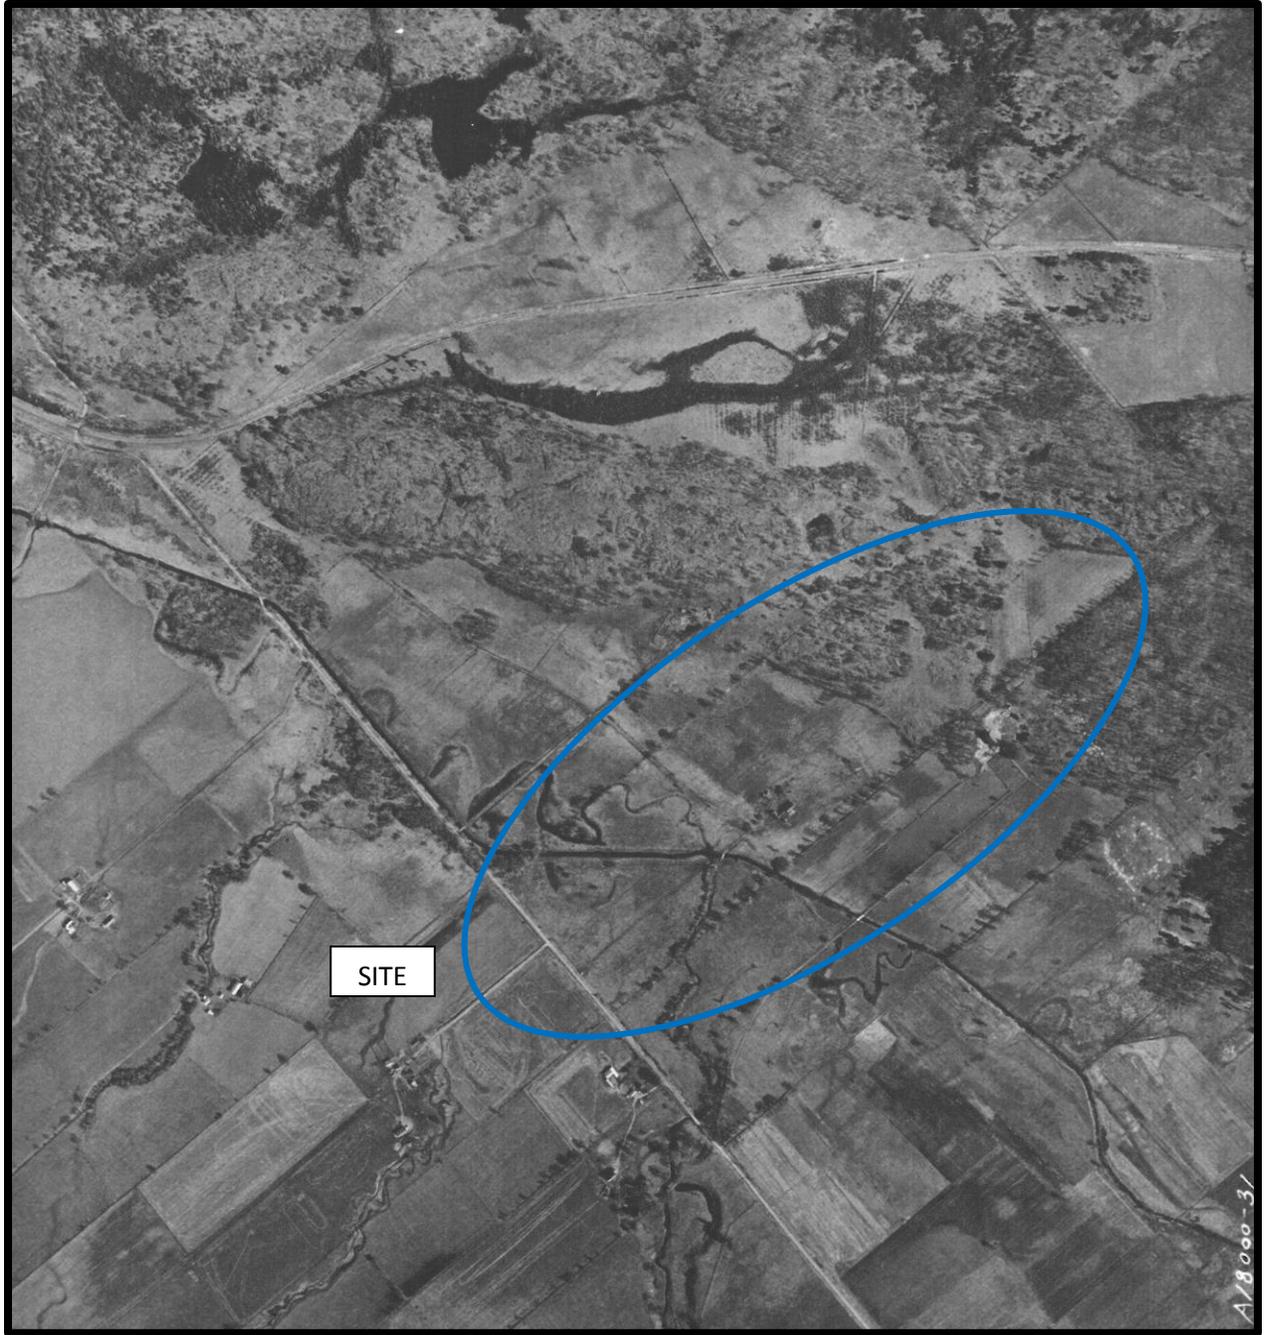
AERIAL PHOTOGRAPH
1963

| 1963 | The farmsteads on the subject site appear to be in disuse and trees appear to be reclaiming agricultural land. No significant changes appear to have been made to the neighbouring properties. |

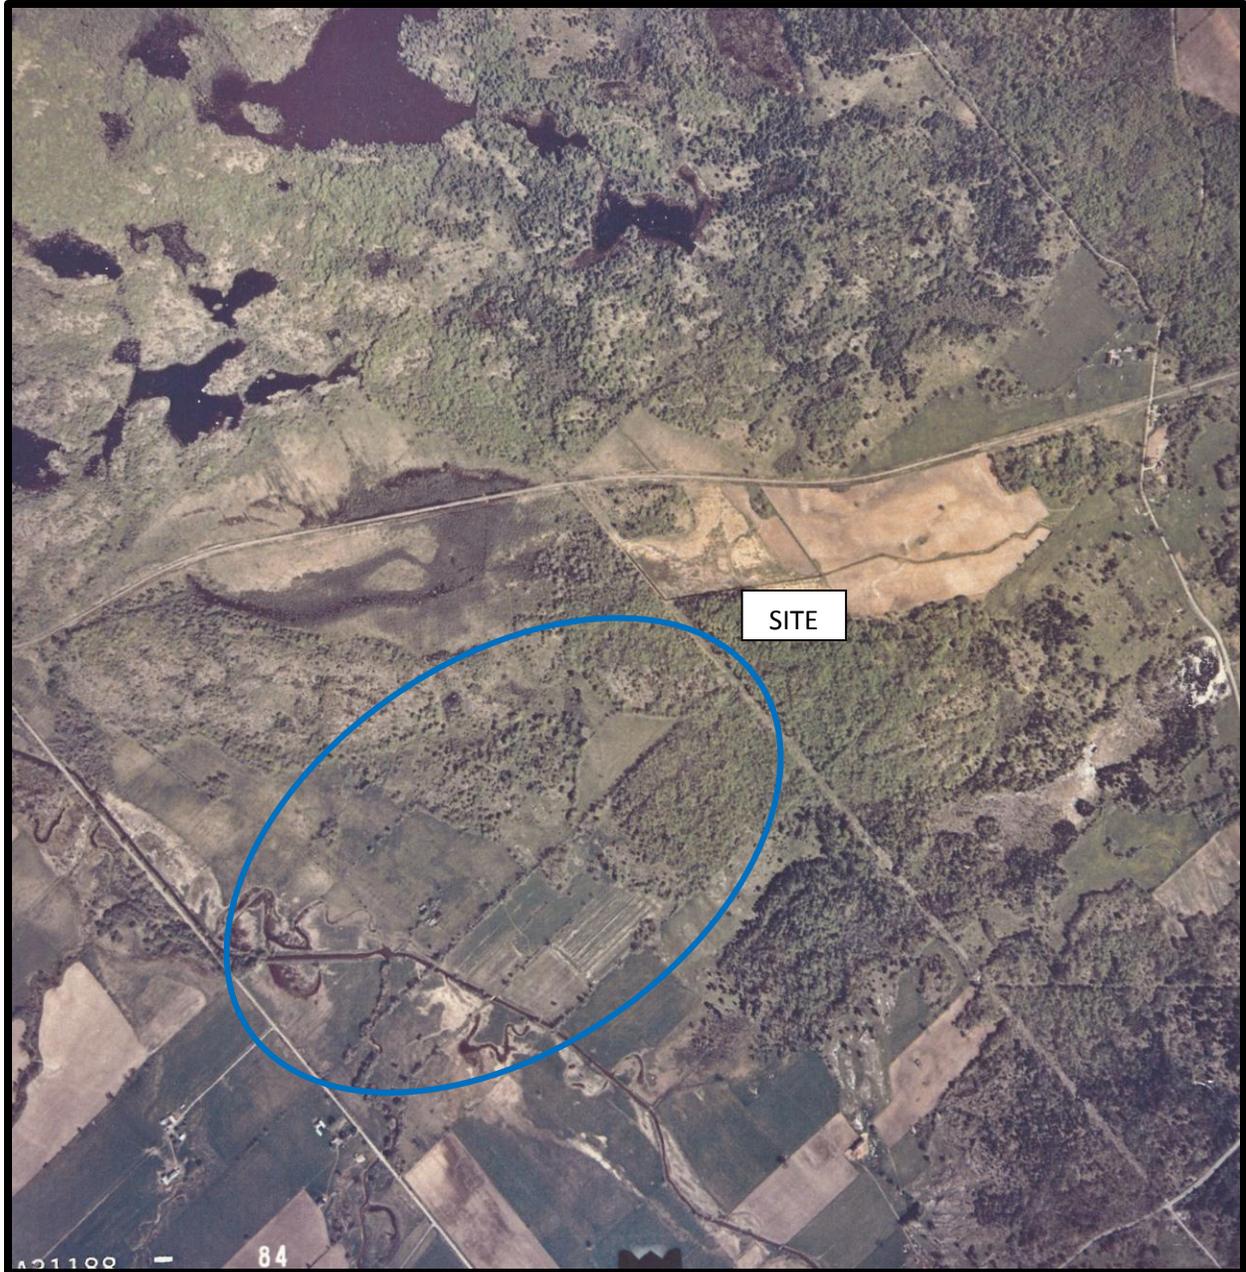
AERIAL PHOTOGRAPH
1978

| 1978 | No significant changes appear to have been made to the subject site or neighbouring properties. |

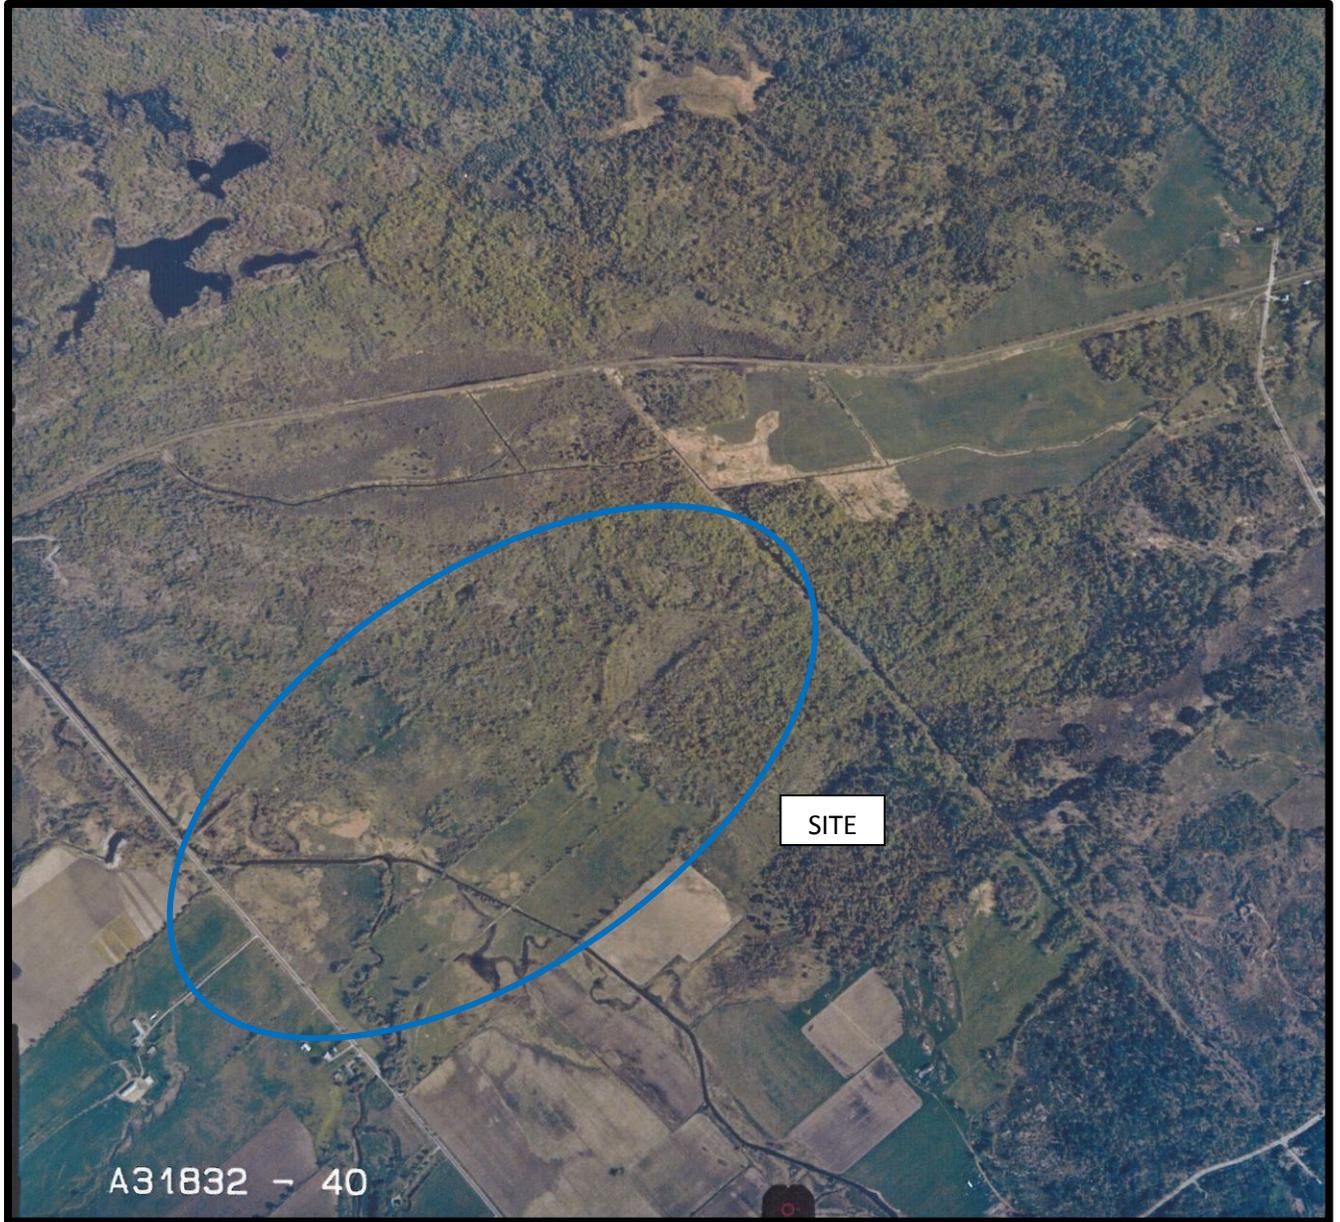
AERIAL PHOTOGRAPH
2002

| 2002 | No significant changes appear to have been made to the subject site or neighbouring properties. |
