Phase I - Environmental Site Assessment

373 Princeton Avenue
Ottawa, Ontario

October 3, 2016

Report: PE3876-1

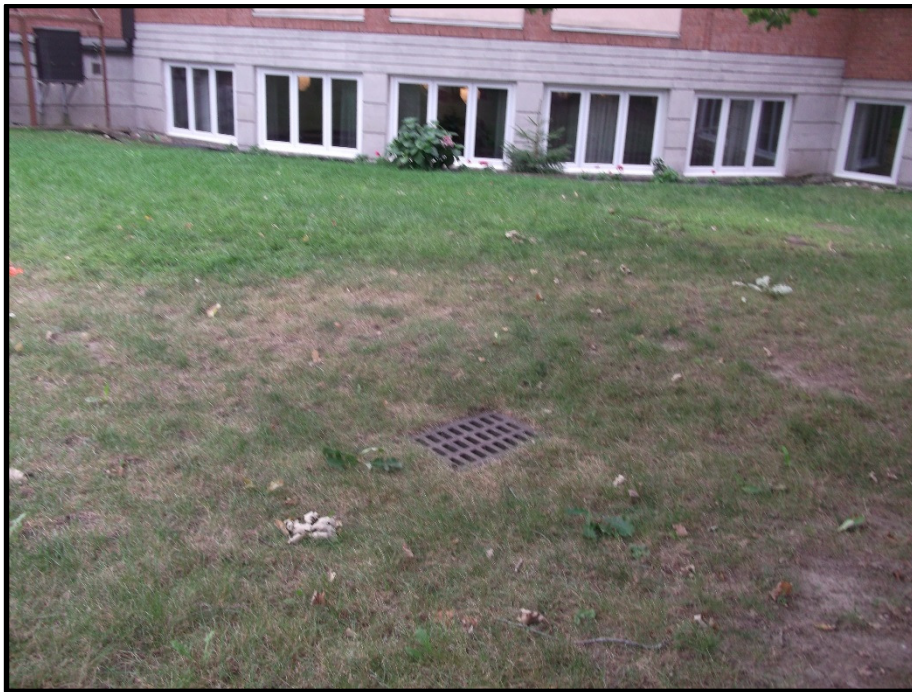
In general, the Phase I Property is relatively flat with a gentle slope down to the south. A low lying area is present between the residential dwellings and the larger subject building (373 Princeton Avenue). The topography in the general area of the Phase I ESA study area slopes down to the south; while further to the north of the site (in the vicinity of Ravenhill Avenue) the topography slopes significantly down to the north. Site drainage consists of a combination of surficial infiltration and sheet flow to catch basins on the Phase I Property (situated in the aforementioned low-lying area and parking lot) and the adjacent roadways.

Photograph 4: Photo illustrates low lying area east of 373 Princeton Avenue.

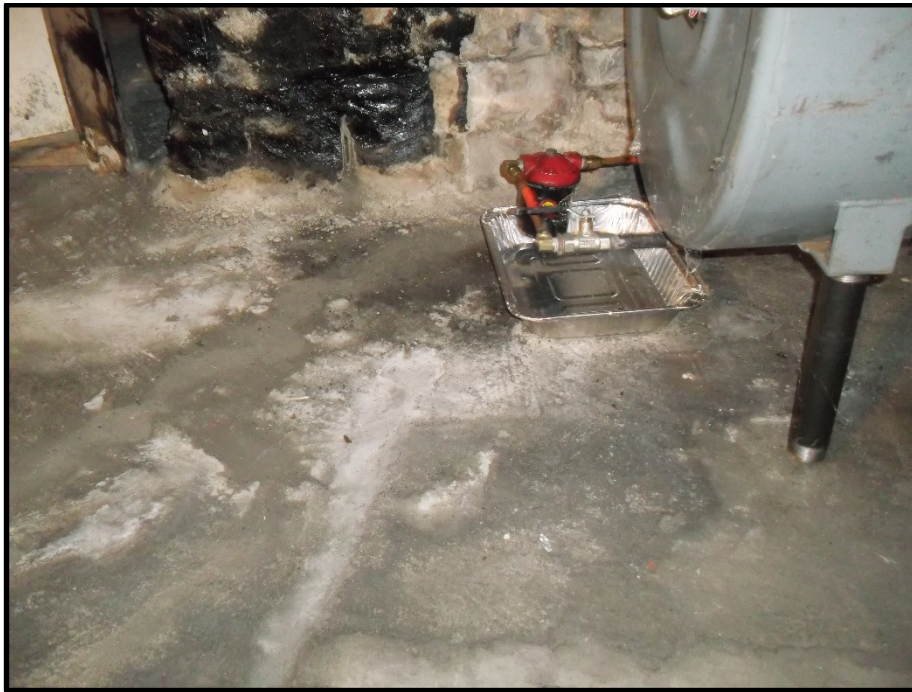
A domestic-sized (905 L) aboveground storage tank (AST) was present in the basement of the dwelling addressed 530 Edison Avenue. At the time of the site visit, the AST was three quarters full. According to its tag, the AST was constructed in 2003 with 2mm thick steel walls; the associated oil-fired furnace was installed in 1997. Staining was noted on the concrete floor in the vicinity of the AST and around the base of the furnace. The floor slab was generally in good condition at the time of the site visit.

The existing oil distribution line leading from the tank to the furnace was present above the floor slab and covered in an orange, PVC material. An older copper line was observed protruding from the concrete floor slab between the AST and the furnace.

Photograph 11: Photograph illustrates portion of AST in the basement of 530 Edison Avenue, as well as some staining on the concrete floor slab and the location of the partially buried former oil line.

Based on the results of the Phase I ESA, **it is our opinion that a Phase II-Environmental Site Assessment is required for the property**, to further investigate the potential for soil and groundwater impacts in the vicinity of the fuel oil equipment at 530, 534 and 540 Edison Avenue.

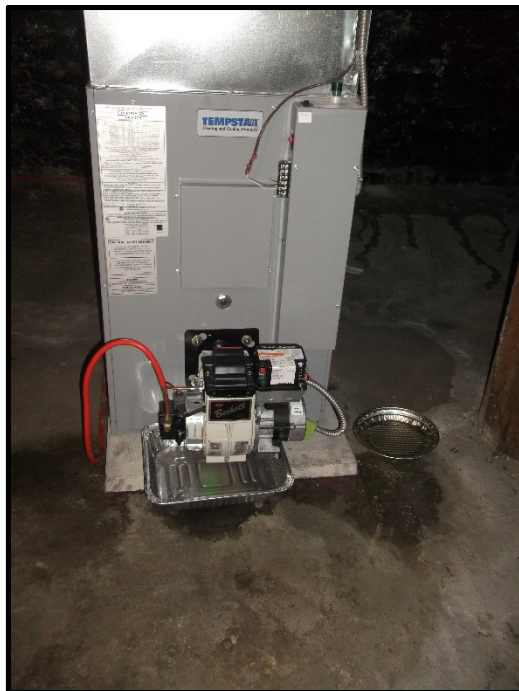
Photograph 12: Photograph illustrates the furnace at 530 Edison Avenue and staining on the surrounding concrete floor slab.

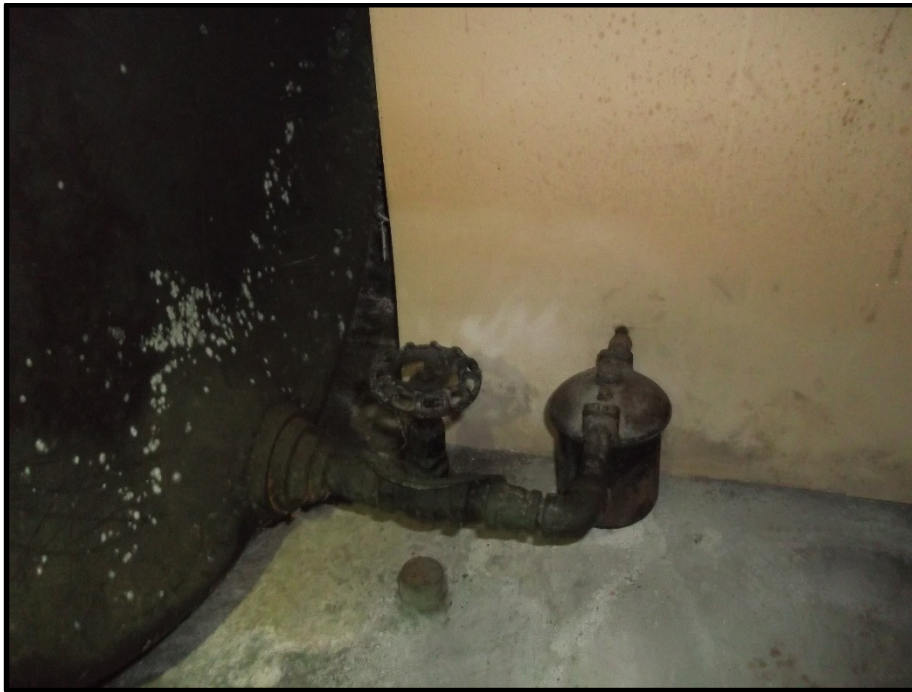
Domestic-sized ASTs, not currently in use, were also observed in the basements of 534 and 540 Edison Avenue. Tags providing tank details were not present on either AST, both of which appeared to be older than that present at 530 Edison. The AST at 534 Edison Avenue was in fair to poor condition at the time of the site visit, with signs of rust and potential pitting. The tank was suspected to be empty, although a minor leak was noted at the bottom of the tank where fuel product had solidified in the form of a stalactite; a small area of staining was observed on the underlying concrete floor slab which was in fair condition at the time of the assessment.

The oil distribution line leading from this AST could not be observed at the time of the site visit as the line travelled behind the gypsum board and at some point entered the concrete floor slab. The line was observed to exit vertically from the concrete floor slab immediately adjacent to the furnace. No obvious signs of leakage or staining were noted on the concrete floor slab, other than the staining noted above. The majority of the floor slab was painted and in fair condition at the time of the site visit.

Photograph 13: Photograph illustrates a portion of AST at 534 Edison Avenue, a 2.5 cm capped pipe in the concrete floor and the copper line leading behind the drywall.

The 2.5 cm pipe in the concrete floor of 534 Edison Avenue should be further investigated in order to determine what purpose it served.

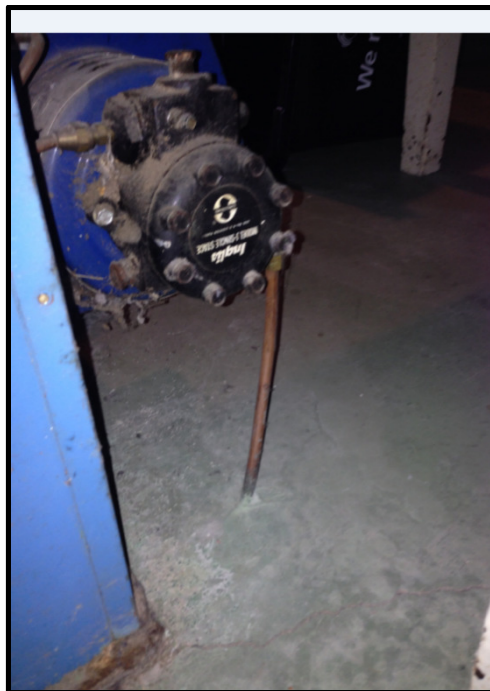
Photograph 14: Photograph illustrates copper oil line at 534 Edison Avenue, exiting the concrete floor slab in the vicinity of the furnace.

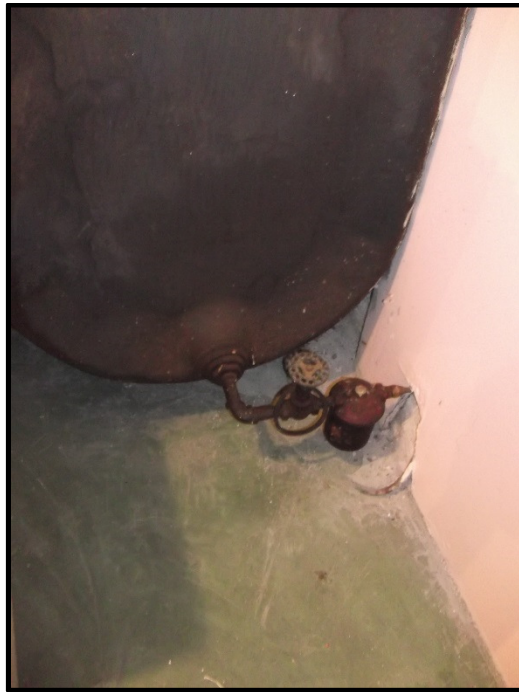
The oil line leading from the AST at 540 Edison Avenue was partially buried in the upper portion of the concrete floor slab beneath the tank. No obvious signs of staining were noted on the AST or concrete floor slab beneath the AST or in the vicinity of the furnace. The floor slab was painted and in poor condition with large cracks at the time of the site visit.

Photograph 15: Photograph illustrates a portion of the AST at 540 Edison Avenue and the copper oil line entering the concrete floor slab beneath the tank.
