RE: UHC Chancery Building 231 Cobourg Street, Ottawa Project ADMN/216/276/01 Scoped Environmental Impact Statement - Chimney Swift Surveys

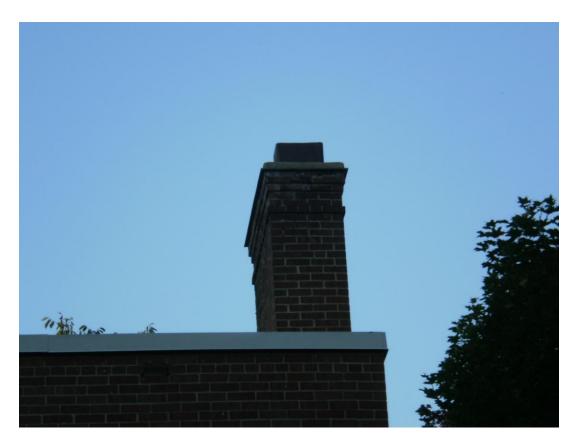
The Uganda High Commission Chancery building at 231 Cobourg Street in Ottawa has an open chimney (Photo 1). The open chimney could be habitat for chimney swift, which is designated a threatened Species at Risk under the provincial Endangered Species Act (2007). There is the potential for future work in proximity or otherwise cause a disturbance to the open chimney. Thus surveys before and at dusk were undertaken in July and early August, 2016 to determine if chimney swifts are utilizing the chimney for nesting.

Chimney swifts were observed flying in the general area on July 20^{th} and 28^{th} , with frequent activity observed on both dates. The chimney swifts were not flying in the vicinity of the open chimney or building at 231 Cobourg Street and did not fly into the chimney. After observations the chimney swifts flew in all directions away from the general area.

Photo 1 – Open brick chimney on the top of the building at 231 Cobourg Street

As the open chimney was not used by chimney swifts it is not considered significant habitat for chimney swifts. It is recommended that the chimney be removed, capped or screened, with this work completed after October 31st and before April 15th, 2017.

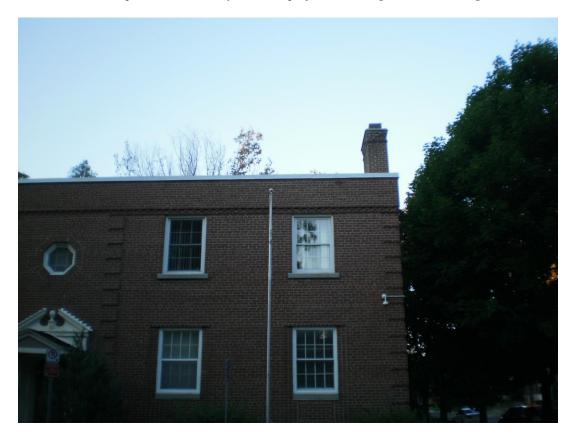
Photo 2 – South half of the building at 231 Cobourg Street with the chimney on south face of the building
