FINAL REPORT ON

Phase I Environmental Site Assessment 4791 Bank Street Kellam Lands Ottawa, Ontario

Report Number: 13-1122-0223

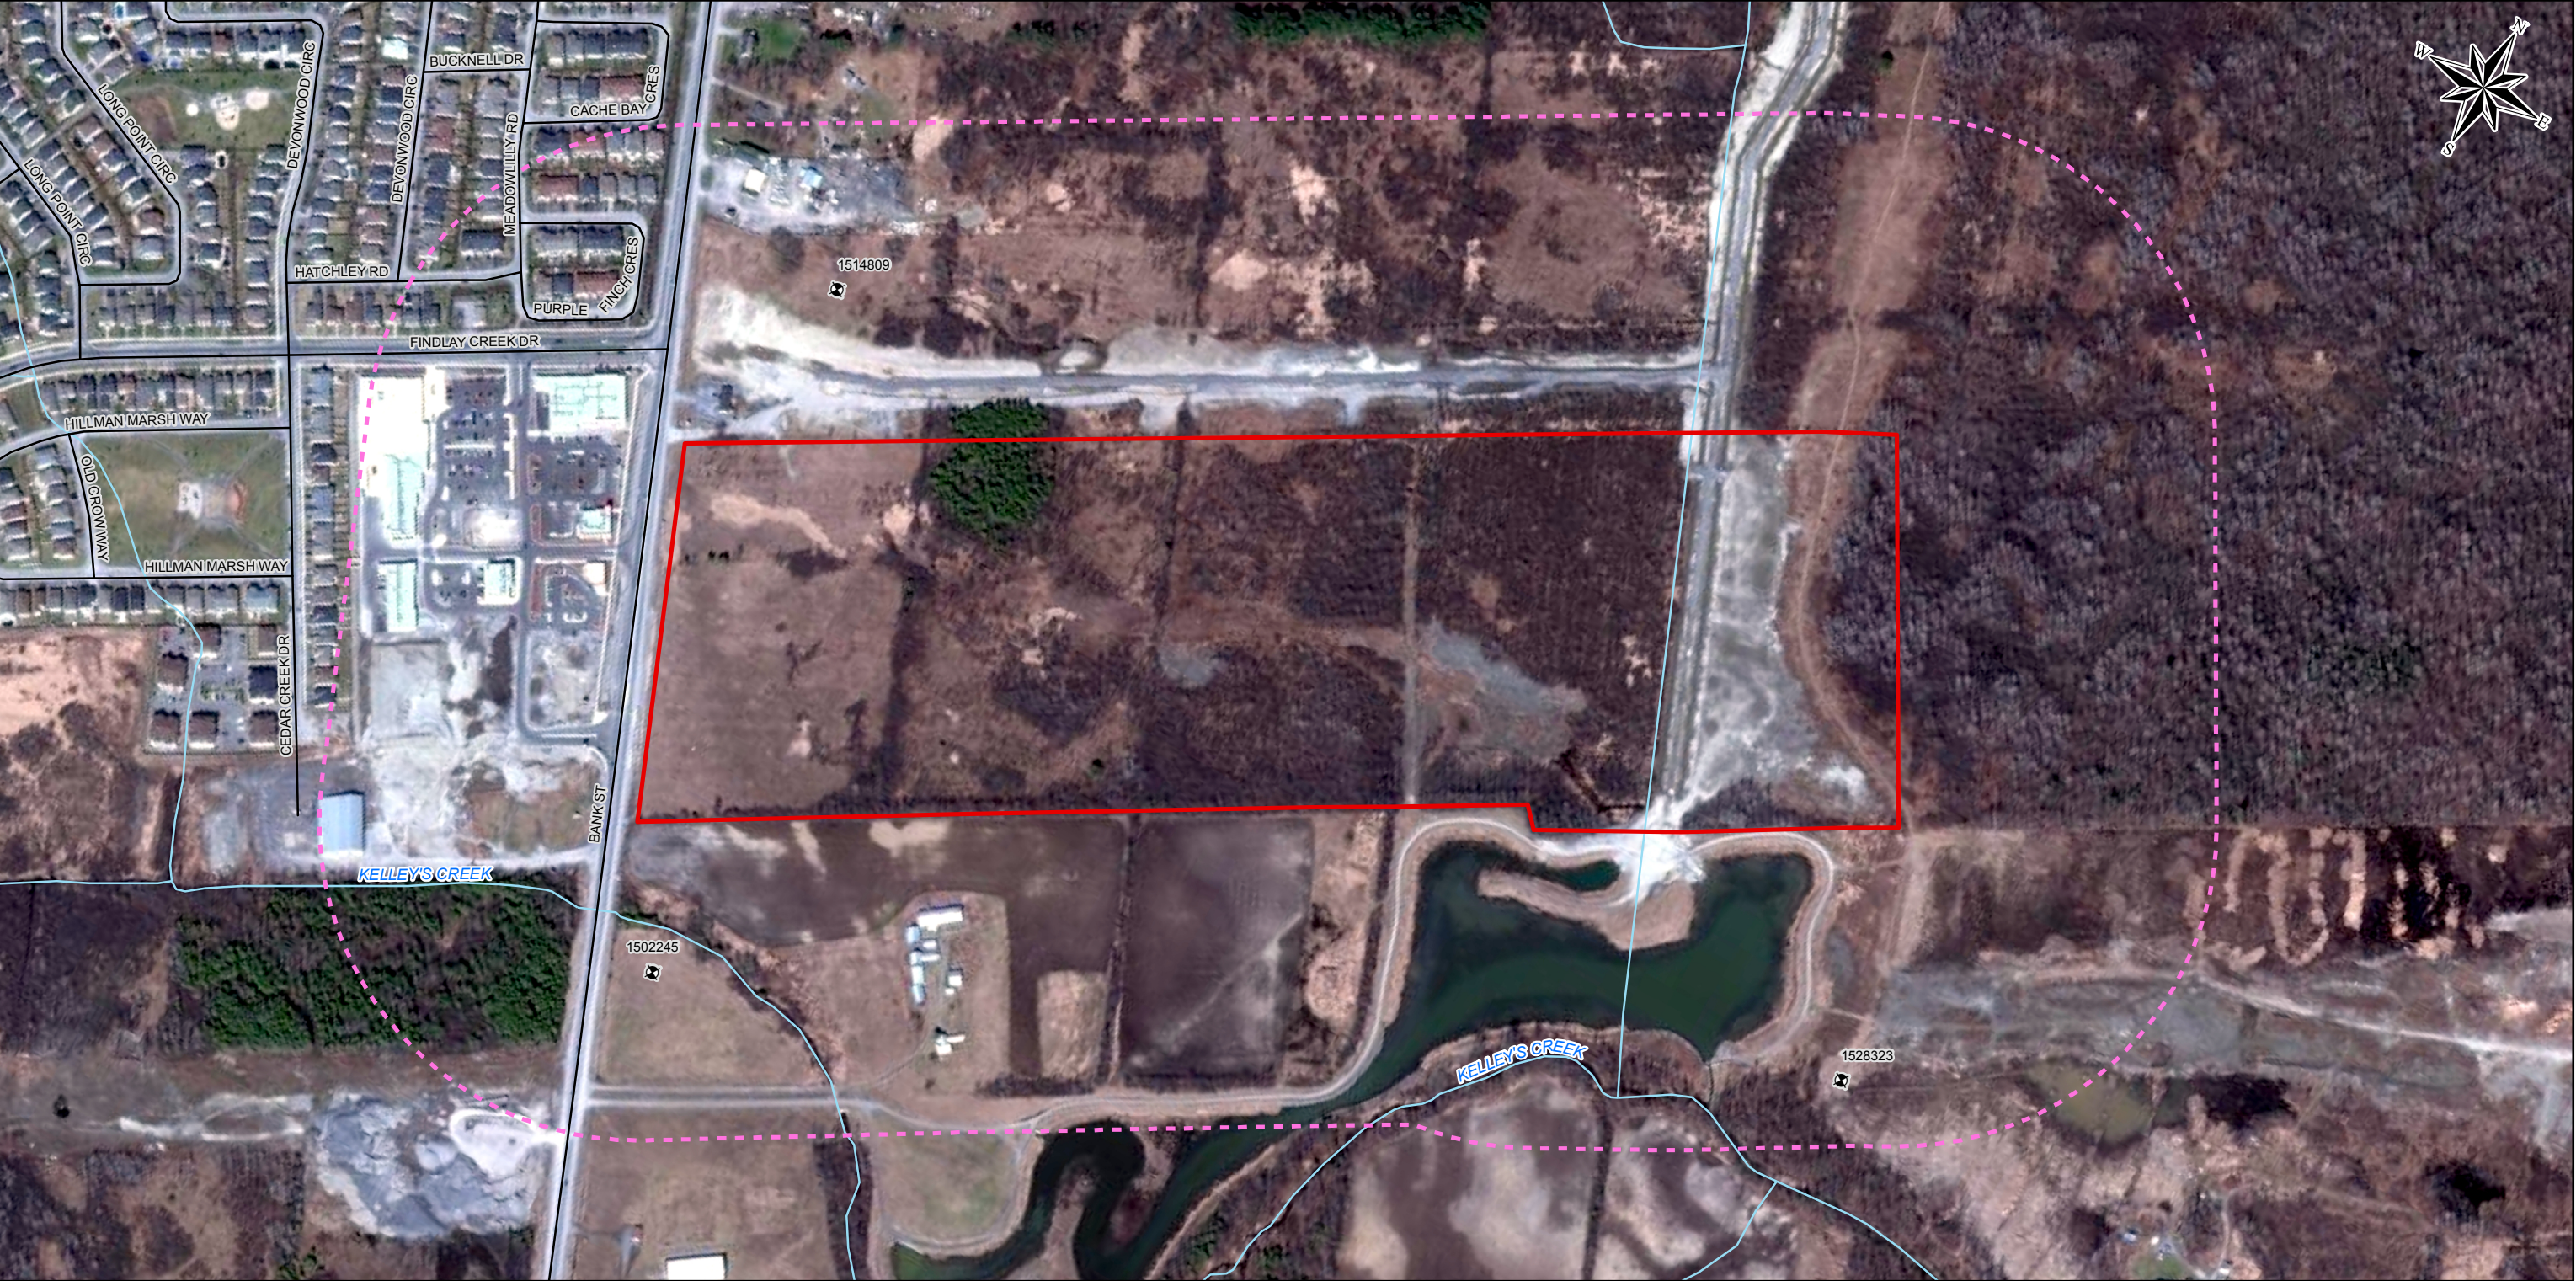
Golder Associates Ottawa, Ontario	PROJECT No. 13-1122-0223		SCALE AS SHOWN	REV. 0.0
	DESIGN	BM	2013-11-11	FIGURE 2
	GIS	BR	2013-12-10	
	CHECK	BM	2013-12-10	
	REVIEW	DHP	2013-12-10

A Phase One ESA is a preliminary qualitative assessment of the environmental condition of a property, based on a review of current activities and historical information for the Site and a review of relevant and readily available environmental information for the surrounding properties located within a 250 metre ("m") radius of the municipal boundary of the Site (collectively referred to as the "Phase One Study Area"). The boundaries of the Phase One Study Area are presented in Figure 2.

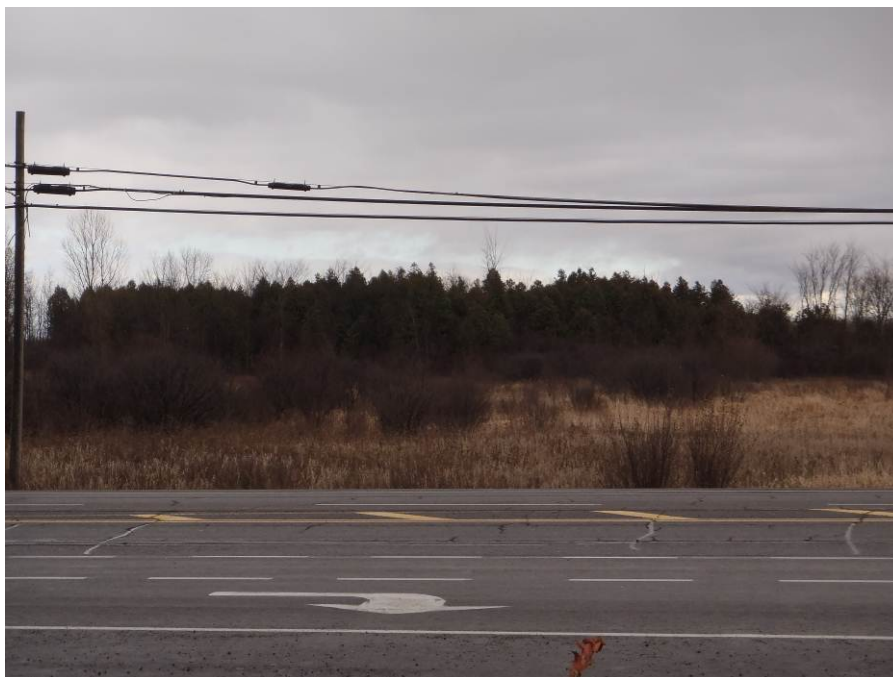
Photograph 1: Looking east, from across Bank Street, towards the forested/vacant portion of the Site.

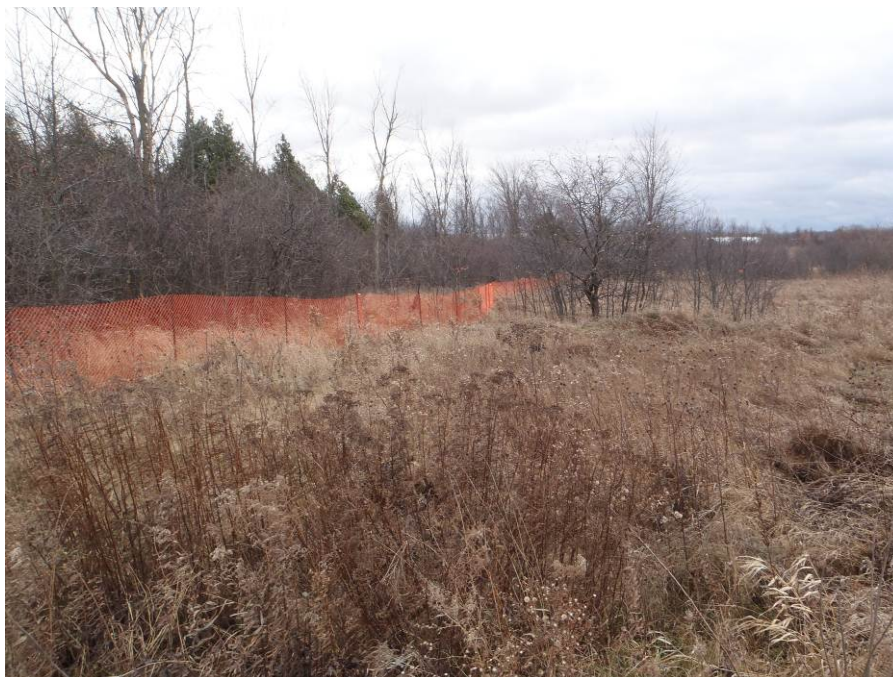
Photograph 7: Looking west towards forested area fenced off in the north central area of the Site.

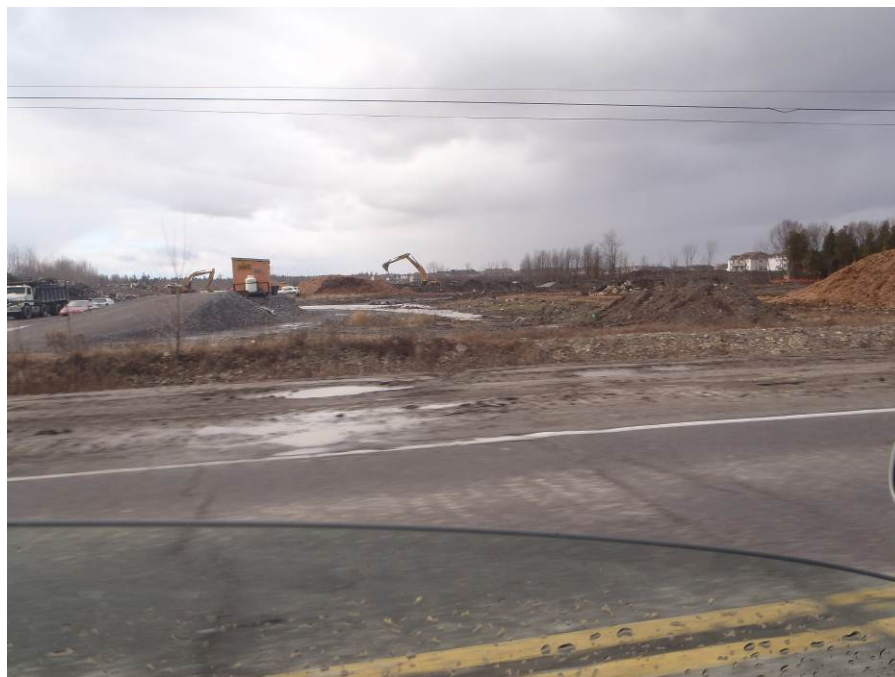
Photograph 9: Looking west towards construction activities taking place at 4798 Bank Street, located 160 m southwest of the Site.

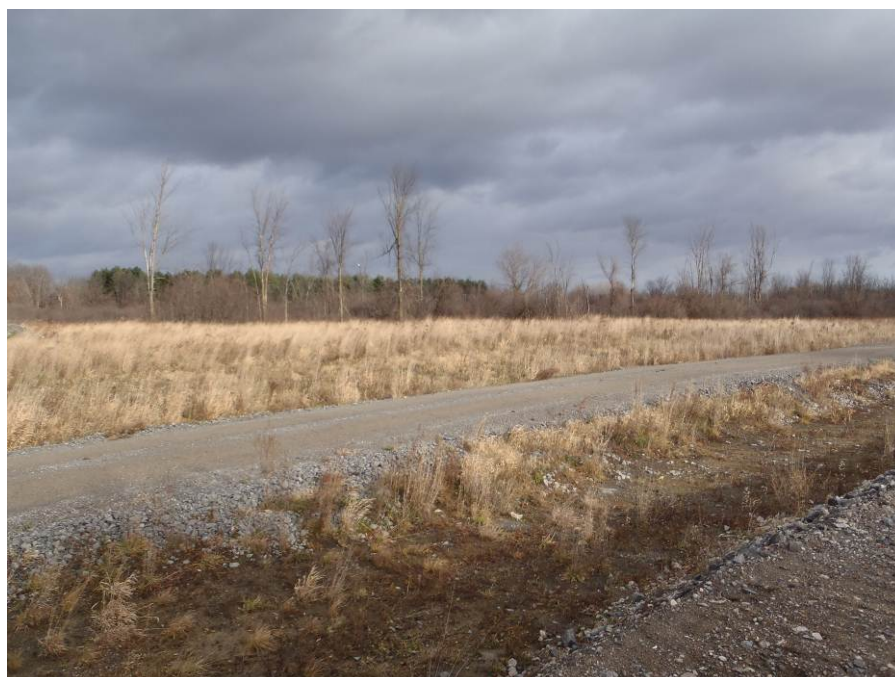
Photograph 12: Looking northeast towards the sewer alignment located on the adjacent vacant land adjacent to the north of the Site.
