**Phase I - Environmental Site Assessment**

5431 & 5505 Fernbank Road  
Ottawa, Ontario

Mattamy Homes

Report: PE3996-1

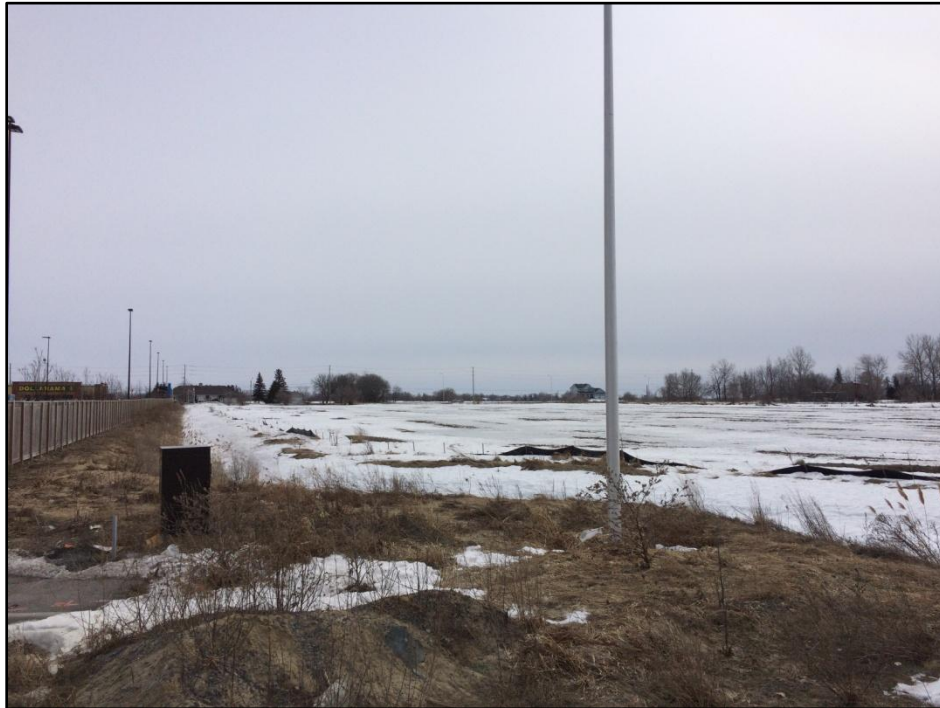
Photograph 1: View of the east property line of 5431 Fernbank Road, looking south from the west end of Cope Drive.

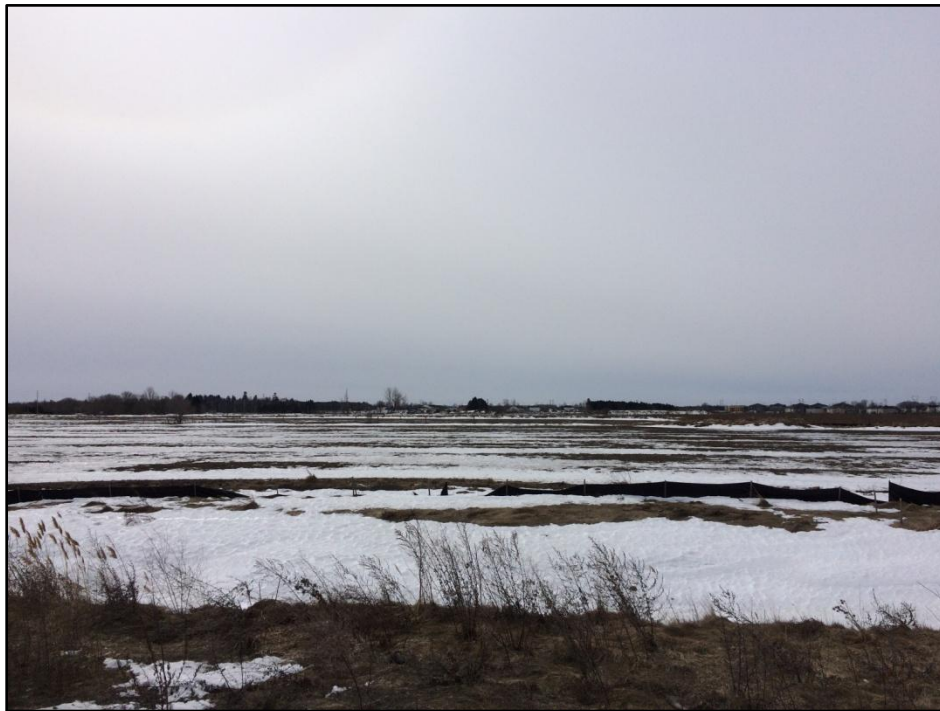
Photograph 2: View of 5431 and 5505 Fernbank Road, looking west from the west end of Cope Drive. The property boundary separating 5431 and 5505 is approximately in the center of the photograph.

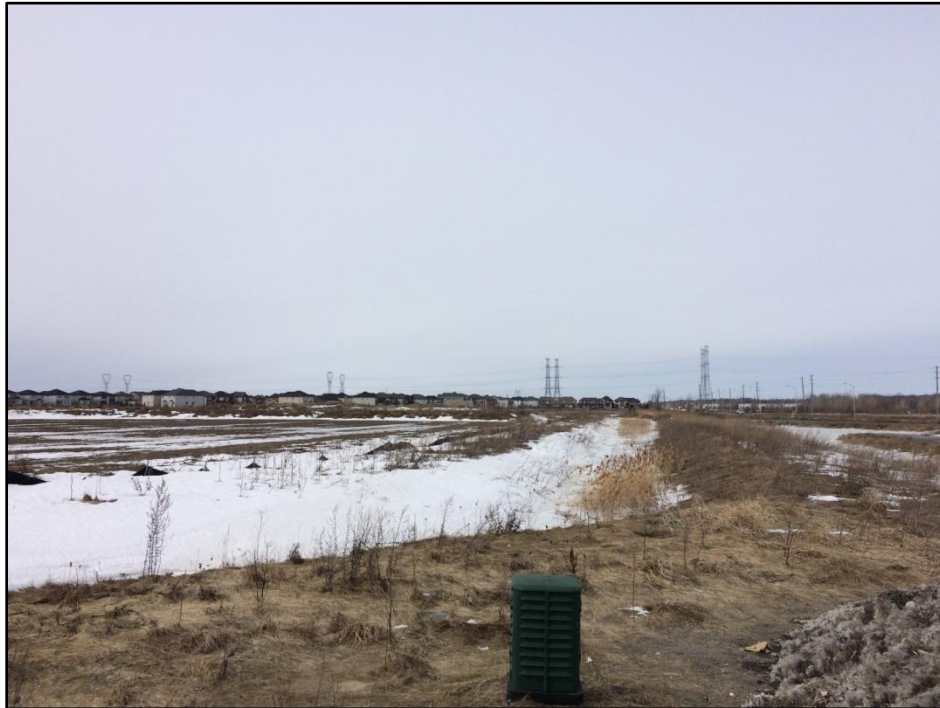
Photograph 3: View of the east property line of 5505 Fernbank Road, looking north from the west end of Cope Drive. Terry Fox Drive can be seen on the right-hand side.

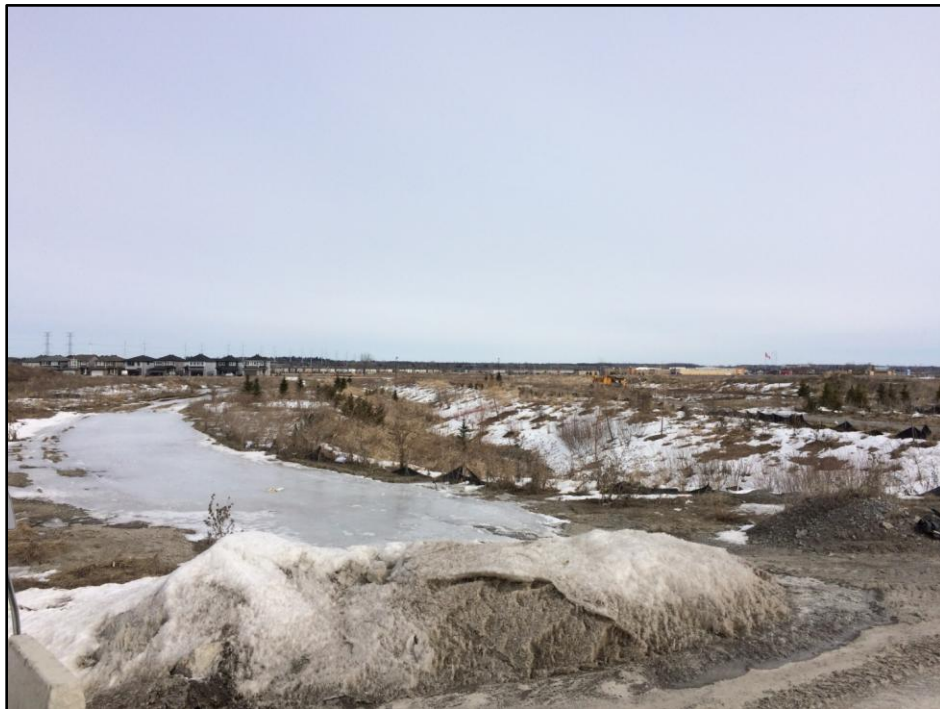
Photograph 4: View of the north property boundary of 5505 Fernbank Road, looking east from the south end of Tapadero Avenue. The Monahan Drain, Branch B, can be seen on the center-right side.

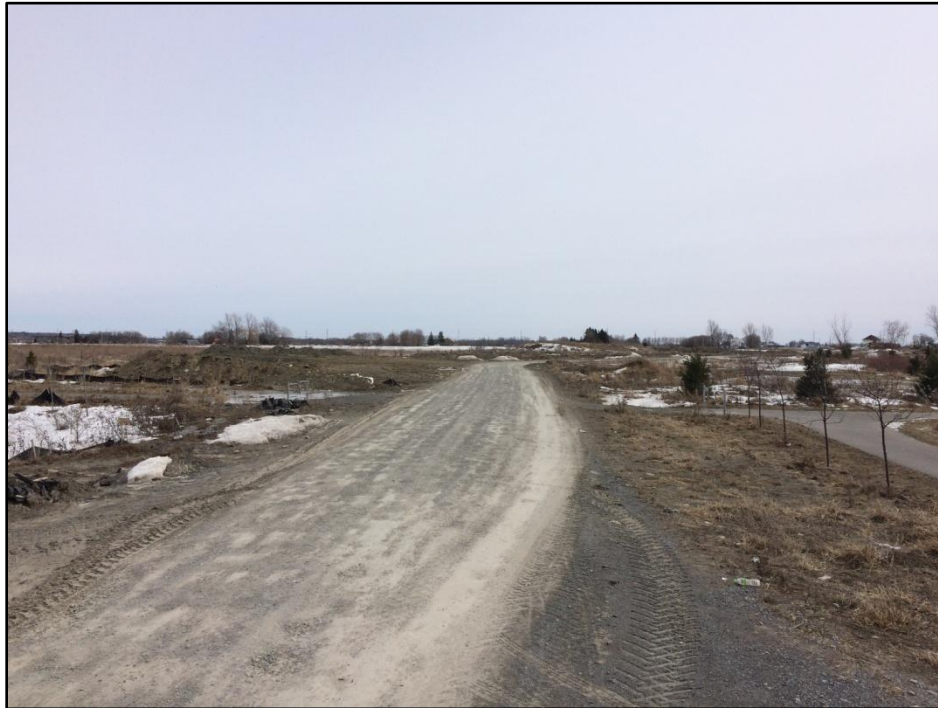
Photograph 5: View of 5505 Fernbank Road, looking south from the south end of Tapadero Avenue.

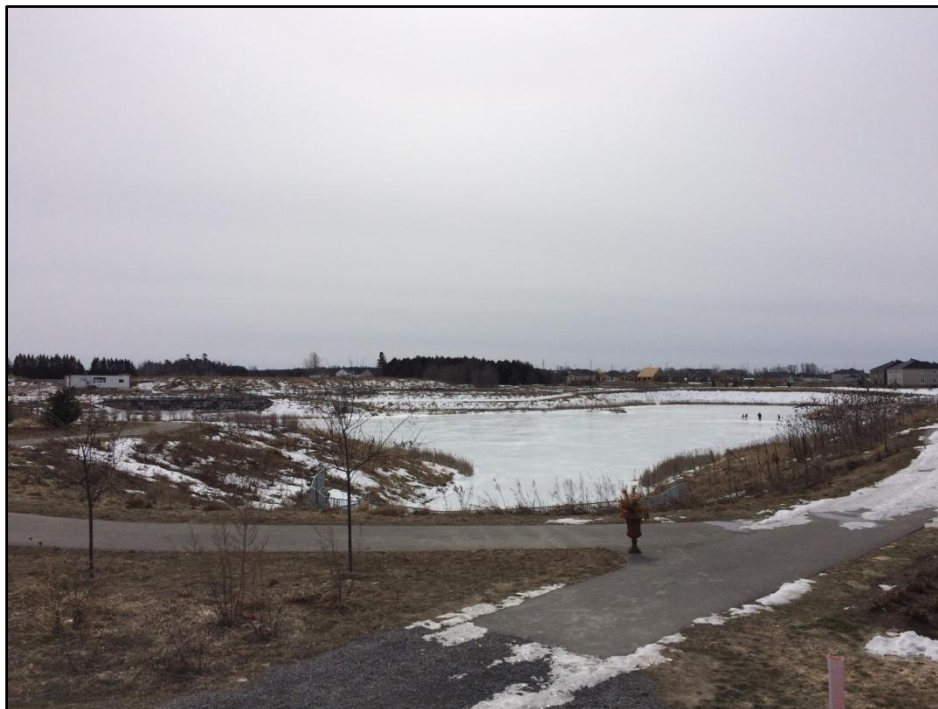
Photograph 6: View of the northwest corner of 5505 Fernbank Road, looking southwest from the south end of Tapadero Avenue. The Storm Water Management Pond associated with the Monahan Drain can be seen in the center of the photograph.

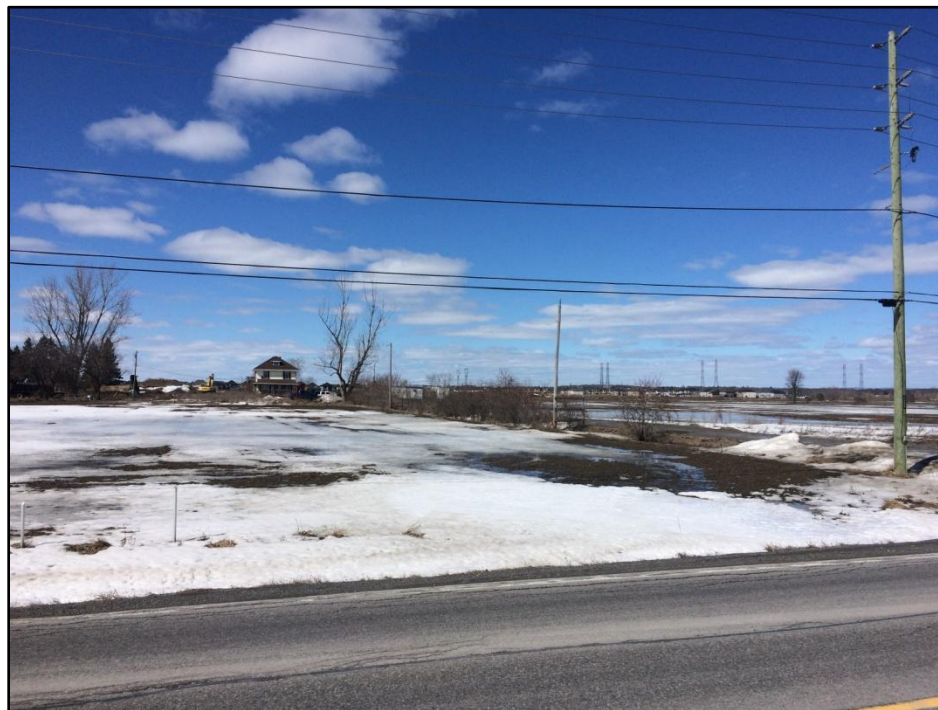
Picture 8: View of the southwest corner of the subject site. The residential dwelling formerly listed as 5555 Fernbank Road can be seen in the photo. Looking north from the south side of Fernbank Road.

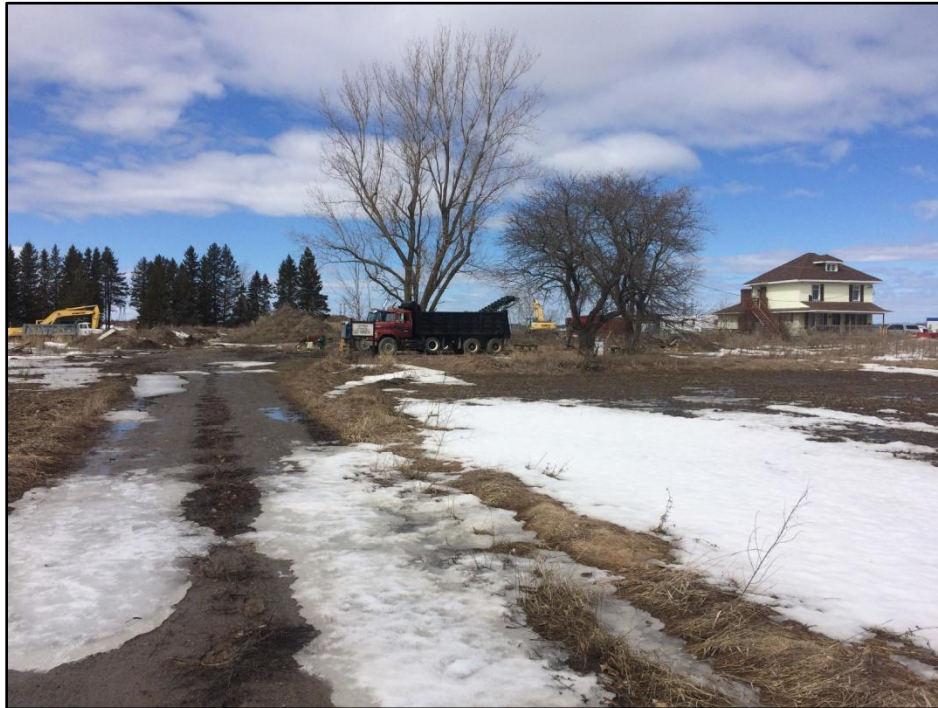
Some waste materials were observed to the west of the 5555 former dwelling. Waste materials consisted of used tires, a car battery, a propane tank and empty gasoline, oil and anti-freeze containers. No staining or adverse odours were noted around these items. It appears that they have just been stored at this location. This general area was also used for parking of onsite heavy equipment. The above-noted site features are shown on Drawing PE3996-1 - Site Plan.

Picture 9: View of the southwest corner of the subject site. The residential dwelling formerly listed as 5555 Fernbank Road can be seen on the right and used vehicles and equipment in and around the waste storage area can also be seen.

It is recommended that the identified waste items be properly disposed of and that future waste generated onsite be properly stored in preparation for disposal.

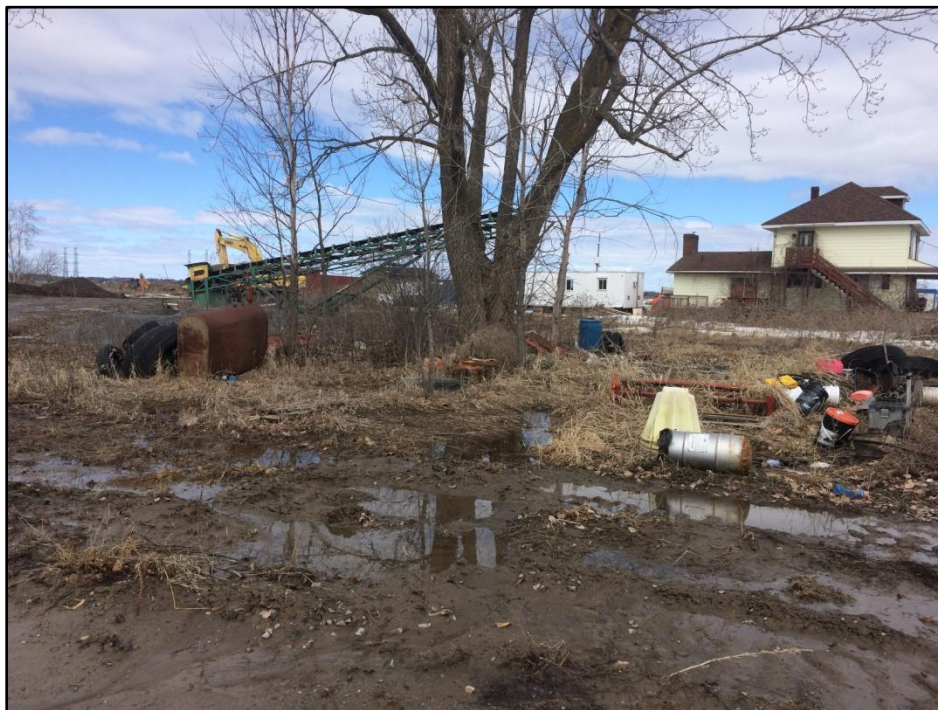
The area west of the 5555 former dwelling was observed to have some waste materials present, however, no staining or adverse odours were detected in this area. Due to the small quantity of waste materials and absence of visible surface soil and water impacts, the waste storage area is not considered a PCA. No other PCAs were observed on the subject site at the time of the assessment.

Picture 10: View of the waste storage area. The residential dwelling formerly listed as 5555 Fernbank Road can be seen in the background. No staining or adverse odours were detected in the waste storage area.

It is recommended that the identified waste items be properly disposed of and that future waste generated onsite be properly stored in preparation for disposal.
