Phase One Environmental Site Assessment

770 Somerset Street West and
13 Lebreton Street North

Ottawa, Ontario

14-12815-001-PH1

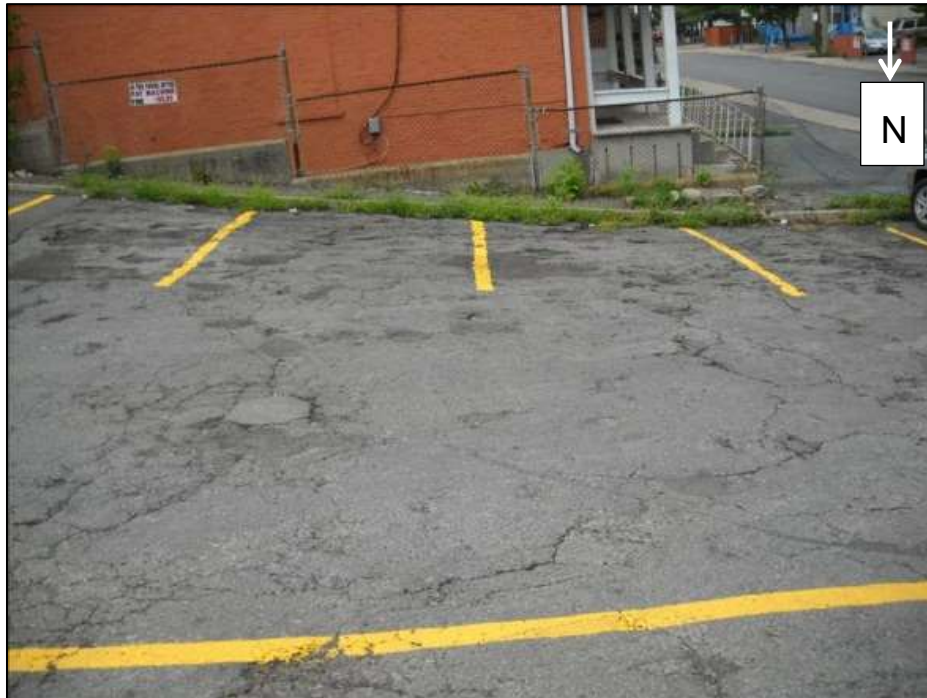
Since the 2001 phase one ESA investigation, the automotive repair shop has been removed and the site has been repaved. The Subject Property consists of a paved asphalt parking lot that is used by the general public. The asphalt on the eastern half was in good condition while the western half was in poor condition (Photograph 1).

Photograph 1: Paved section of parking lot in poor condition.

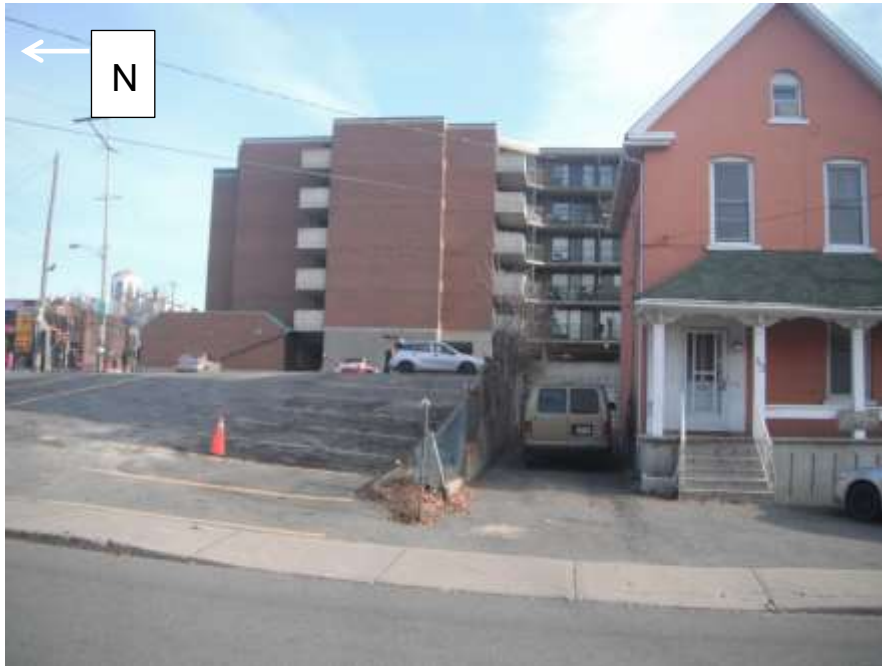
The residence (Photograph 3) is at a lower elevation than the parking lot (Photograph 4). The topography of the Subject Property slopes down to the west.

Photograph 3. Residence at 13 Lebreton Street North

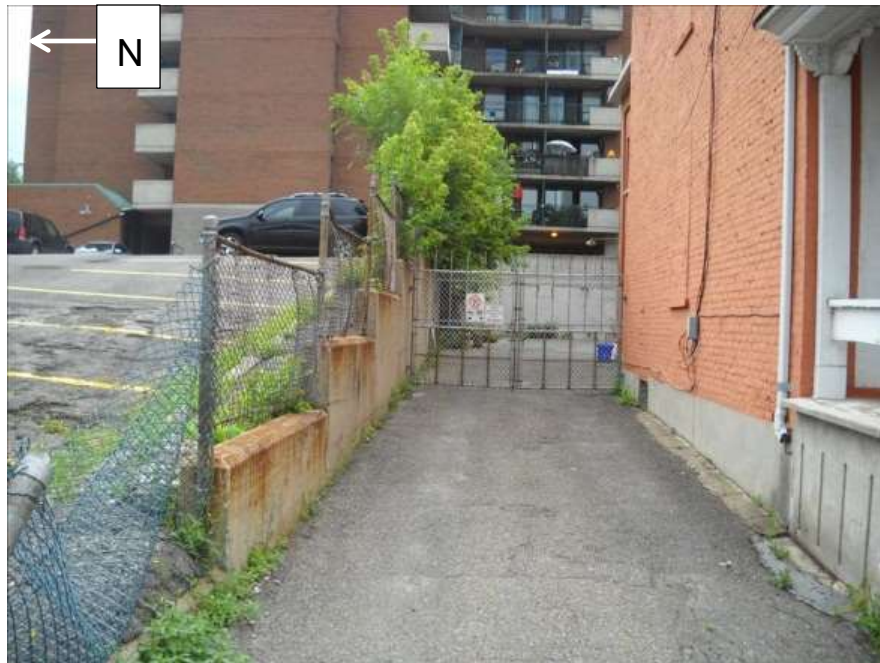
Photograph 4. Boundary between 770 Somerset Street West and 13 Lebreton Street North
